## Incident Summary #II-1215144-2021 (#22593) (FINAL)

| | Regulated industry sector | | Electrical - Low voltage electrical system (30V to 750V) | |
| Incident overview | | An arc flash occurred on an energized 208 volt, 3 phase meter stack in the electrical room of an apartment building while an electrician was replacing a circuit breaker that fed power to one of the units. An abnormal arcing fault resulted in the arc flash, which burned the electrician and travelled up the meter stack ultimately melting through all 3 bus bars. | | |

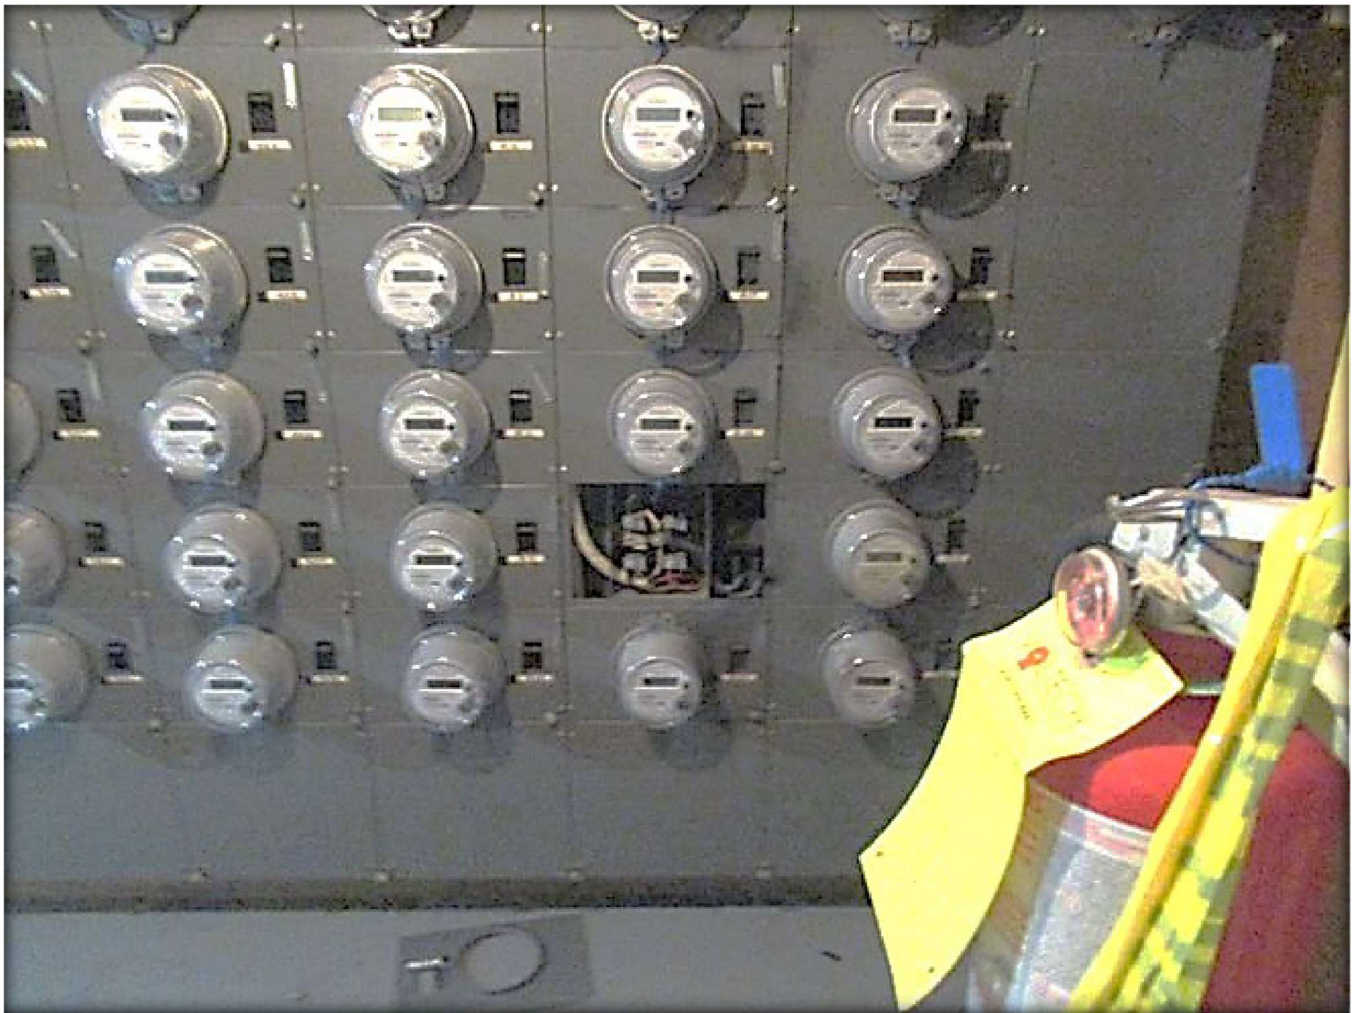
| Facts and evidence | <ul style="list-style-type: none"> <li>-Statement from the electrician that was injured that they were changing a breaker in the damaged meter stack (SEE FIGURE #1), and that they had not shut off the main disconnect.</li> <li>-Statement from the electrician that they had performed the same removal and replacement procedure without incident two days prior.</li> <li>-Statement from the electrician that they heard a boom and saw a large flash while attempting to push the breaker into the bus bars, and that no tools were being used at that moment.</li> <li>-Statement from WorksafeBC that the only personal protective equipment (PPE) in use by the electrician was a medical mask and standard work gloves.</li> <li>-Statements from witnesses on site that the electrician had char marks on his face, that the chest area of his shirt was black, and that his eyes were very red immediately after the incident.</li> <li>-Statements from witnesses that there was smoke in the corridor outside the electrical room and a burning odour, but no signs of fire.</li> <li>-The plastic insulator between breaker connection points on bus bars was broken off, and part of it was found on the floor. SEE FIGURE #4.</li> <li>-The bolt-on connection terminals of the breaker were visibly melted. SEE FIGURE #3.</li> <li>-The breaker connection points on the bus bars were significantly melted. One of them melted completely through at a bolt hole, and the remaining piece was found on the floor. SEE FIGURE #2 and #4.</li> <li>-All three bus bars were melted through at two meter positions above where the breaker was being replaced. SEE FIGURE #5 and #6.</li> </ul> |

Figure 1 - Meter stack post incident with open cover where breaker was being changed while energized.

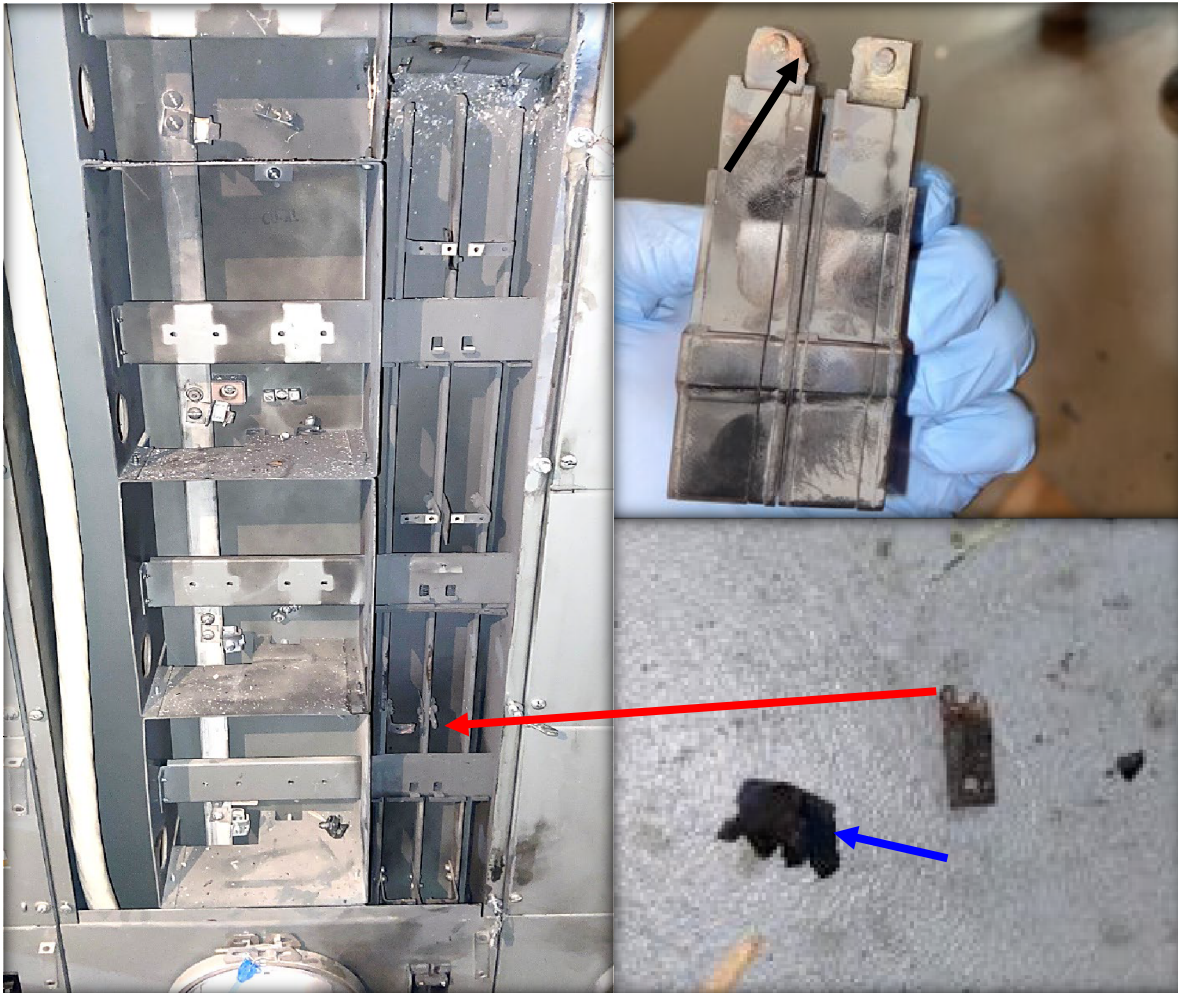
Figure 2 (left side) - Meter stack with metal breaker attachment bracket broken off and on the ground. (red arrow)

Figure 3 (top right) - Metal tabs of the circuit breaker melted (black arrow)

Figure 4 (bottom right) - Piece of broken breaker insulation (blue arrow), piece of melted bus bar connection tab (red arrow)

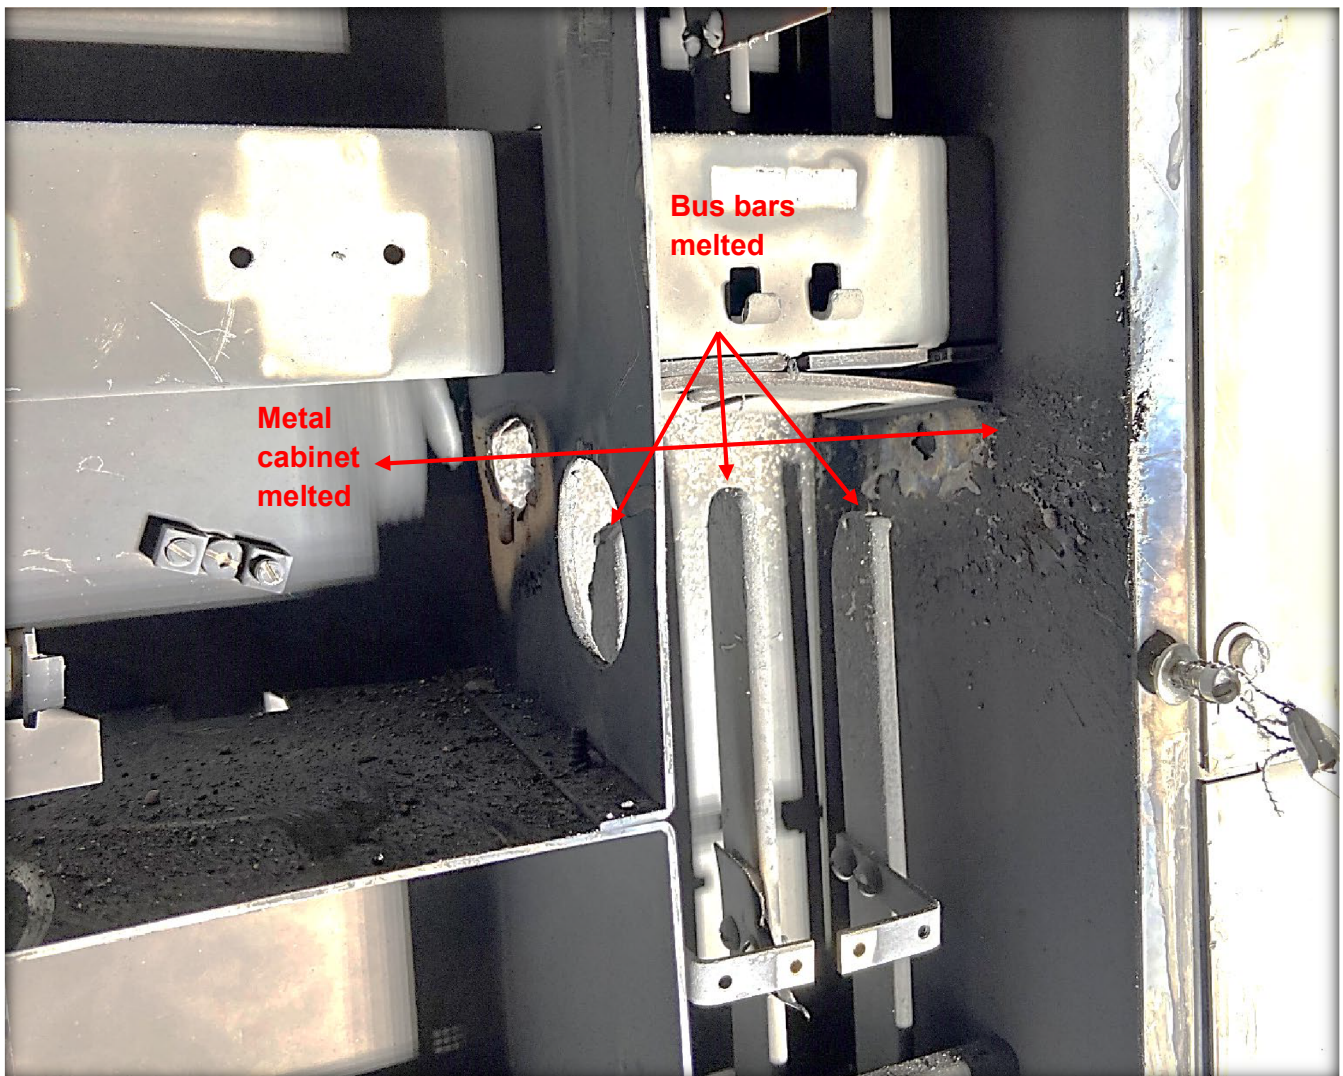
| | <ul style="list-style-type: none"> <li>-Holes were melted in the sides of the meter stack cabinet (SEE FIGURE #5) at the location where the bus bars melted through, indicating that the arc flash conducted to the grounded metal enclosure as well as the bus bars.</li> <li>-Molten metal droplets were found throughout the meter stack.</li> <li>-The interior side of the protective covers above the position where the breaker was being changed were found to be black with smoke damage. The protective cover for the position where the breaker was being changed was clean, indicating it was not in position when the incident occurred. SEE FIGURE #1.</li> <li>-Arc flashes can occur when an electrical connection is made through the air between two phases of an electrical system. The energy involved in the arc flash is dependant on the voltage and current available as well as the time it takes the overcurrent protection to clear the fault.</li> <li>-The Canadian Electrical Code and regulatory requirements stipulate that no repairs or alterations should be carried out on live equipment except where disconnection of the equipment is not feasible. Technical Safety BC also has a directive and information bulletin regarding requirements to not work on energized equipment that can be found at the links below:<br/> <a href="https://www.technicalsafetybc.ca/alerts/directive-bc-electrical-code-section-2-general-rules">https://www.technicalsafetybc.ca/alerts/directive-bc-electrical-code-section-2-general-rules</a><br/> <a href="https://www.technicalsafetybc.ca/alerts/information-bulletin-section-2-requirements-de-energize-electrical-equipment">https://www.technicalsafetybc.ca/alerts/information-bulletin-section-2-requirements-de-energize-electrical-equipment</a> </li> <li>The Technical Safety BC information bulletin also references the WorksafeBC requirements for working on energized equipment, under which the preferred method is also de-energization.</li> </ul> |

Figure 5 - Bus bars and metal cabinet melted from the arc flash event.

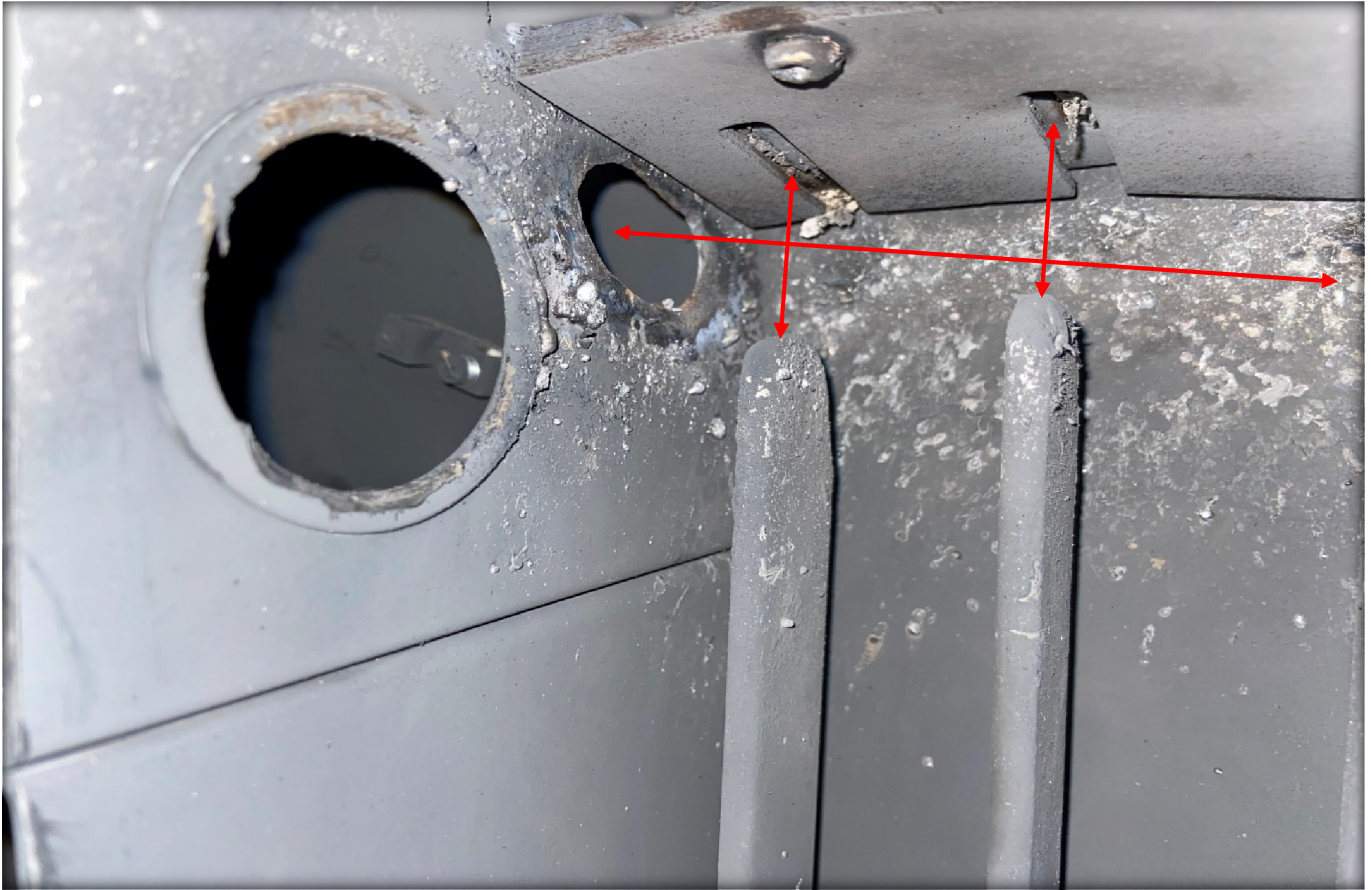
Figure 6 – Close up of bus bars and metal enclosure melted from the arc flash event.
