Incident Summary #II-1253159-2021 (#23971) (FINAL)

| | Regulated industry sector | | Electrical - Extra low voltage (less than 30V) | |
| | Damage | Damage | Damage description | Toxic gas release from a lead acid battery |
| Incident overview | | Workers were exposed to toxic gases from the fumes of a continuously charging lead acid battery. | | |

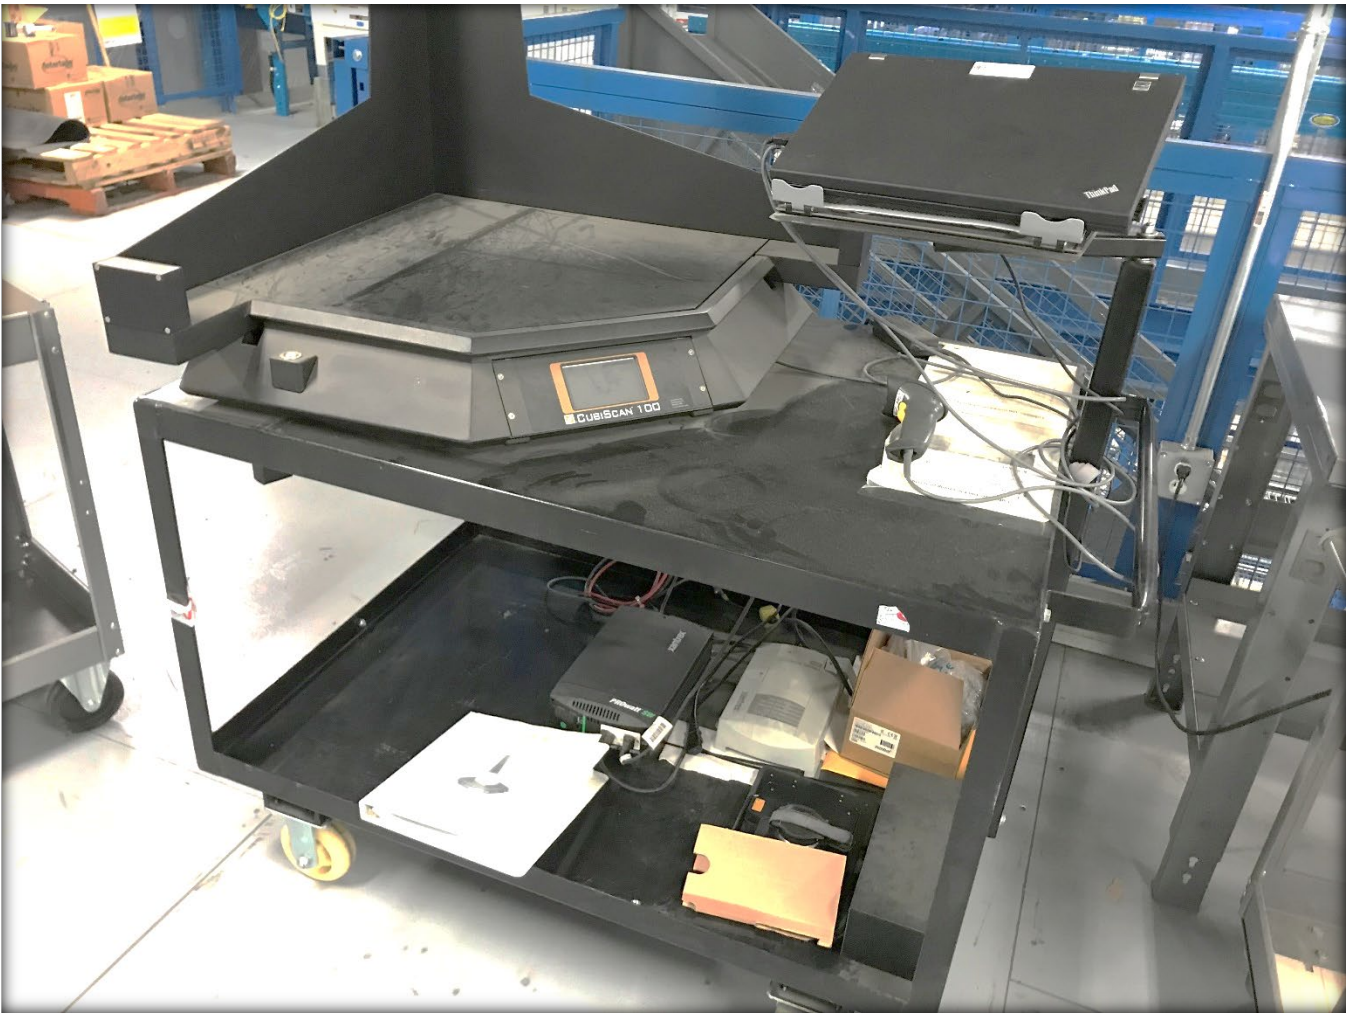
Figure 1 – Cubiscan parcel measuring machine (battery was on the bottom left)

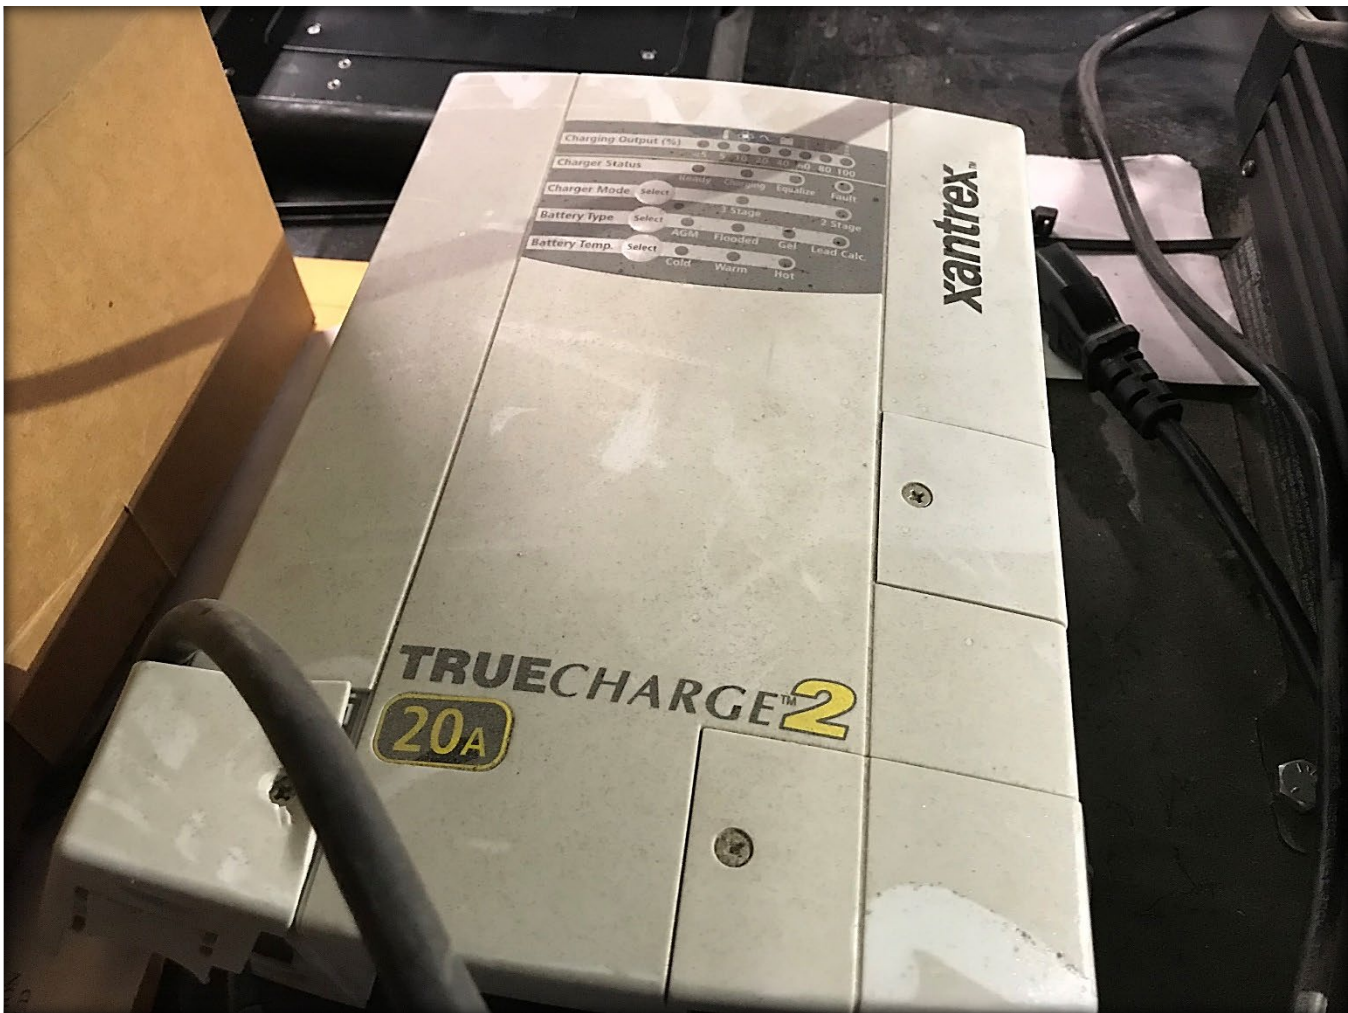
Figure 2 - Battery charger

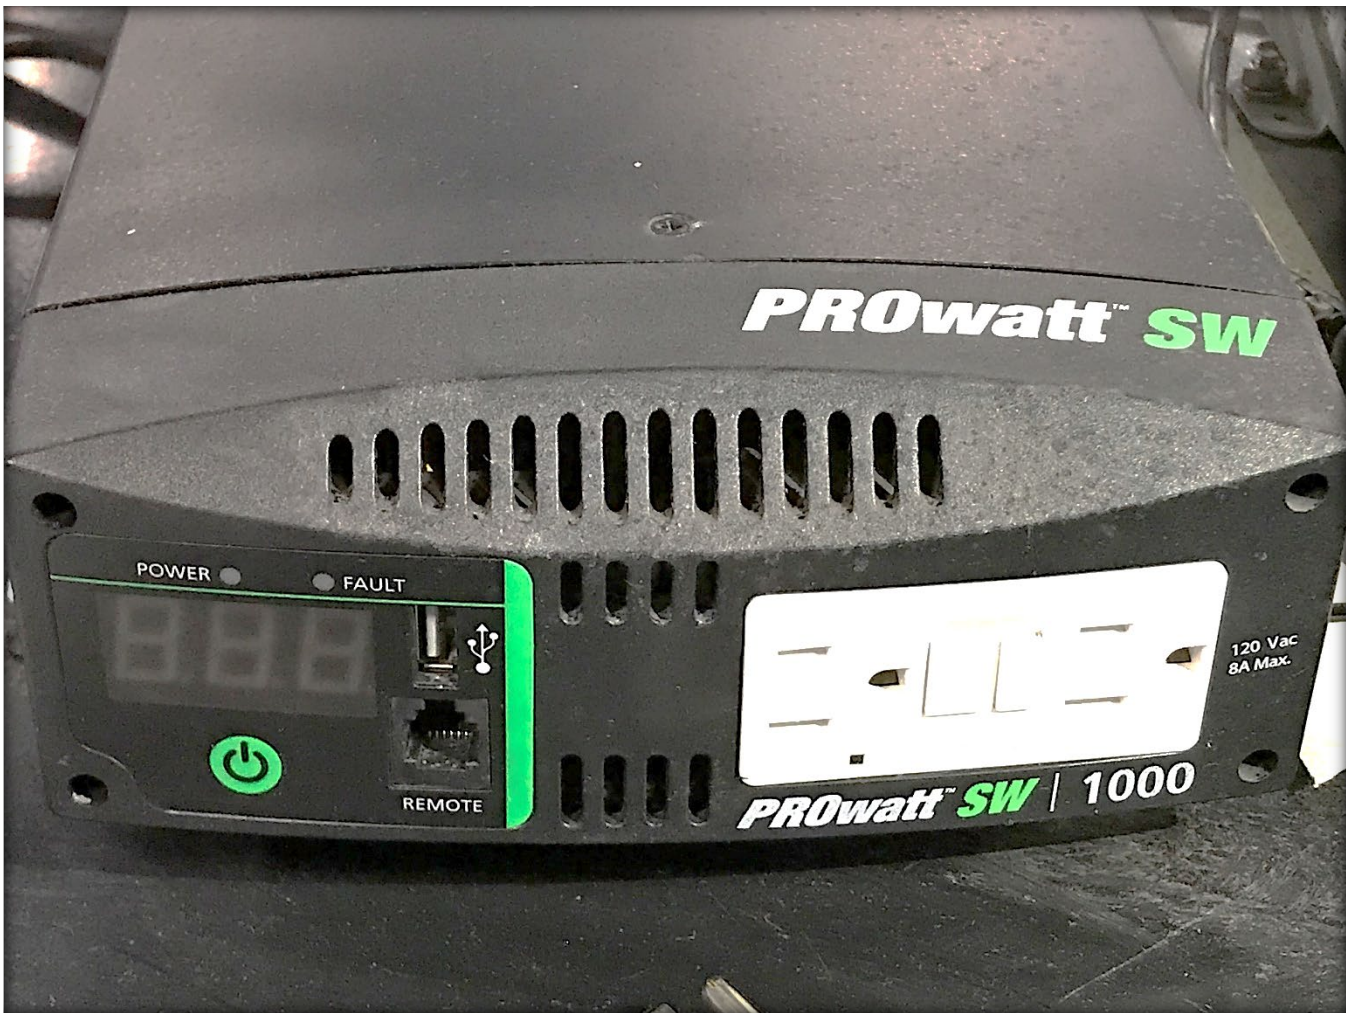
Figure 3 – Inverter that converts DC battery power to AC to power the Cubiscan 100

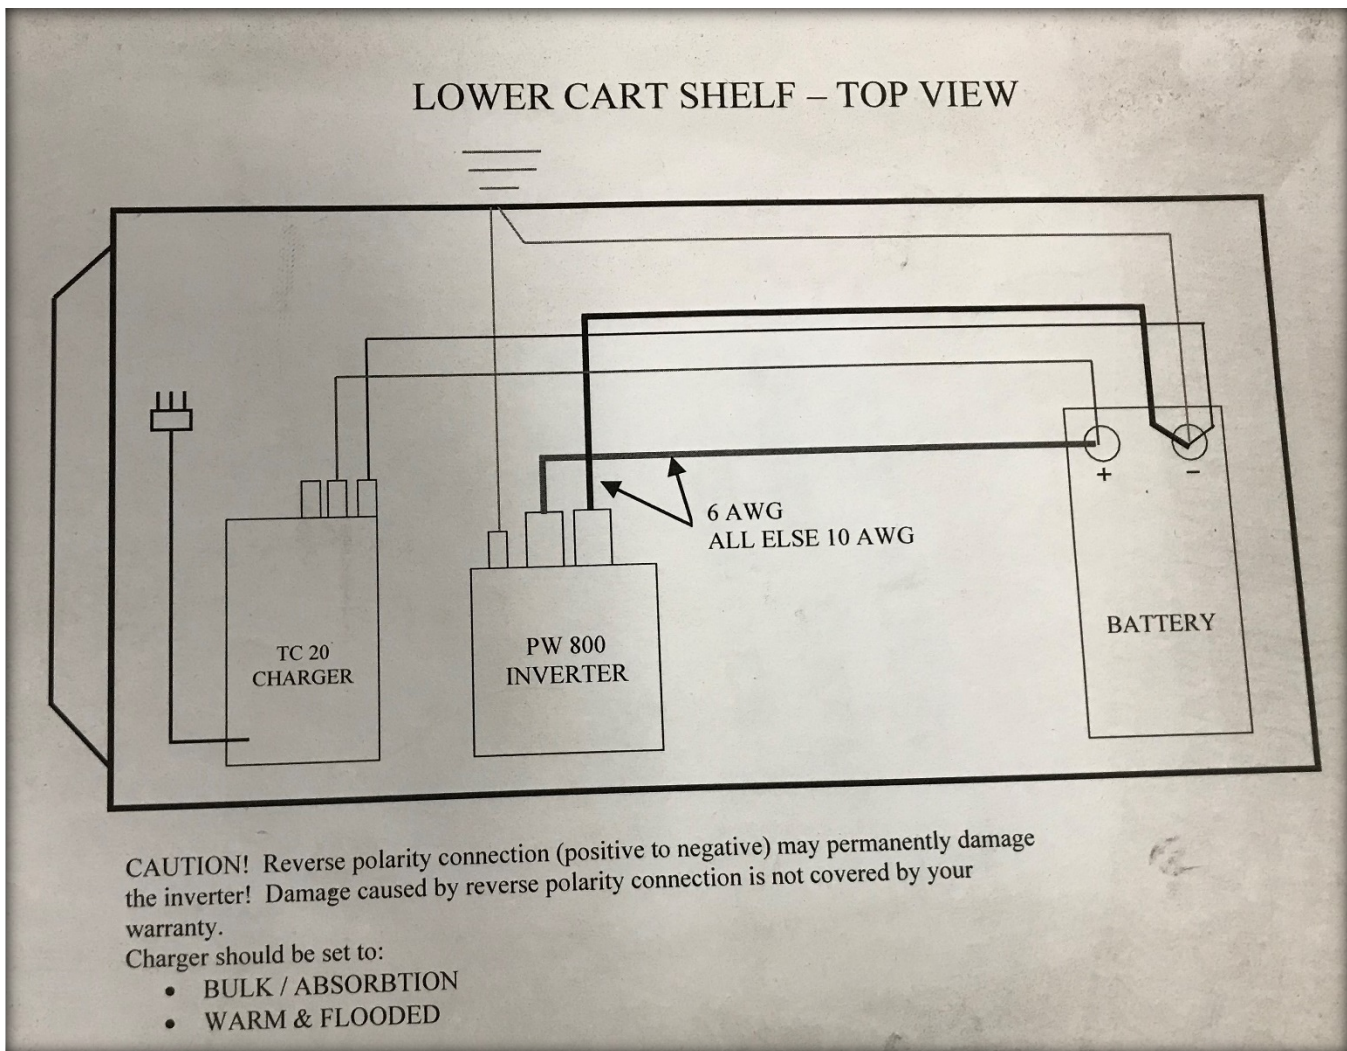
Figure 4 - Power supply system diagram from the Cubiscan 100 manual, charger was set as per the bullets.

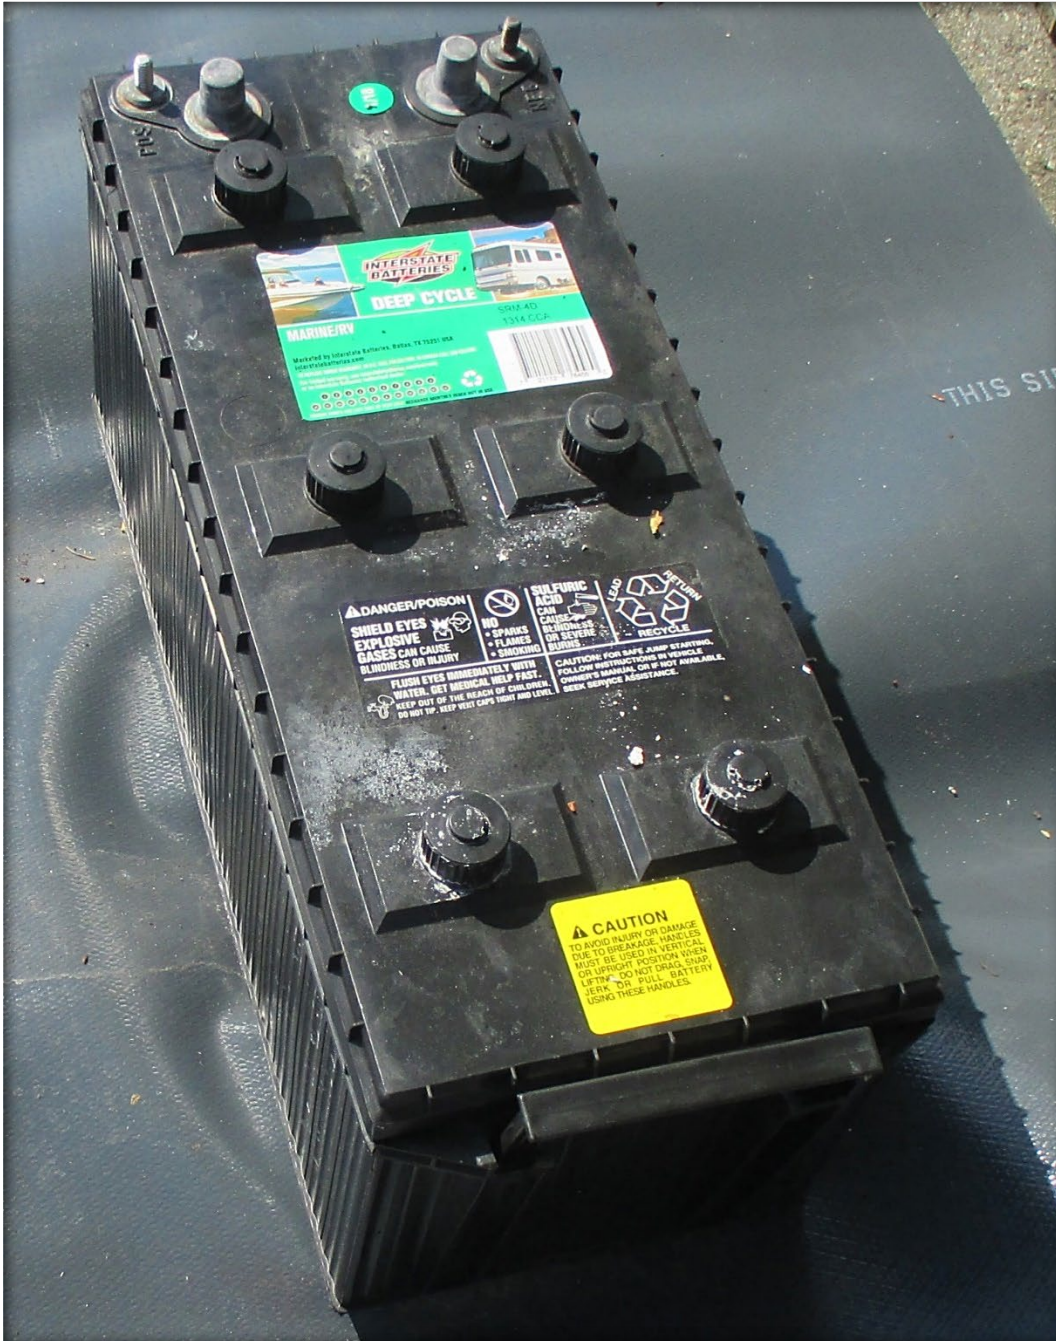
Figure 5 - Battery showing signs of electrolyte residue (white powder)

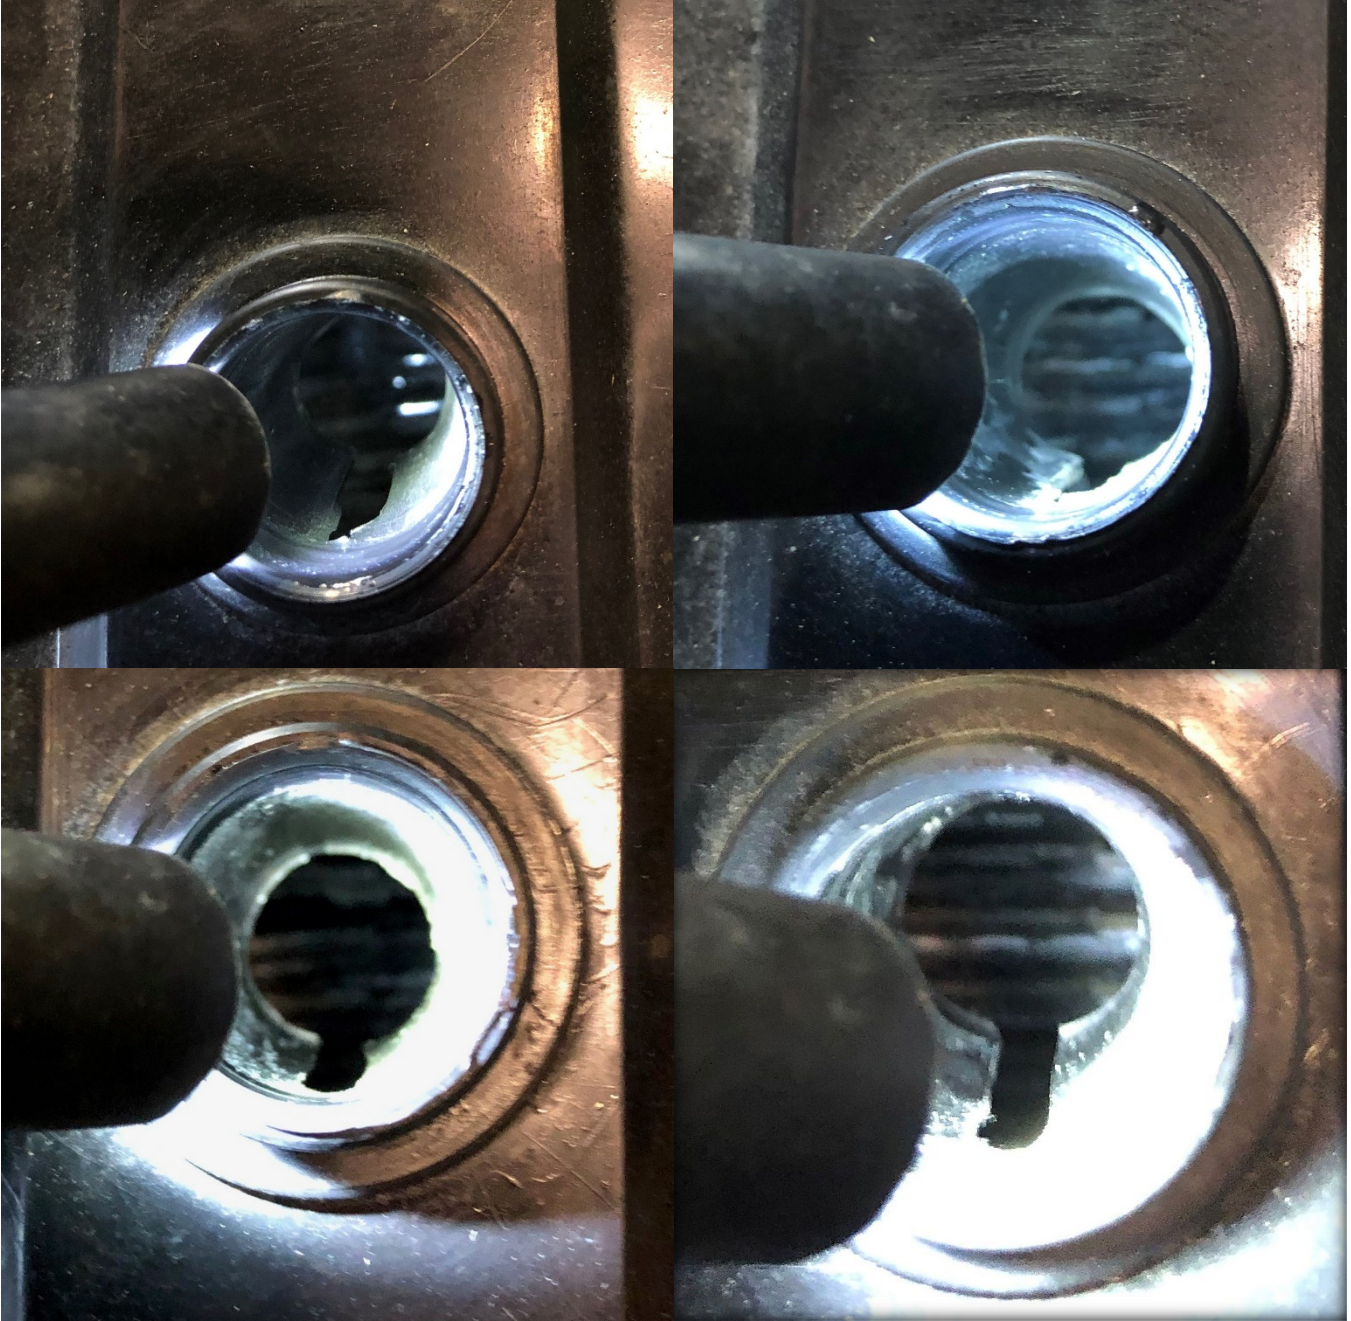
| Failure scenario(s) | <p>The Cubiscan parcel measuring machine was stored for three years on the third floor of the bottle tower as it was not in use. Prior to the incident, the charger was plugged in and the battery was left charging. This very likely resulted in four of the six cells, as the fluid levels depleted, emitting toxic gas such as hydrogen sulphide and sulphur dioxide gas into the indoor workspace as the remaining fluids boiled off. The gas was likely drawn to the open entry doors on the ground level where workers were exposed to the gas.</p> |

| Causes and contributing factors | <p>The incident was very likely caused by the extended overcharging of a lead acid battery without preservation of the battery's minimum fluid levels.</p> <p>The battery's exclusion from the site's maintenance plan was a contributing factor.</p> |

Figure 6 - Of the six cells, four were empty as confirmed by the battery manufacturer's representative.

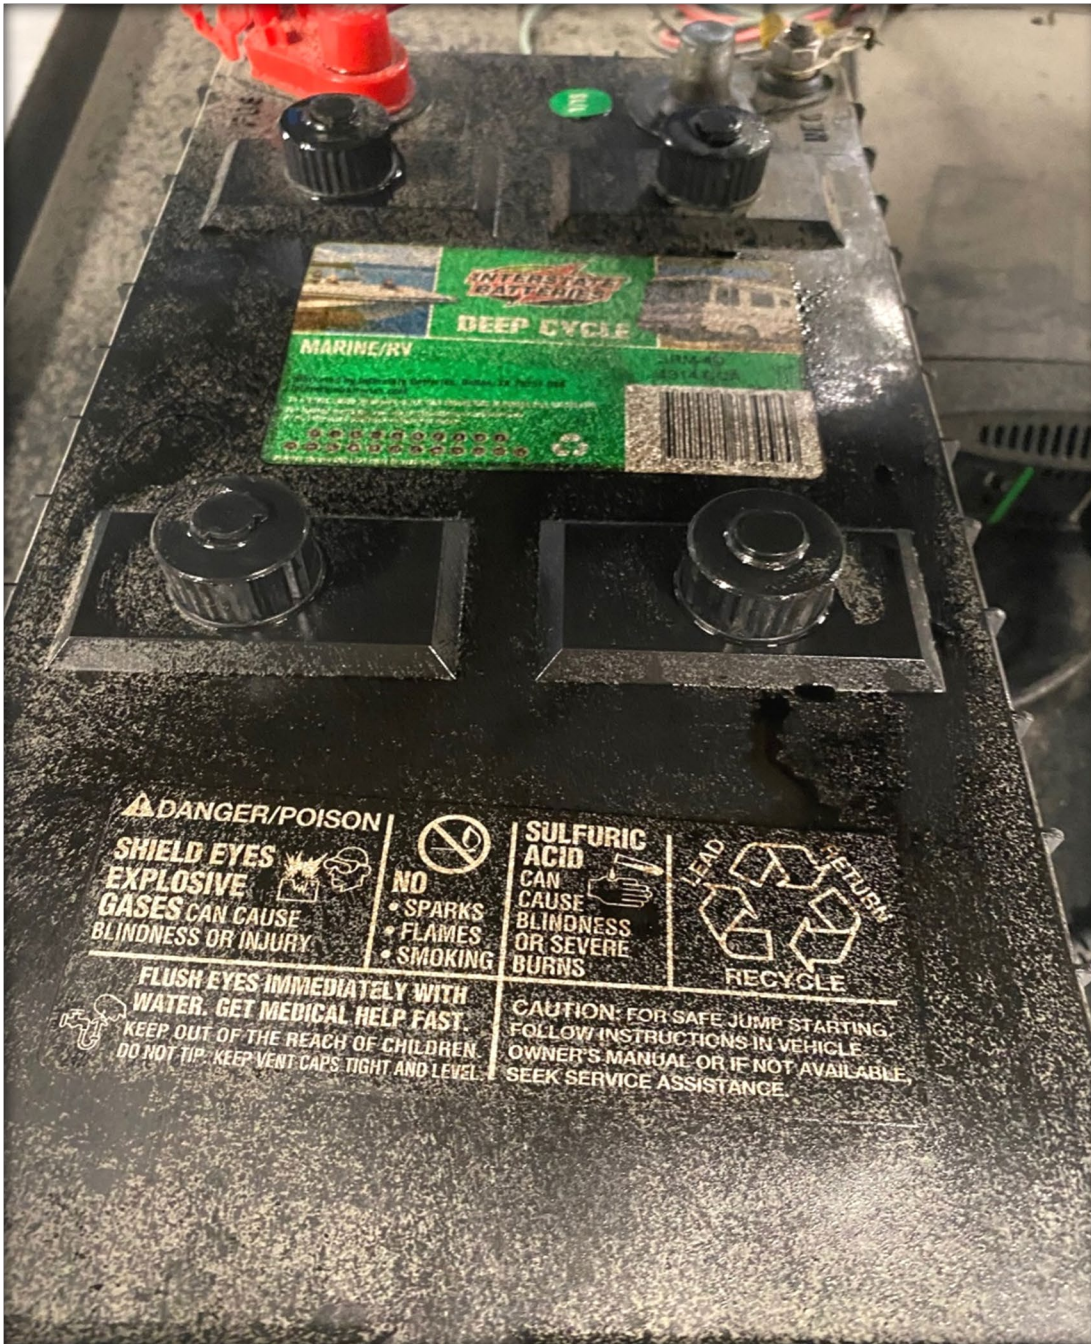
Figure 7 - Battery after the incident with fluid accumulations.
