Incident Summary (II-636492-2018)

SUPPORTING INFORMATION	Incident Date	December 15, 2017
	Location	Langley
	Regulated industry sector	Natural gas system
	Qty injuries Injury description	0
		None
	Injury rating	None
	Damage description Damage rating	Fire damage was contained to exterior wall behind gas fireplace termination
	Damage rating	Minor
	Incident rating	Minor
	Incident overview	A new installation of a gas fireplace installed in a two year old home overheated the combustible wall and caused a minor fire at the side wall termination
INVESTIGATION CONCLUSIONS	Site, system and components	The fireplace installation was a direct vent installation, the chimney has a five inch inside pipe for exhausting the flue products and a eight inch outside pipe for combustion air that extends from the fireplace flue connection to the side wall exhaust termination allowing for sealed combustion, this fireplace is sealed from the interior of the home and uses outside air for combustion. When this type of fireplace is installed the manufactures tests and certifies the installation with required clearances to the fireplace shell and venting materials To begin the operation of the fireplace unit,

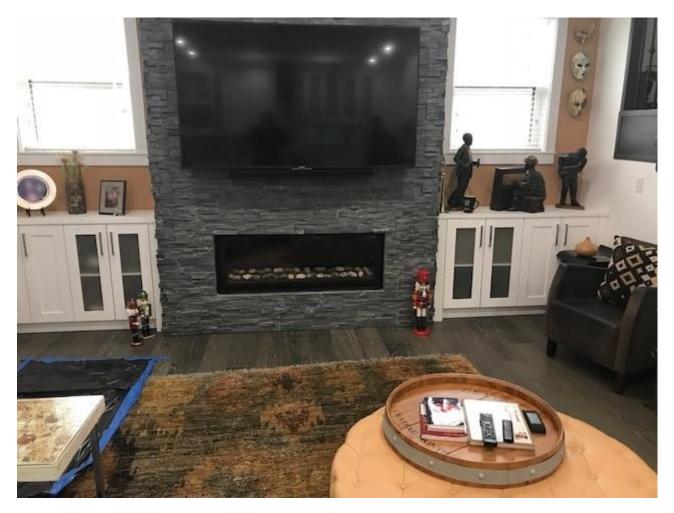
Interior view

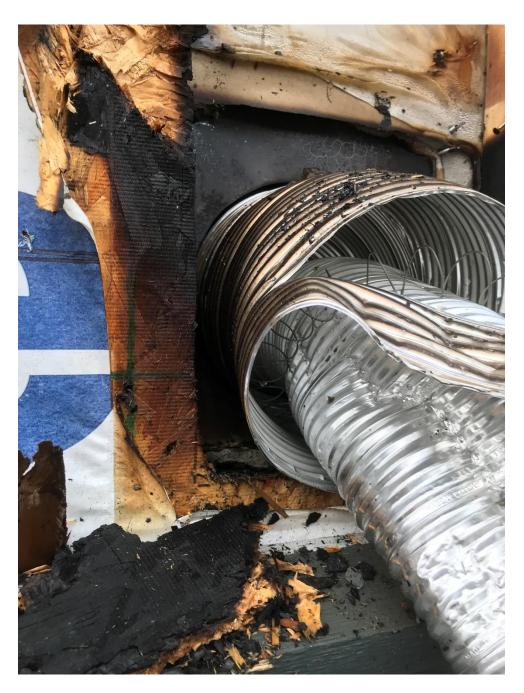
Both of these convection processes immediately begin to slow down, and eventually stop, as soon as the burners turn off.
Failure scenario(s)	Home owner was using fireplace when fire occurred caused by flue gas (heat) escaping from venting system into combustible space just behind vent termination
Facts and evidence	 Two year old installation – confirmed by gas permit Conversation with owner, he indicated that the fireplace was used 6-8 times over the last two years Photographic evidence indicates that the fires origin was directly behind the fireplace vent termination The fire was contained to the area behind the vent termination by the building fire stopping based on the photographic evidence
Causes and contributing factors	The plausible cause of this fire was that the vent pipe and intake piping was split open inside the combustible area directly behind the vent termination allow flue gases to escape which caused the wood framing to catch on fire

Location of fire origin

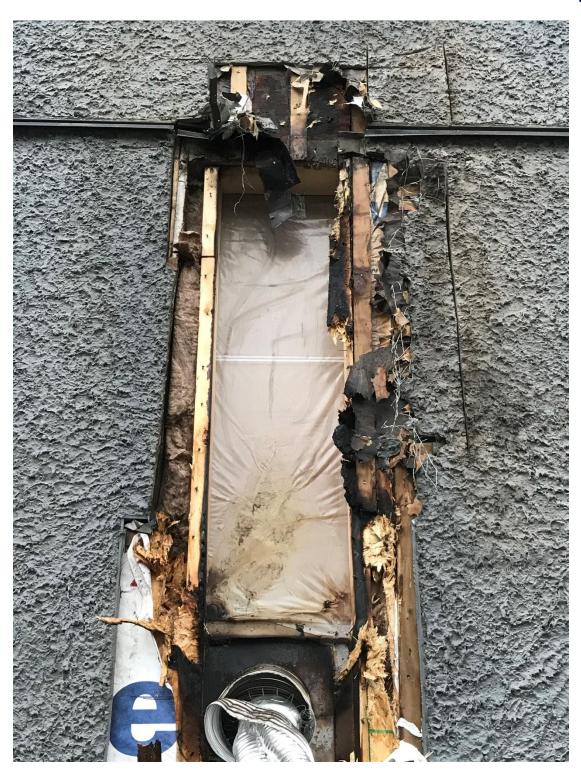
Damage to exterior wall

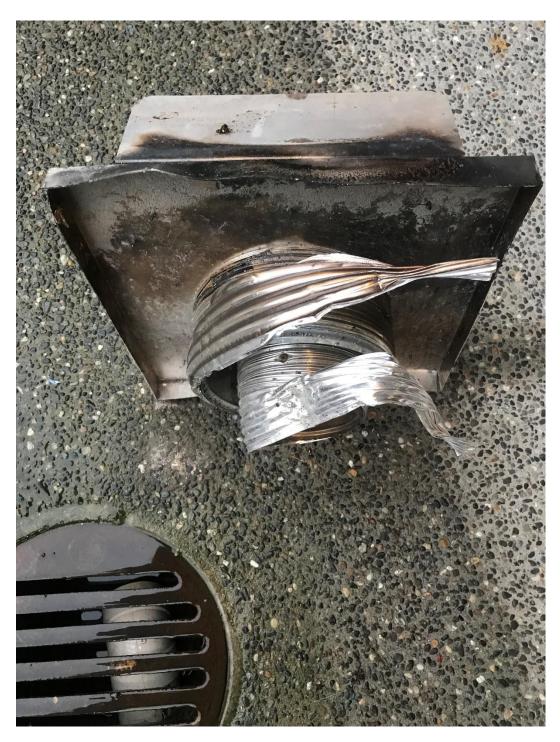
Shows heat was most intense at top edge

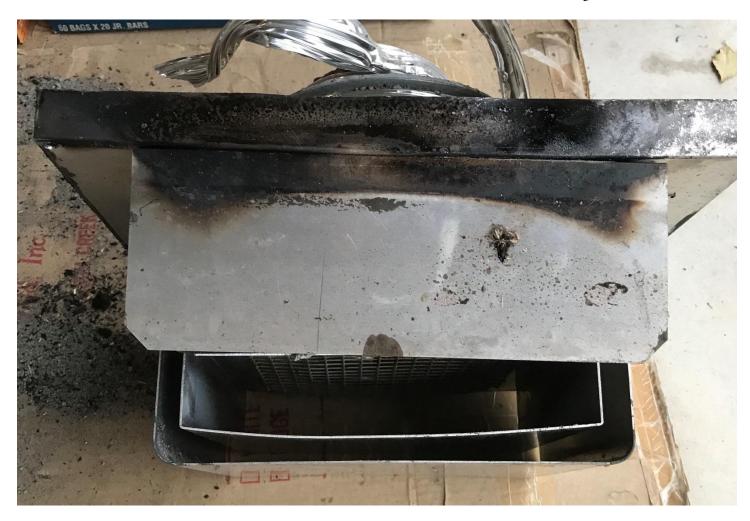
Top and front view of termination
