Acuren Group Inc.

October 11, 2024

File Number: 605-J165446
EGBC Permit Number: 1001973

Re: Outdoor Fibreglass Water Slide Cracking

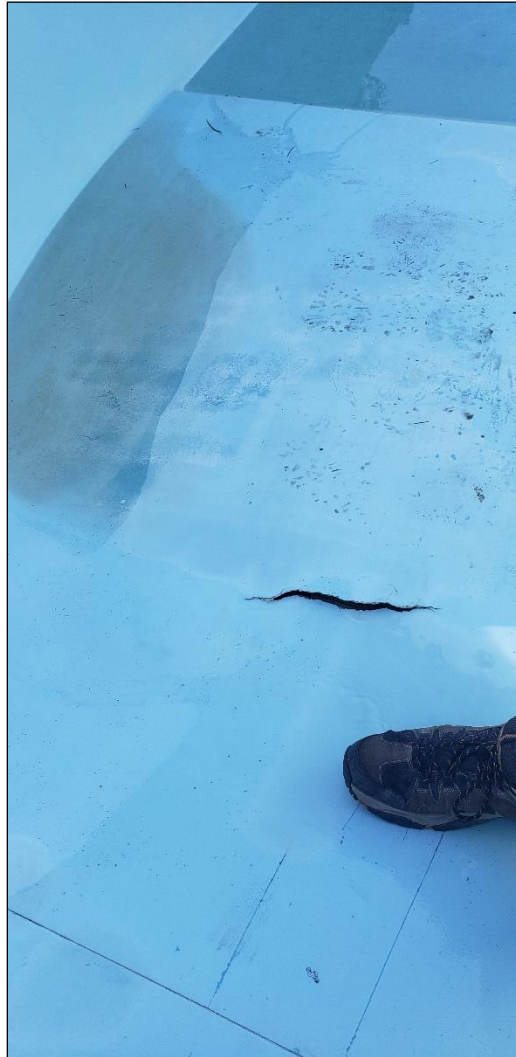
An outdoor fibreglass waterslide suffered cracking which resulted in injuries to the users. An overall view of a typical cracked area is shown in Figure 1 and Figure 2. A sample of the cracked fibreglass was removed from the slide as shown in Figure 2.

Figure 1 Overall view of transverse fracture in fiberglass slide.

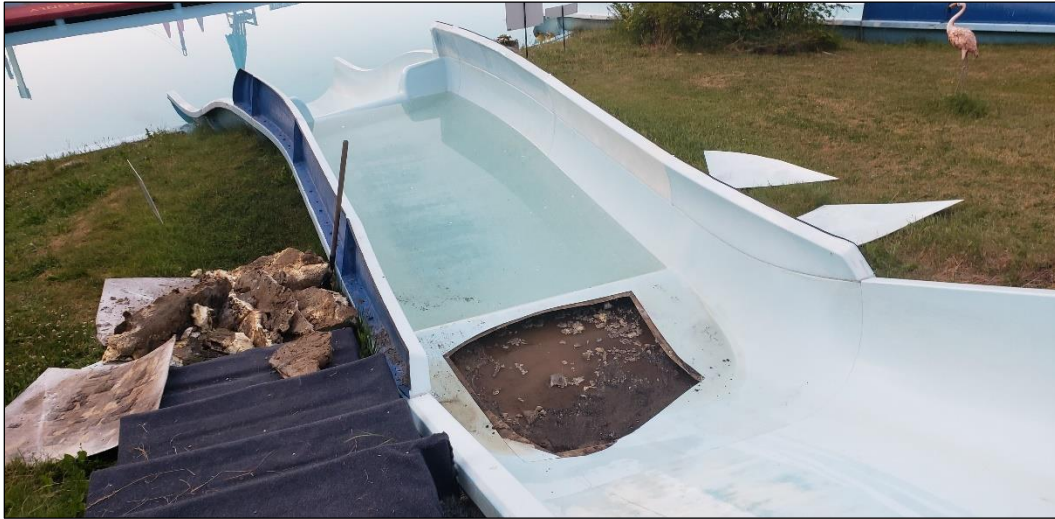
Figure 2 Area of cut out fibreglass showing deteriorated foam under cracked panel.

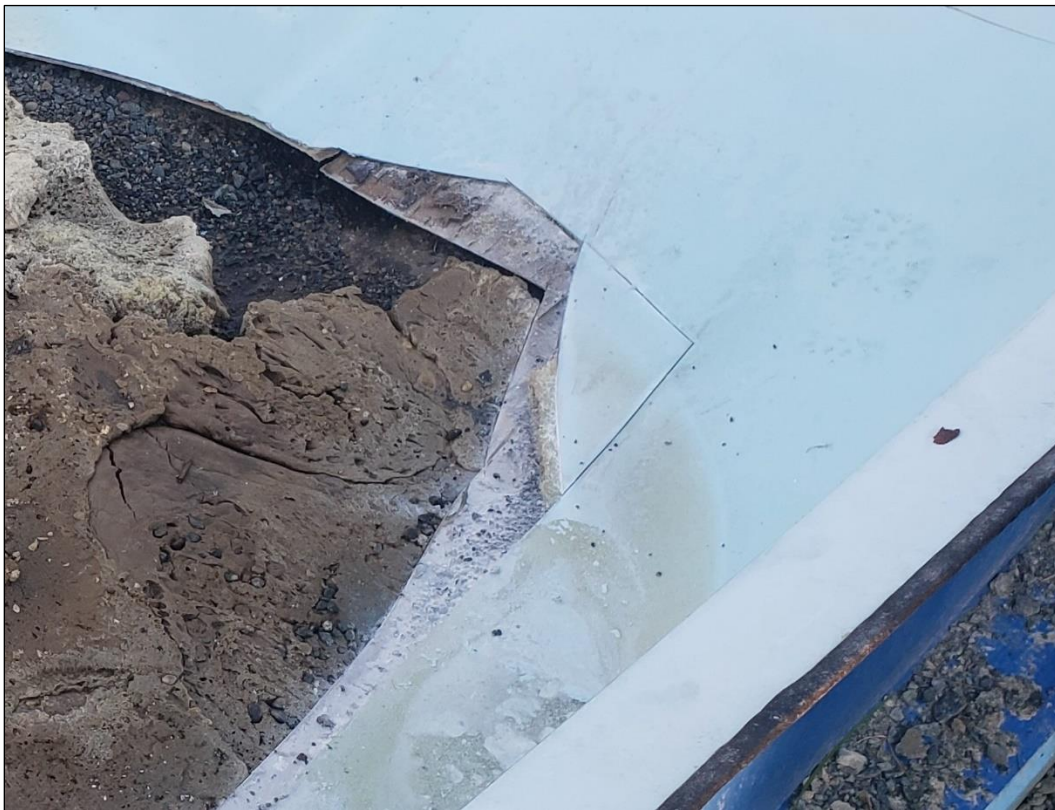
The fibreglass sliding surface is supported by the ground into which the slide is placed and the wooden core which separates the inner and outer fibreglass components of the slide. The slide construction is shown in Figure 3.

Figure 3 Cut is slide near fracture showing slide construction with wood core and an inner and outer layer of fibreglass. Underlying dark material is injected foam.

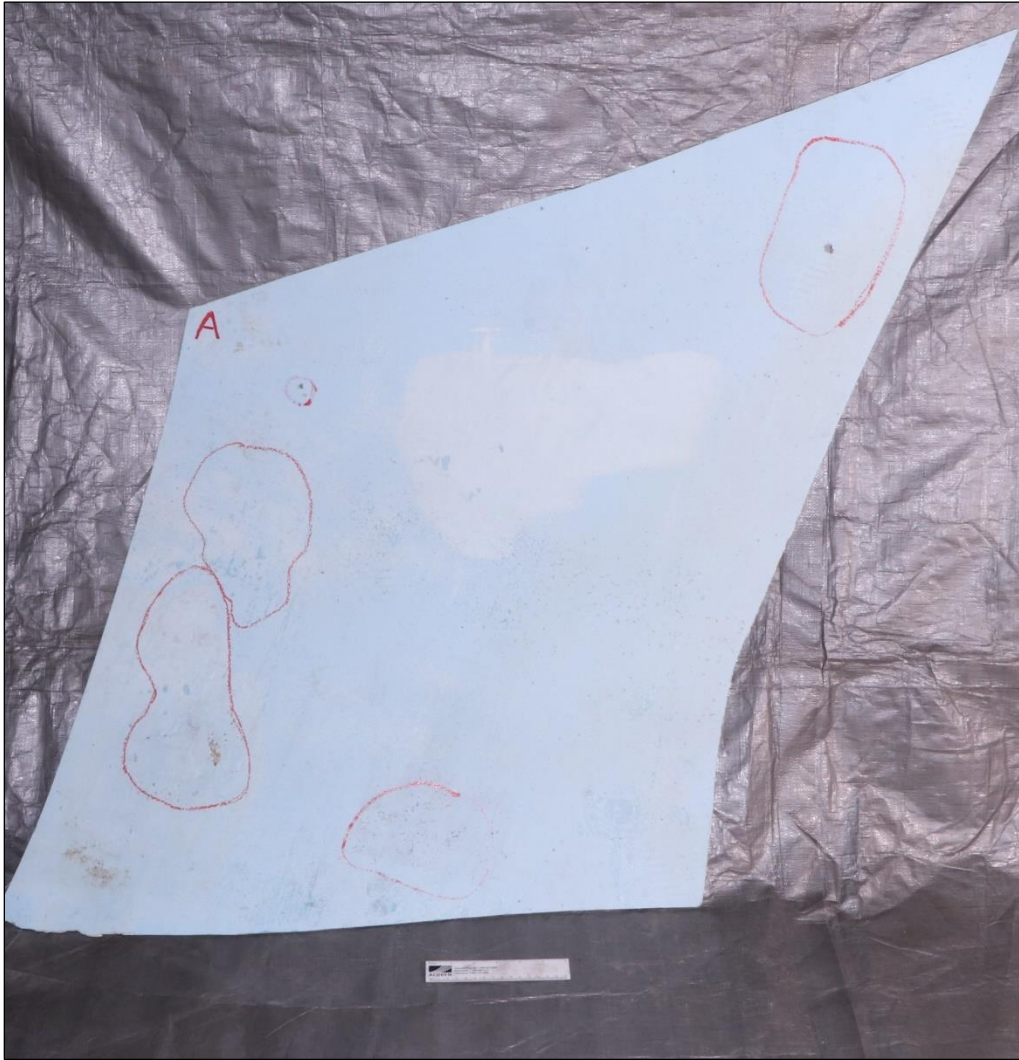
Samples A - E are relatively large pieces cut from the slide. The pieces contain evidence of drilled holes where foam was injected to prevent deflection. The time at which the foam was placed is not known. All of the pieces show evidence of discolouration and deterioration from exposure to the environment. Evidence of prior repair patches are present with samples A - C and show discolouration in the form of light patches (Figures 4, 6, and 8). The light patches are evidence of disbonding of the gel coat from the underlying glass fibres.

Figure 4 Sample A running surface showing discolouration and areas of surface damage.

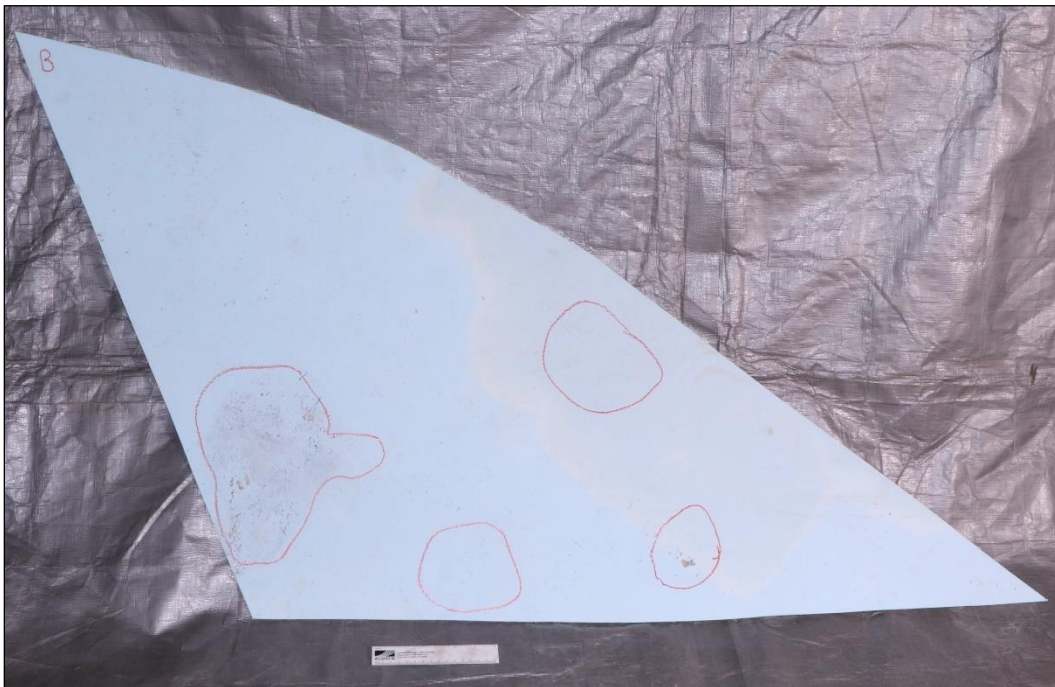
Figure 6 Sample B running surface showing discoloration and areas of surface damage.

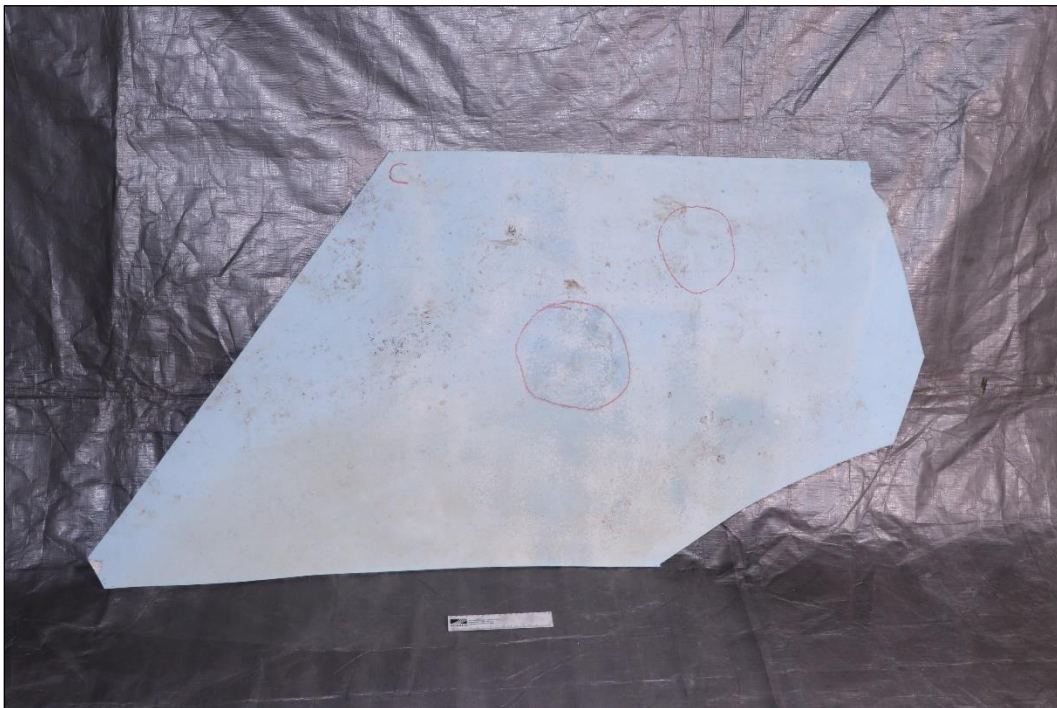
Figure 8 Sample C running surface showing discolouration and areas of surface damage.

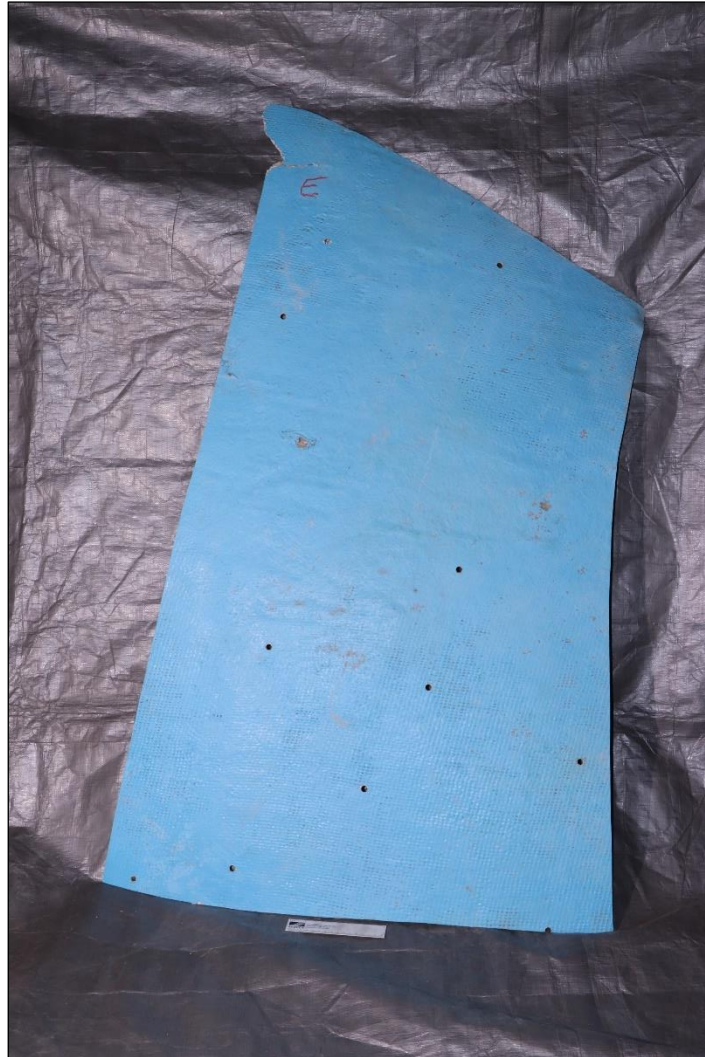
Figure 12 Sample E front surface. Note holes drilled for foam injection.

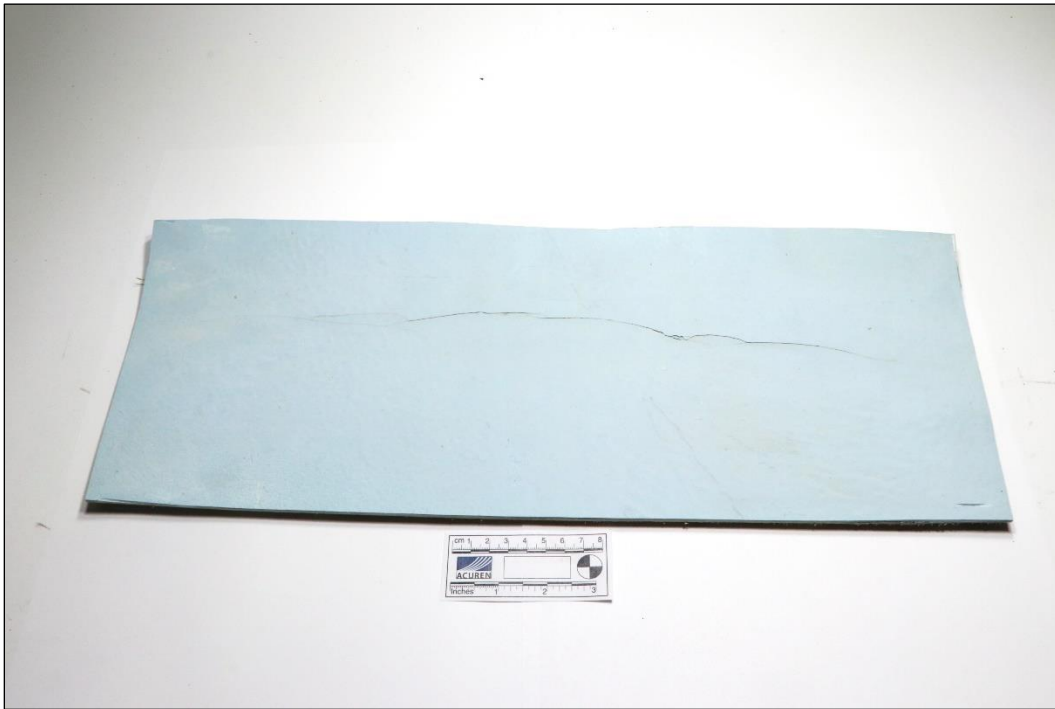
Figure 14 Sample F showing long transverse crack on running surface.

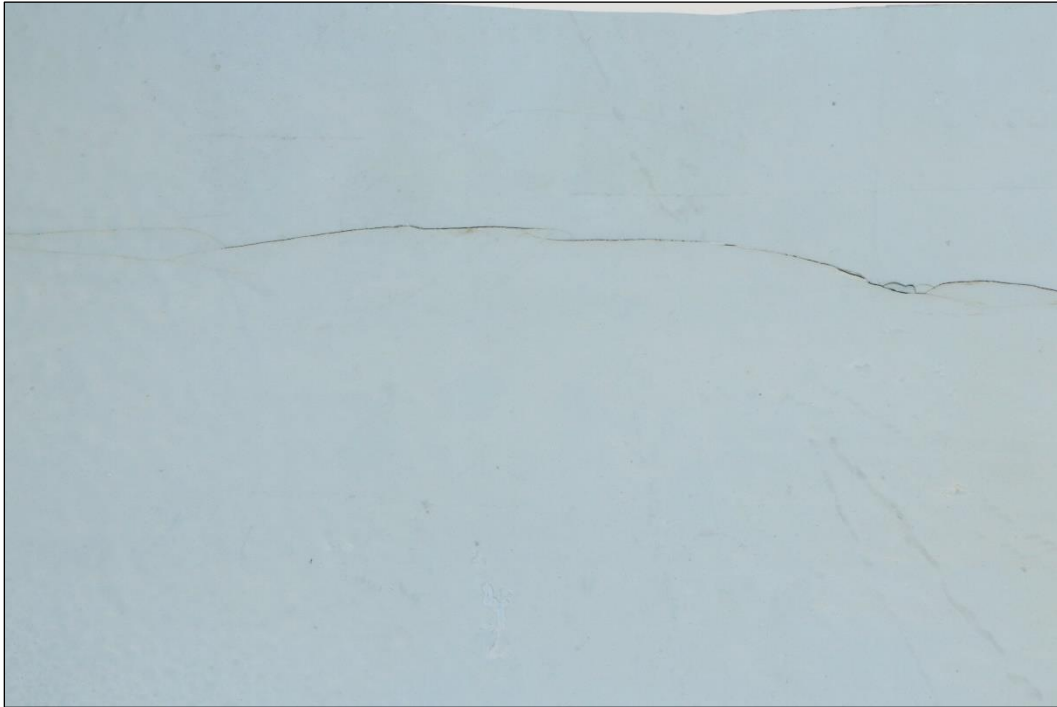
Figure 16 Closer view of crack on sample F.

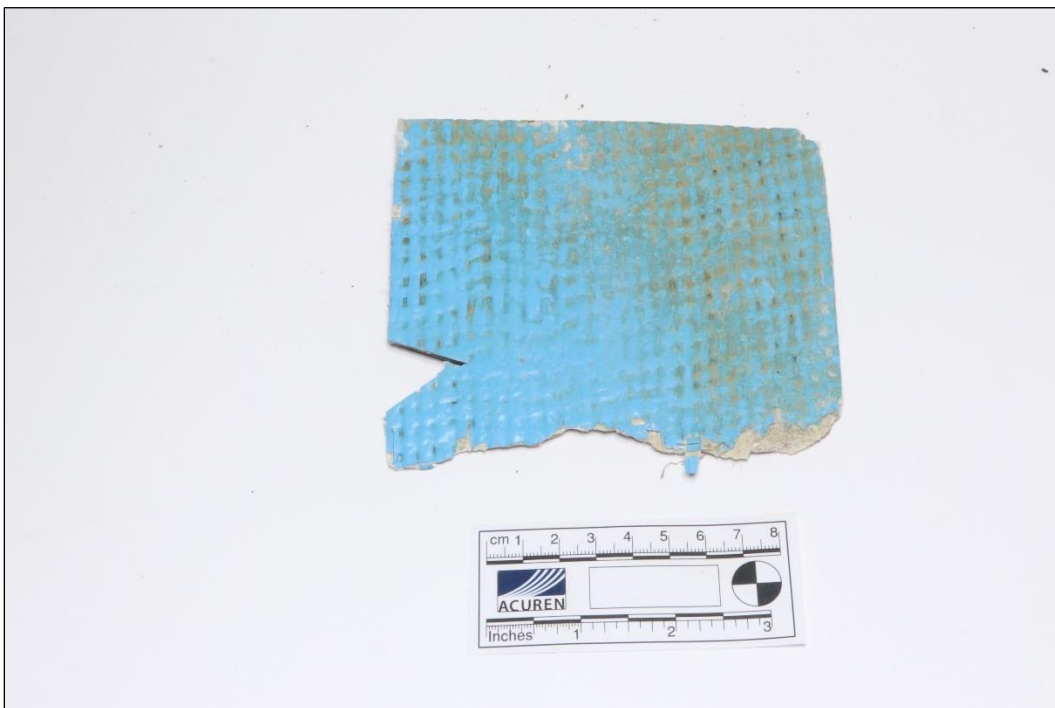
Figure 19 Sample H front surface containing fracture. Notch was cut by others.

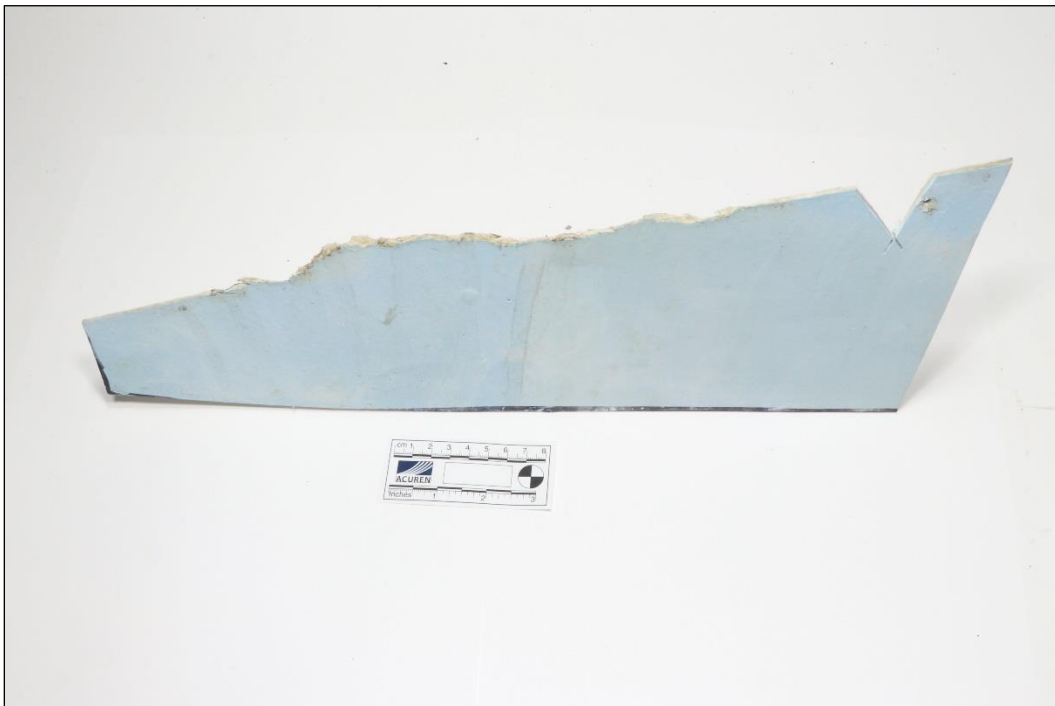
Figure 21 Sample I running surface. Notch was cut by others. Fracture is present along 80% of the top edge.

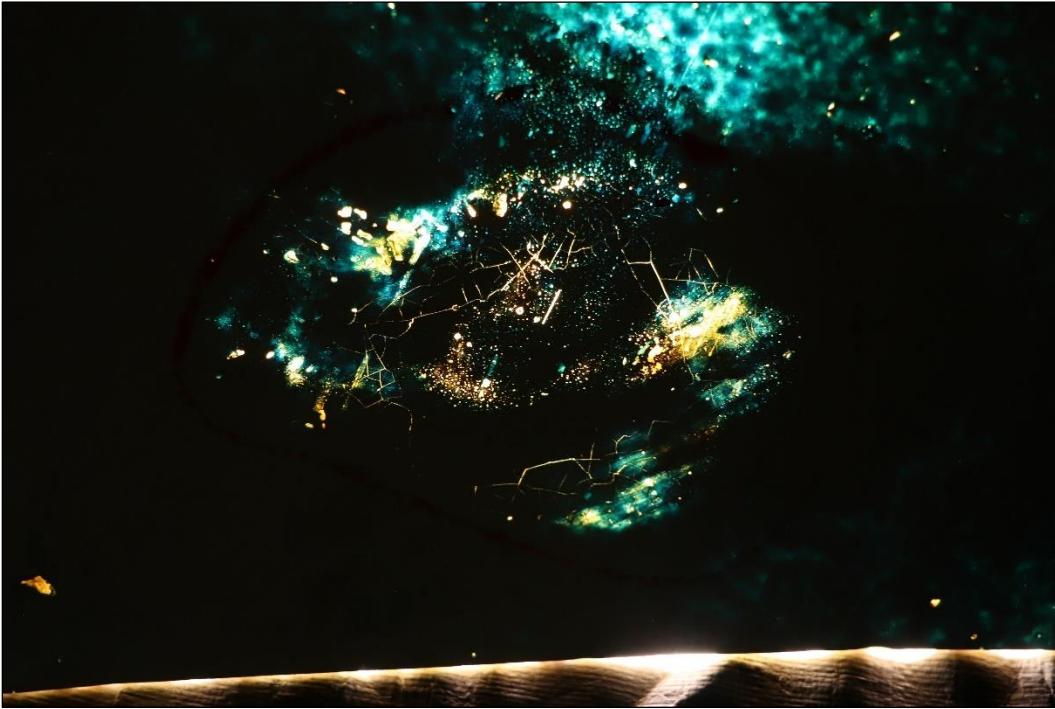
High intensity light was used to examine the samples A - C in different areas around the cut-out pieces. Fine cracks were found with most of the areas examined (Figures 23 - 33). Previously repaired areas (Figures 25, 28, 31, 34) appeared to be of poor quality and did not match the thickness or integrity of the original fibreglass material.

Figure 24 Cracking exposed by backlighting sample A1.

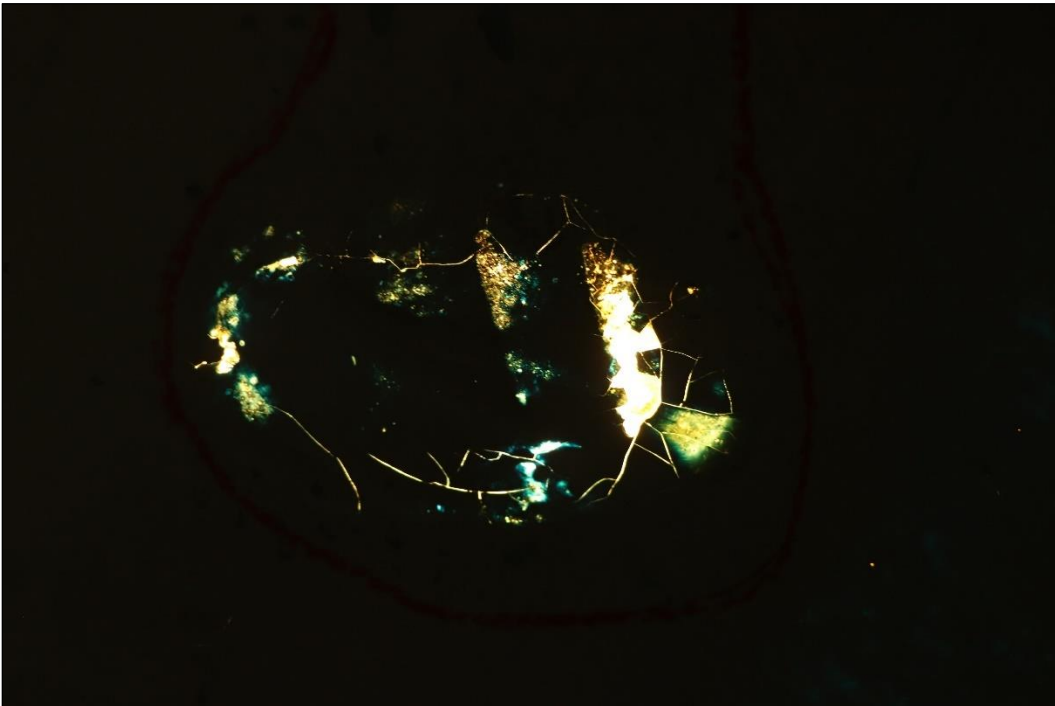
Figure 25 Cracking exposed by backlighting sample A2.

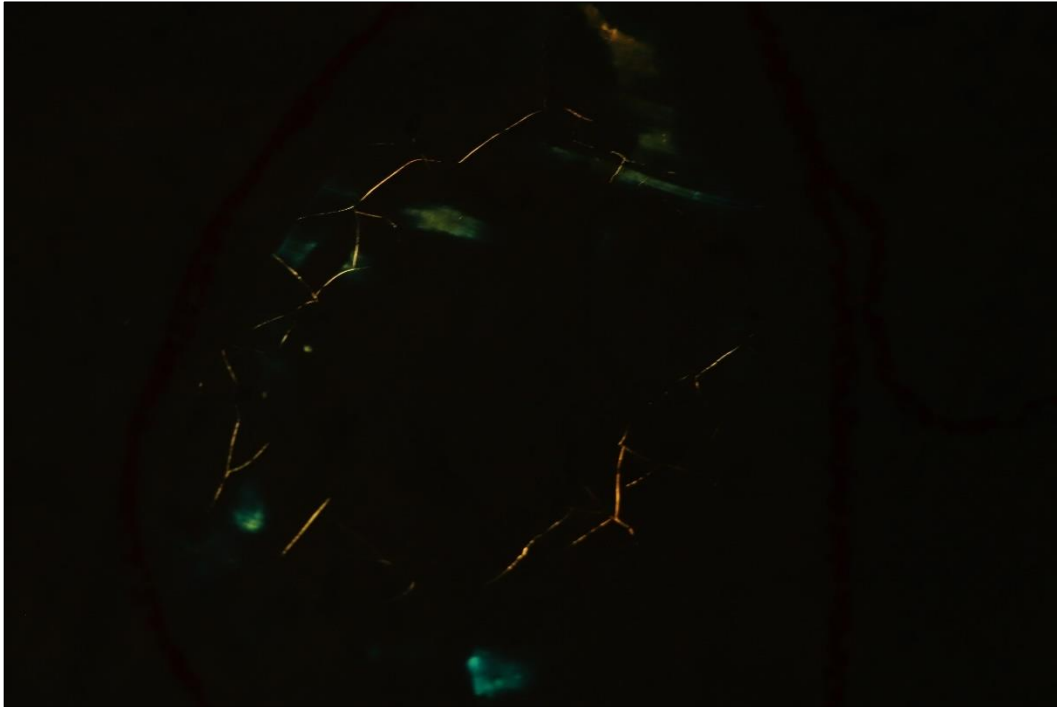
Figure 26 Cracking exposed by backlighting sample A3.

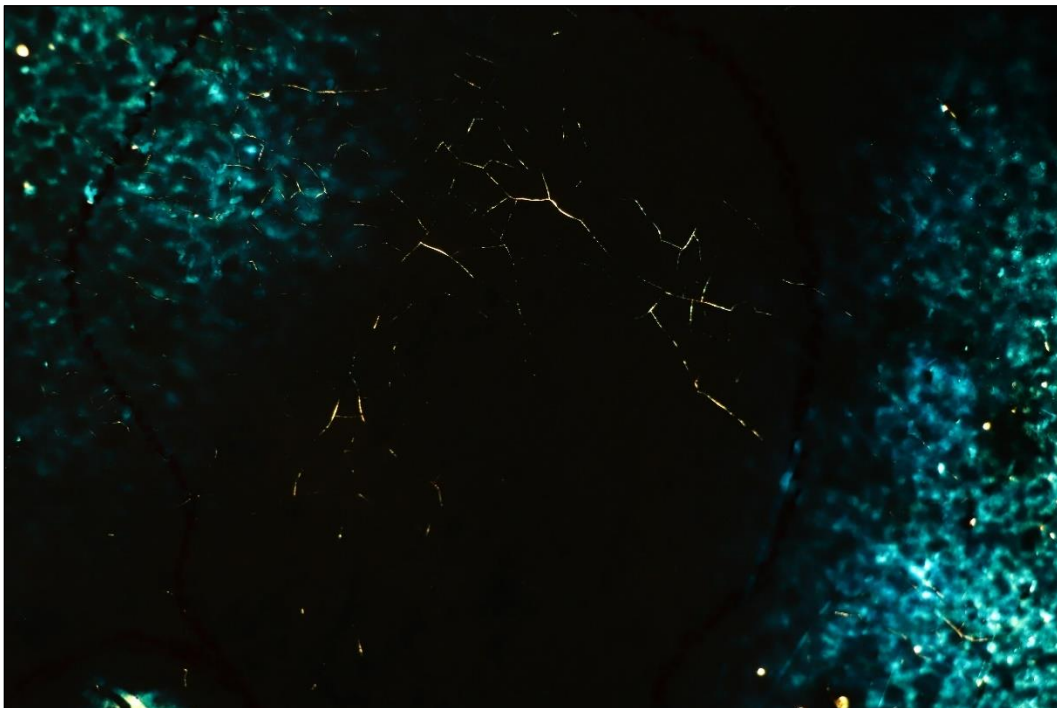
Figure 27 Cracking exposed by backlighting sample A4.

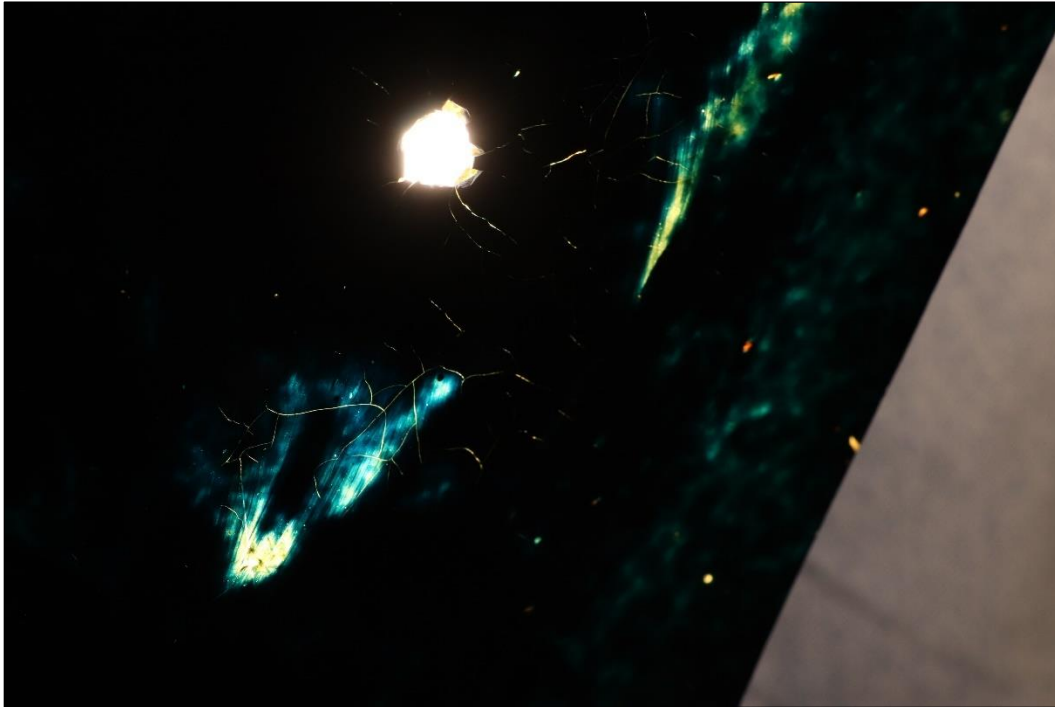
Figure 28 Cracking exposed by backlighting sample A5.

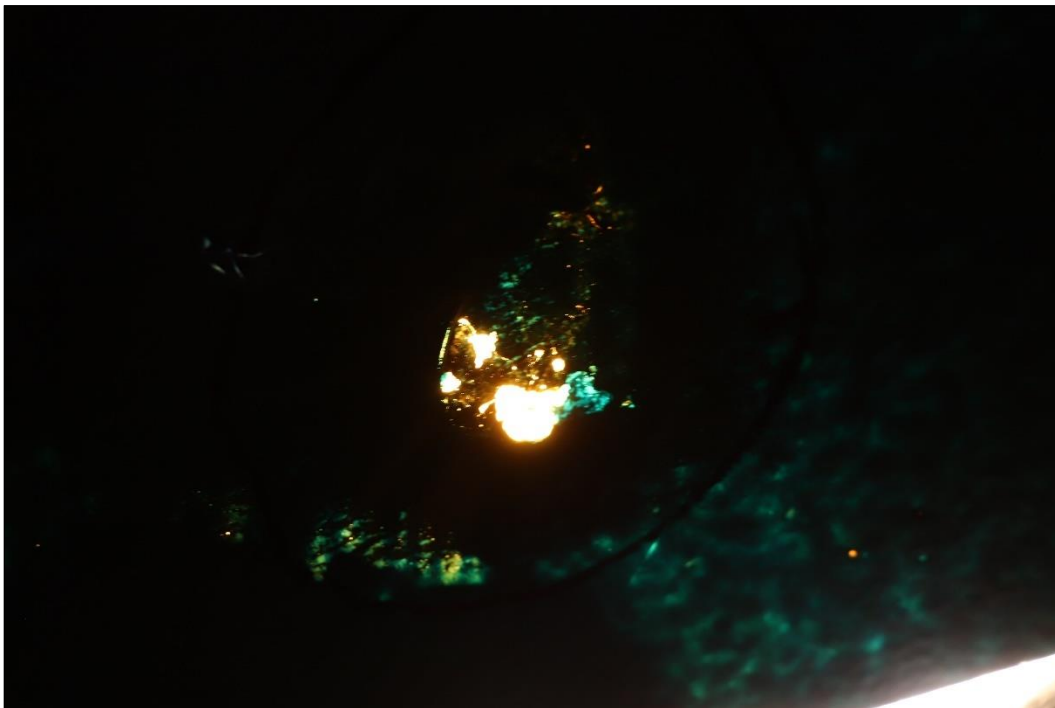
Figure 29 Weak thin area exposed by backlighting sample B1.

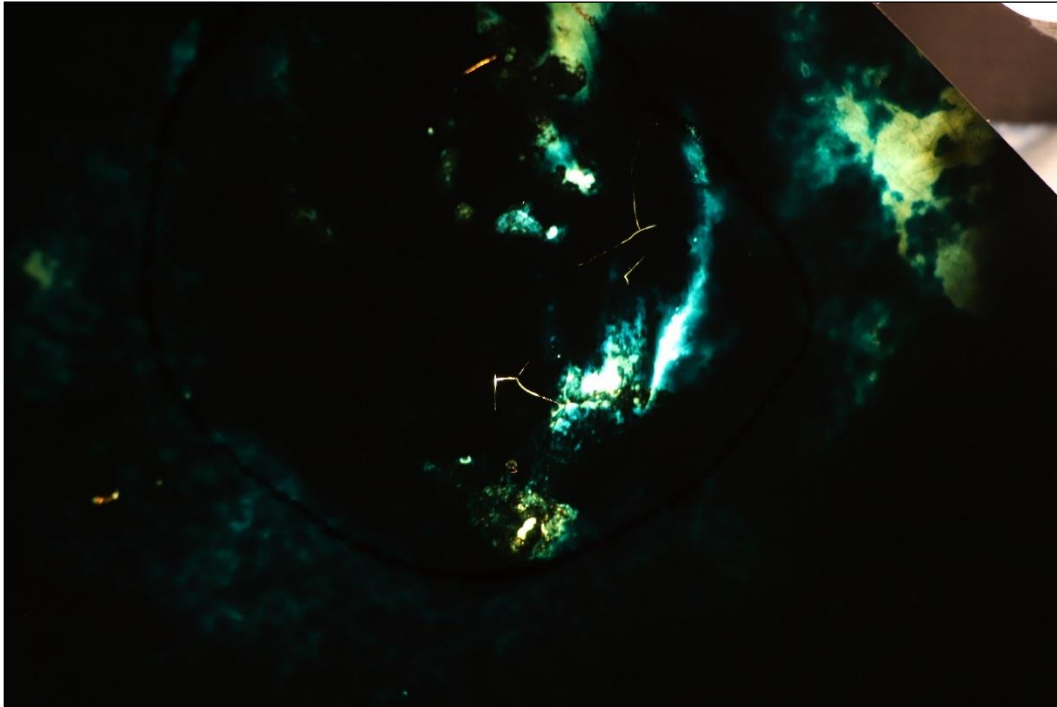
Figure 30 Cracking and weak areas exposed by backlighting sample B2.

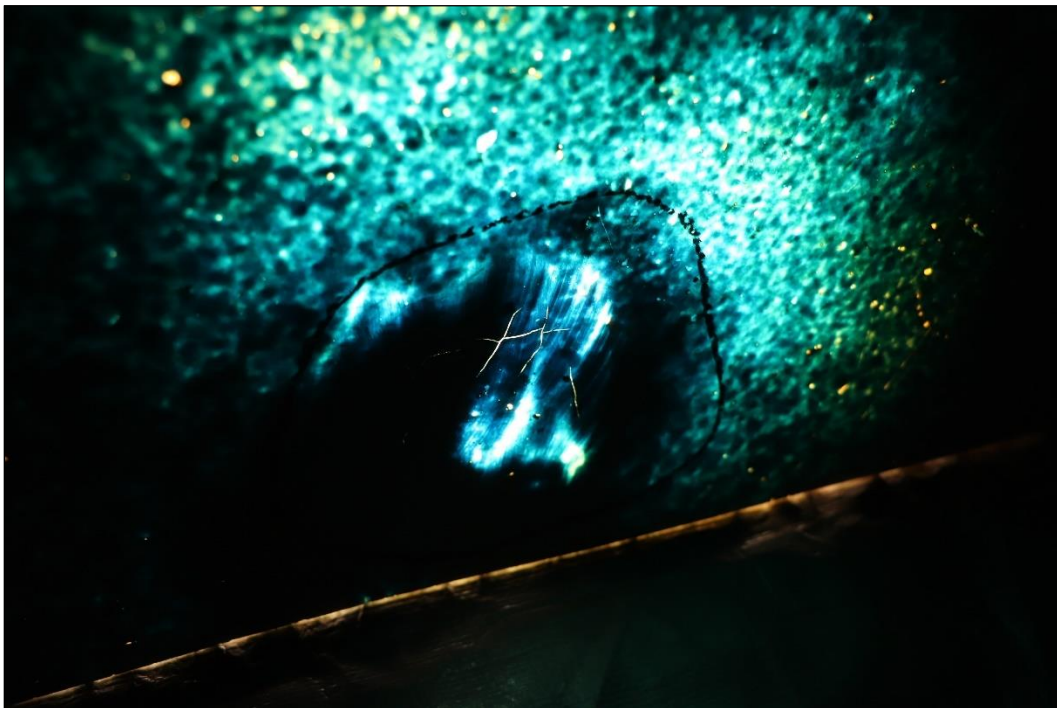
Figure 31 Cracking and weak areas exposed by backlighting sample B3.

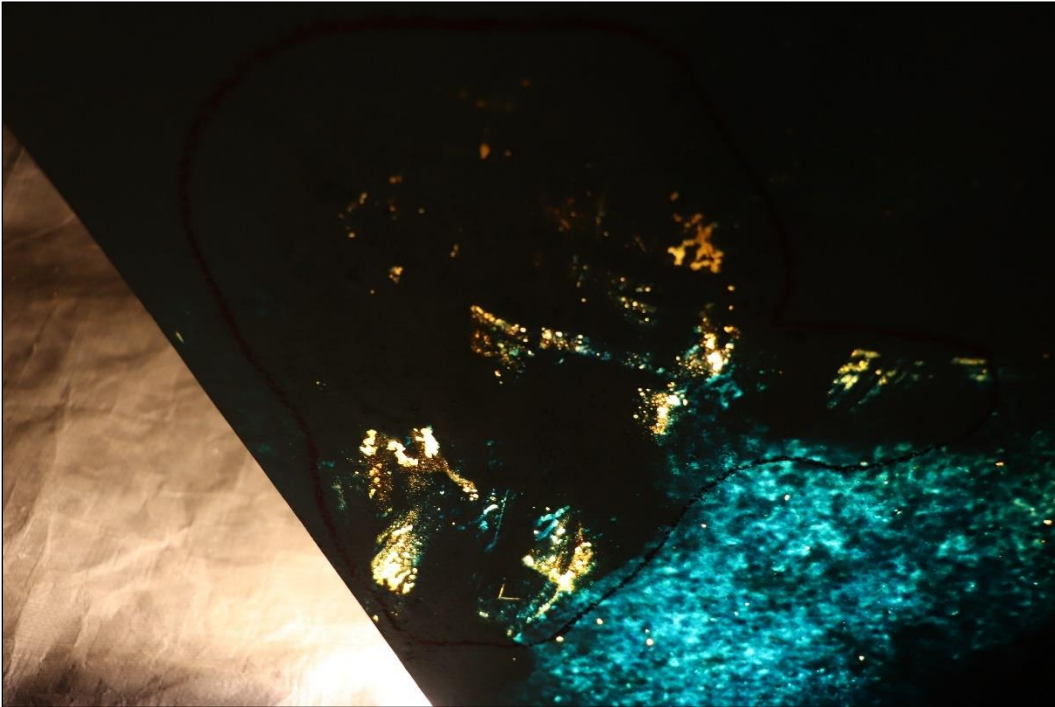
Figure 32 Weak areas exposed by backlighting sample B4.

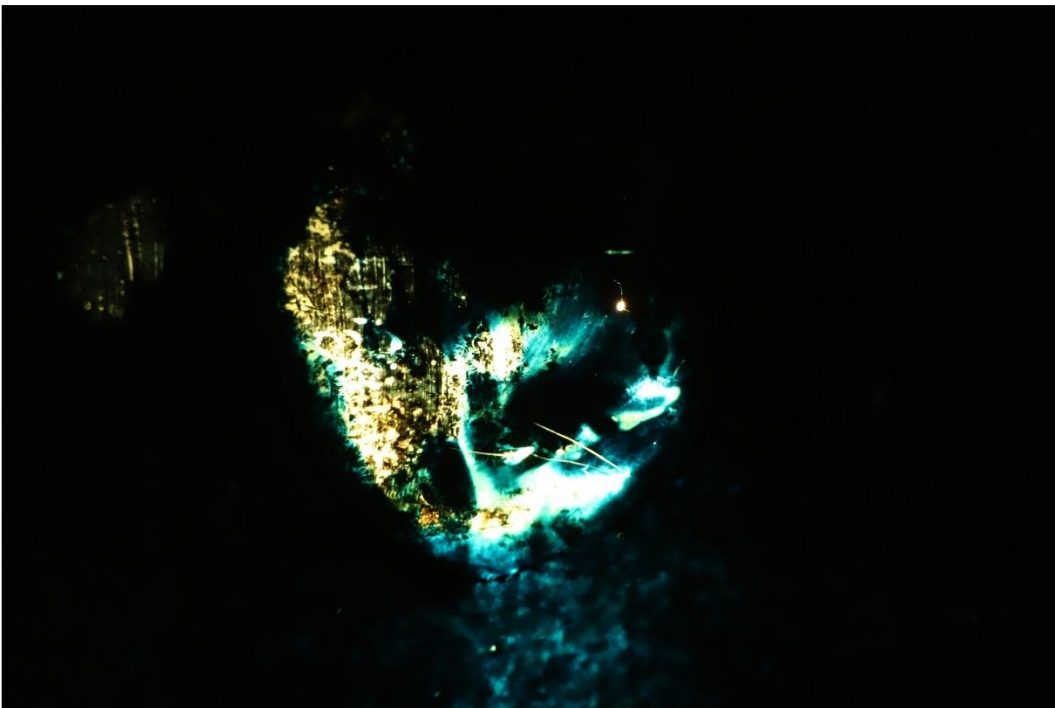
Figure 33 Cracking and weak areas exposed by backlighting sample C1.

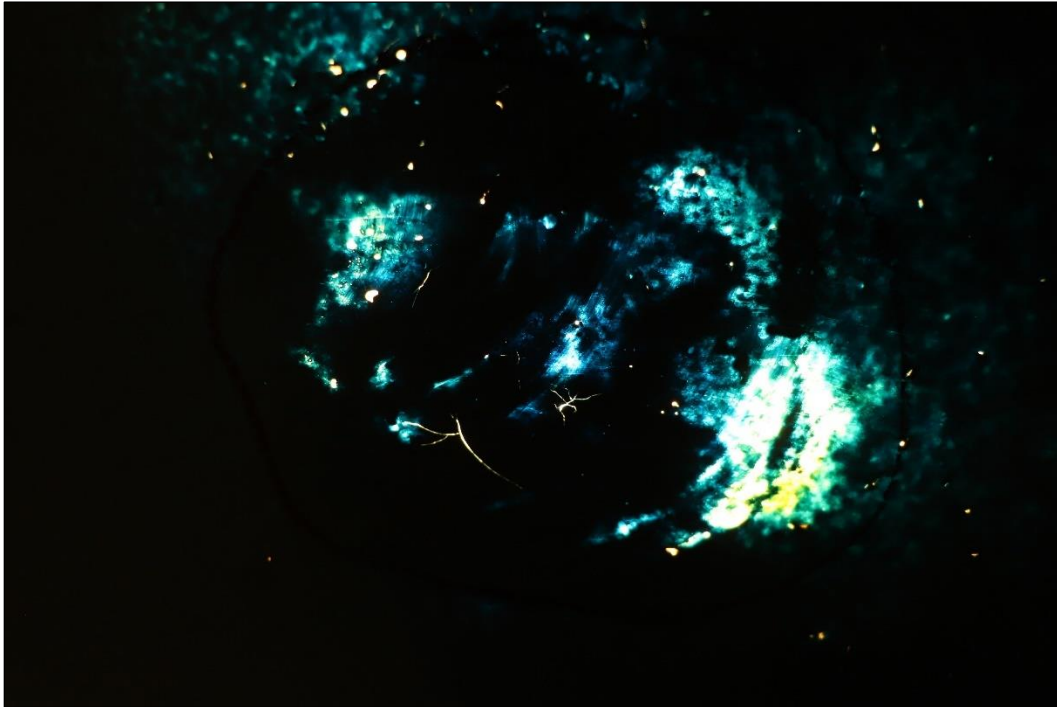
Figure 34 Cracking and weak areas exposed by backlighting sample C2.

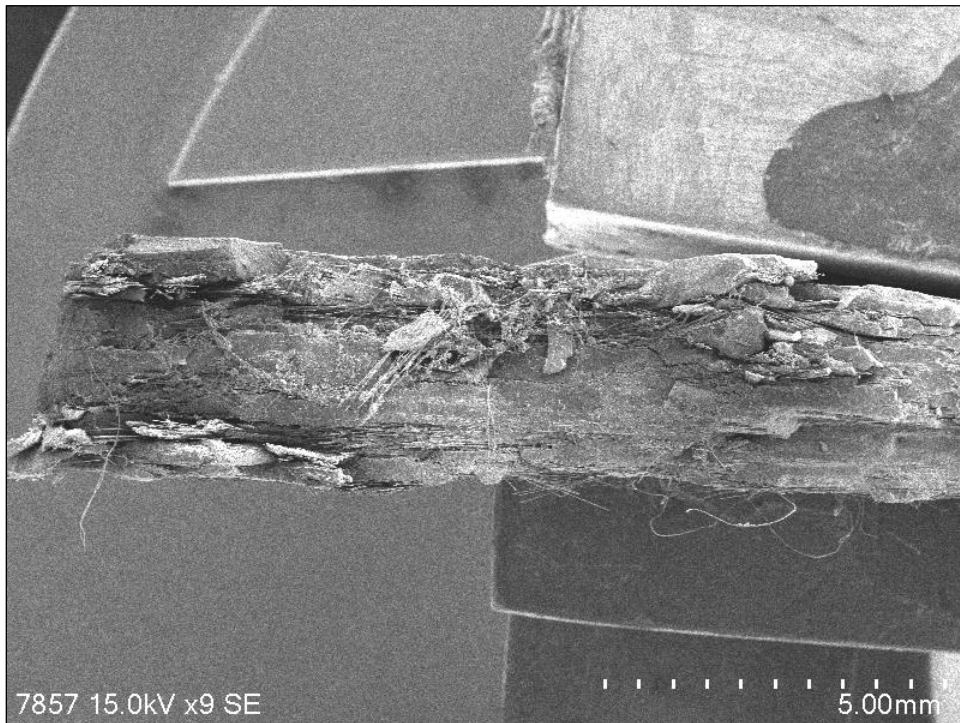
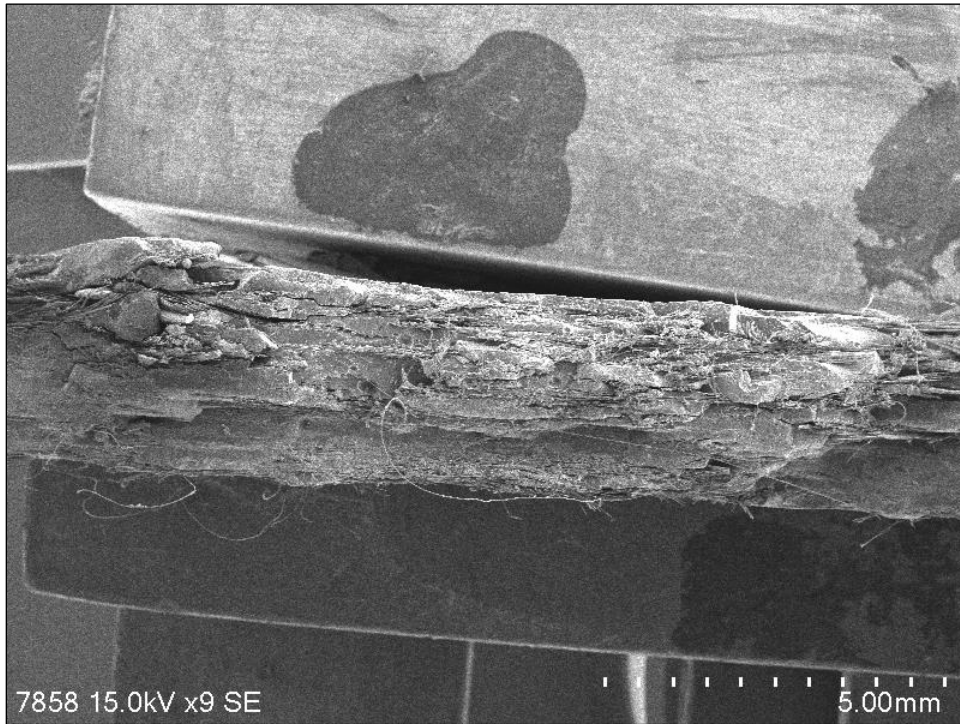
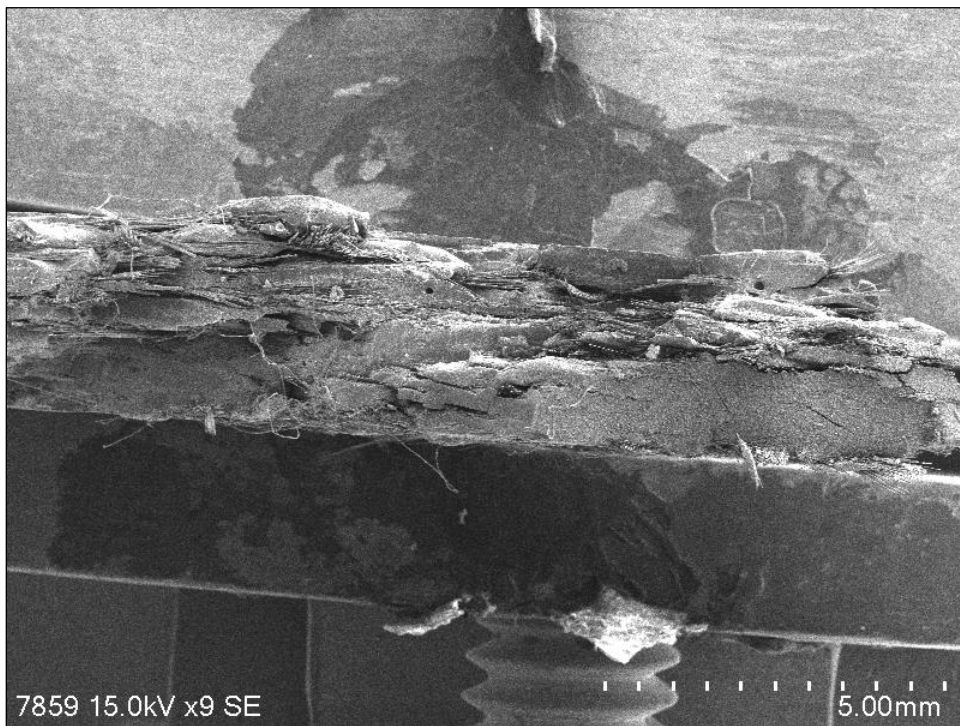
Low magnification views of the sample I outer layer fracture surface are shown in Figures 35 - 47. The three low magnification images (35 - 37) are from the same long fracture shown in Figure 21. The layered nature of the hand laid up fibreglass can be seen in the images. Fibres can be seen running both longitudinally and transverse to the direction of the fracture. Typical longitudinal fibres can be seen in Figure 38. The fibre surfaces are relatively clean and appear to be free of protective resin. Closer views of the longitudinal fibres are shown in Figures 39 and 40. The lack of well bonded resin on the fibres allows the fibres to become damaged and susceptible to fracture.

Figure 35 SEM view of sample I left edge of sample.

Figure 36 SEM view of sample I left edge center of sample.

Figure 37 SEM view of sample I right edge.

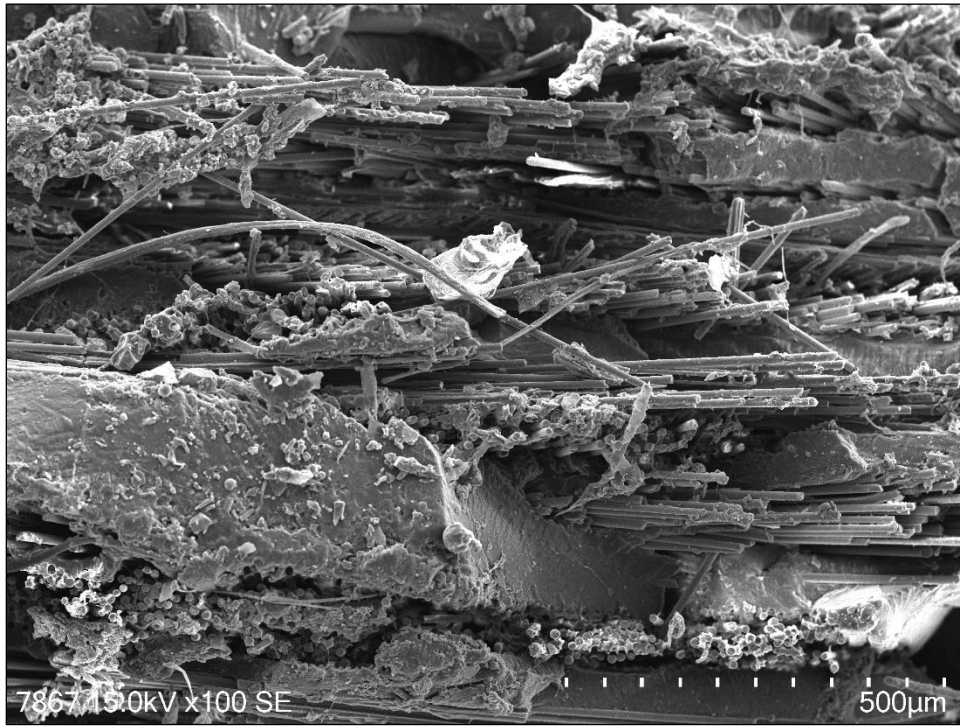
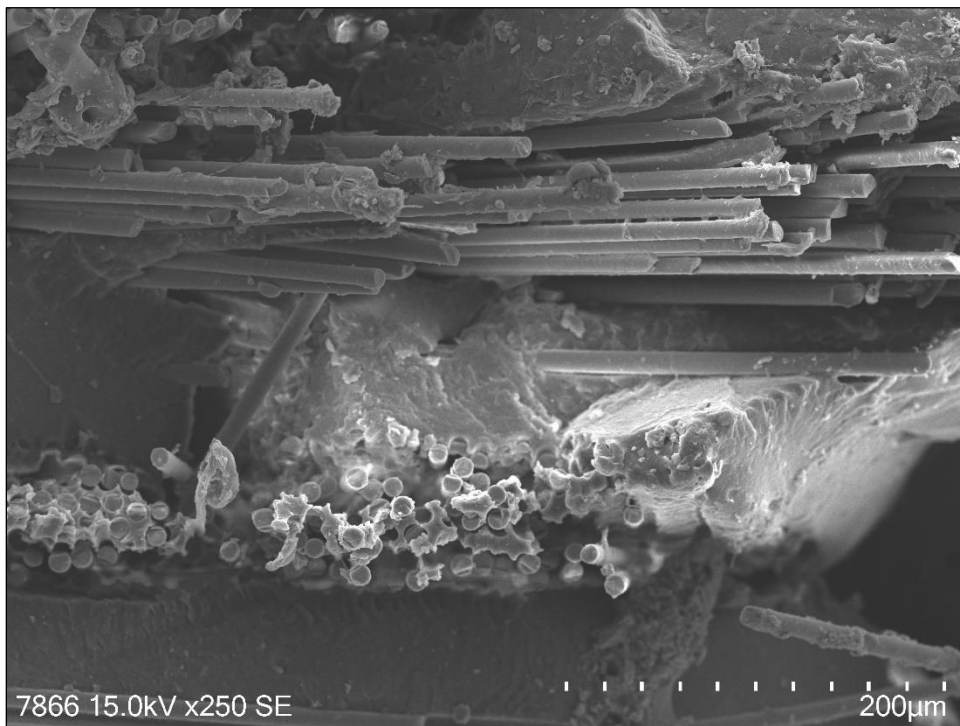
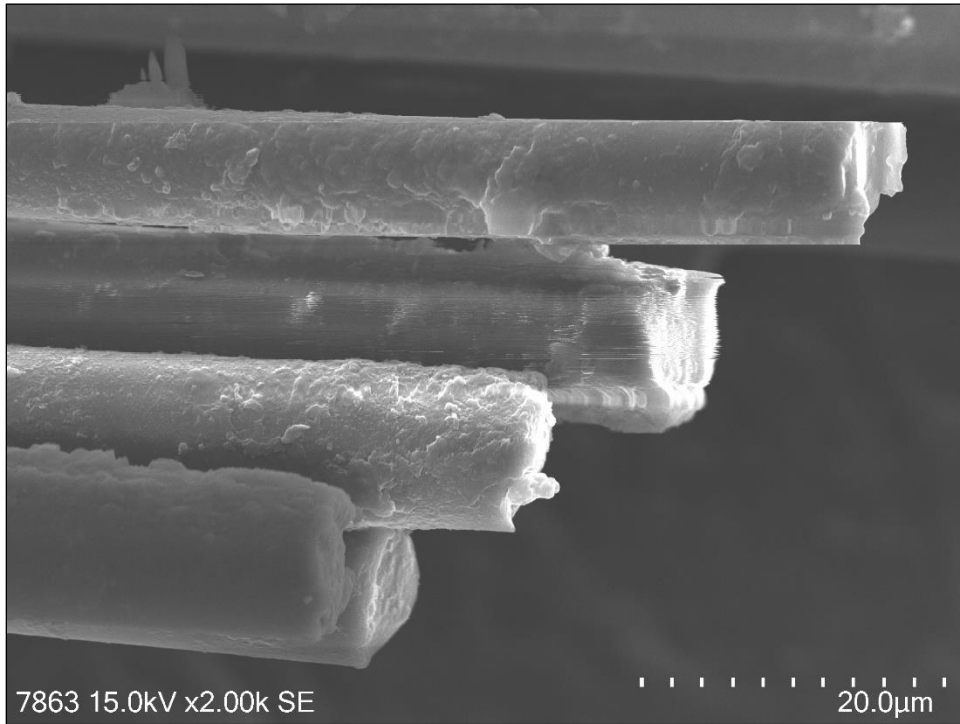
Figure 38 SEM view of clean longitudinal fibres in area of fracture.

Figure 39 SEM view of clean longitudinal fibres with no bonding to resin.

Figure 40 Higher magnification SEM view of clean longitudinal fibres with no bonding to resin.

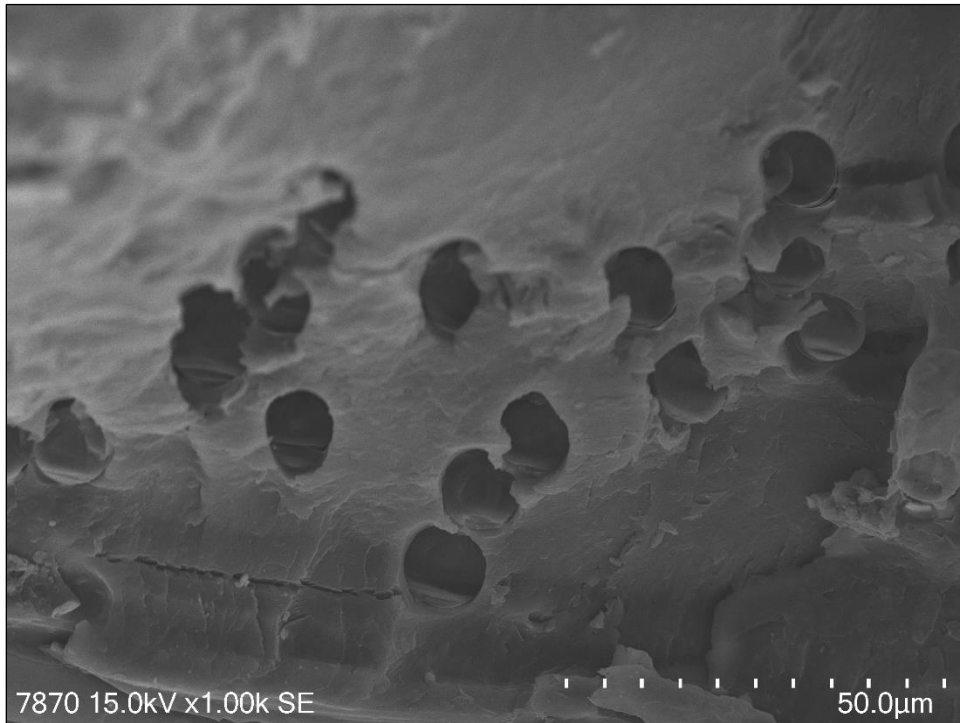
Some areas of the fracture contain well packed and well bonded fibres and have fractured in a single transverse plane. Matrix material in these areas appear well bonded to the fibres and the matrix is cracked by a fatigue mechanism (Figure 41). In other areas, the fibres are pulled out cleanly and the matrix material appears brittle (Figures 42 and 43). Both types of fracture may occur in the progressive-type failure observed with the fibreglass sheet.

Figure 41 Fatigue cracking in fracture zone. Note no extension of fibres.
