Acuren Group Inc.

October 11, 2024

File Number: 605-J165446
EGBC Permit Number: 1001973

Re: Outdoor Fibreglass Water Slide Cracking

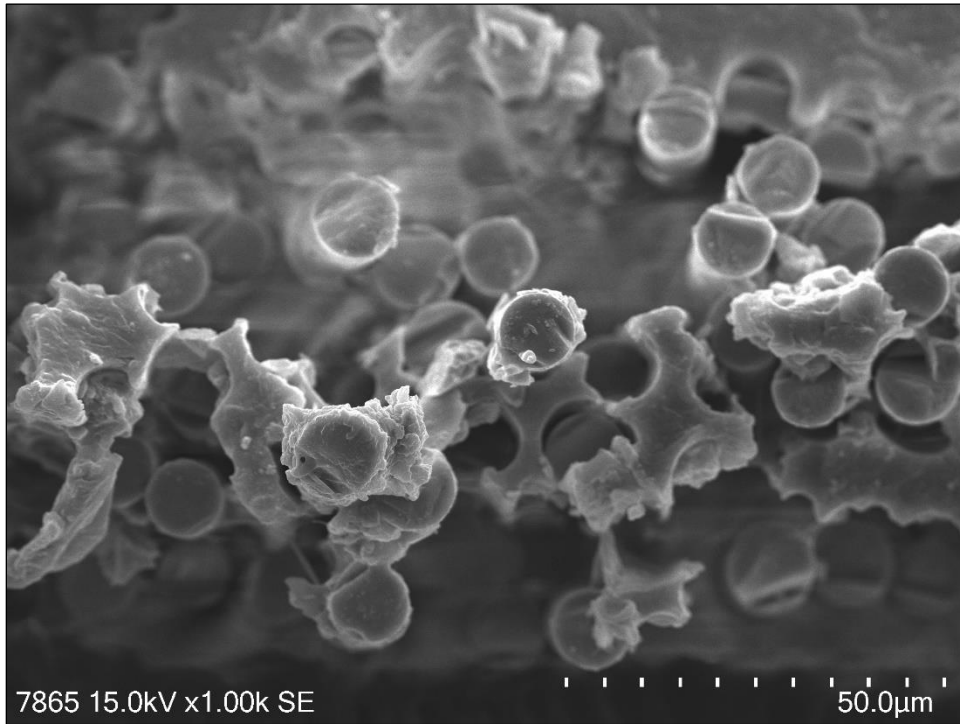
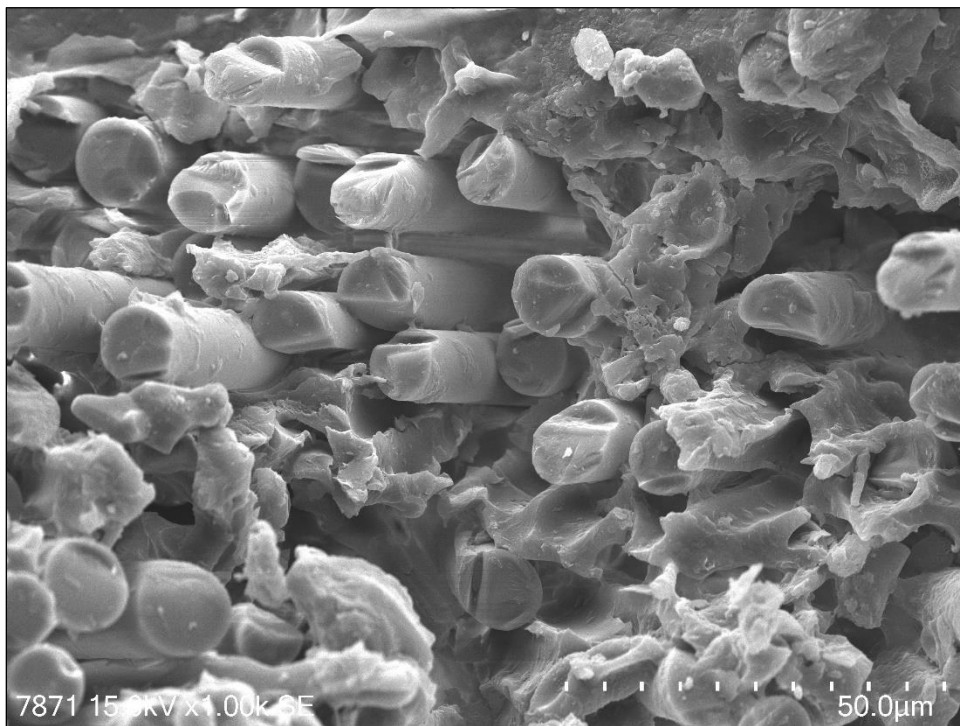
Some areas of the fracture contain well packed and well bonded fibres and have fractured in a single transverse plane. Matrix material in these areas appear well bonded to the fibres and the matrix is cracked by a fatigue mechanism (Figure 41). In other areas, the fibres are pulled out cleanly and the matrix material appears brittle (Figures 42 and 43). Both types of fracture may occur in the progressive-type failure observed with the fibreglass sheet.

Figure 42 Brittle fracture where fibres are pulled straight out of matrix.

Figure 43 Brittle fracture where fibres are pulled straight out of matrix.

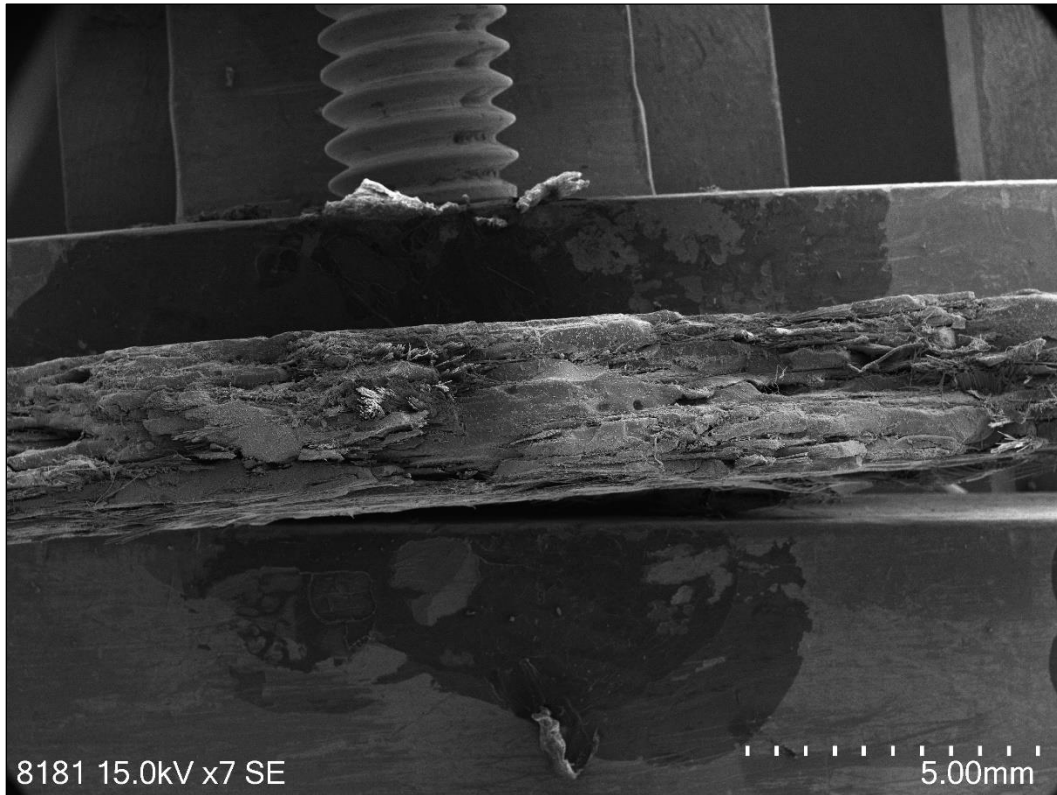
The inner fibreglass sheet fracture is shown at low magnification in Figure 44. The fractured fibre layers are much tighter than with the outer layer fracture and show more evidence of fatigue rather than the outer fibreglass layer (Figures 45 and 46). Smaller areas of brittle fracture were found along the sample with long pulled out fibres (Figure

Figure 44 Inner fiberglass sheet fracture from sample "H" at low magnification

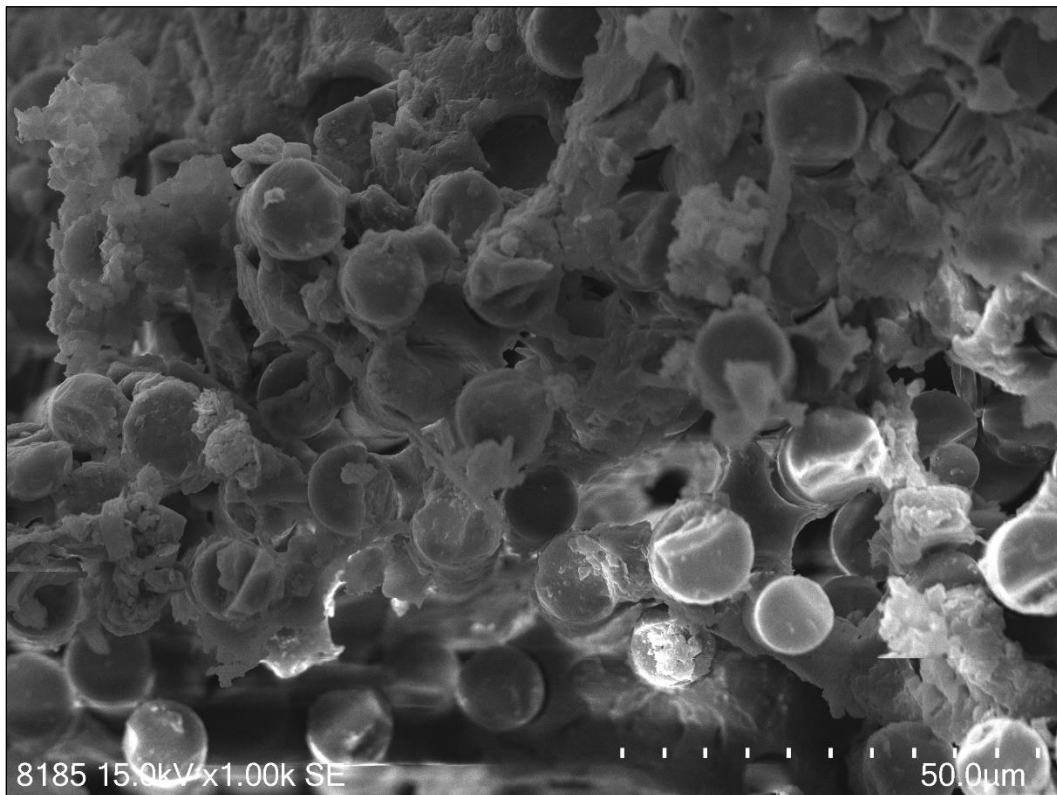
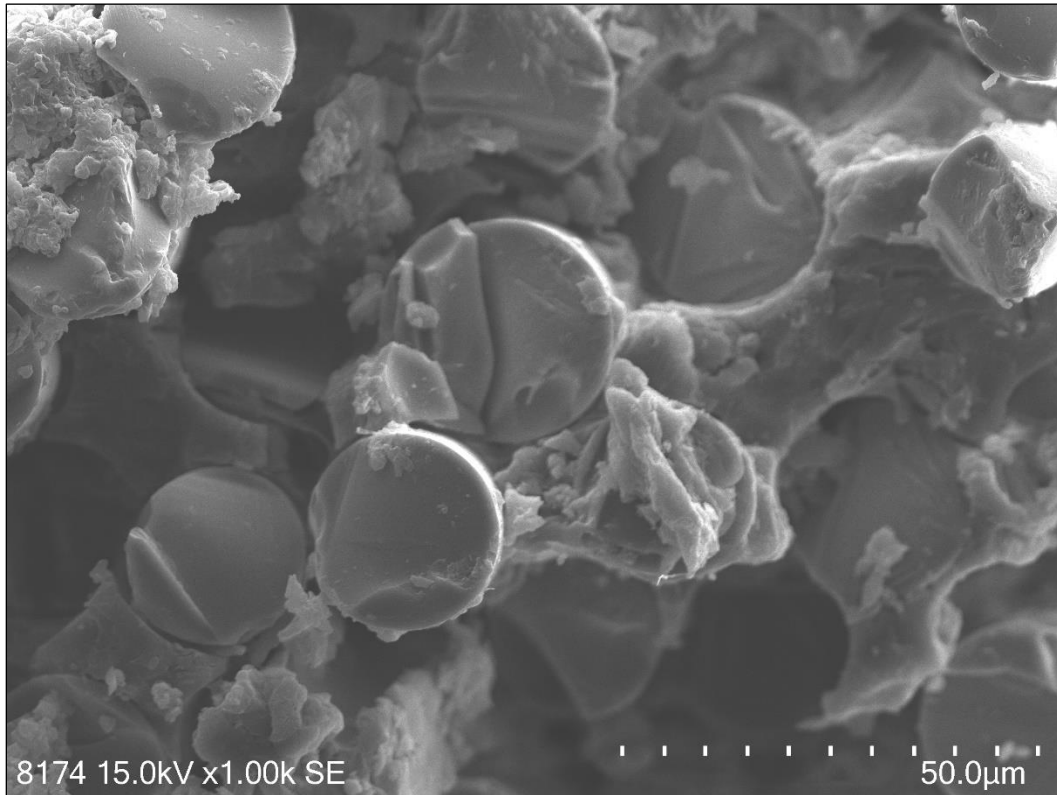
Figure 45 Fatigue area on inner sheet fracture with resin well bonded.

Figure 46 Closer view of fatigue area showing short fibres and well bonded resin.

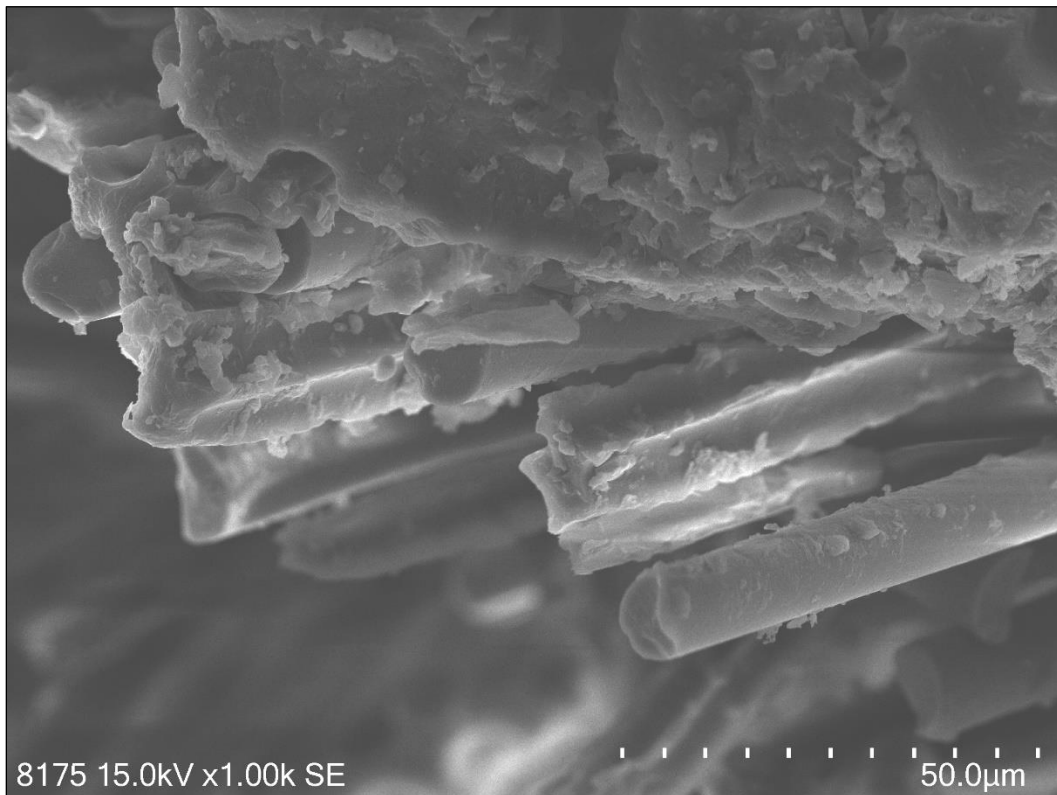
47). The amount of brittle fracture present on the inner fibreglass layer was less than that found with the outer layer.

Figure 47 Area of brittle fracture showing long fibres and lack of resin near fracture.
