Incident Summary #II-1806945-2024 (#55190) (FINAL)

SUPPORTING INFORMATION	Incident Date	December 9, 2024
	Location	Prince George
	Regulated industry sector	Boilers, PV & refrigeration - Boiler and pressure vessel system
	Injury Qty injuries	0
	Injury description	N/A
	Impact Injury rating	None
	Impact Damage description	Fire damage to vessel resulted in minor shell distortion, damaged insulation, scale formation and instruments destroyed.
	Impact Damage rating	Minor
	Incident rating	Minor
Incident overview		A fire occurred inside a biofuel filter vessel during its drying cycle.
INVESTIGATION CONCLUSIONS	Site, system and components	<p>A biofuel process converts raw oils such as canola and used cooking oil into renewable crude oil by a series of filtering and polishing methods. The crude slurry made up of the raw oils is filtered in a crude adsorbent filter, which is a vertical stainless steel cylindrical pressure vessel containing a series of adsorbent (leaf) filters. A diatomaceous earth (a naturally occurring, soft, siliceous sedimentary rock) and oil mixture introduced to the slurry circulates in the vessel providing filtration of impurities such as metals and solids which adhere

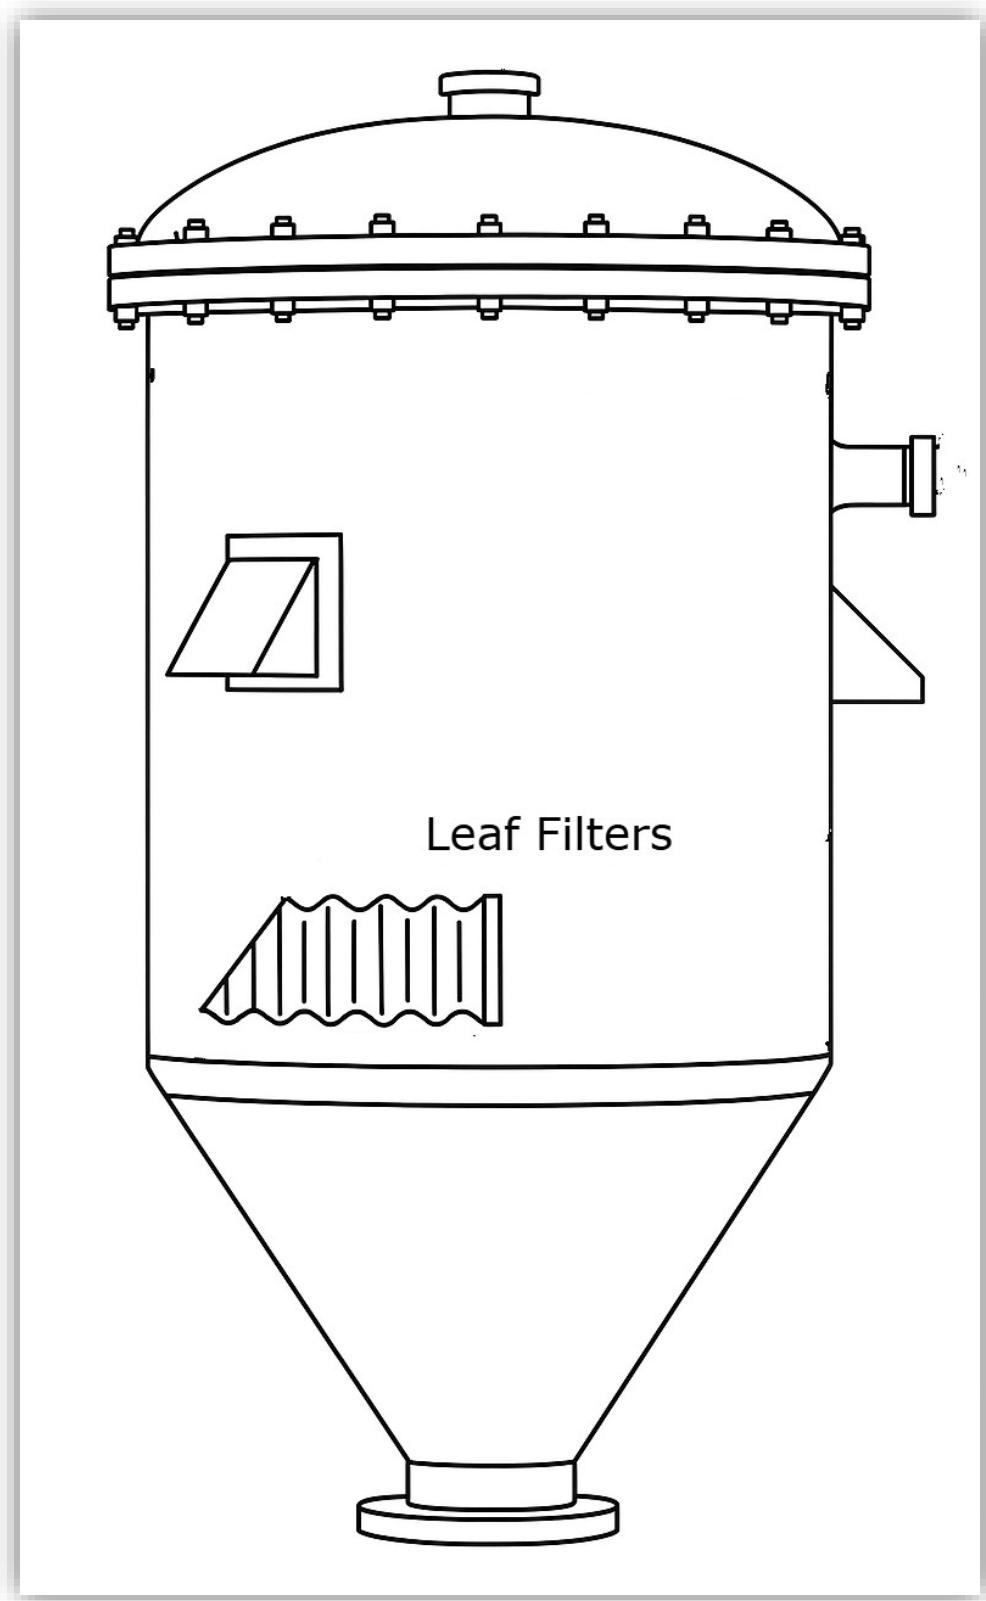
Image 1 - Filter vessel diagram.

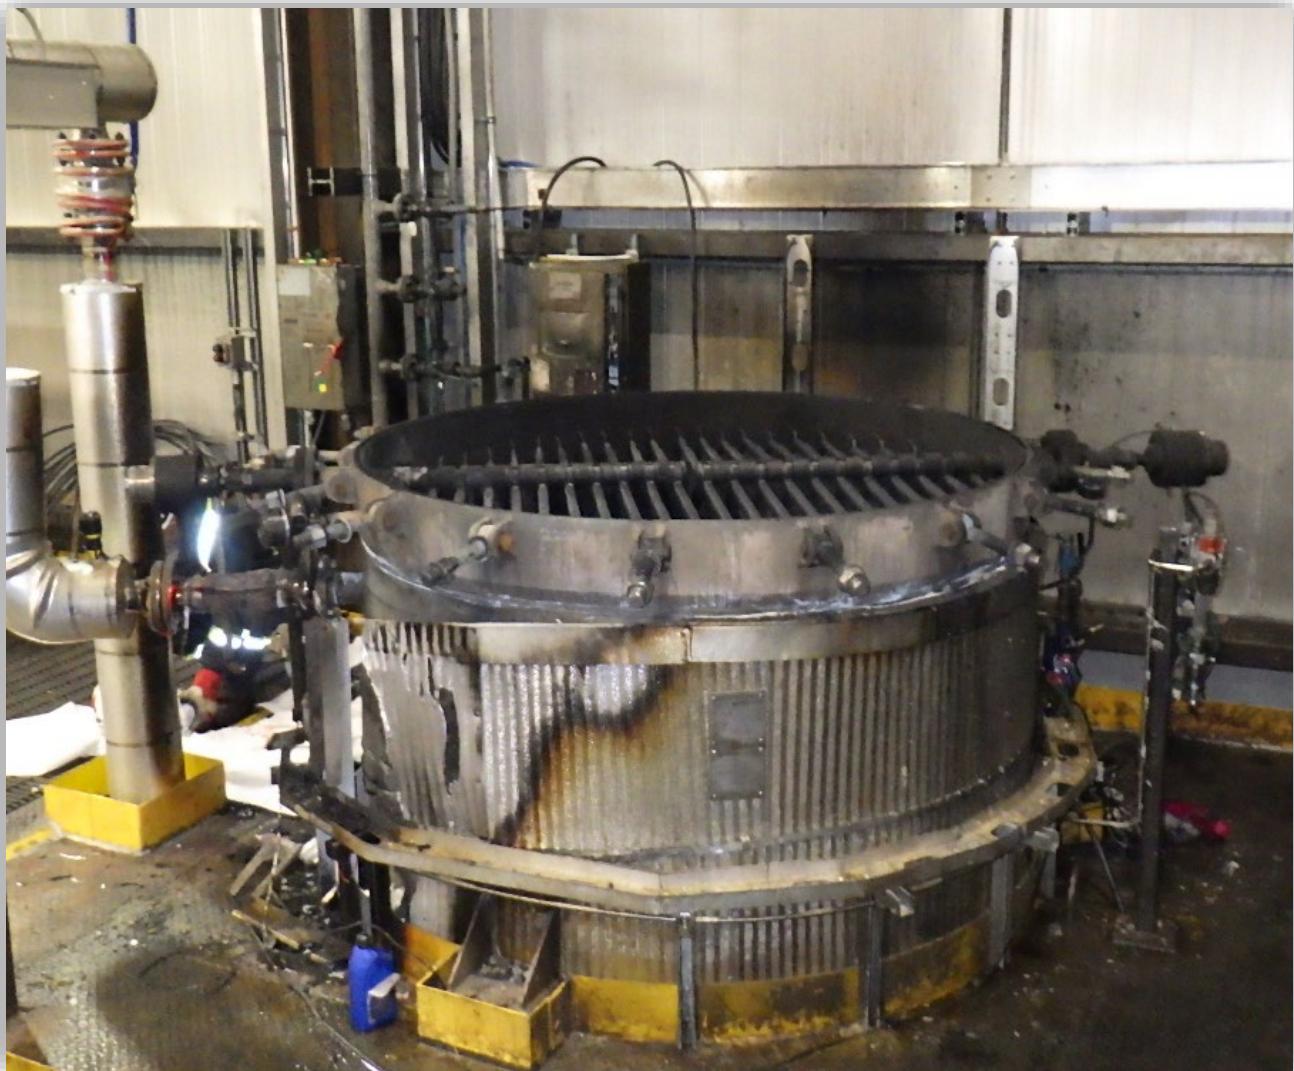
Failure scenario(s)	<p>The diatomaceous earth filter media, laden with trace minerals started to self-heat during a longer than normal drying cycle. An additional filter aid media was introduced to the process and was prone to particulate carryover which created a restriction in the air discharge, contributing to higher temperatures in the vessel. Fire developed as a result of an extended drying cycle of the filter media, leading to oxidation and ignition.</p>

Causes and contributing factors	<p>It is highly likely that the fire was initiated by an extended drying cycle of the diatomaceous earth filter media, leading to oxidation and ignition that caused a fire and damage to the vessel.</p> <p>The contributing factor was adjustments to operating parameters and filter media without employing management of change review.</p>

Image 2 - Fire damaged filter vessel with top cover removed.

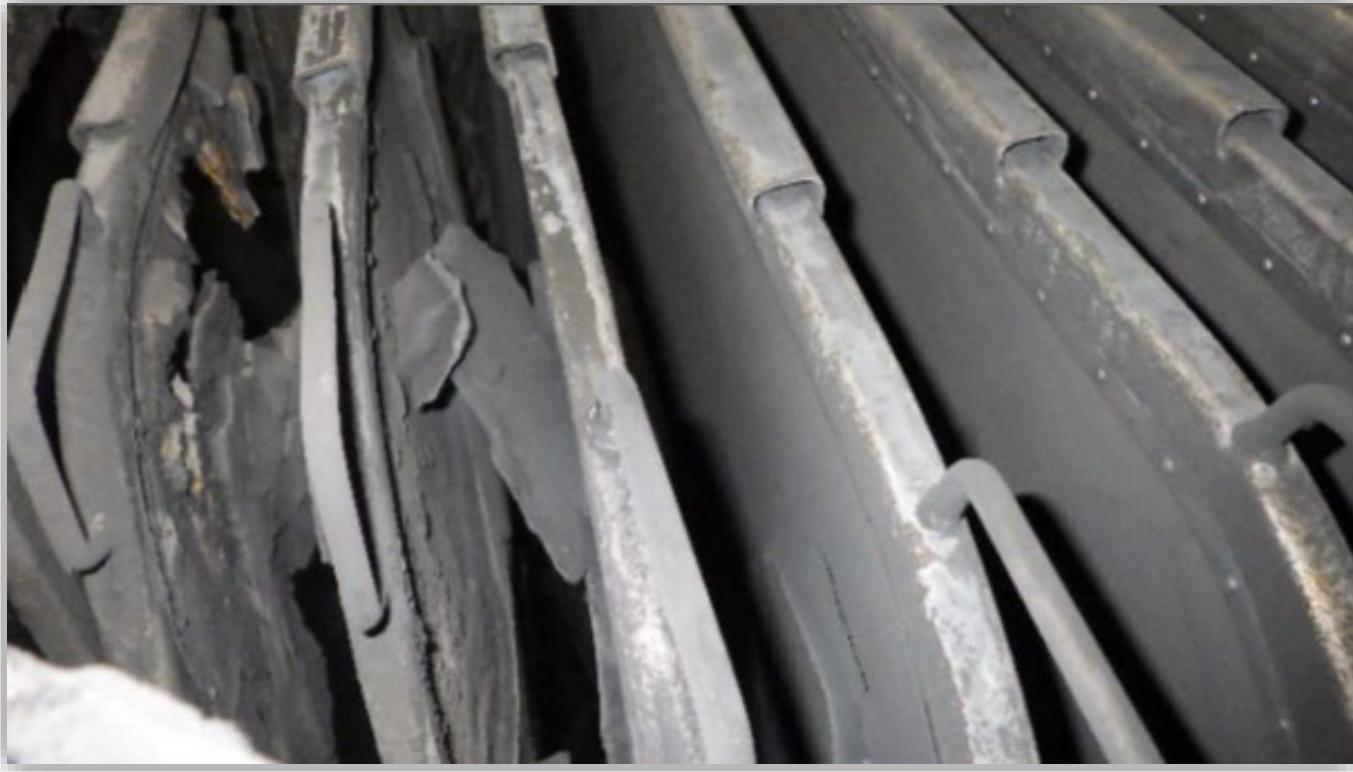
Image 3 - Damaged leaf filters.
