Incident Summary #II-1872877-2025 (#56576) (FINAL)

SUPPORTING INFORMATION	Incident Date	February 24, 2025
	Location	Castlegar, BC
	Regulated industry sector	Gas - Natural gas system
	Qty injuries	2
	Impact Injury	Injury description
		One occupant (Tenant 1) was found deceased in the upstairs rental suite. A second occupant (Homeowner) was found in the basement and taken to hospital with severe symptoms of Carbon Monoxide (CO) poisoning but later released.
	Impact Damage	Injury rating
		Fatal
		Damage description
INVESTIGATION CONCLUSIONS	Site, system and components	The vent piping system for the natural gas furnace separated at an elbow joint inside the home releasing flue gases containing high levels of CO into the home.
		Damage rating
		Moderate
		Incident rating
SUPPORTING INFORMATION	Incident overview	Severe
		A malfunctioning gas furnace located in the lower suite of a two-storey residential home expelled flue gasses containing high levels of CO into the home through a disconnected vent joint. CO built up into the home's living spaces both upstairs and downstairs causing exposure to occupants. The CO exposure caused serious illness to a homeowner who lived in the basement su

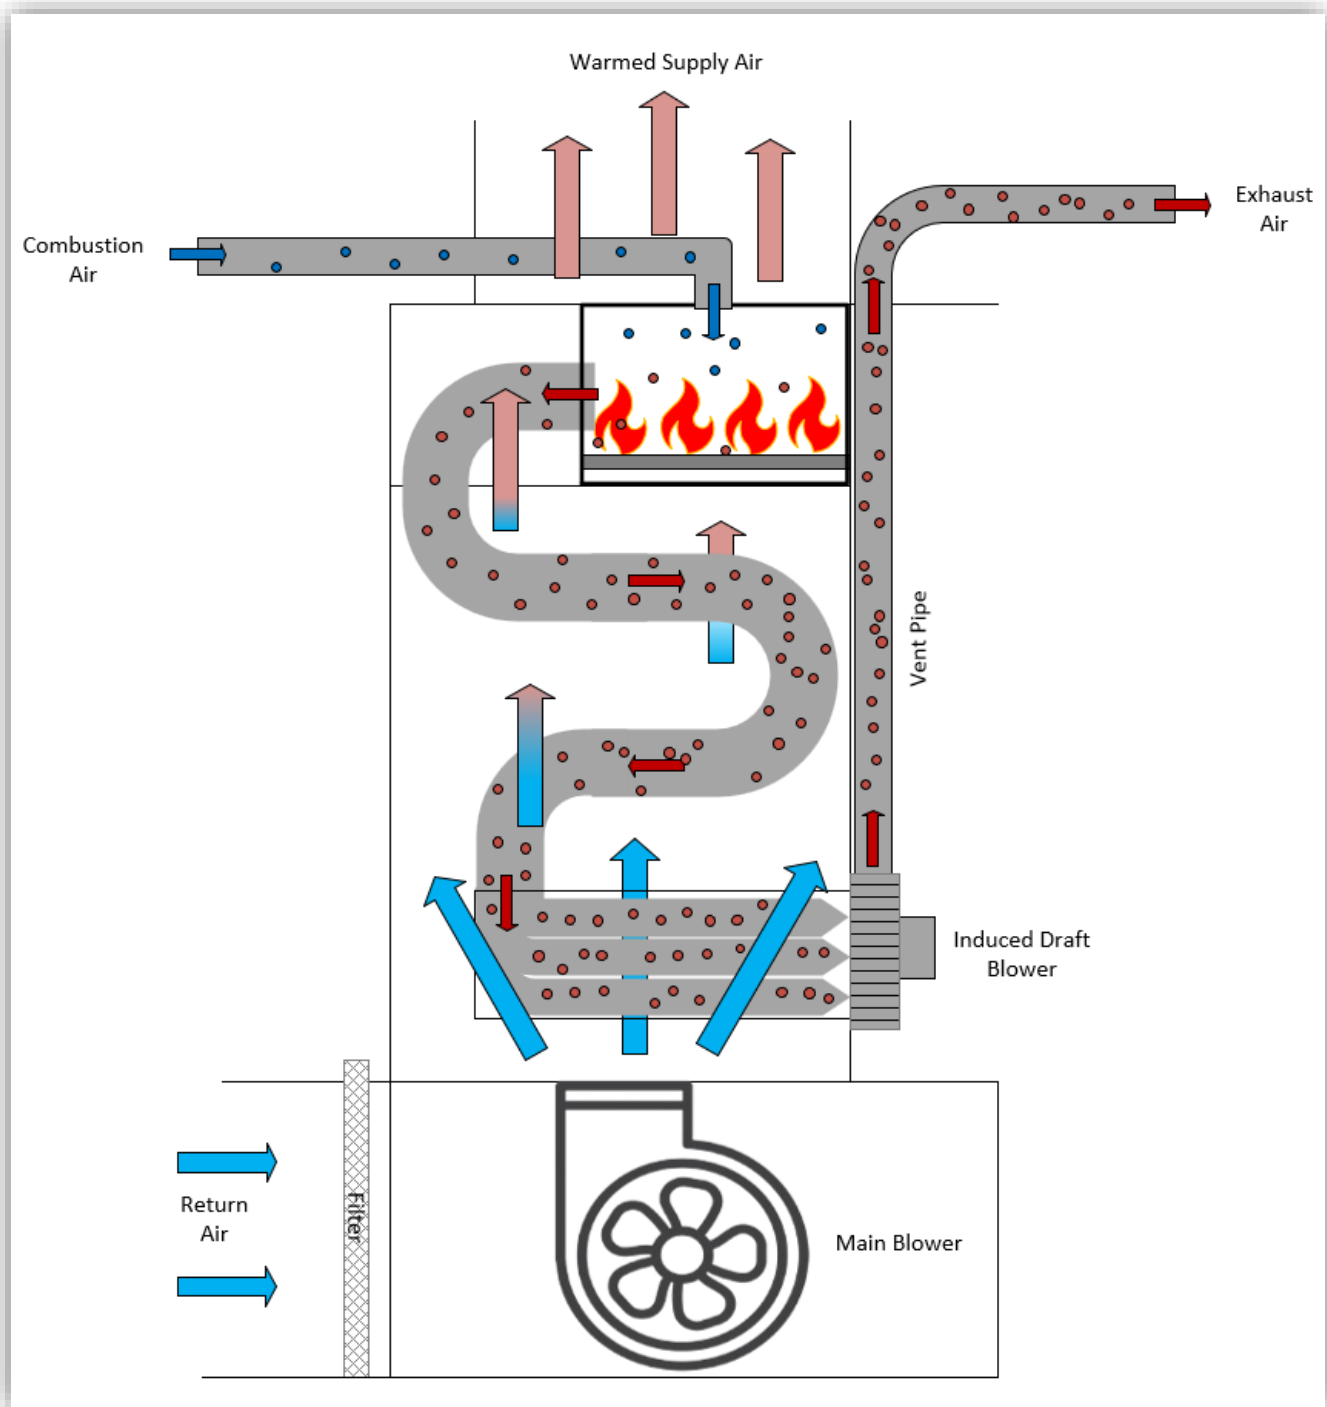
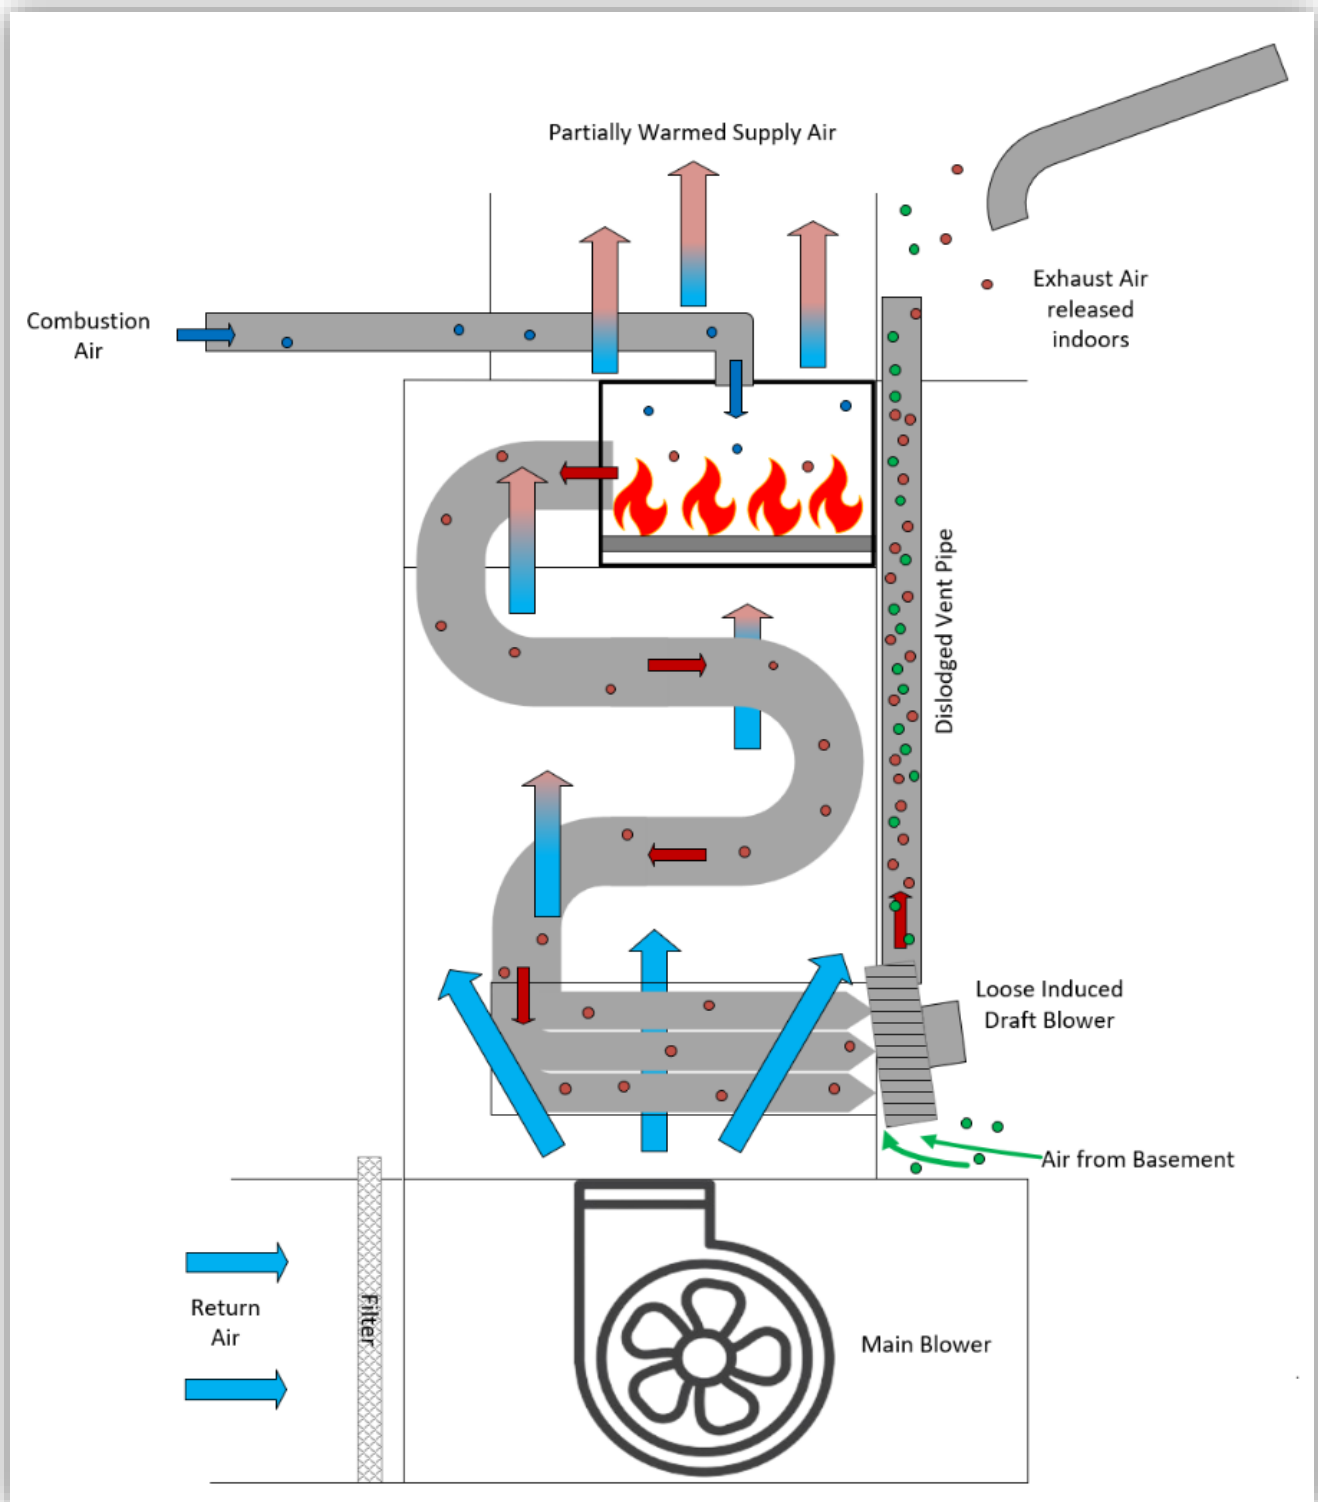
At some point, the bolts holding the inducer fan to the furnace were loosened breaking the seal between the inducer fan and the furnace. This allowed the inducer fan to draw some air from the room instead of drawing it all through the burners. This small change would have two significant impacts on the operation of the furnace:

1. As a portion of the air being pulled by the inducer fan now bypassed the burners, there was insufficient oxygen for combustion at the burners resulting in significantly elevated levels of CO in the flue gas (>400 ppm).
2. The cool air flowing into the inducer fan could have cooled the gasses at the location of the high limit switch and satisfied the pressure sensing safeties resulting in continued operation of the furnace, when otherwise it would have likely shut itself off due to the activation of one or multiple safety mechanisms.

Image 2 – Diagram of typical furnace operation (top) and furnace operation with loose induced blower and detached vent pipe (bottom).

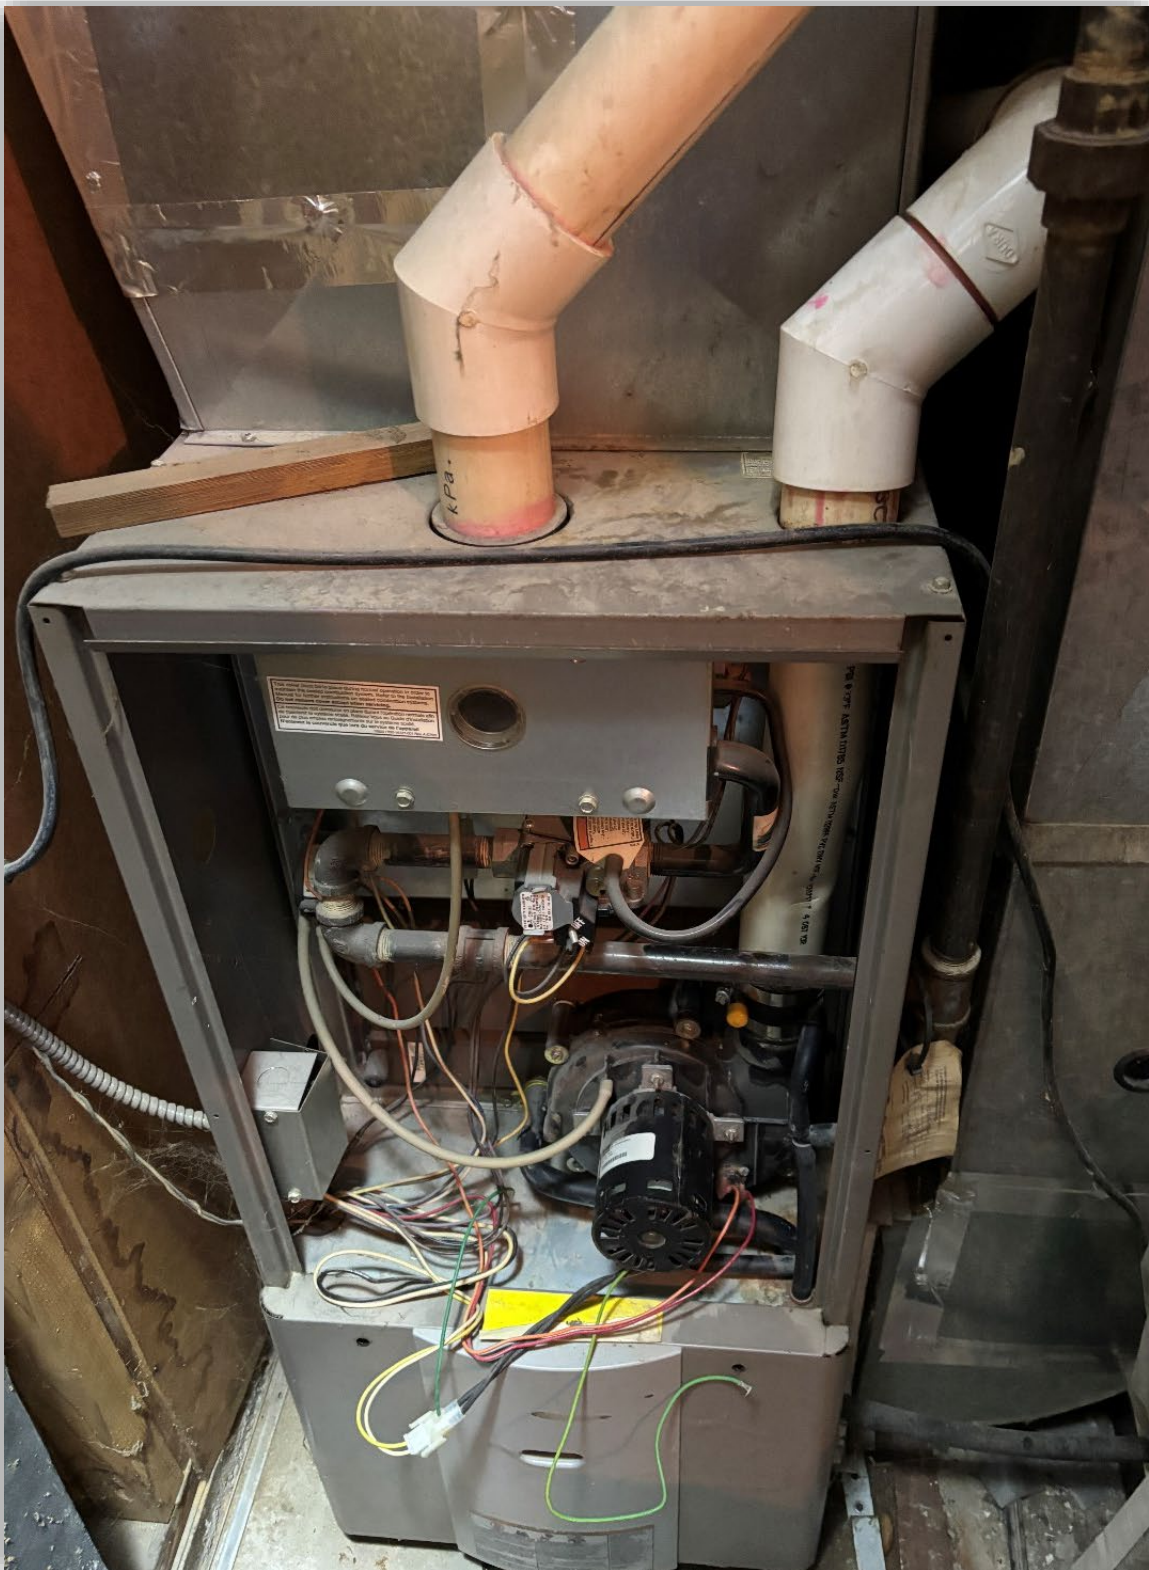
- No CO detectors were found on premises; however, eight different smoke alarms were found in the upstairs suite.
- The top cover of the furnace was found to be laying on the ground beside the furnace.

Image 3 – Gas furnace with upper cover removed as found after incident.

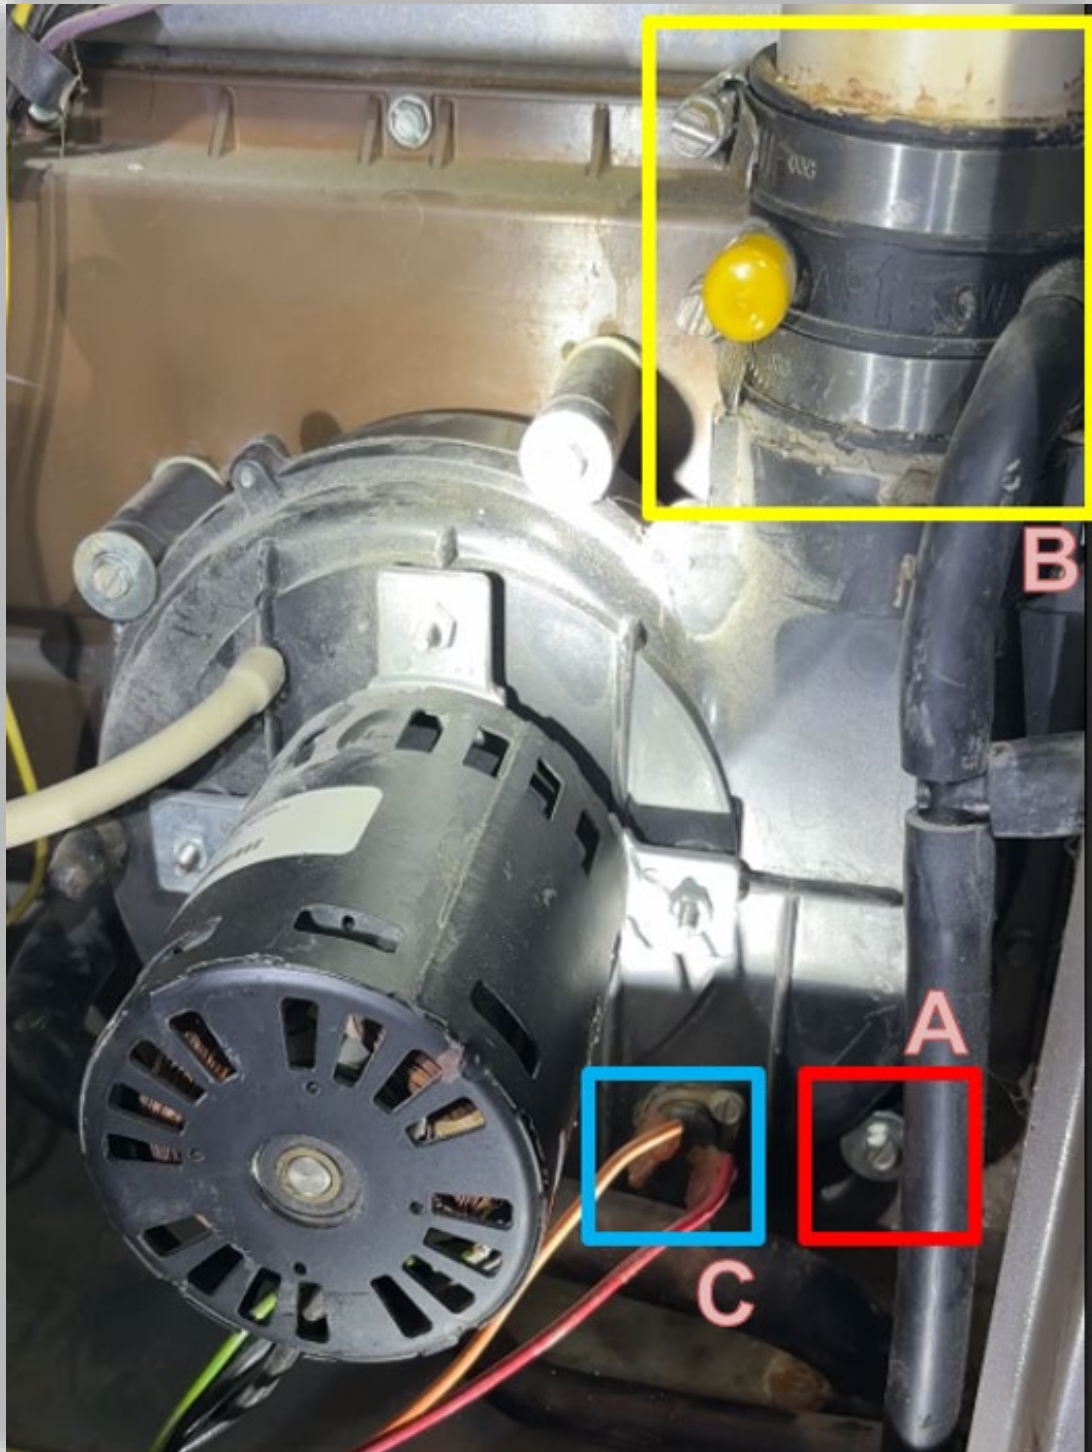
- Flue gas condensate was found forming in a pocket made by the failed vent section causing the induced-draft fan to intermittently surge in pressure.
- The induced-draft fan assembly was found loosely mounted to the furnace with 4 of 5 hold-down screws loosely installed and not making a tight seal.

- No action was taken in response to the licensed gas contractor's recommendations to replace and/or repair the furnace.
- The loose inducer fan housing bolts created insufficient air flow to the gas burner which caused incomplete combustion, the production of high levels of CO in the flue gases, and delayed ignitions. The change in airflow likely also limited the effectiveness of the inducer fan high limit switch.

Image 4 – Draft inducer motor showing loose mounting bolts [A] leaking “Fernco” vent pipe coupling [B], and high temperature limit switch [C].

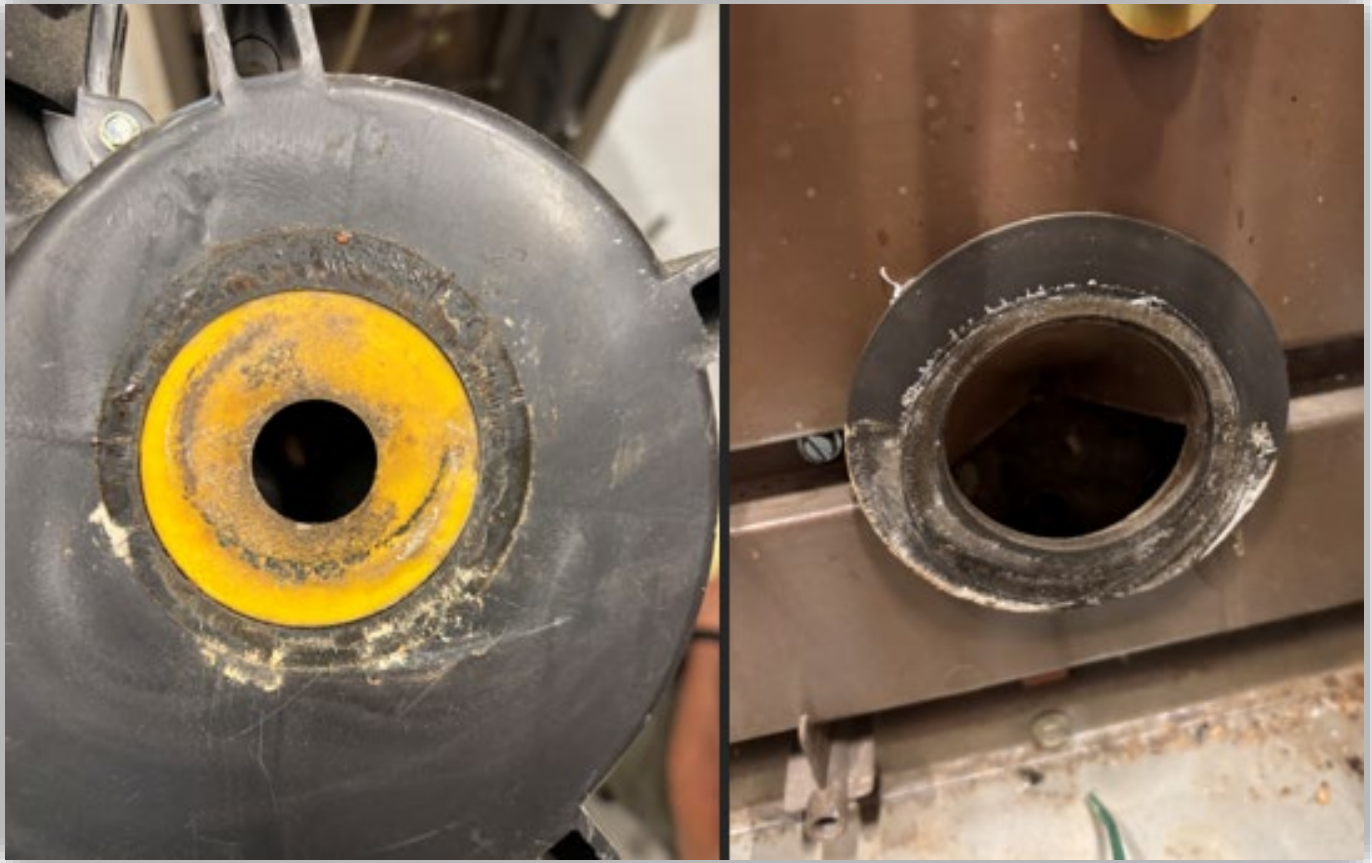
Image 5 – Draft inducer motor connection to furnace showing condensate leakage from improper seal from loose connection.

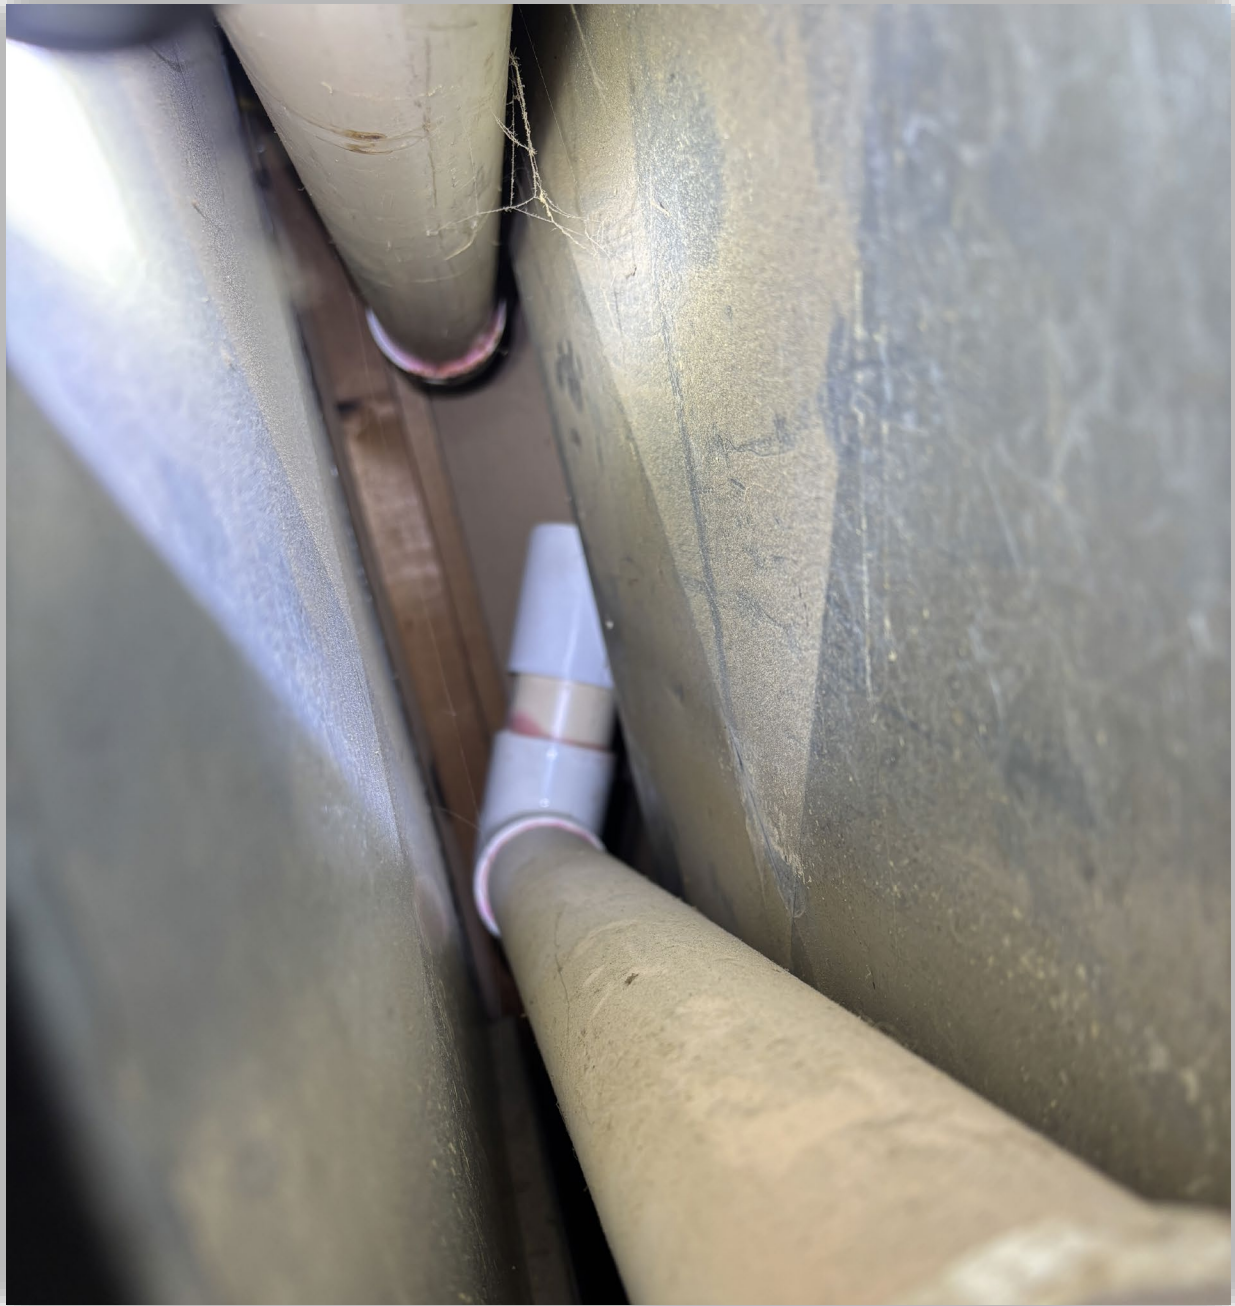
- The flue vent behind the furnace was found disconnected, solvent edging showed the pipe had been inserted at an angle and with insufficient depth.
- The flue vent as found was not completely inserted (prior to the incident) when installed at the furnace connection point, allowing it to distort in position and break the connection seal following the downstream vent section failure.

- The incorrectly assembled PVC vent pipe joint allowed it to come apart when strained, allowing flue gasses to enter the home.
- The furnace did not receive the required regular maintenance outlined by the manufacturer which led to an extremely dirty air filter and secondary heat exchanger that restricted airflow which would have caused operational issues and was likely related to the reported tripping of the high limit switch.

Image 6 – Disconnected flue vent pipe behind furnace as found after incident.

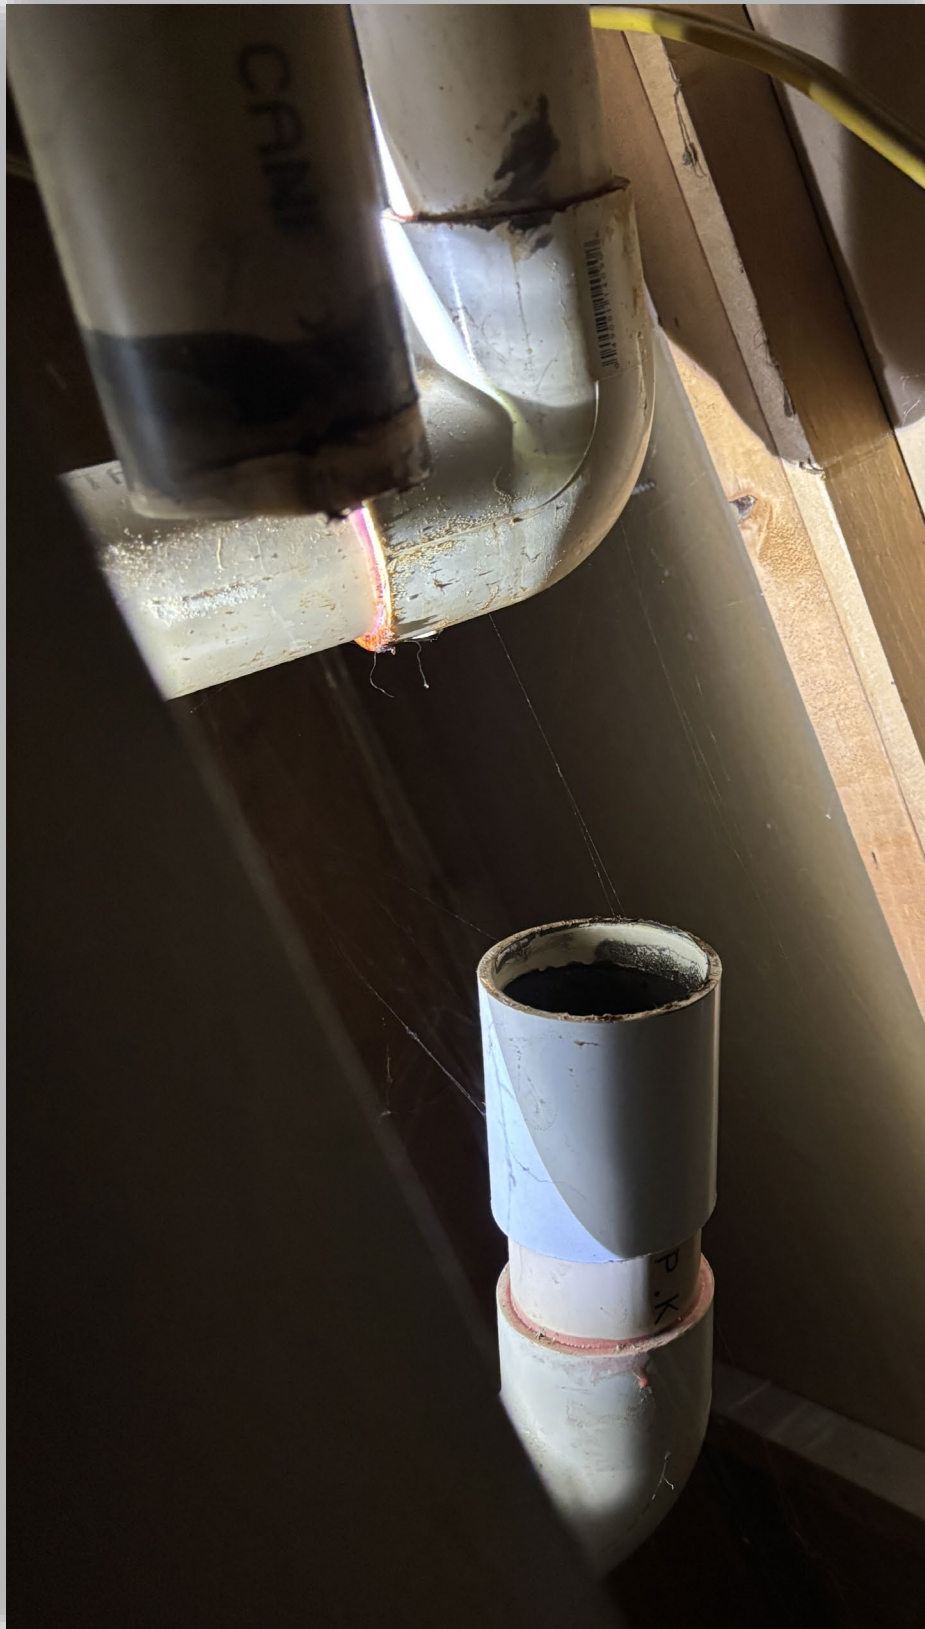
Image 7 – Disconnected flue vent pipe from other angle.

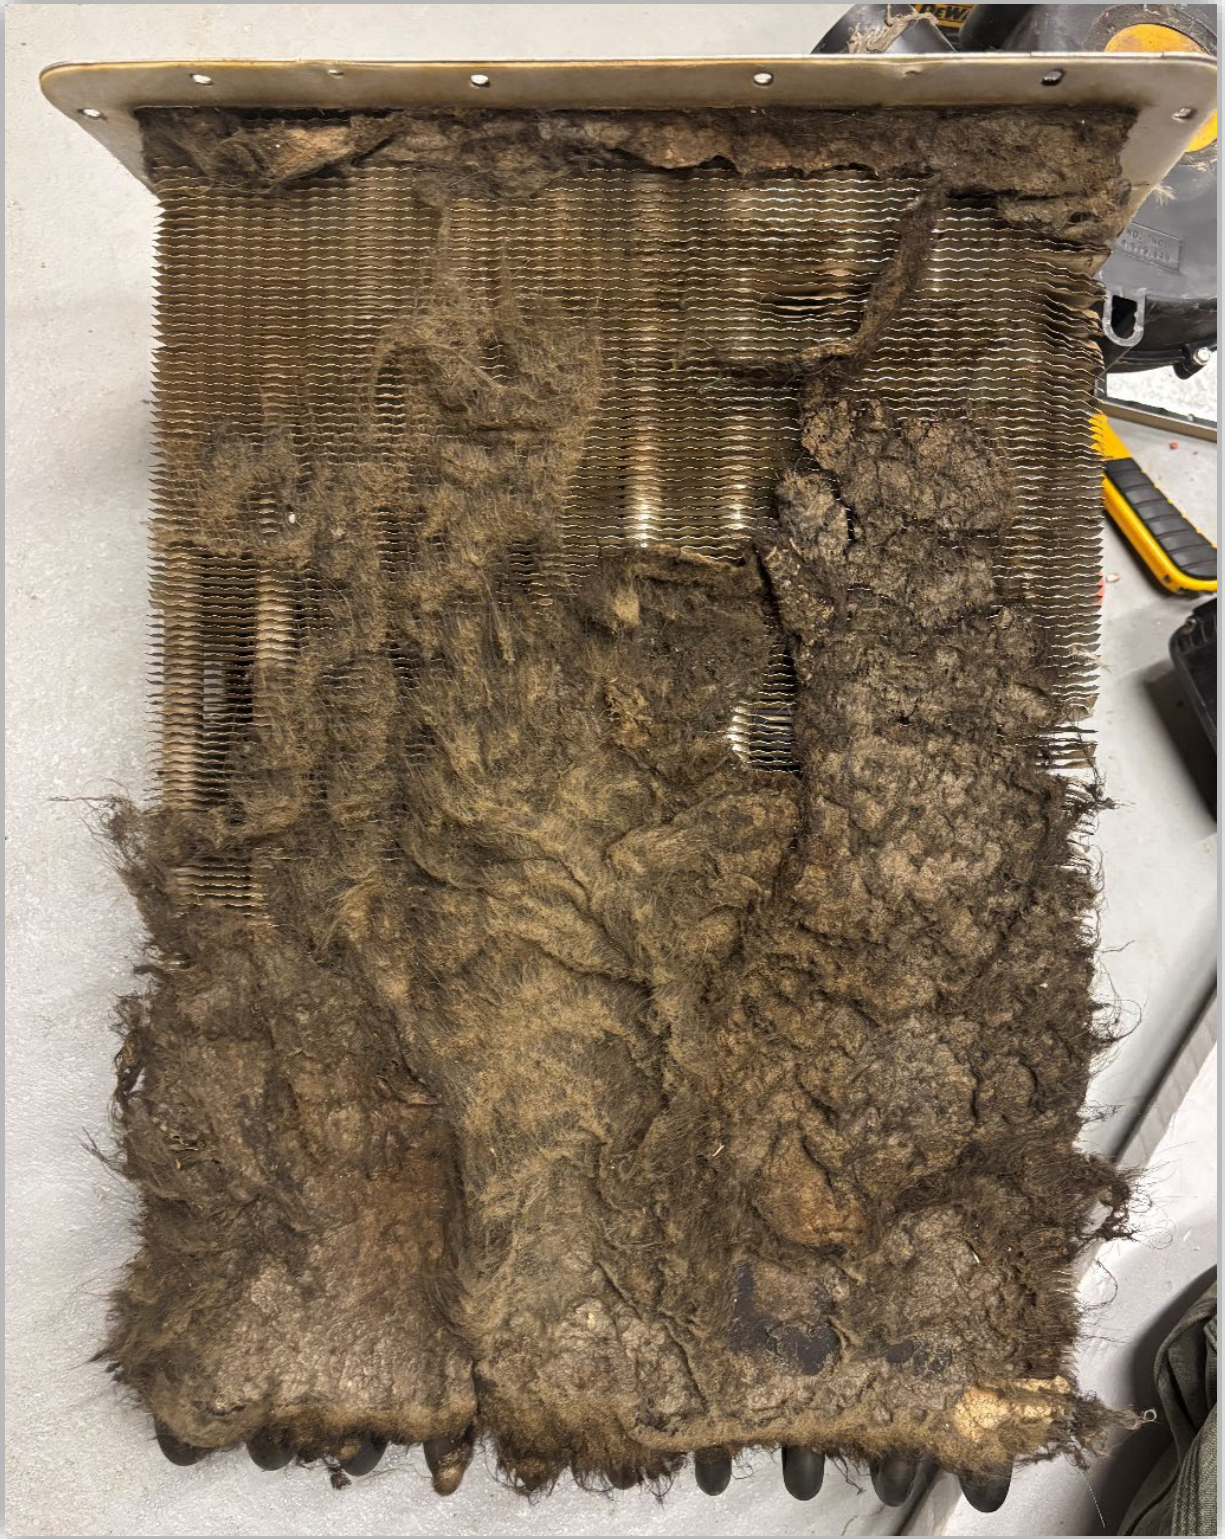
Image 8 – Dirty secondary heat exchanger found during furnace disassembly.
