Incident Summary posse file 5565801 (UW-320027-2015)

SUPPORTING INFORMATION		Incident Date		November 29, 2015
		Location		Mission
SUPPORTING INFORMATION		Regulated industry sector		Electrical – Low voltage electrical system
		Impact	Injury	Qty Injuries
Injury description				n/a
Injury rating				n/a
Damage	Damage description		Melting, charring and discoloration of a receptacle at the conductor terminations	
	Damage rating		Moderate	
Incident rating		Moderate		
DESCRIPTION	Incident overview		<p>The Mission Fire Department reported an incident involving electrical that was attended by first responders on November 29, 2015.</p> <p>The incident involved a receptacle in the living room of a single family dwelling unit. The tenant first reported hearing popping and crackling noises but was unable to pin point where the noises were coming from. A few hours later the tenants smelled burning which seemed to be coming from near a receptacle. They contacted the fire department who subsequently attended the scene.</p> <p>The fire department scanned the wall with their thermal imaging device which showed a hot spot around the electrical outlet box. They located the circuit breaker in the electr

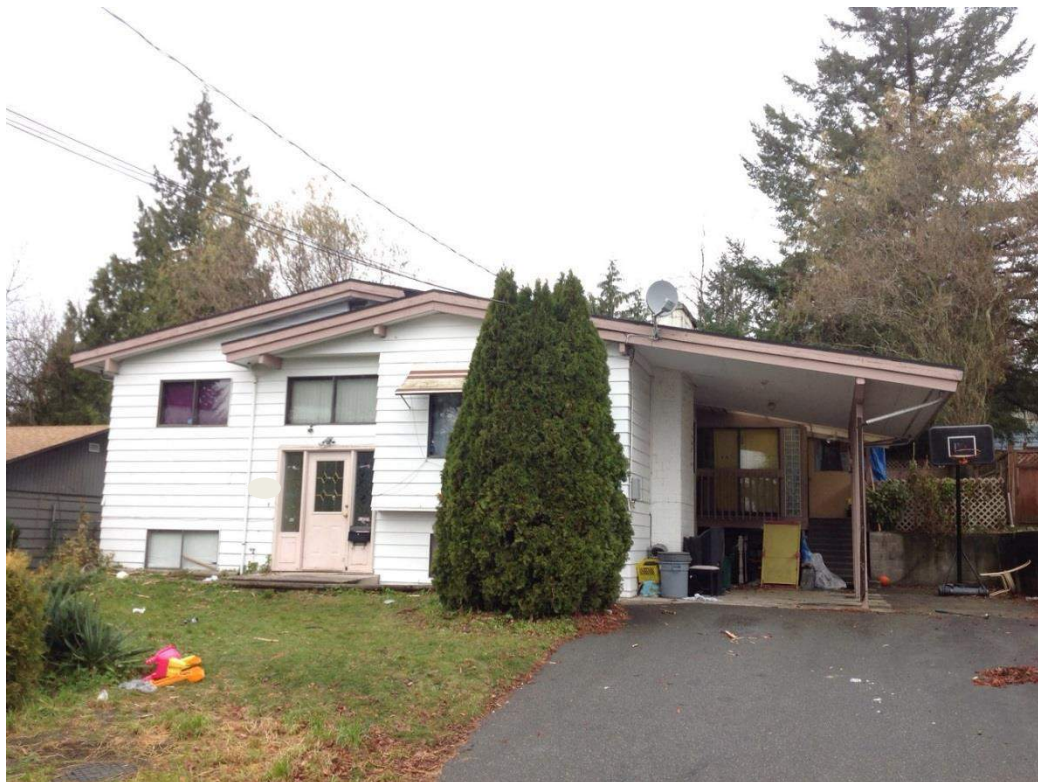
Photo 1: Front of the house where incident occurred.

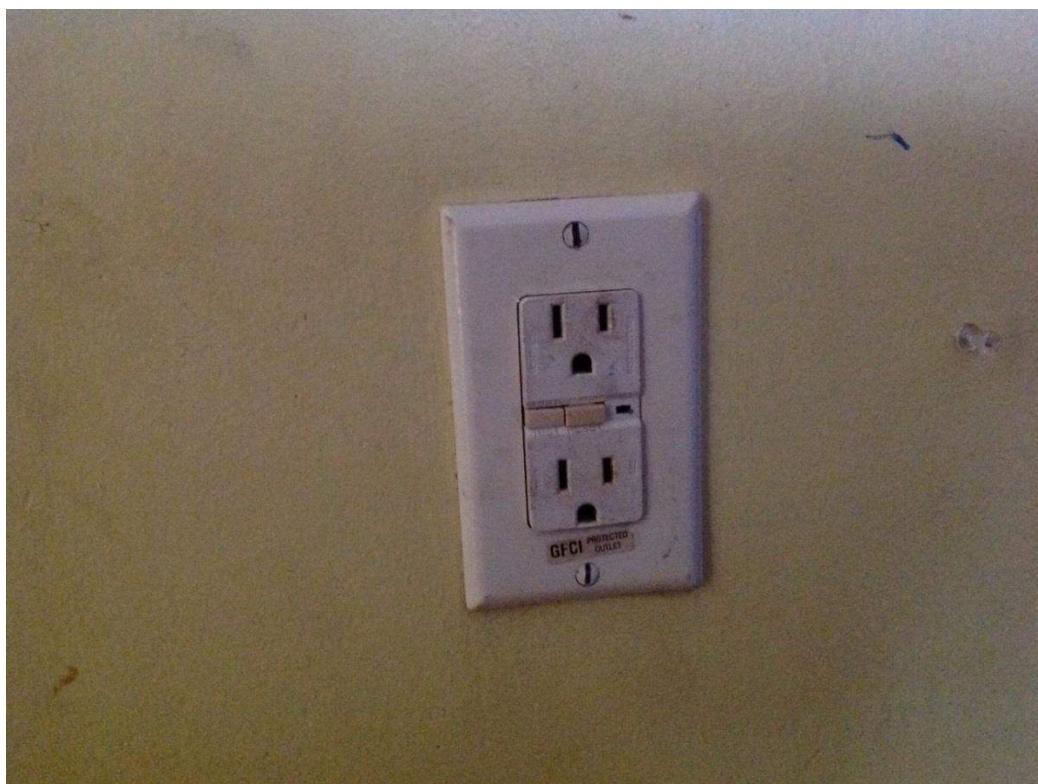
Photo 2: failed receptacle as installed – no evidence of damage when viewed.

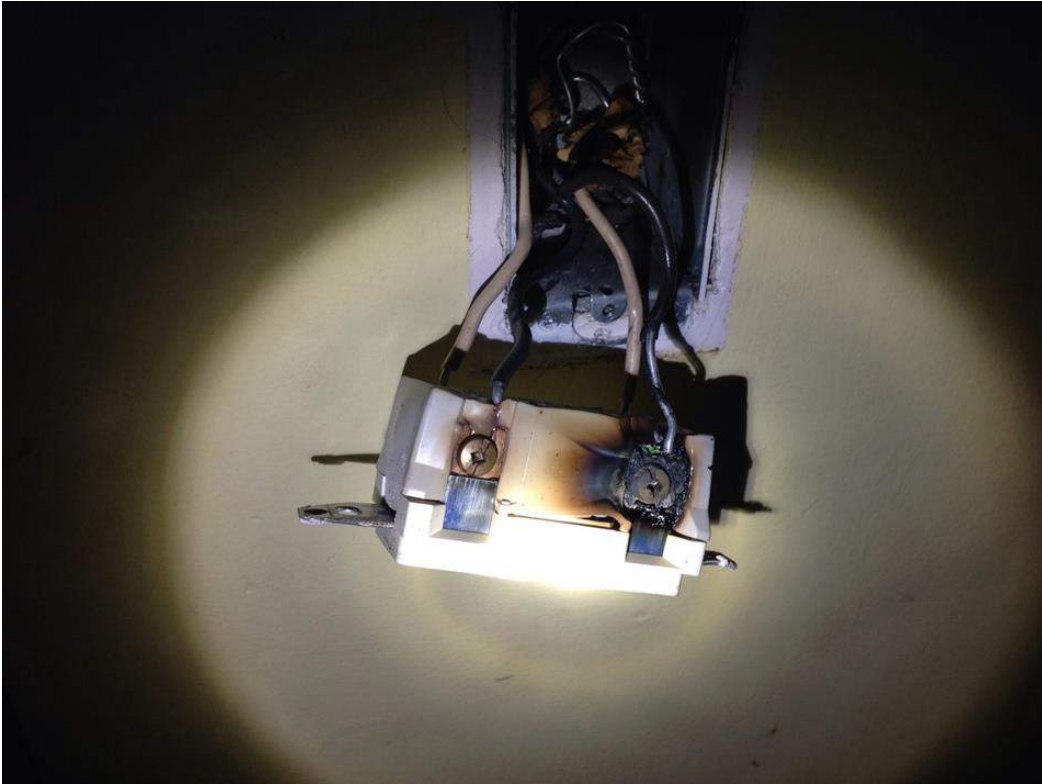
<p>Causes and Contributing Factors</p>	<p>The cause of this incident was an incompatible receptacle installed on aluminum wiring likely by an unqualified person. The BC Electrical Code rule 2-024 requires electrical equipment to be of a kind or type and rating approved for the specific purpose for which it is to be employed.</p>

Photo 3: Heat damaged receptacle removed from outlet box. Discoloration at thermally damaged conductor termination.

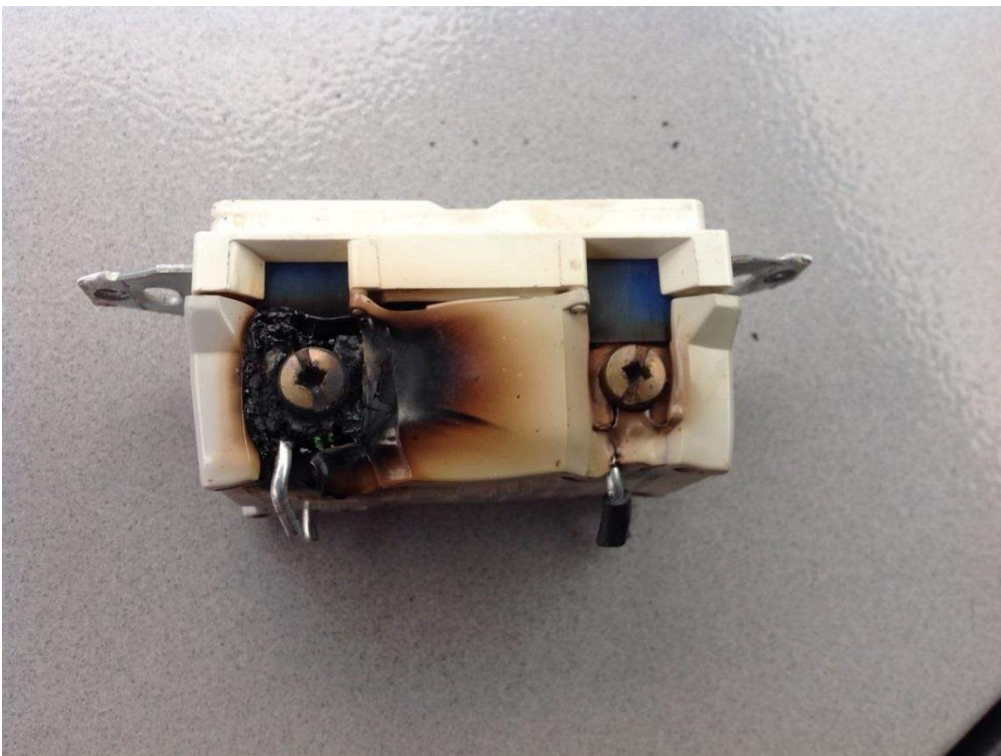
Photo 4: Damaged receptacle cut from house #12 awg aluminium wiring.

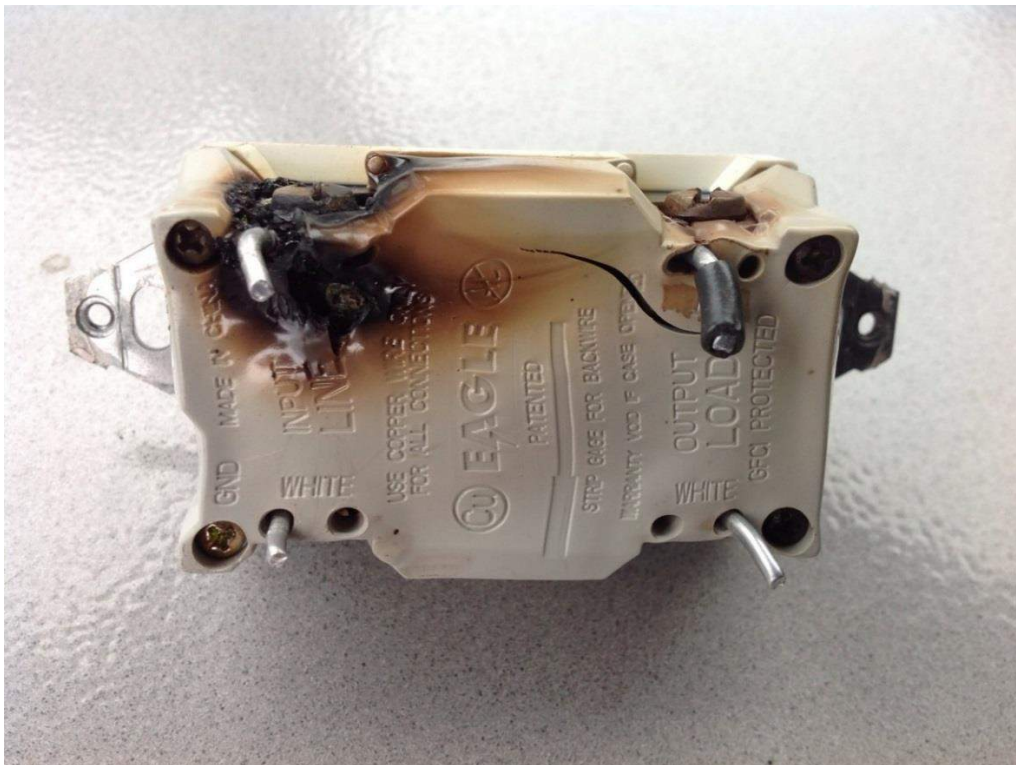
Photo 5: Back of damaged receptacle cut from #12 awg aluminium house wiring. Note the statement “USE COPPER WIRE ONLY FOR ALL CONNECTIONS” and the Cu (copper) symbol and the ‘no AL (Aluminium)’ symbol.
