Richmond Apartment Explosion Incident Investigation

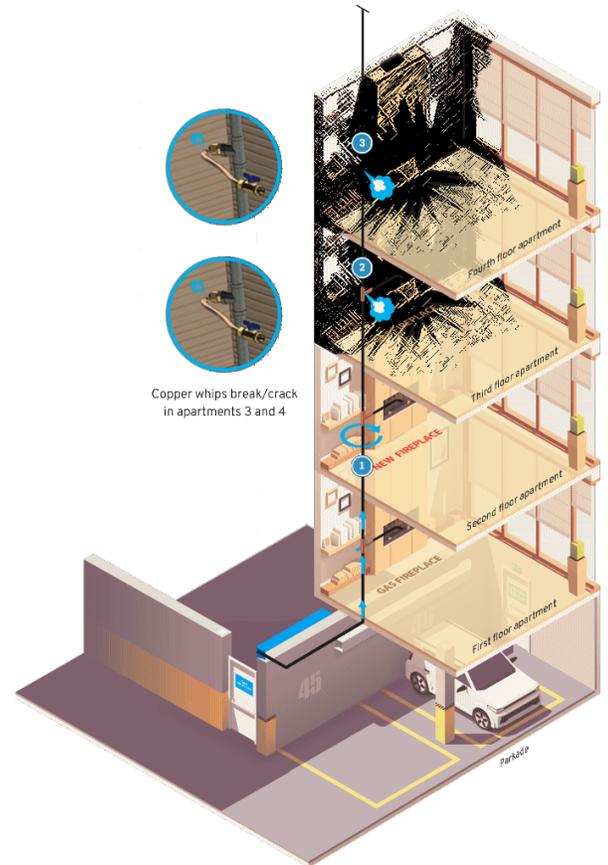
Natural gas supply in the building is distributed through a gas piping system in the lower level parkade, which is then branched to a number of vertical gas pipes known as risers which provide gas to the individual suites, including the fireplaces.

Each of the fireplaces in the building is connected to the gas riser using a narrow copper pipe known as a “whip”, attached to a T-fitting in the riser. To accommodate the configuration of the new fireplace, the contractors working on the fireplace retrofit turned the gas riser pipe and T-fitting and pushed them out of the way. This caused the copper whips attached in the third and fourth floor suites to break/crack.

Because the gas fitters had not turned off the gas supply serving the riser, gas then leaked out of the broken/cracked whips and was ignited by a fireplace pilot light in a suite on the fourth floor, resulting in an explosion in suites on the third and fourth floor.
