**Incident Summary #II-1748998-2024 (#50512) (FINAL)**

SUPPORTING INFORMATION	Incident Date	August 16, 2024
	Location	Hope
	Regulated industry sector	Electrical - Low voltage electrical system (30V to 1000V)
	Qty injuries	1
	Injury description	Minor scrapes and abrasions
	Injury rating	Insignificant
	Damage description	Arc flash burn marks to the vehicle, complete destruction of the electric vehicle charger adaptor. Damage to the charging cable and internal components of the commercial electrical vehicle charger.
	Damage rating	Major
	Incident rating	Major
	Incident overview	While charging a Tesla EV at a non-Tesla commercial electric vehicle charger, a short circuit between the charging cable of the charger and an after-market charging adaptor resulted in an arc-flash.
INVESTIGATION CONCLUSIONS	Commercial electric vehicle (EV) charging stations are available for public use at select locations such as gas stations, shopping malls and in other locations. In North America there are three primary styles of charging plugs and sockets depending on vehicle manufacture and charging station output. AC charging stations typically use a SAE J1772 – Type 1 connector good for up to 19 kilowat

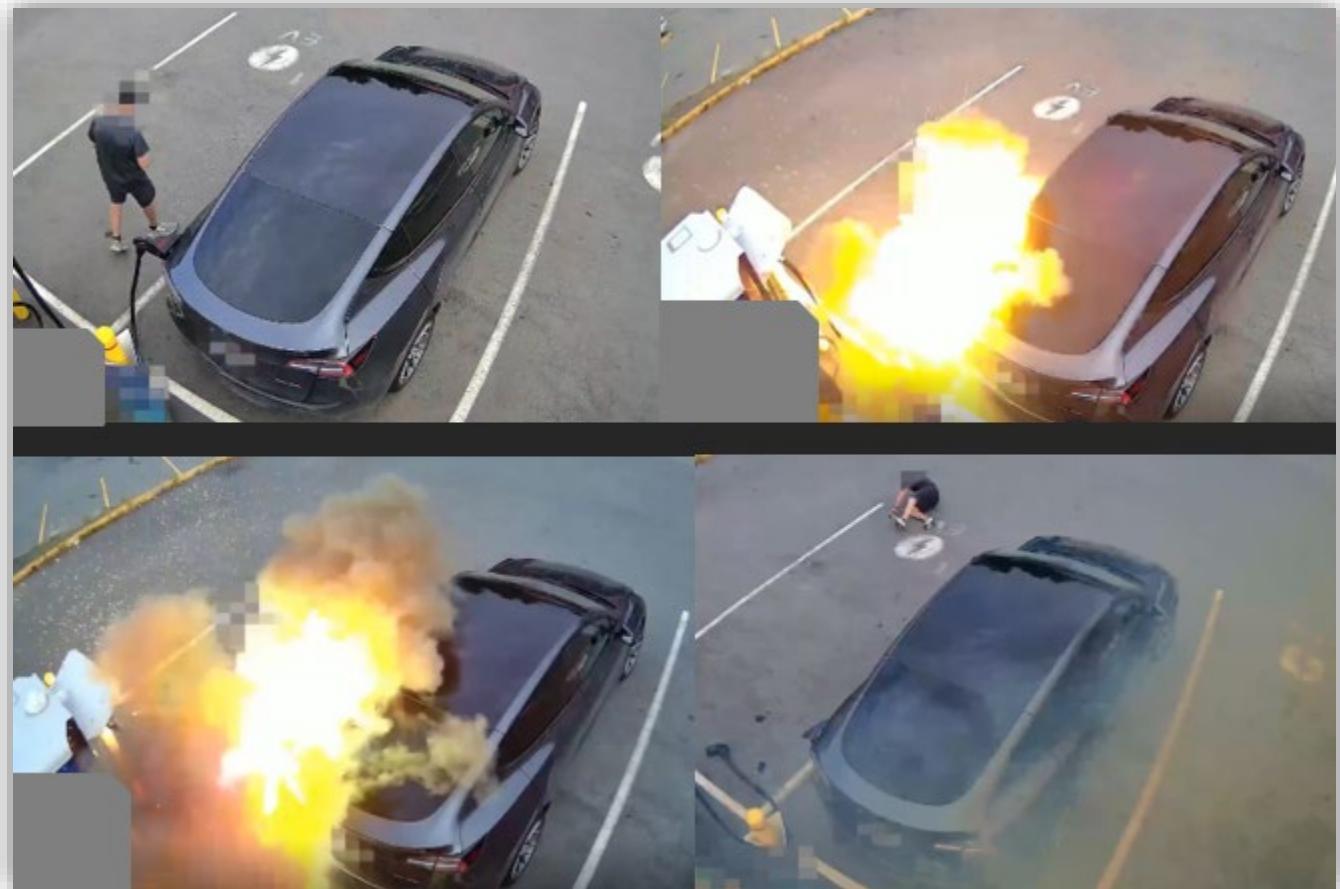
Image 1 – Stills taken from security camera footage of the incident.

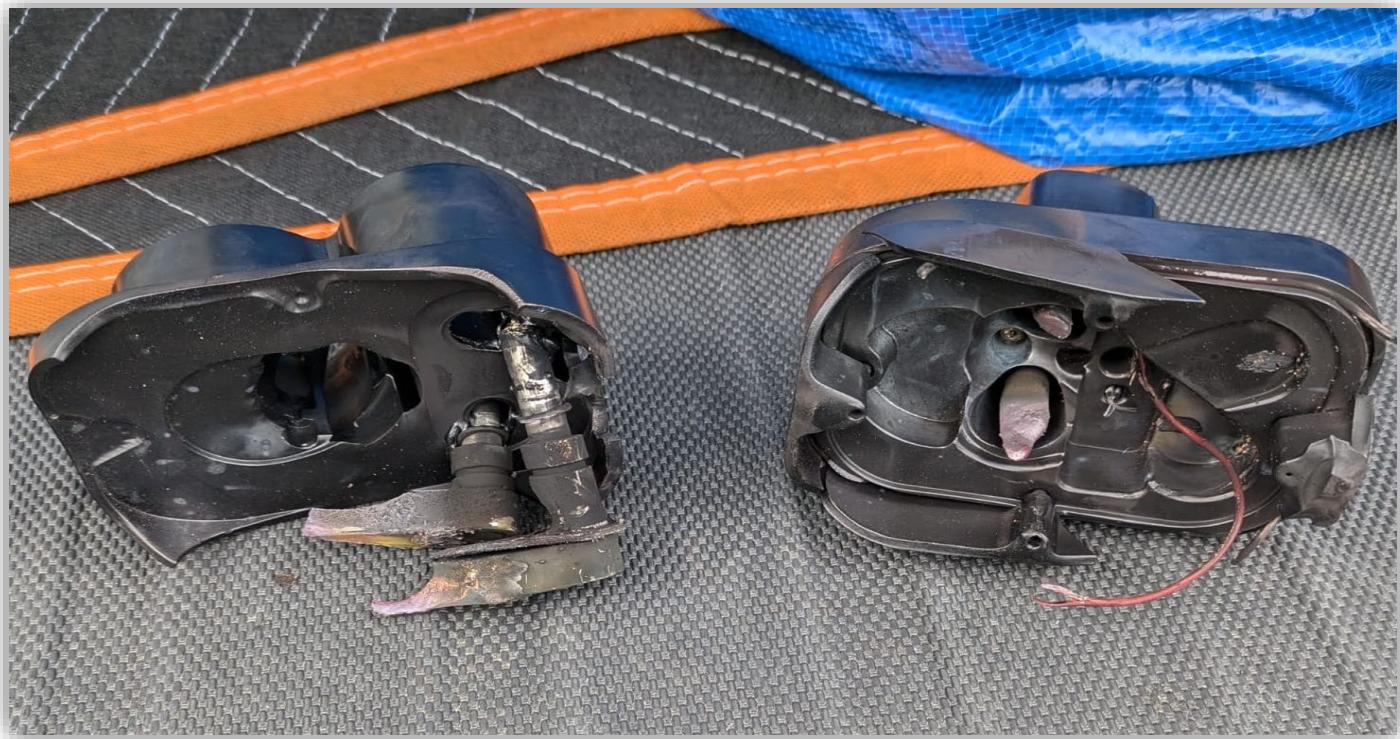
Causes and contributing factors	<p>A short circuit in the charging adapter, caused an arc-fault and arc-flash damaging electrical components and injuring the owner.</p> <p>Contributing factors to the incident include:</p> <ul style="list-style-type: none"><li>• The use of an unapproved charging adapter to charge the vehicle.</li><li>• The inability for manufacturers to test and approve charging adapters for use in Canada due to there being no finalized approval standard at the time.</li></ul>

Image 2 - Adaptor blown in half with terminals showing signs of extreme heat.

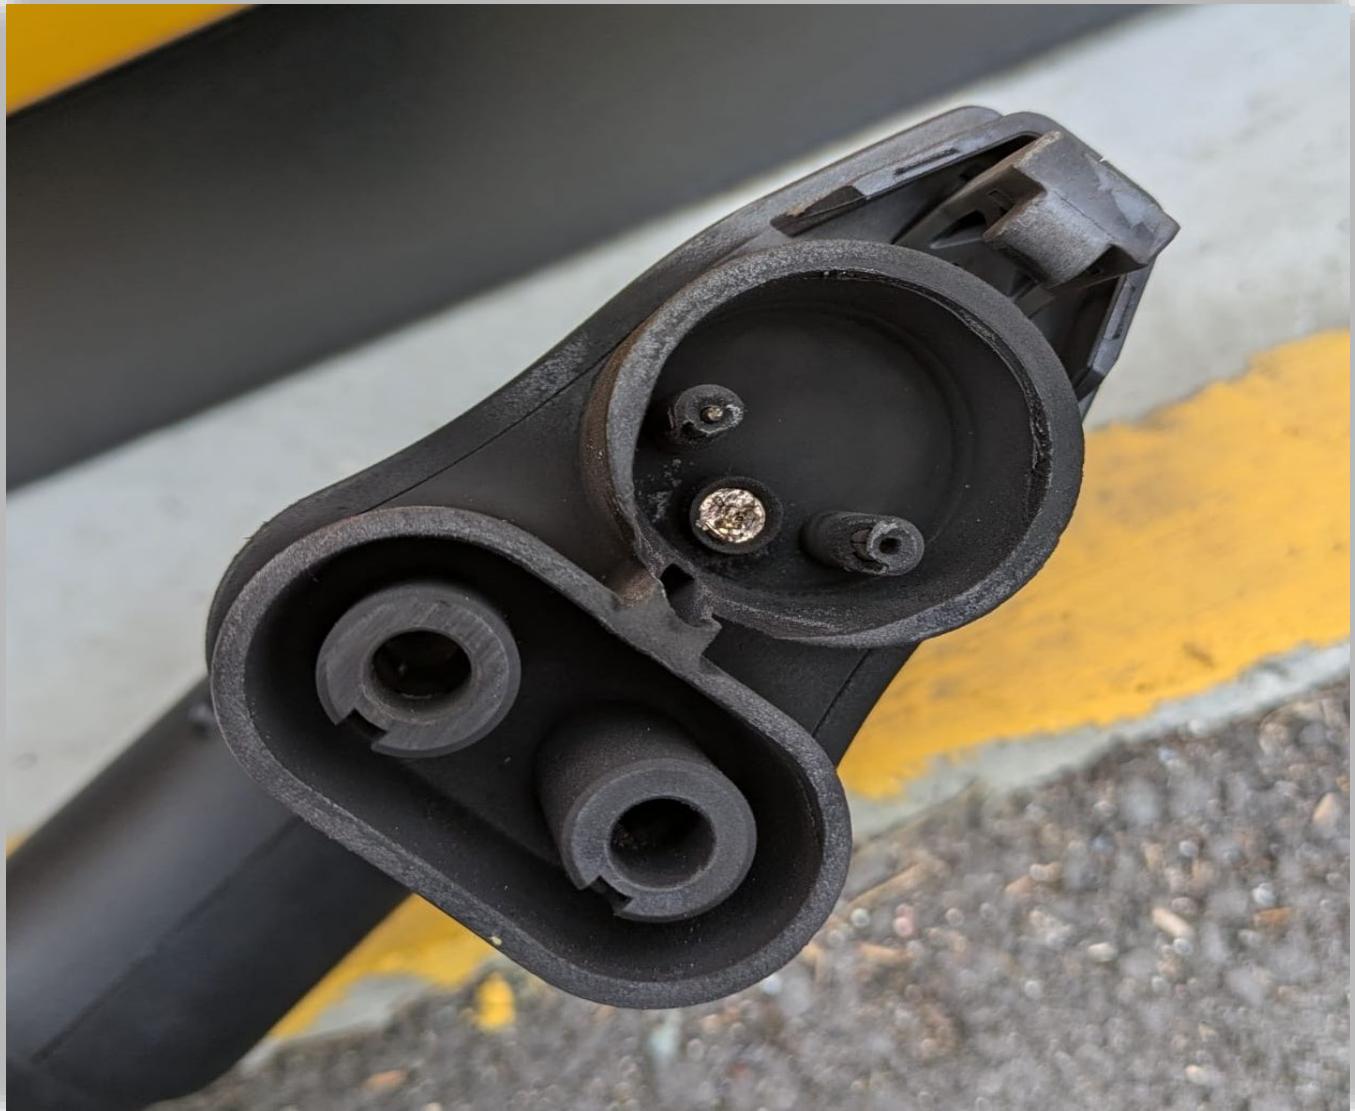
Image 3 - The ground terminal on the charging cable melted away.

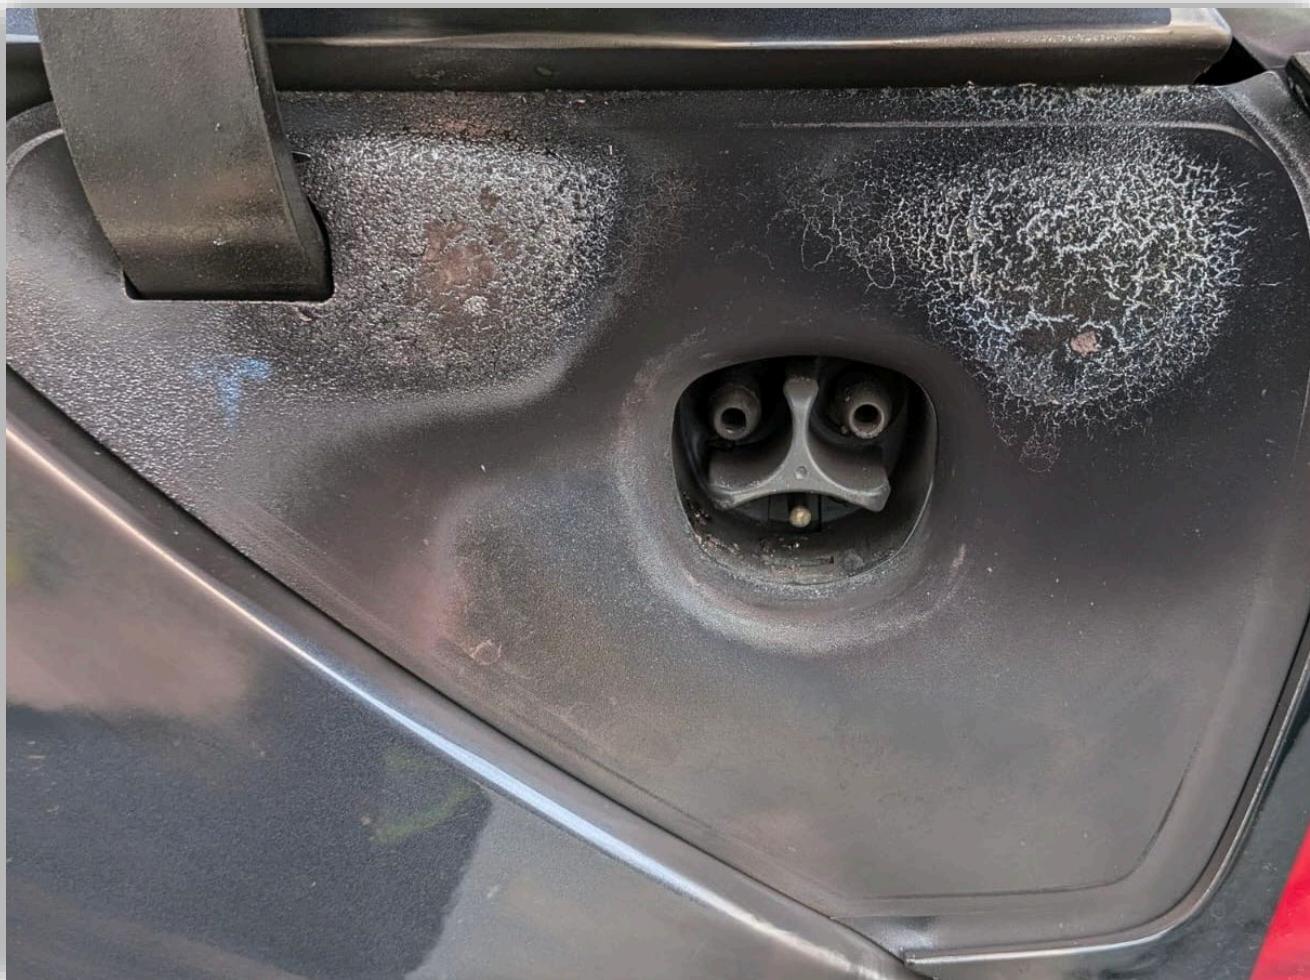
Image 4 - Electrical burn marks on the vehicle but charging terminals show little sign of damage.

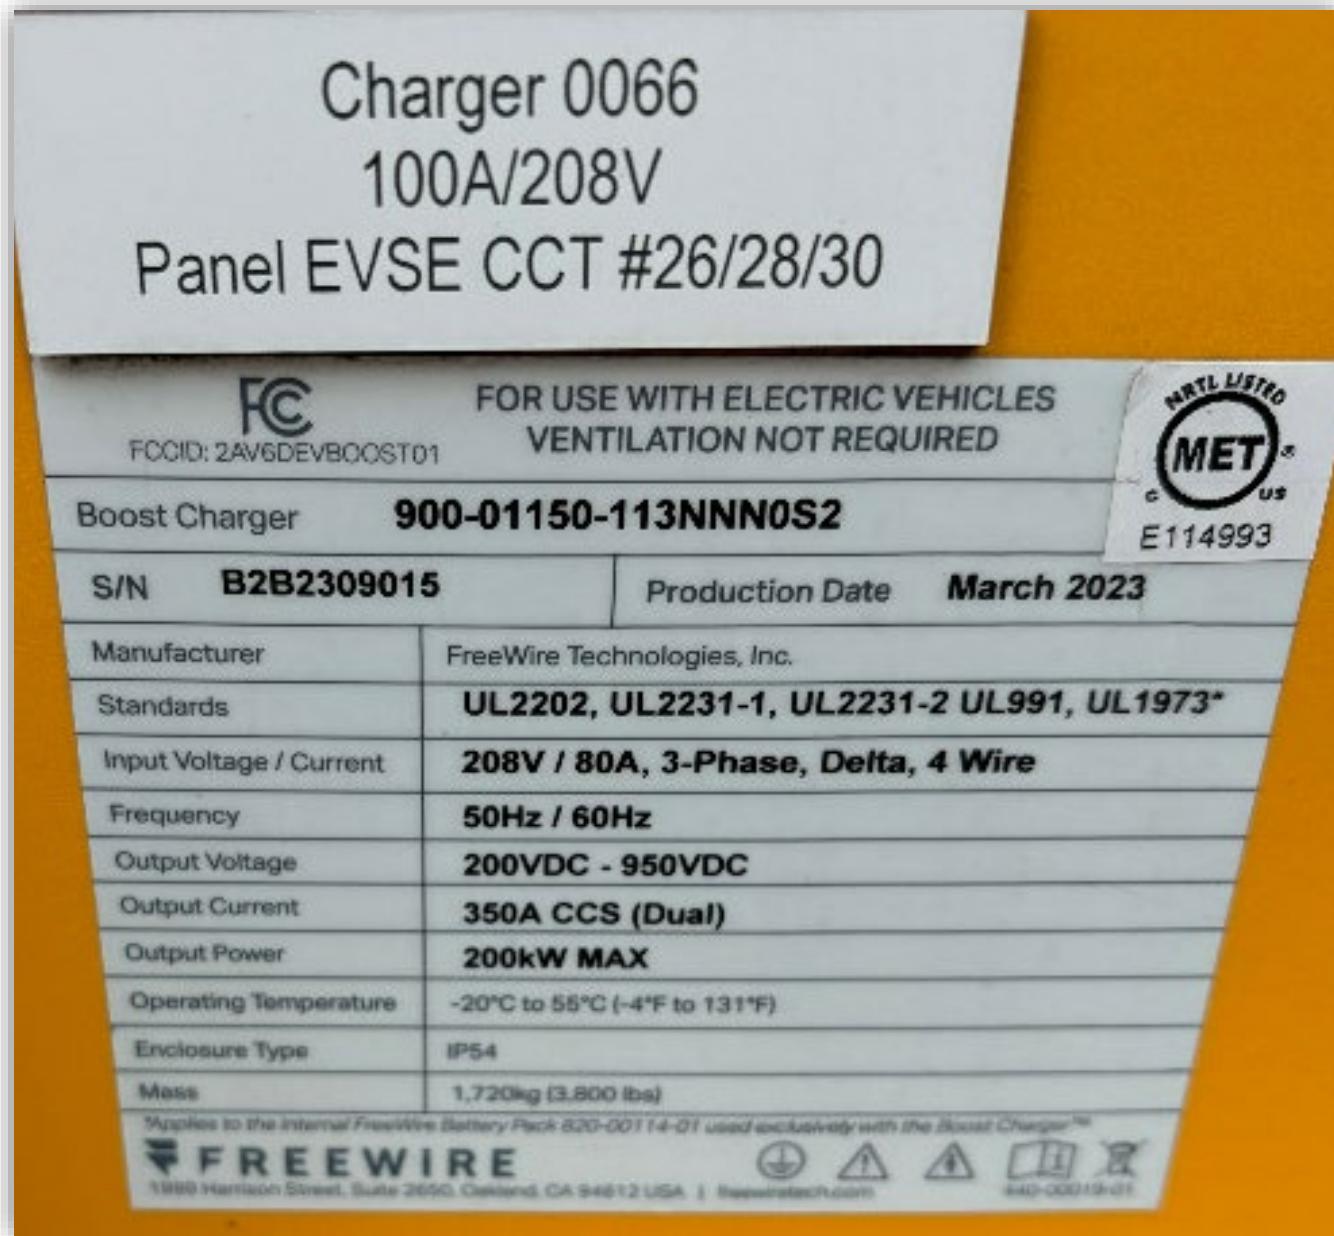
Image 5 – Data tag for the charging station showing 200kW max power output.
