Incident Summary #II-1490880-2023 (#30925) (FINAL)

SUPPORTING INFORMATION	Incident Date	January 7, 2023	
	Location	Richmond	
	Regulated industry sector	Gas - Natural gas system	
	Impact	Qty injuries	0
		Injury description	No reported injuries
		Injury rating	None
	Damage	Damage description	Natural gas leaked from a cement kiln and ignited in a fireball.
		Damage rating	Minor
Incident rating	Minor		
Incident overview	A removable pilot is used to ignite the main burner of a large cement kiln. The automatic pilot was damaged and stopped working. While attempting to manually operate the pilot with bypassed safety switches, gas leaked from an opening where a safety sensor was removed and ignited in a fireball.		
INVESTIGATION CONCLUSIONS	Site, system, and components	<p>The facility uses a large kiln to produce cement products that has been in operation since 1999. The kiln has a 200,000,000 btu natural gas fired burner system to produce the high heat needed for the kiln. When the kiln is operating it can also be supplied with additional solid fuels to aid in the heat production. The main gas burner for the kiln is ignited by a 200,000 btu natural gas pilot burner system that was approv

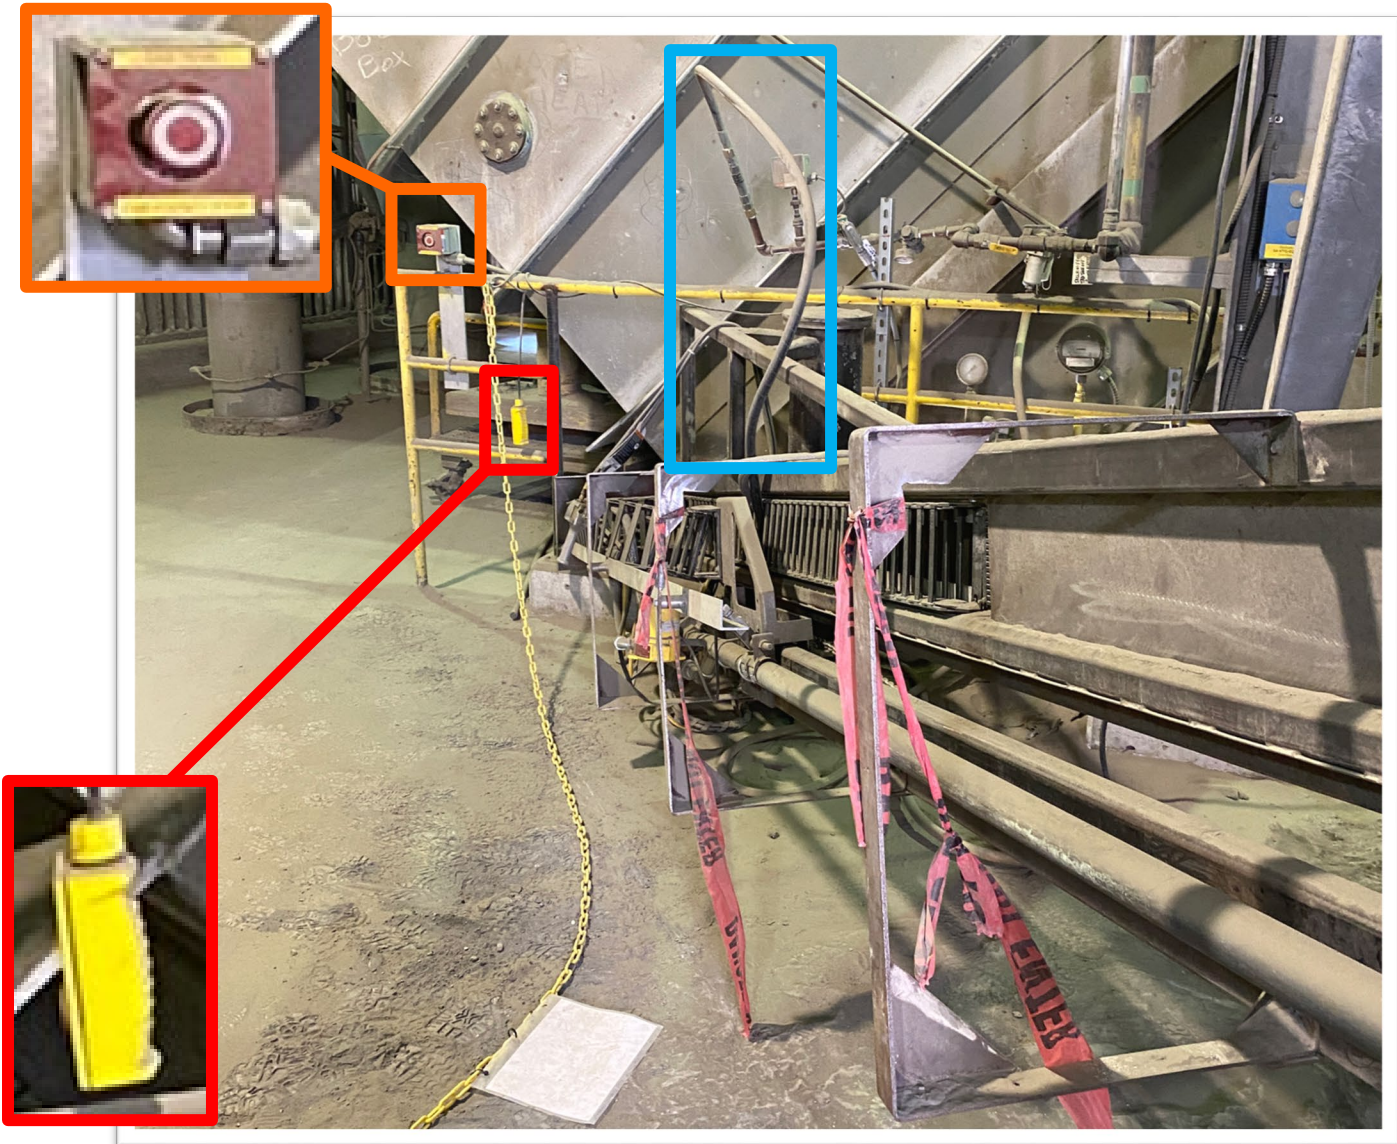
Photo 2 (Photo taken before incident) – Pilot tube assembly on retractable rail. **BLUE** - the pilot gas line. **RED** - the controller for moving the pilot tube in and out of the kiln. **ORANGE** - the emergency stop button.

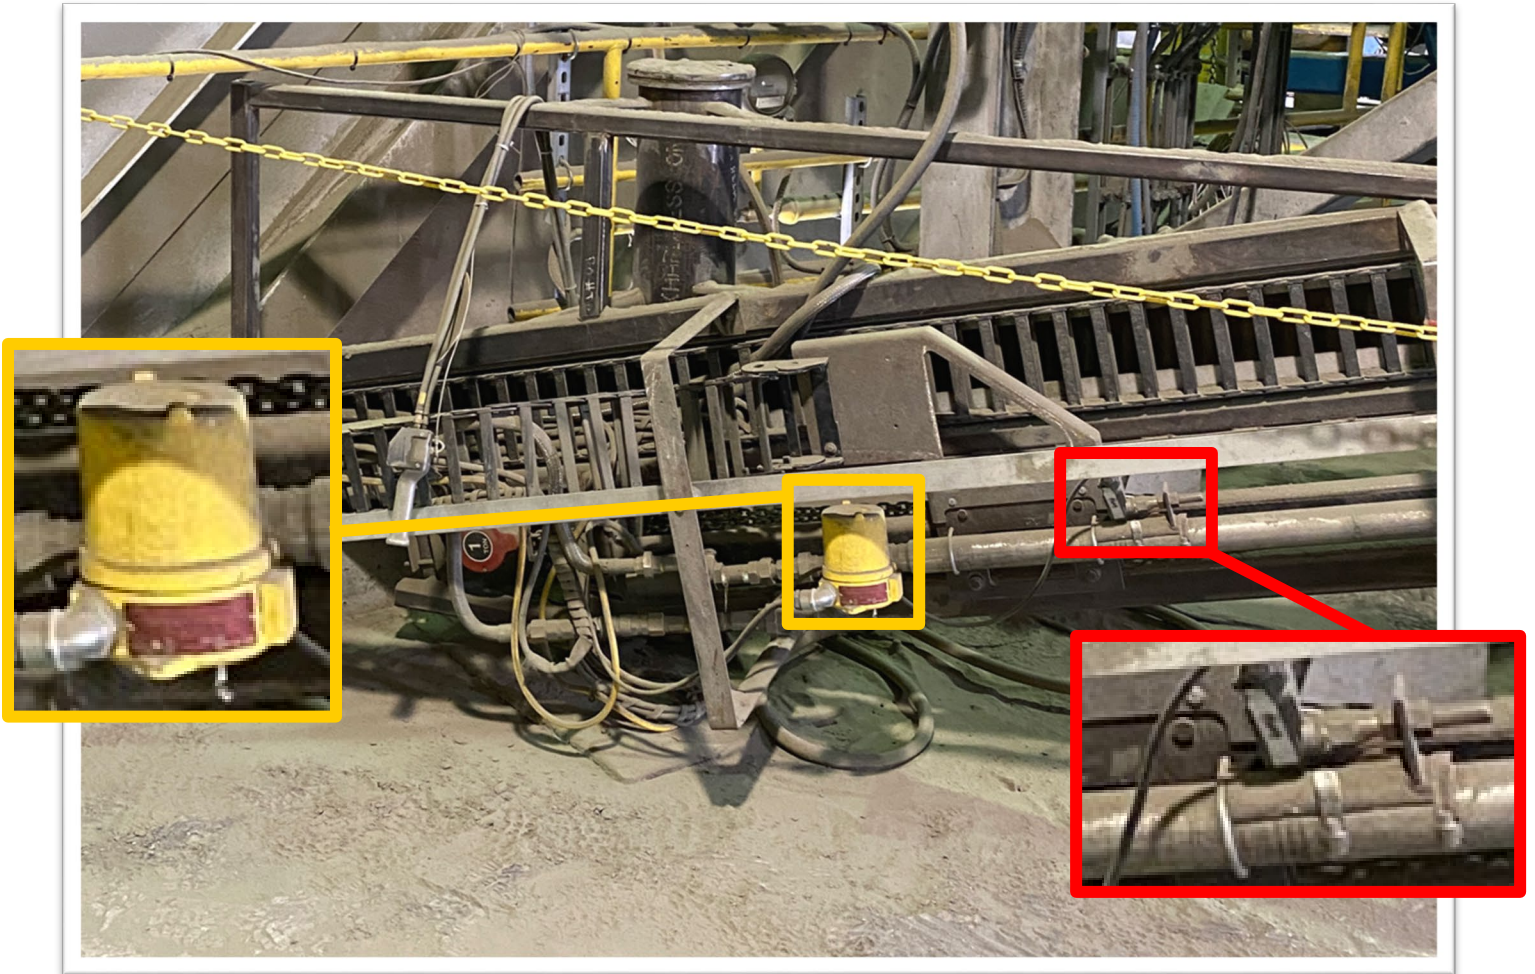
Photo 3 (*Photo taken before incident*) - Pilot tube assembly on retractable rail. **RED** - the proximity sensor. **YELLOW** - ignitor enclosure.

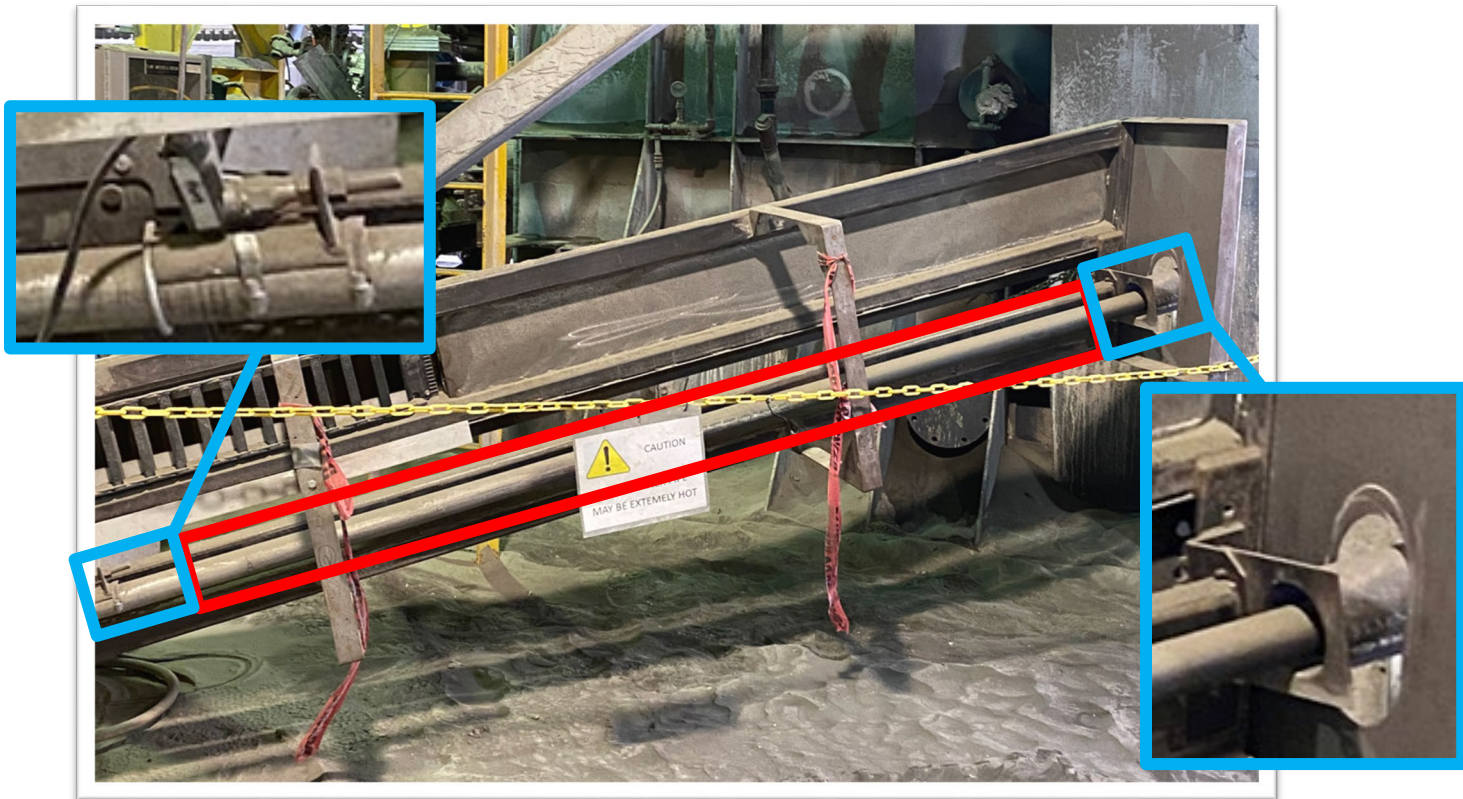
Photo 4 – **RED** - pilot tube retracted from kiln. **BLUE** - proximity sensor and flange that will close the switch when it the sensor close to it.
