## Incident Summary #II-851653-2019 (#12284) (FINAL)

Incident Date	May 9, 2019 (#12284) (FINAL)
SUPPORTING INFORMATION	Location	Duncan
	Regulated industry sector	Electrical - High voltage electrical system (greater than 750V)
	Qty injuries	0
	ਨੇ Injury ਦ description	NA
	Injury rating	NA
	E Damage description ☐ Damage rating	Small forest fire, approximately 50x100.
	Damage rating	Minor
	Incident rating	Minor
	Incident overview	A private 2.4kv power line appears to have arced to an guy line causing a fire.
INVESTIGATION CONCLUSIONS	Site, system and components	<ul> <li>Pole structure means a main support for a line and consists of one or more poles plus any guys, anchors, push braces, and civil works required to provide structural stability and make it free standing.</li> <li>Primary line means a line operating at a potential in excess of 750 V conductor to ground and lower than 60 kV conductor-to-conductor.</li> <li>Span guy means a guy that spans the distance between structures.</li> </ul>

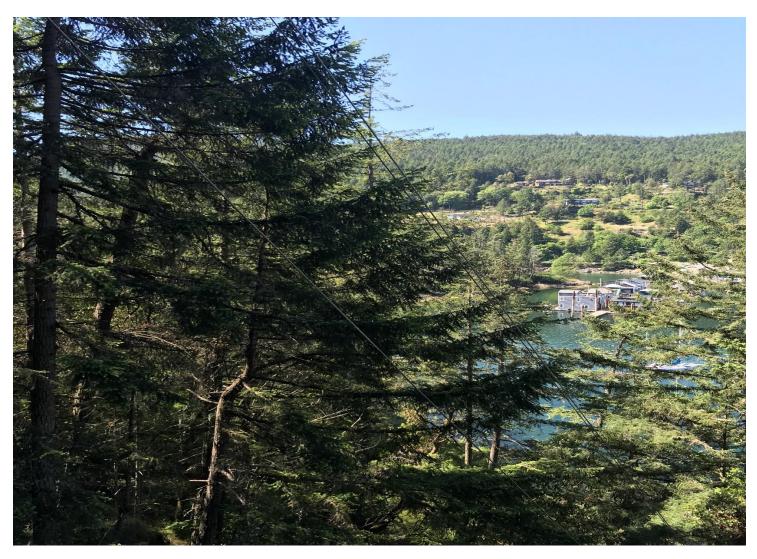
Failure scenario(s)	Clearance between the primary line and the span guy run parallel to each other was approximately 25mm as observed on May 10 <sup>th</sup> . With the lines this close together simply leaning against the pole was enough to get them to touch each other. Originally the span guy was installed approximately 10-12 inches below the primary in 1996, (Witness Statements). A severe wind storm last December damaged the line and Pole Structure downstream of the span guy location, the line was reinstalled, and likely changed the loading and sag characteristics of the structure. The span guy only had insulators at the uphill end, the bolt that attached the span guy to the downhill terminal pole was a couple inches away from a grounded surge arrestor brace. This was a low enough resistance to blow the expulsion fuse located approximately 400m away.
	Facts and evidence	Photos, witness statements.

Causes and contributing factors	The fire was caused by the improper installation of the span guy.

View of primary line and span guy, approximately 25mm apart.
