Incident Summary #II-1487206-2022 (#30819) (FINAL)

SUPPORTING INFORMATION	Incident Date	December 28, 2022	
	Location	Armstrong	
	Regulated industry sector	Electrical - High voltage electrical system (greater than 750 V)	
	Impact	Qty injuries	0
		Injury description	N/A
		Injury rating	None
	Damage	Damage description	A 6 section 25 kilovolt (kV) indoor, high voltage, metal-clad switchgear unit had 2 modules destroyed by a fault that started a small fire within the structure. The fault also permanently damaged an outdoor 10-15 megavolt ampere (MVA) 138 kV - 25 kV pad mount transformer in the switchyard. The damage resulted in significant downtime for the facility.
		Damage rating	Severe
Incident rating	Severe		
Incident overview	A high voltage electrical fault occurred at an industrial lumber mill and plywood plant. The fault occurred inside an indoor 25 kV metal-clad switchgear enclosure. The overcurrent protection of the primary voltage system was a circuit breaker located upstream on the 138 kV primary line. The breaker was in a locked condition and failed to open after a fault, allowing high current to continue and damage the downstream switchgear. The fault continued to occur fo

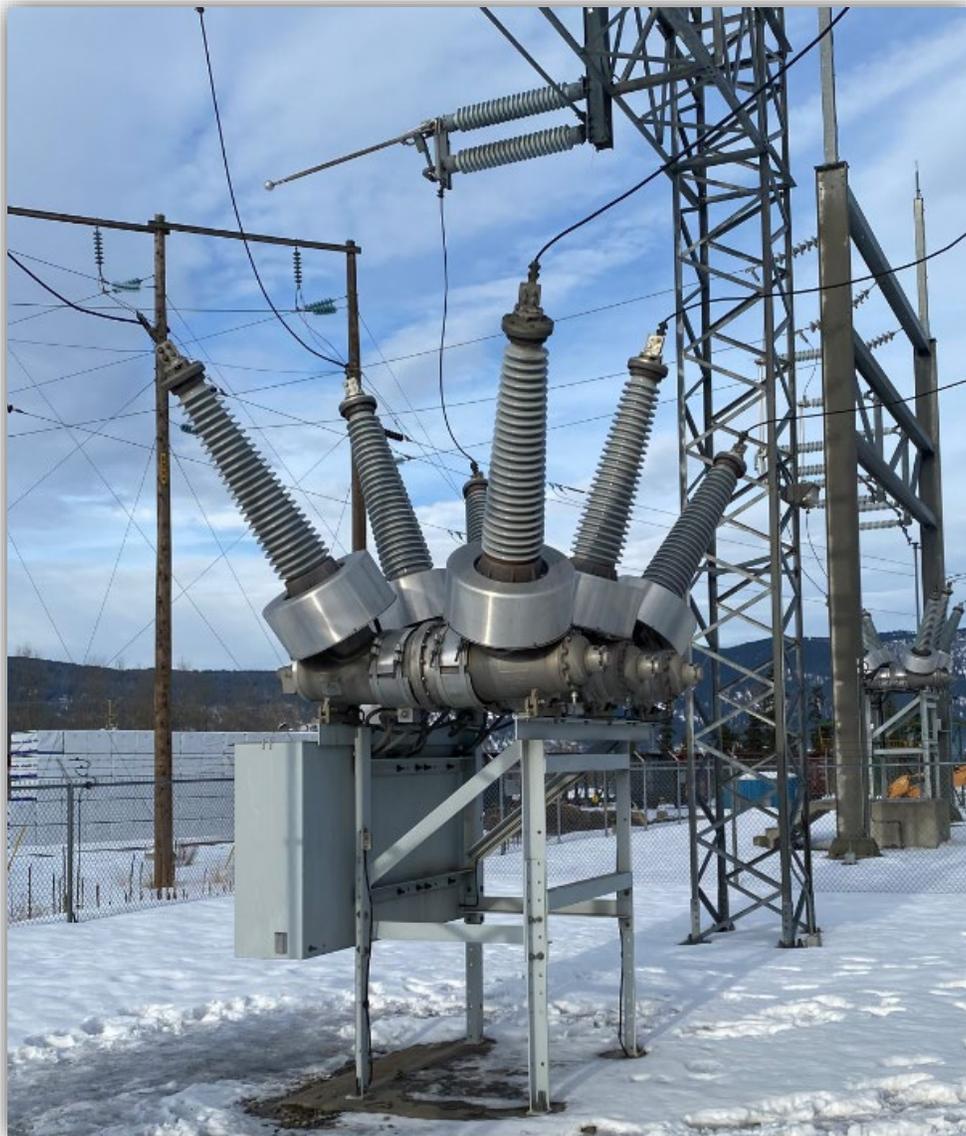
The failure to repair the low gas pressure in the 138 kV breaker was a contributing factor to the incident by allowing it to not disconnect power and allowing the fault to continue for up to 3 minutes which greatly increasing the amount of damage which resulted.

Photo 1 - 138 kV SF-6 main overcurrent breaker, first and only overcurrent protection prior to the switchgear disconnects, Breaker was in 'lock out mode' due to insufficient gas pressure.

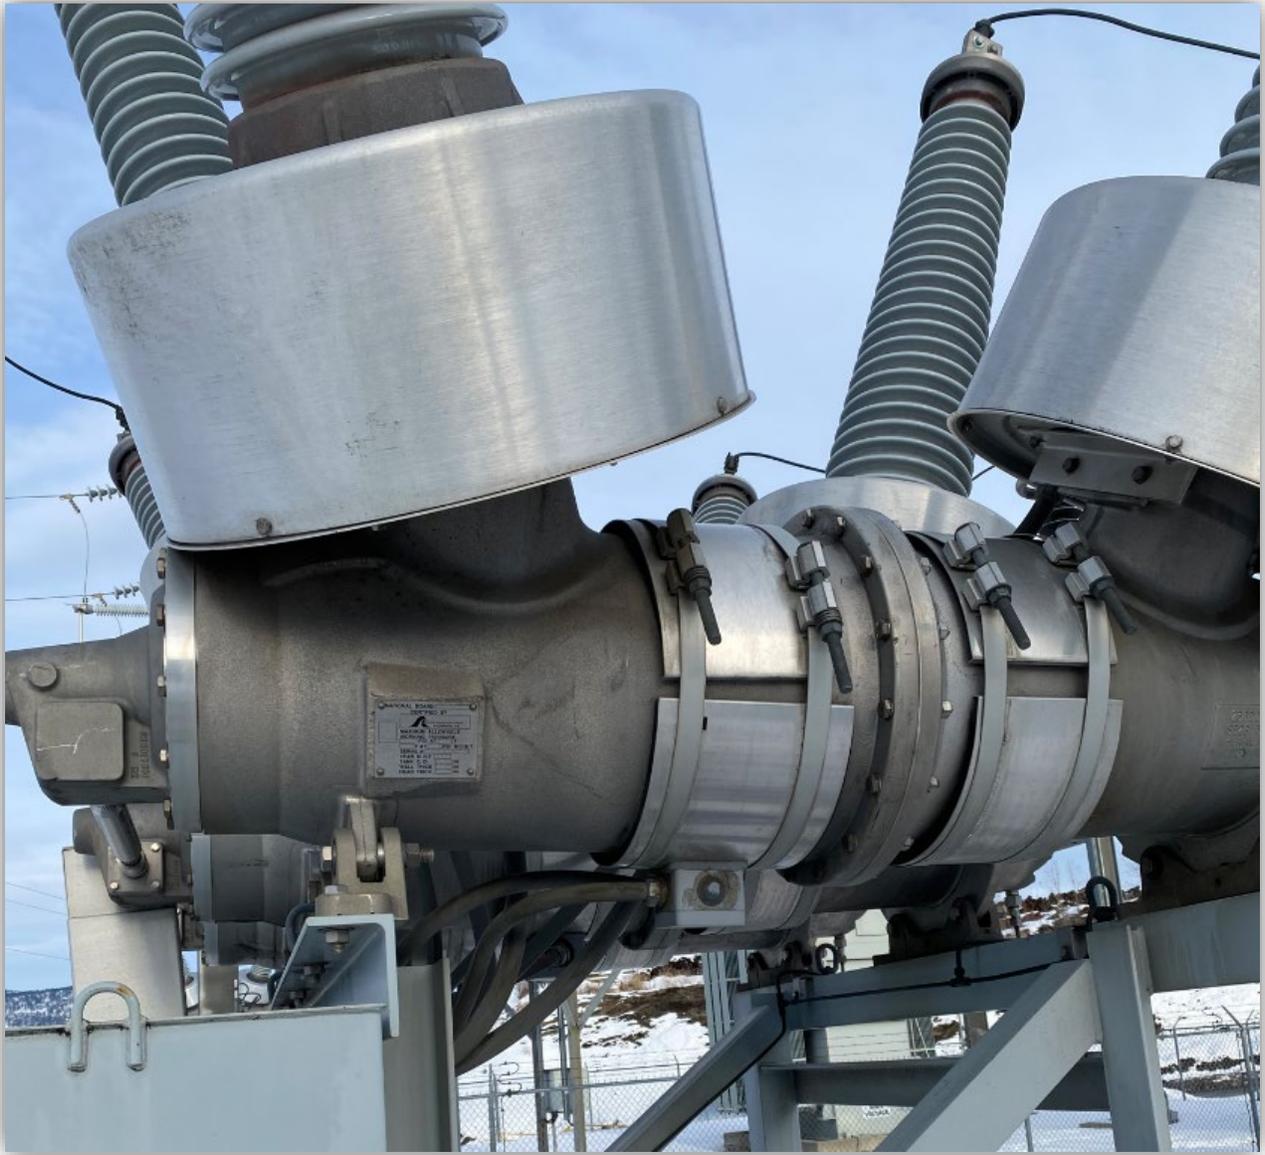
Photo 2 - Close up view of SF-6 breaker equipment with electric heating bands.

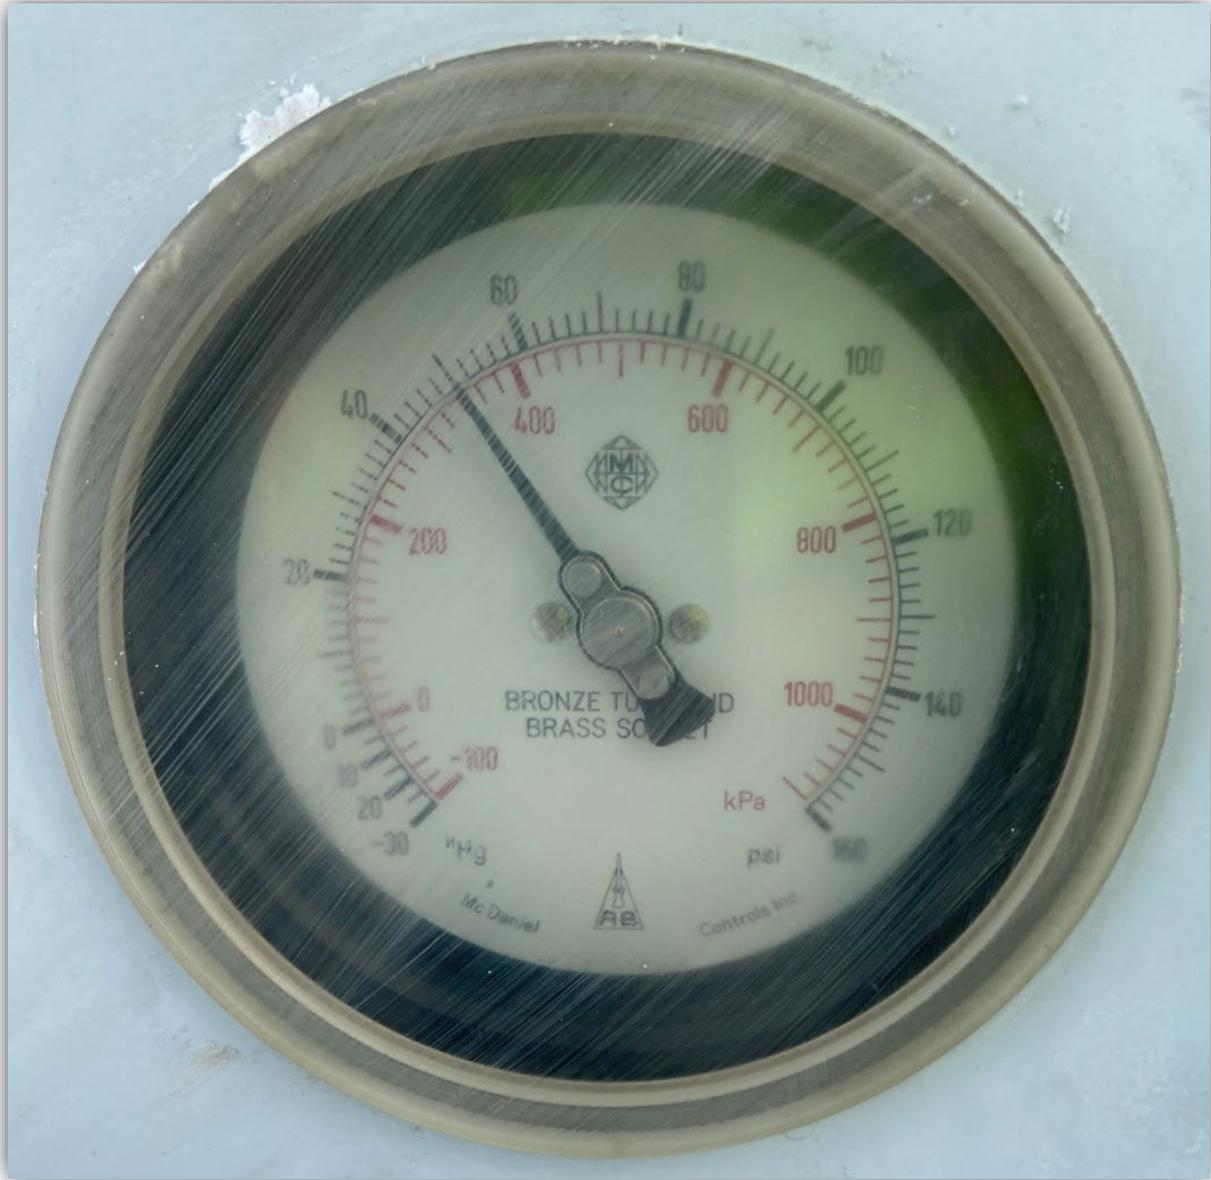
The extreme cold weather may have contributed to the low gas pressure in the 138 kV breaker.

Photo 3 - SF-6 breaker gas pressure at time of assessment at 50 psi. Low Pressure alarm is triggered at 76 psi and breaker lock-out mode is 72 psi preventing breaker from operating.

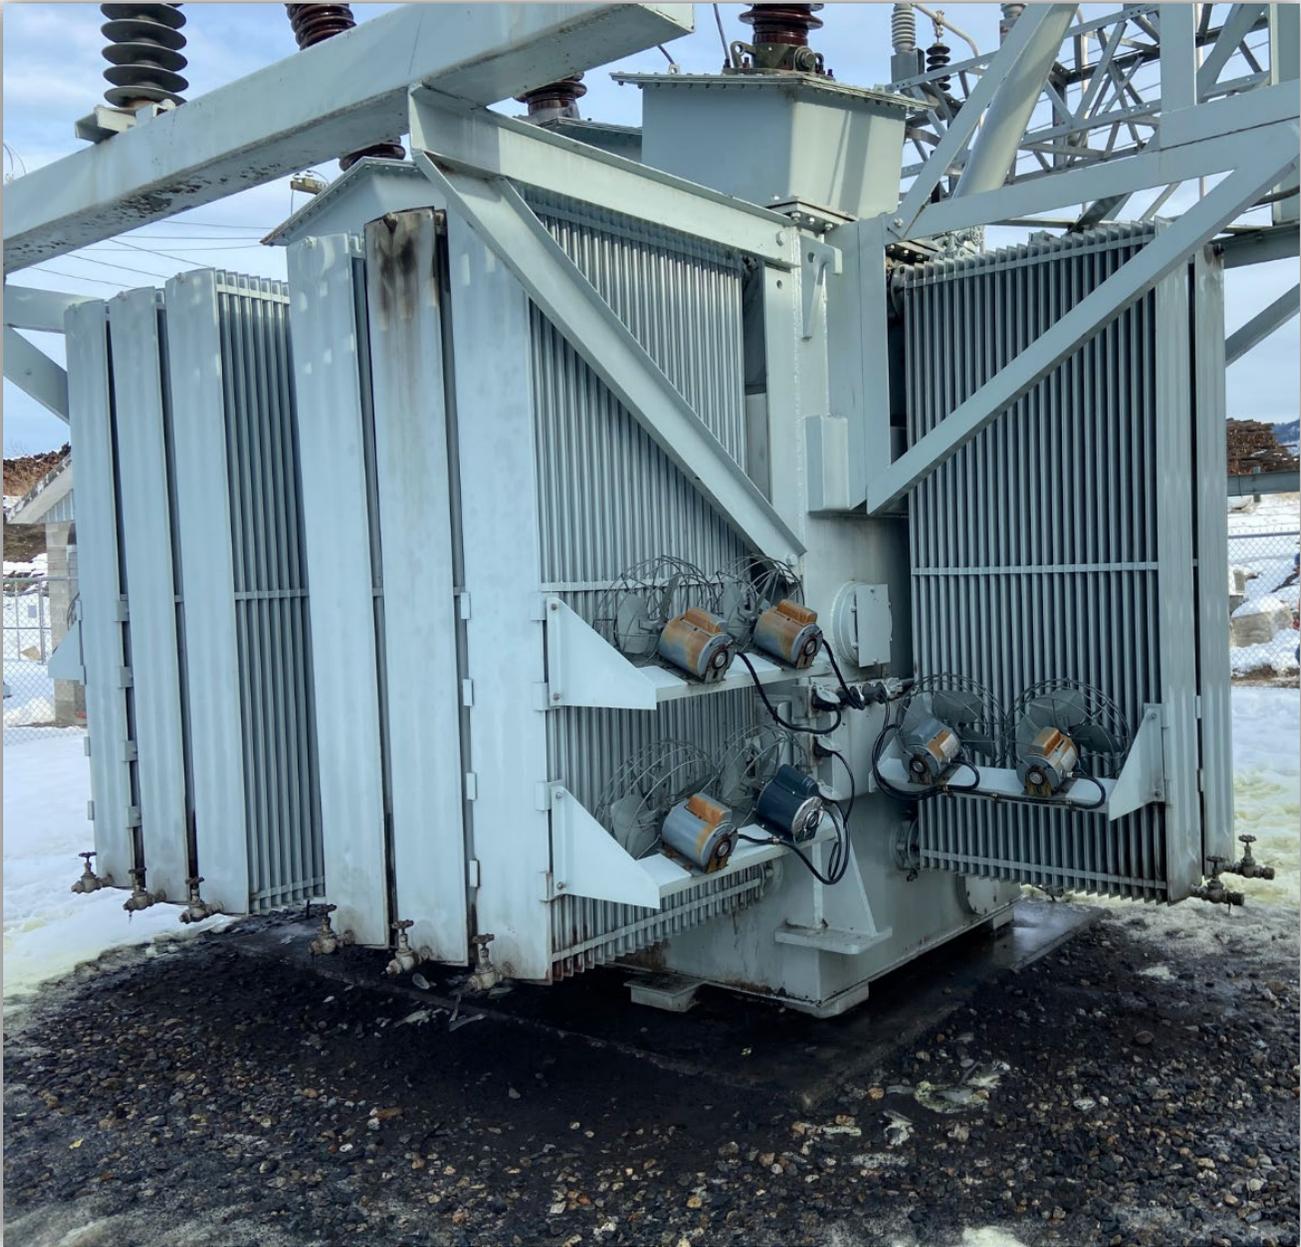
Photo 4 - 138-25 kV transformer showing oil spillage on ground.

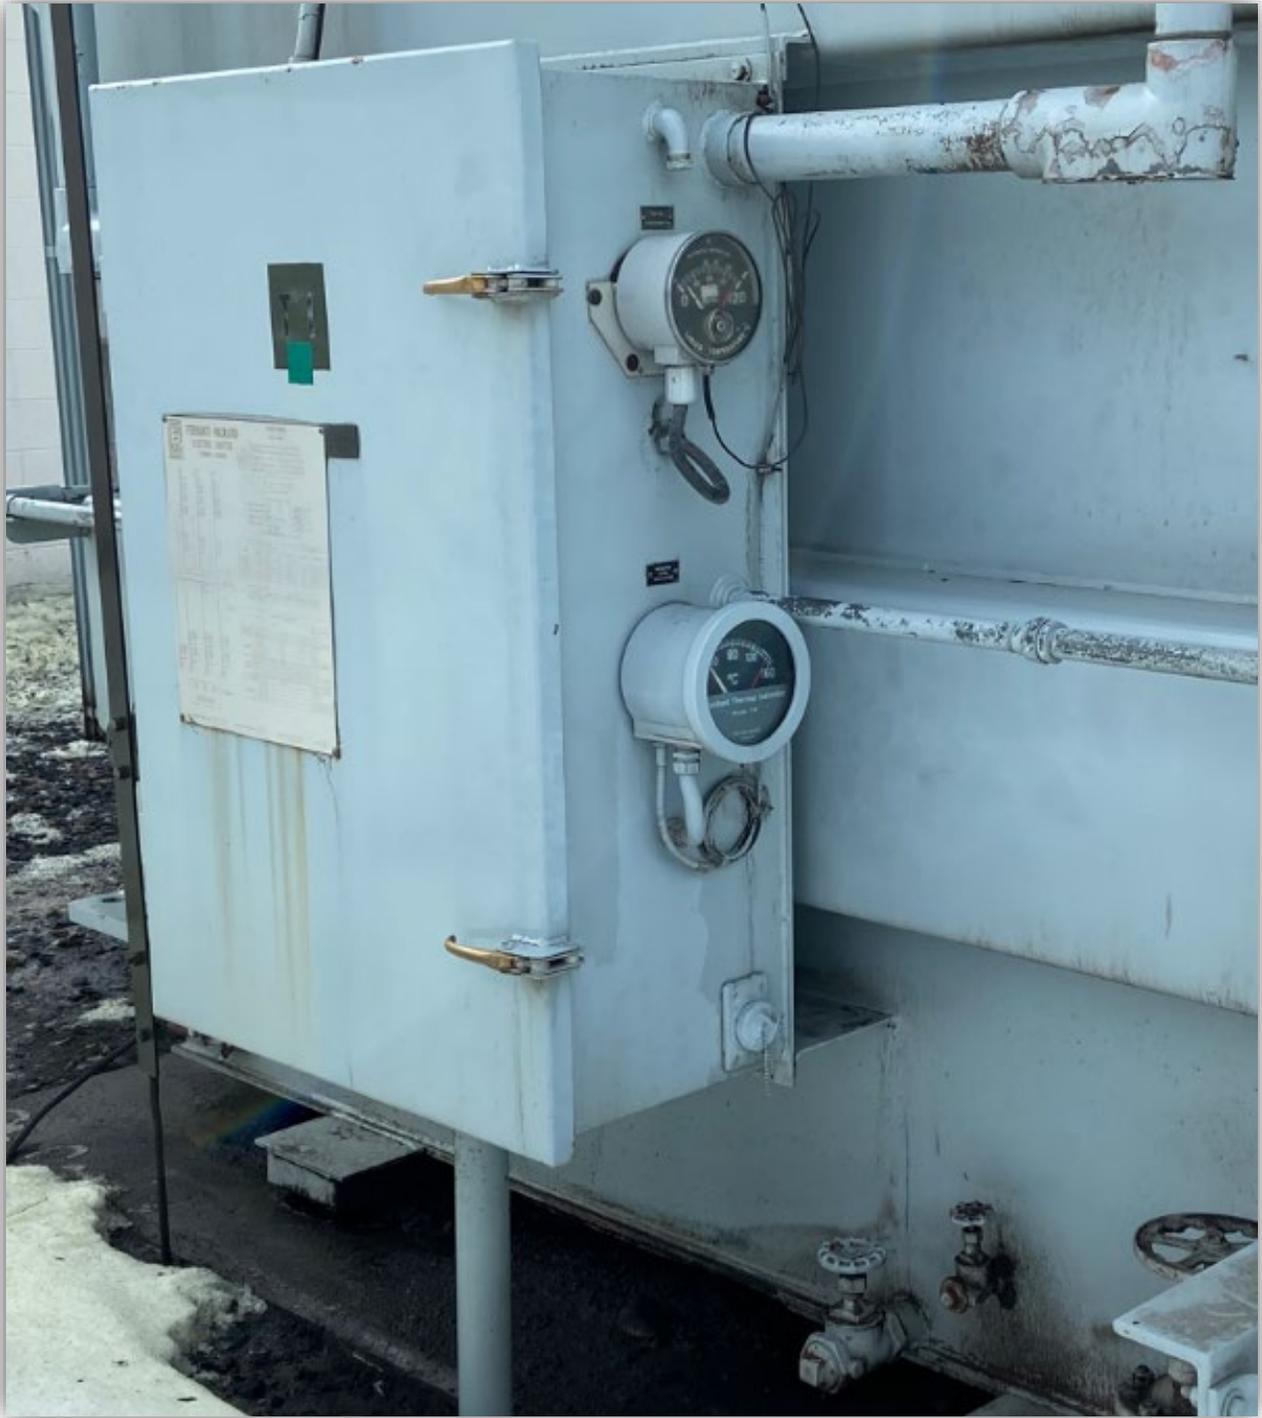
Photo 5 - Transformer control cabinet with gauges.

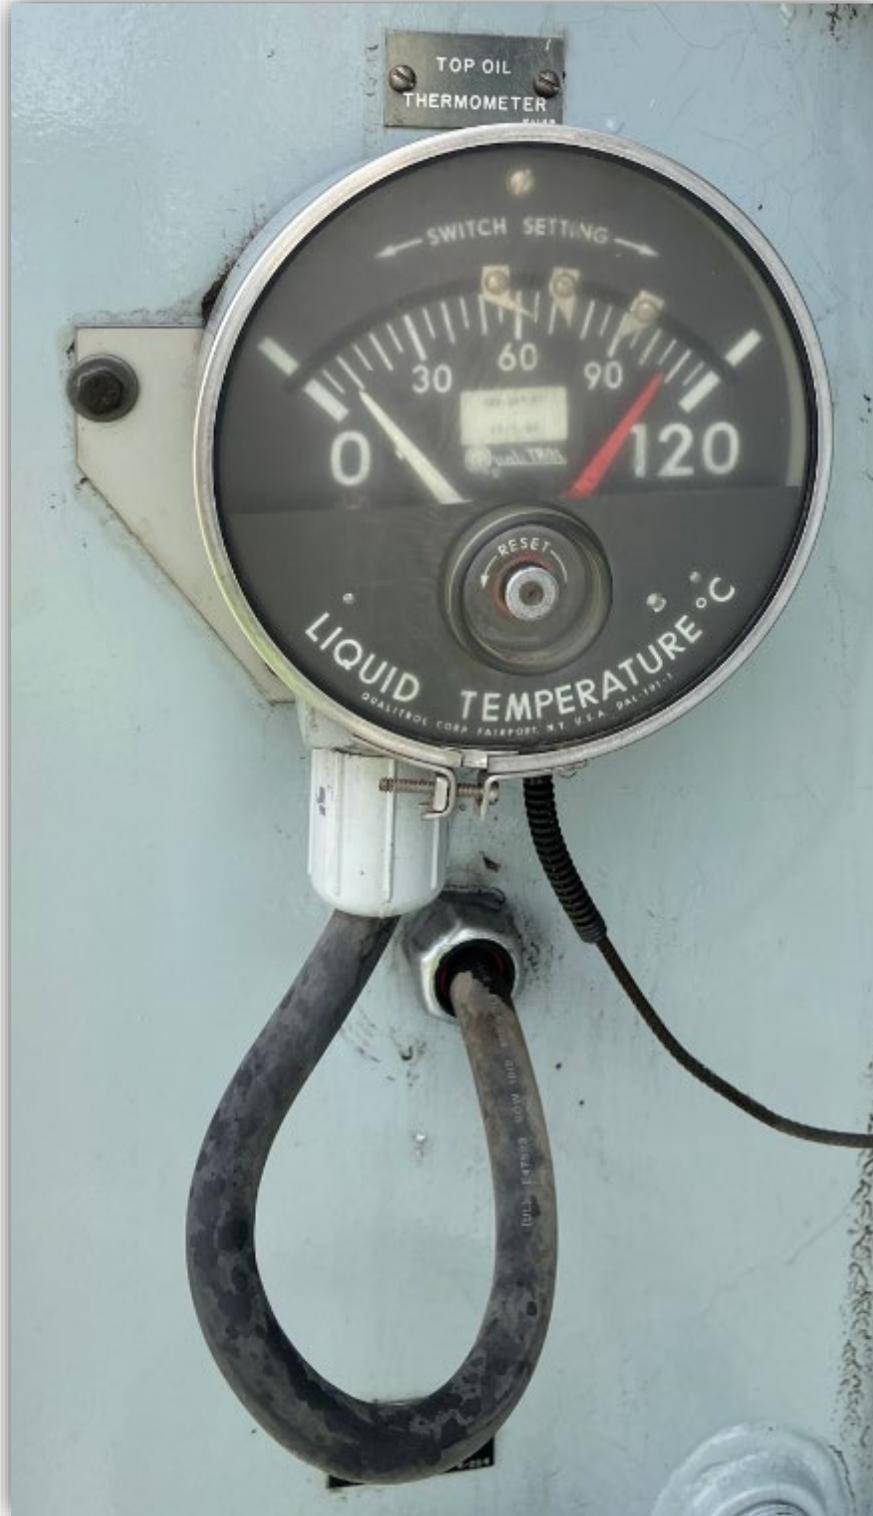
Photo 6 – Transformer oil temperature gauge with red indicator showing oil temperature reached nearing 110 degrees Celsius.

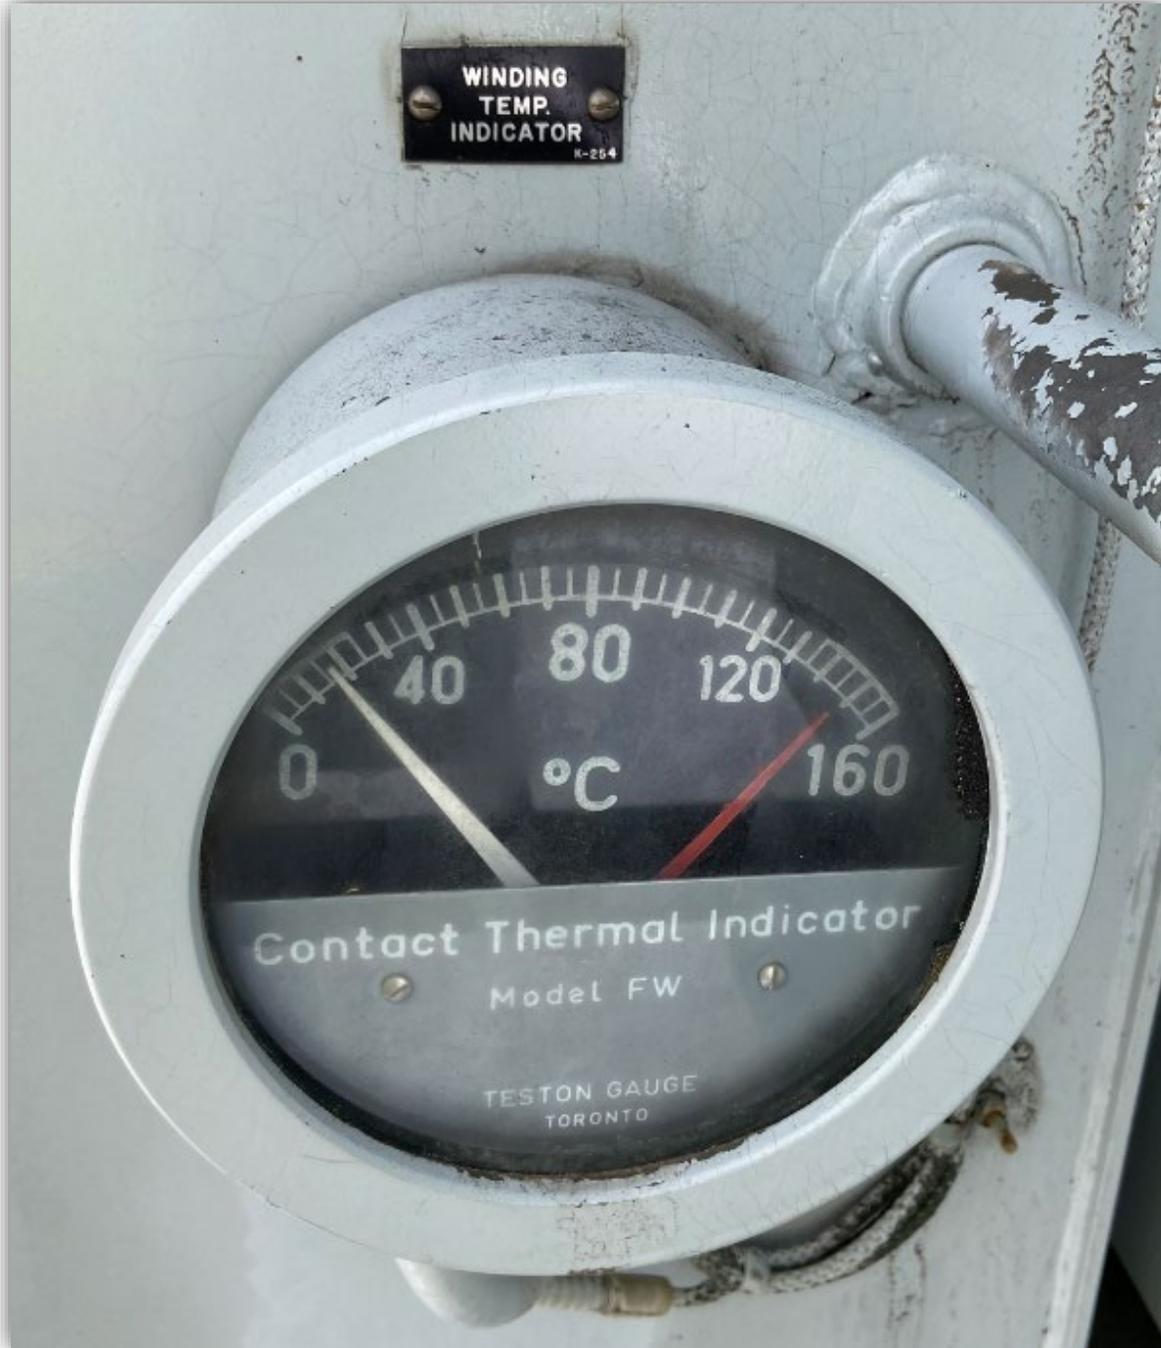
Photo 7 - Transformer winding temperature gauge with red indicator showing winding temperature reached 145+ degrees Celsius.

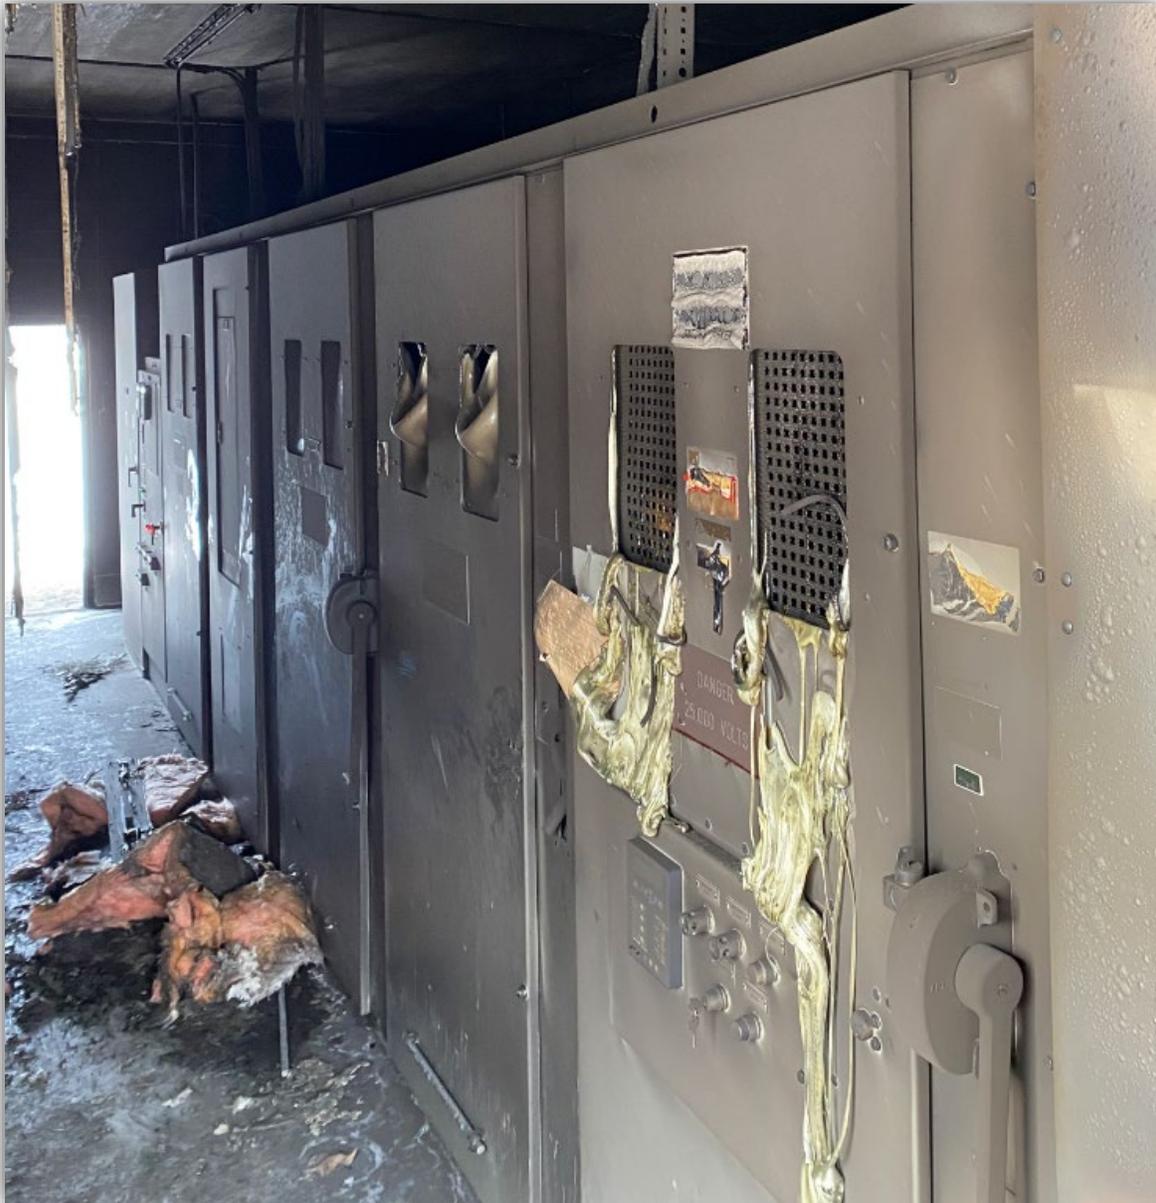
Photo 9 - Front view of 25kV switchgear, module closest is #6- chip mill where majority of damage occurred in the back of the unit, next unit is #5 where initial stress cone fault occurred in the back of the unit.

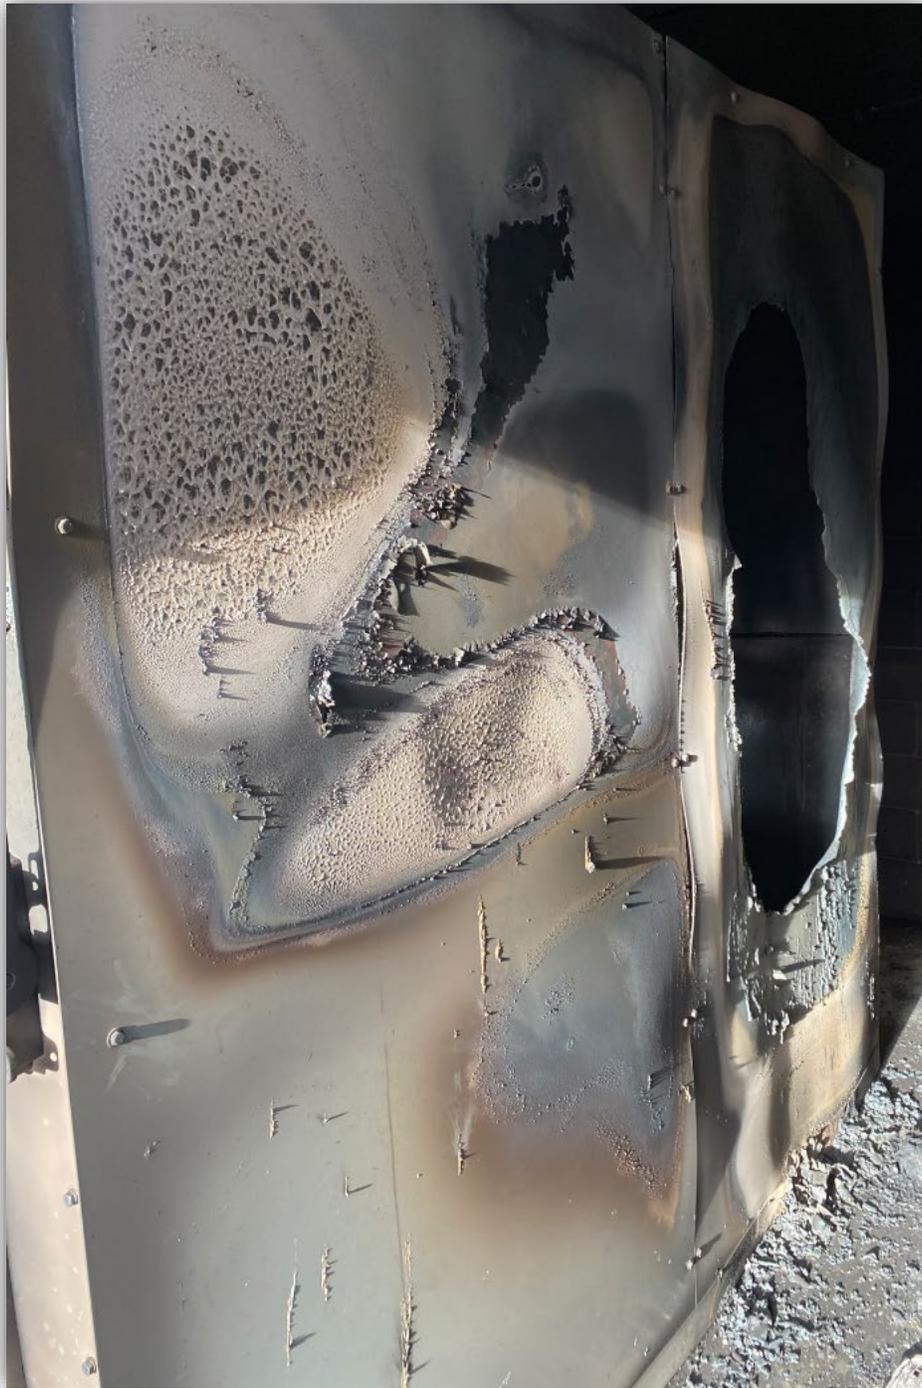
Photo 10 - End section of Unit #6 chip mill where majority of damage occurred, back side of unit has large hole approx. 2'w x6' high blown through it.

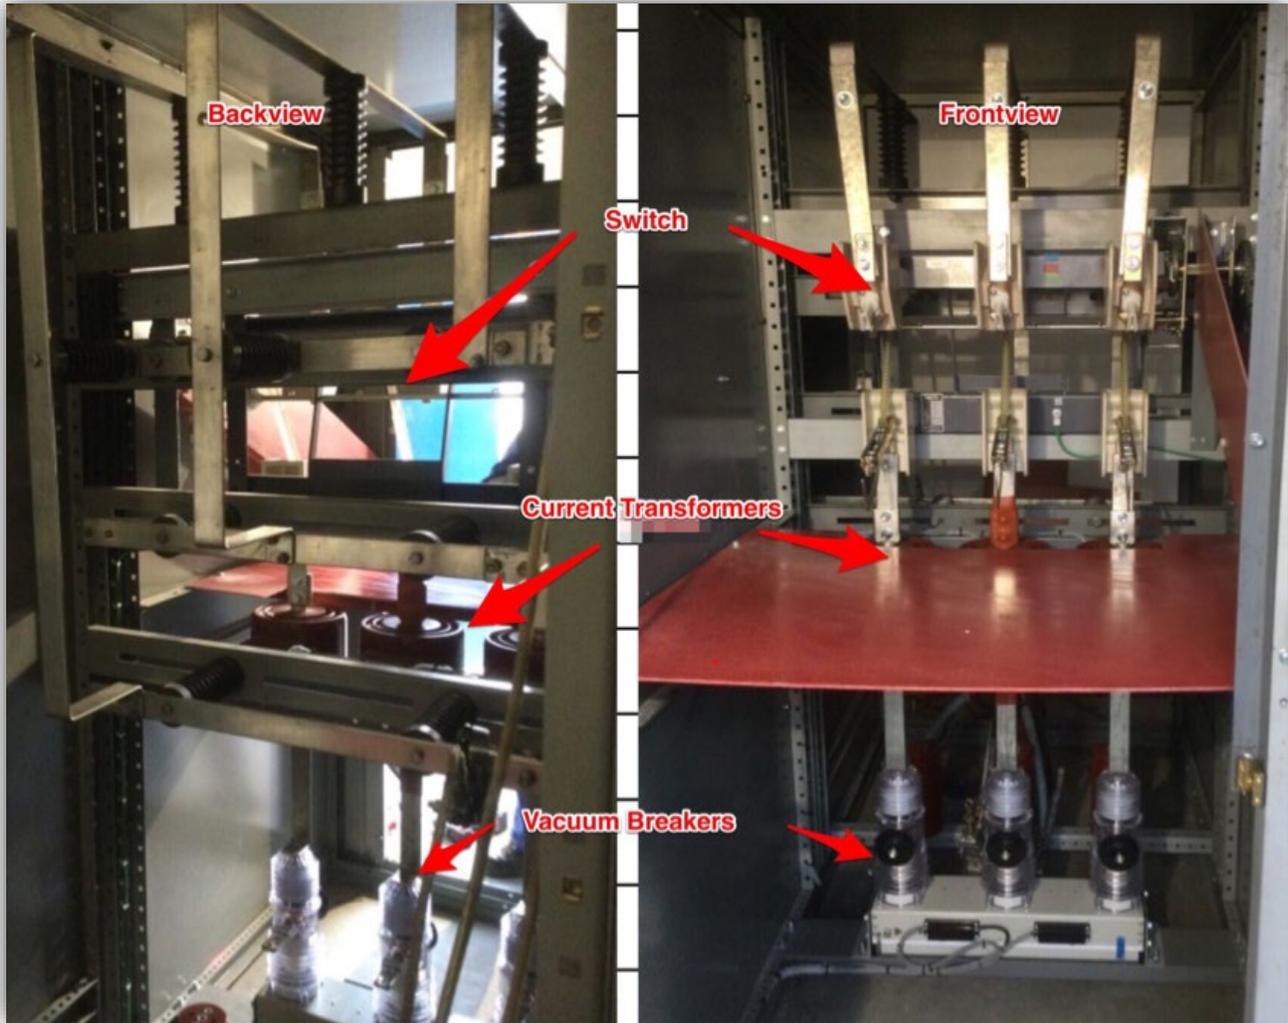
Photo 11 - Unit #6 'prior' to incident with front side and backside views.

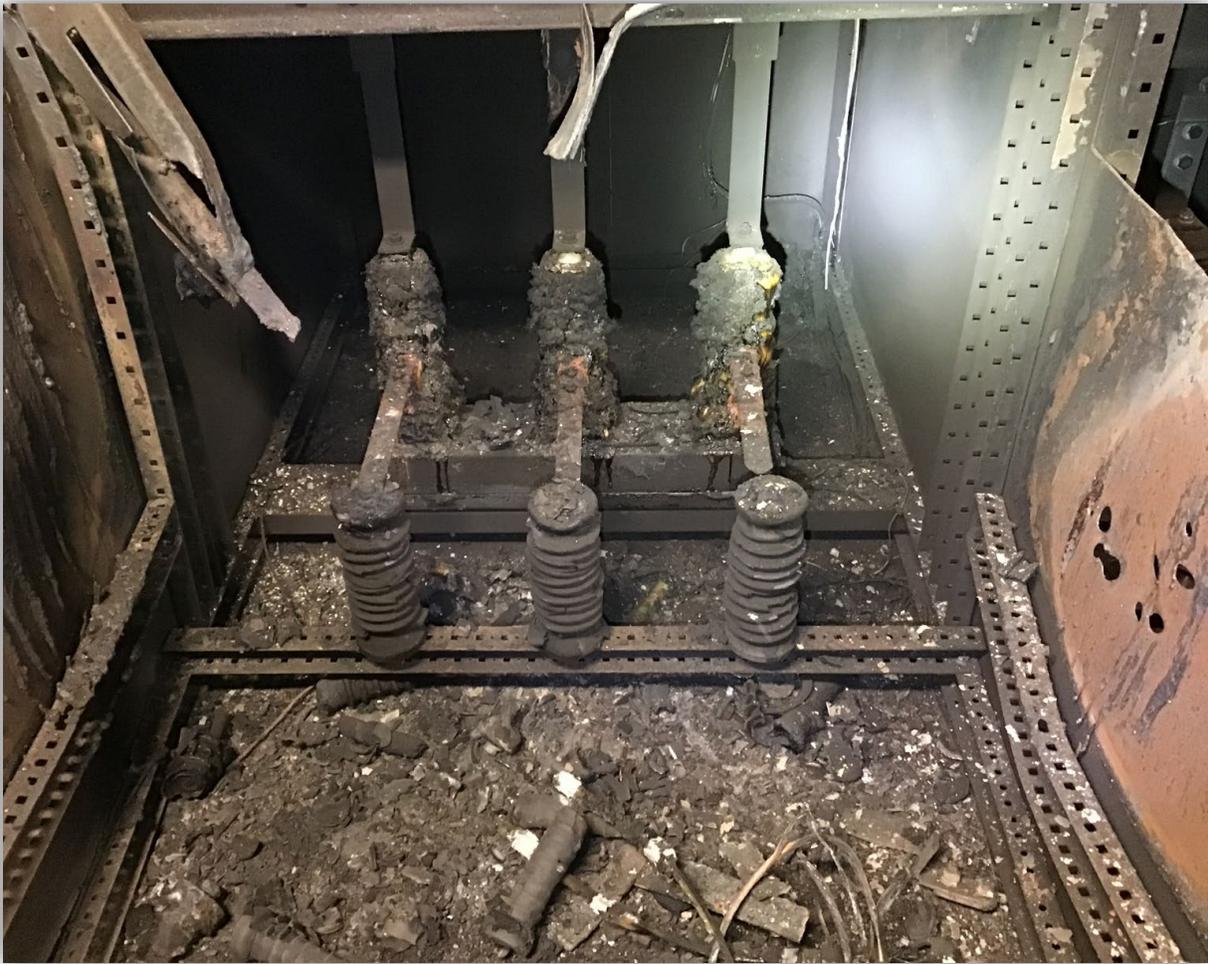
Photo 12 – Unit #6 after incident with back cover removed. Cables through floor no longer exist and are burnt off at floor level.

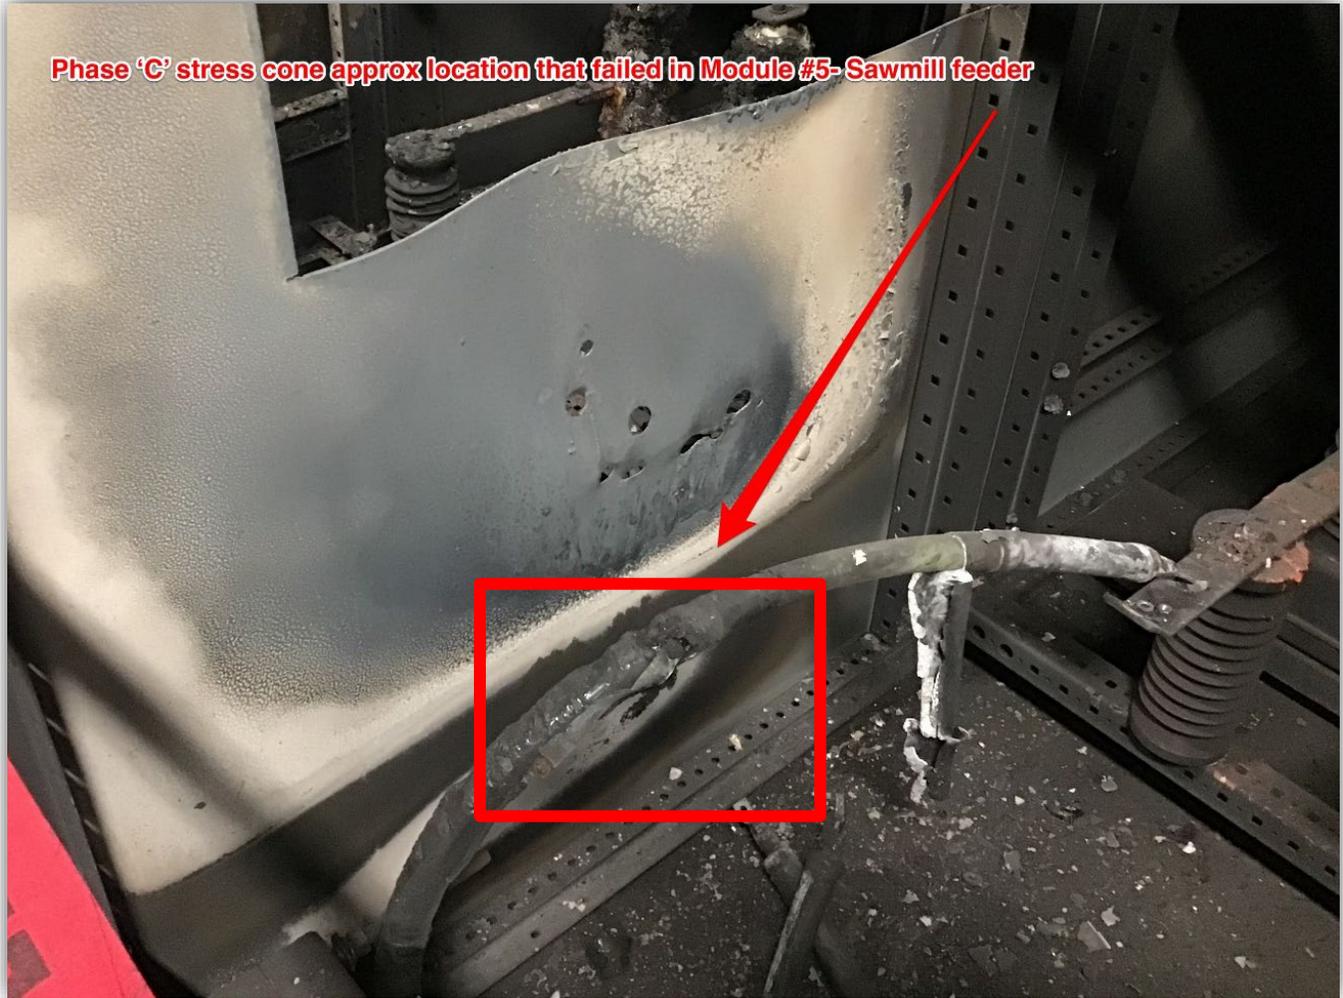
Onsite investigation found a stress cone on 25 kV phase C (load side of vacuum breaker) that had a noted fault in the connection (Photo 13-15), a clear hole was noted from the interior conductor through the insulating material and shorting to the semi-conductors shield with the bonding shield. They noted as being typical for a fault from the inside blown outwards.

The cause of the incident was the breakdown and failure of the cable stress cone on the phase C cable.

Photo 13 - Module #5 with cable laying in approximate location of operation, the cable has a noted fault on the stress cone.

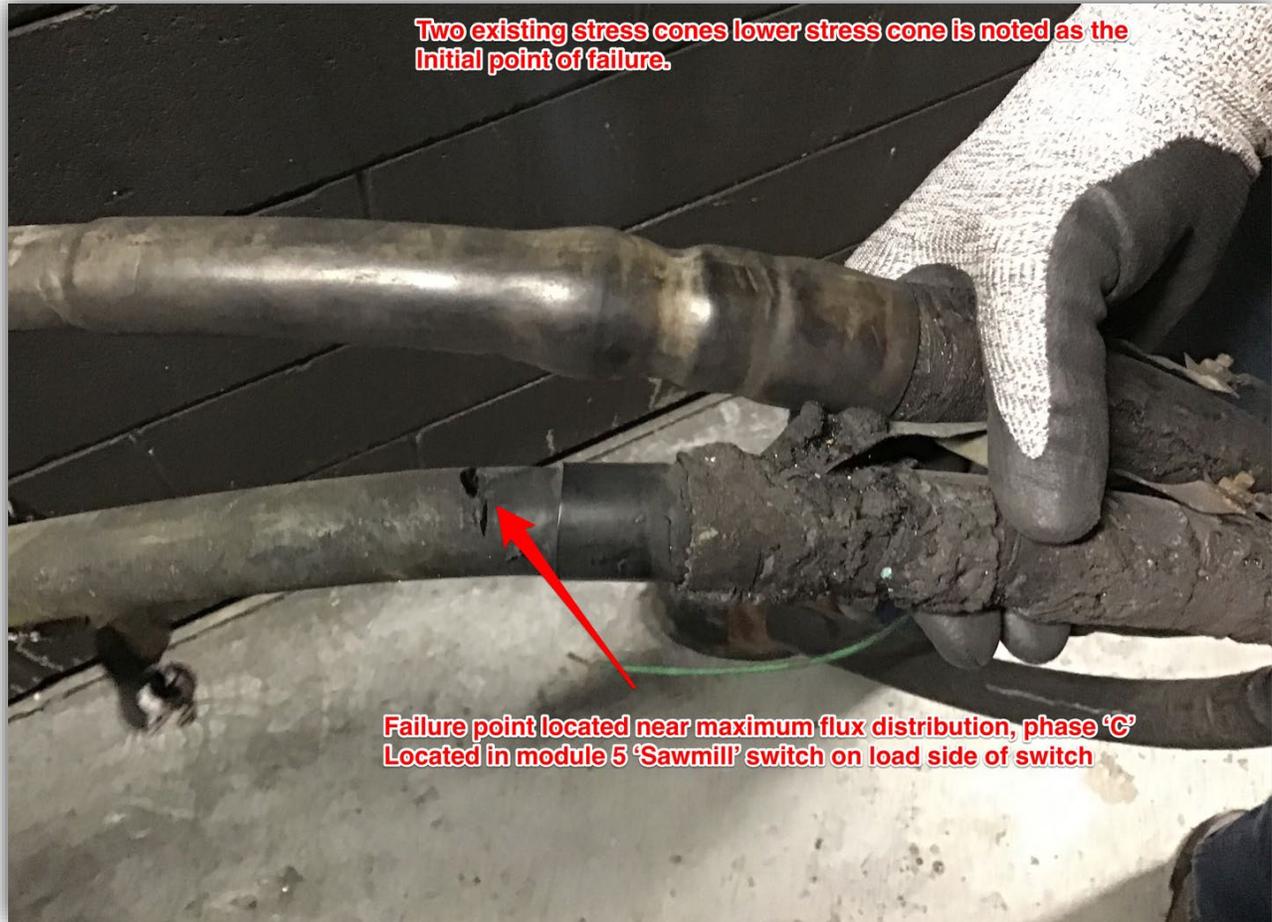
Photo 14 - Two of the stress cones cut out from Modules #5 with failed cable noting location of fault within the stress cone.

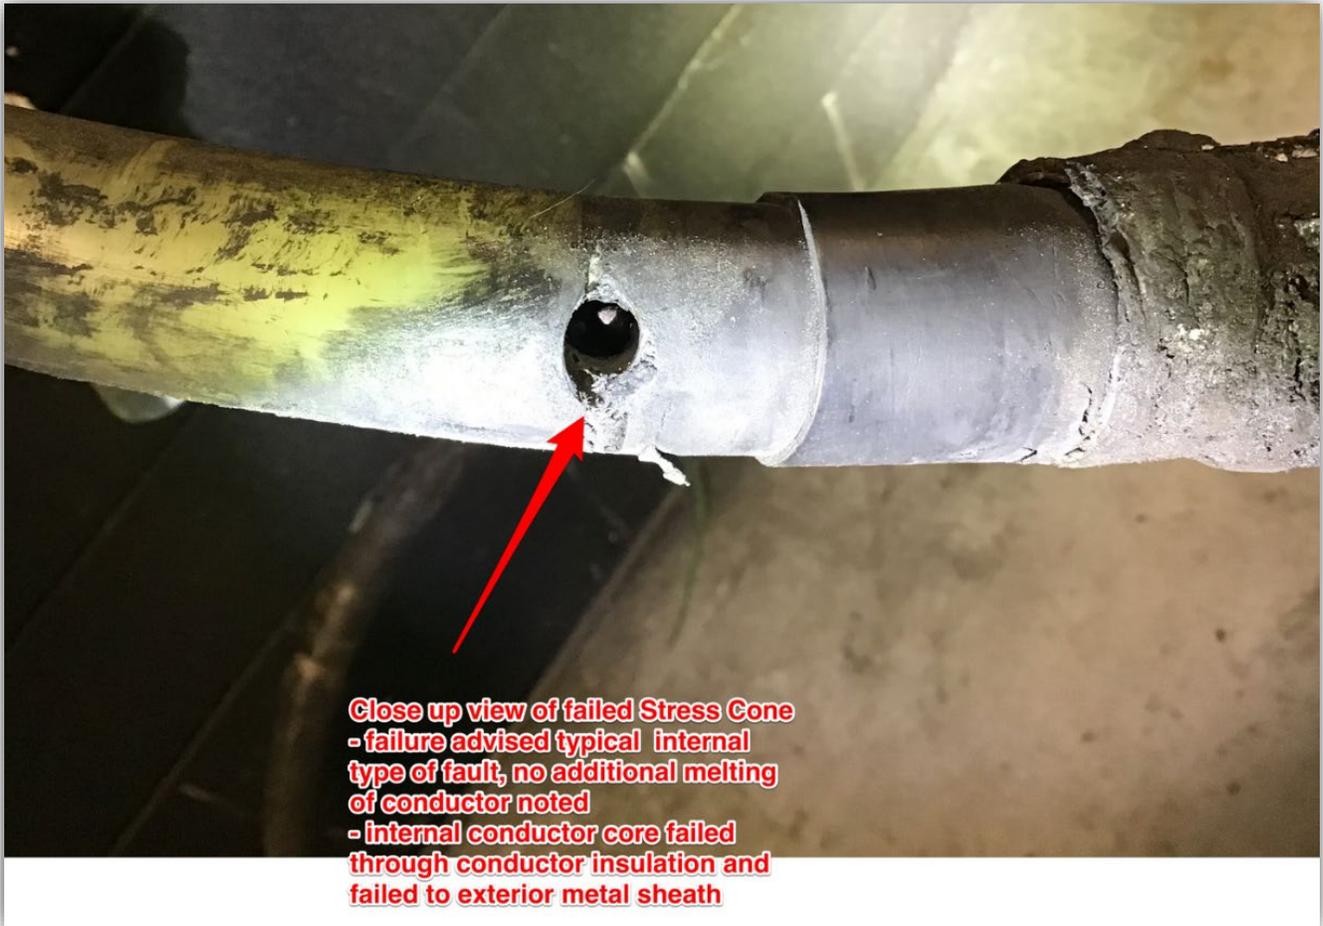
Photo 15 - Close-up photo of failure point of cable within stress cone. Interior conductor is noted to be blown out from the interior outwards.

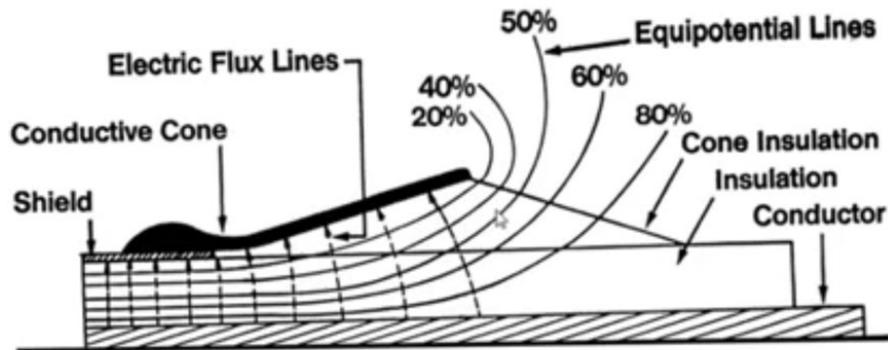
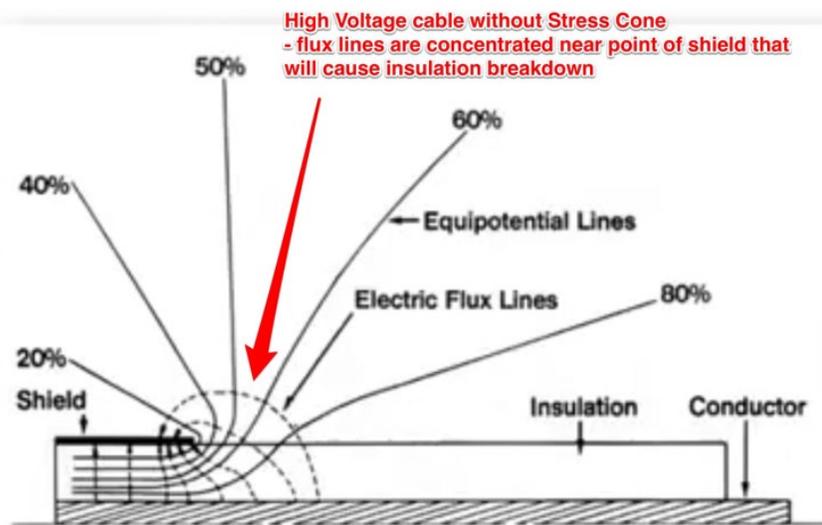
Properly installed stress cone provides additional insulation at high stress area and reduces insulation breakdown

High Voltage cable without Stress Cone - flux lines are concentrated near point of shield that will cause insulation breakdown

Photo 16 - Shows stress cones are installed and what they do to providing a long-lasting operation of cable terminations. Upper shows how the lines of flux are spread out to dissipate and minimize the degradation of the cable insulation. The lower diagram provides 'how' the lines of flux are contained within a short space that will cause a quick failure of the cable insulation due to heating.
