## Incident Summary #II-1619613-2023 (#40337) (FINAL)

SUPPORTING INFORMATION	Incident Date	October 17, 2023		
	Location	Prince George		
	Regulated industry sector	Electrical - High voltage electrical system (greater than 750V)		
	Impact	Qty injuries	0	
		Injury	Injury description	N/A
			Injury rating	None
	Damage	Damage description	One of the high voltage current transformers arced to the high voltage switchgear enclosure.	
		Damage rating	Moderate	
Incident rating	Moderate			
Incident overview	One of the high voltage current transformers (CT) within the outdoor high voltage switchgear arced to the switchgear enclosure. The CT appears to have a crack in the molded case around the CT. The failure caused the BC Hydro fuses to trip causing the emergency generator to start. A second generator large enough to run the whole building was brought to site and connected until the high voltage switchgear could be repaired.			
INVESTIGATION CONCLUSIONS	Site, system and components	Three high voltage CT's monitor the current level passing through each phase of the high voltage buss within the high voltage switchgear.

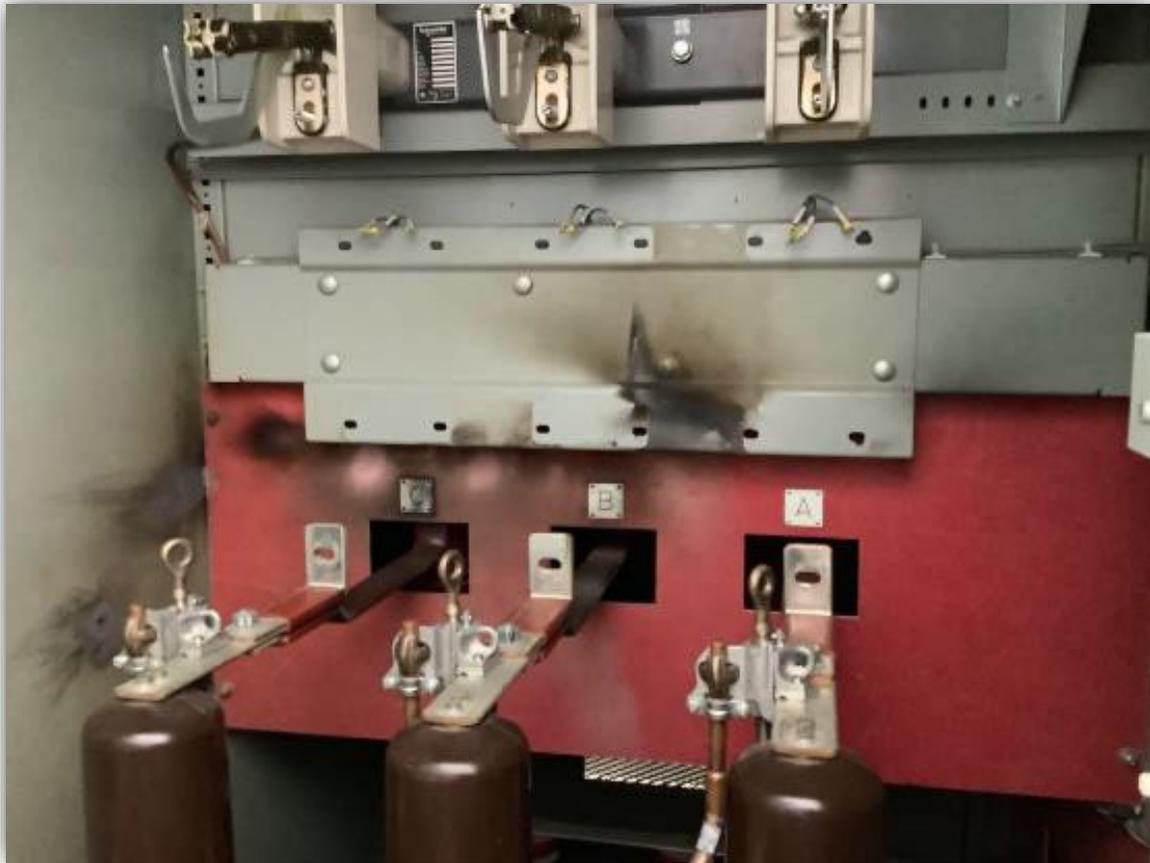
Failure scenario(s)	<p>The CT that failed had a visibly large crack in its case. Upon inspection of all CT's after their failure and removal, each CT could be seen to have cracks with the failed CT having the largest crack. Once the CT casing cracked it left a small enough exposed air gap between the high voltage winding of the CT and the switchgear enclosure for there to be an arc between this exposed high voltage winding and the metal grounded switch gear enclosure.</p> <p>The contributing factors are the CT casing material appears to be porous material. The inside of the switchgear where the CT's are located does not have heat. With the switchgear enclosure being outdoors, over time moisture built up within the porous casing. In winter the freezing temperatures caused the CT casings to start to crack.</p>		
	Facts and evidence	The attached photos show the CT casings have cracked.		
	Causes and contributing factors	The cause of the flashover within the high voltage compartment of the switch gear was cracking of the CT casing exposing the internal high voltage winding. This winding was able to arc across the air gap to the grounded high voltage metal switch gear enclosure.

The contributing factors were that the only heat source within the switch gear is a small baseboard electric heater on the opposite side of the switch within the PT compartment. There is no way for proper heat transfer between these two sides of the high voltage switch; therefore, once the CT casing was exposed to moisture due to condensation from the switch being outside and exposed to the sun, the moisture within the CT casing started to crack with the extreme low winter temperatures.

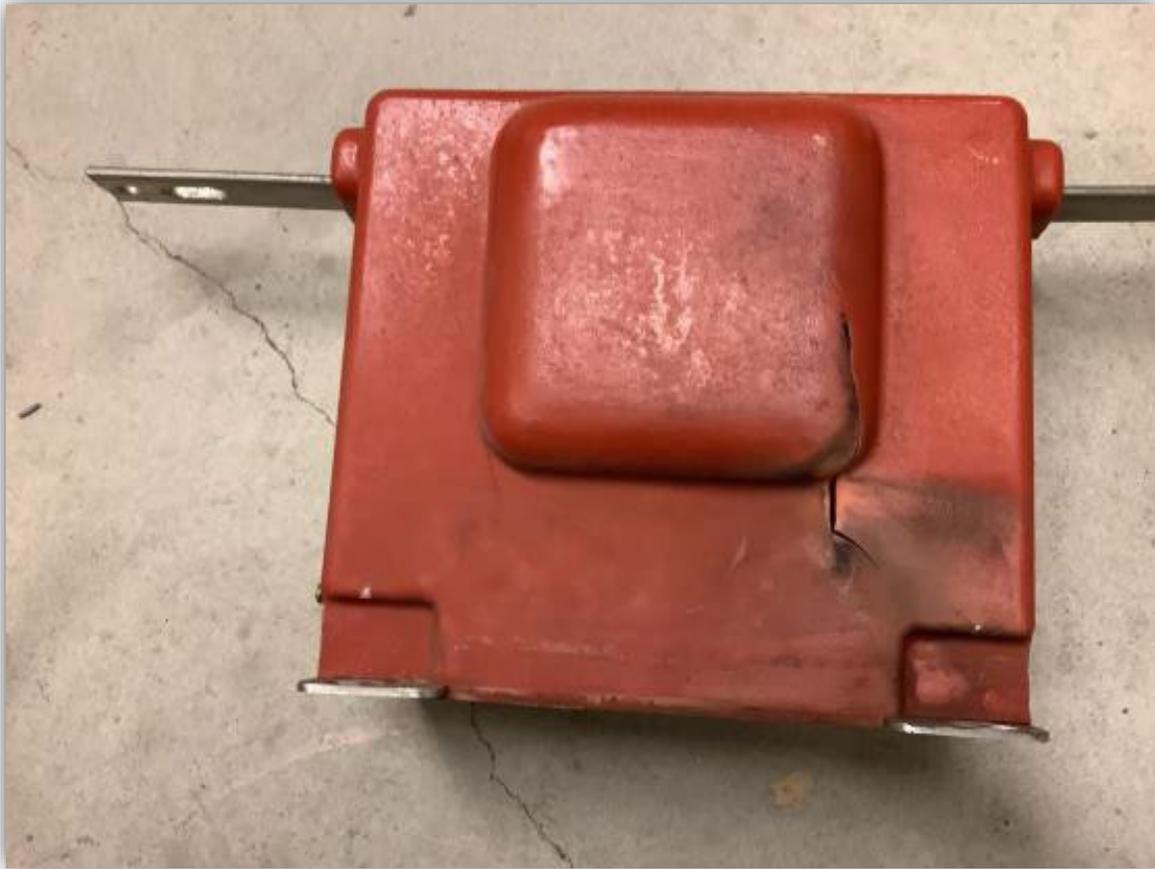
INSTRUMENT TRANSFORMERS, INC.  
CURRENT TRANSFORMER MSV 15.5KV  
100.5 A. 0.1 B0.9 RF 1.33 @ 30°C  
BIL 110KV 50/60Hz CTWH5-A-110-T150-101
