Incident Summary #II-1222001-2021 (#22773) (FINAL)

SUPPORTING INFORMATION	Incident Date	May 27, 2021	
	Location	Vancouver	
	Regulated industry sector	Elevating devices – endless- belt manlift	
	Impact	Qty injuries	1
		Injury description	Cuts, abrasions to arms and legs
		Injury rating	Minor
	Damage	Damage description	No damage to equipment or property
		Damage rating	None
Incident rating	Minor		
Incident overview	A worker attempting to use a manlift lost their footing when stepping onto the treadle. The worker was pushed down through the floor opening between the 4th floor and 3rd floor after getting hit by the following treadle. The worker's hand and leg got caught on a side panel during the fall. The emergency stop device was enabled but the manlift was then restarted twice without notice.		
INVESTIGATION CONCLUSIONS	Site, system and components	<p>1) Manlift, endless-belt type</p> <p>The manlift is of the endless-belt type, consisting of a power driven endless-belt. The belt is a loop that moves in one direction, allowing trained and authorized personnel to travel up or down, by using one side of the loop to ride up or the opposite side of the loop to ride down. The belt is prov

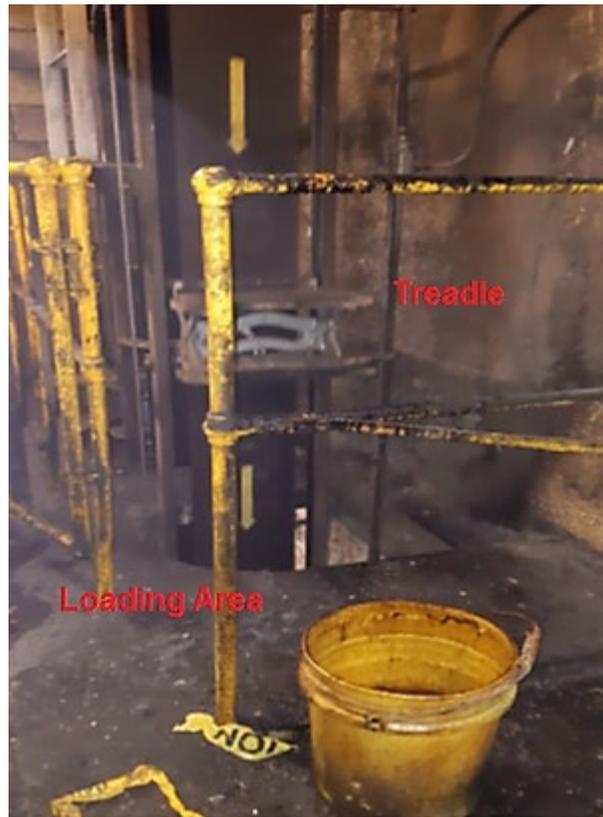
Photo #1 – Manlift loading area

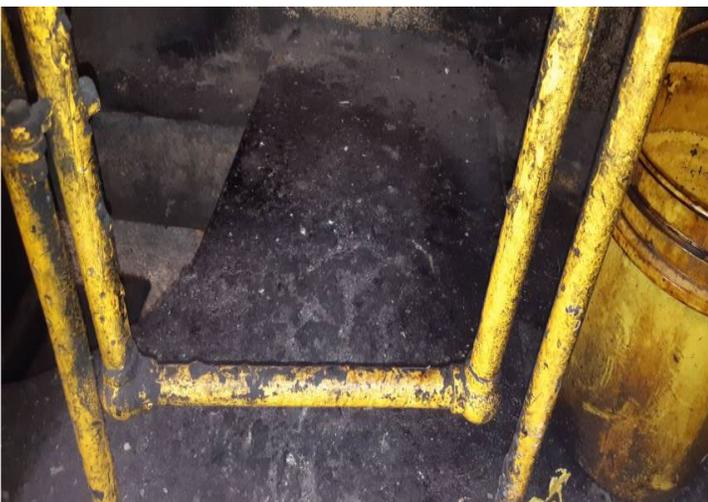
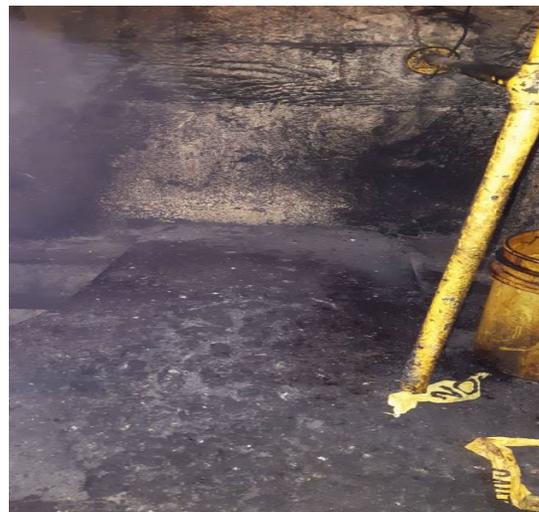
<p>Causes and contributing factors</p>	<p>It is possible that the sticky floor substance may have contributed to the worker losing their balance as they attempted to get on the manlift. It is very likely that limited in-house training on the use of the manlift, along with the lack of understanding of the emergency stopping device functions, contributed to the start-up of the manlift after the emergency stop had been pulled. It is unlikely that equipment failure was a cause of the incident.</p>

Photo #2 & 3 - Factory-related substance build up on the landing area

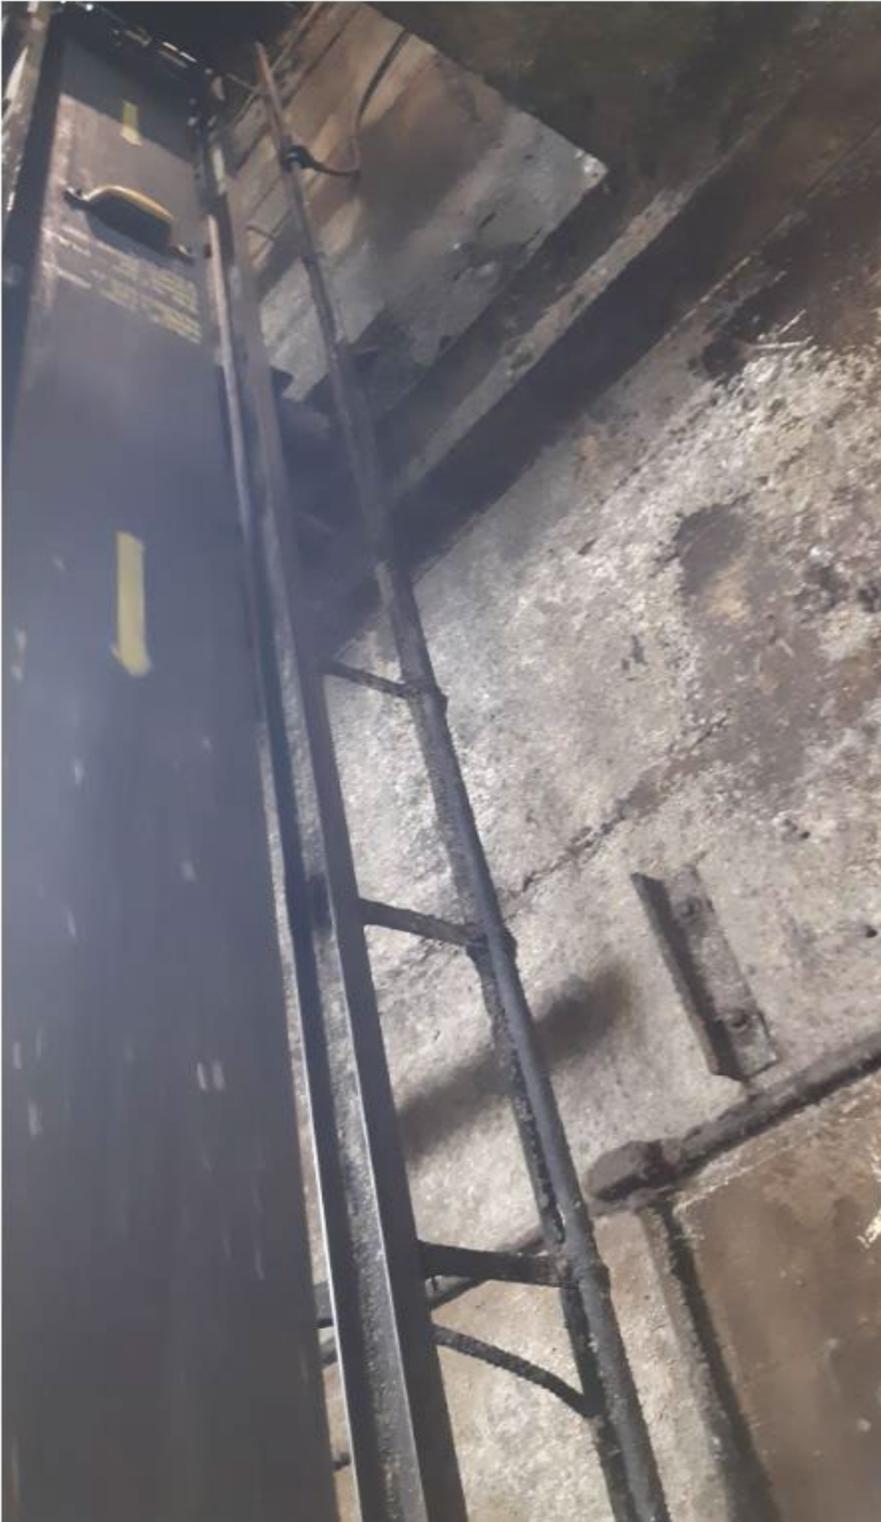
Photo #4 - 3rd floor landing, looking up to 4th floor
