Incident Summary #II-1174543-2021 (#21555) (FINAL)

SUPPORTING INFORMATION	Incident Date		April 5, 2021	
	Location		Whistler	
	Regulated industry sector		Passenger ropeways - Above surface ropeway	
	Impact	Injury	Qty injuries	0
			Injury description	NA
			Injury rating	None
		Damage	Damage description	<ul style="list-style-type: none">• Damaged grip fixed and mobile jaws• Damaged work carrier upper basket• Haul rope scuffing and a few deformed wires• Station entrance minimal cosmetic damage
			Damage rating	Moderate
	Incident rating		Moderate	
Incident overview		Maintenance crew ran work carrier into a return station with the basket up. The carrier jammed in the entrance, causing damage to the carrier grip and minor scuffing and abrasions on the haul rope.		
INVESTIGATION CONCLUSIONS	Site, system and components		<p>Incident occurred at the bottom return station of a 4-passenger carrier, detachable grip ropeway.</p> <p>Ropeway is designed and capable of operating in reverse.</p> <p>Grips detach from the haul rope as they enter the stations (either in forward or in the reverse direction). The grip/carrier is then transported through the station by a configuration of belt driven tires

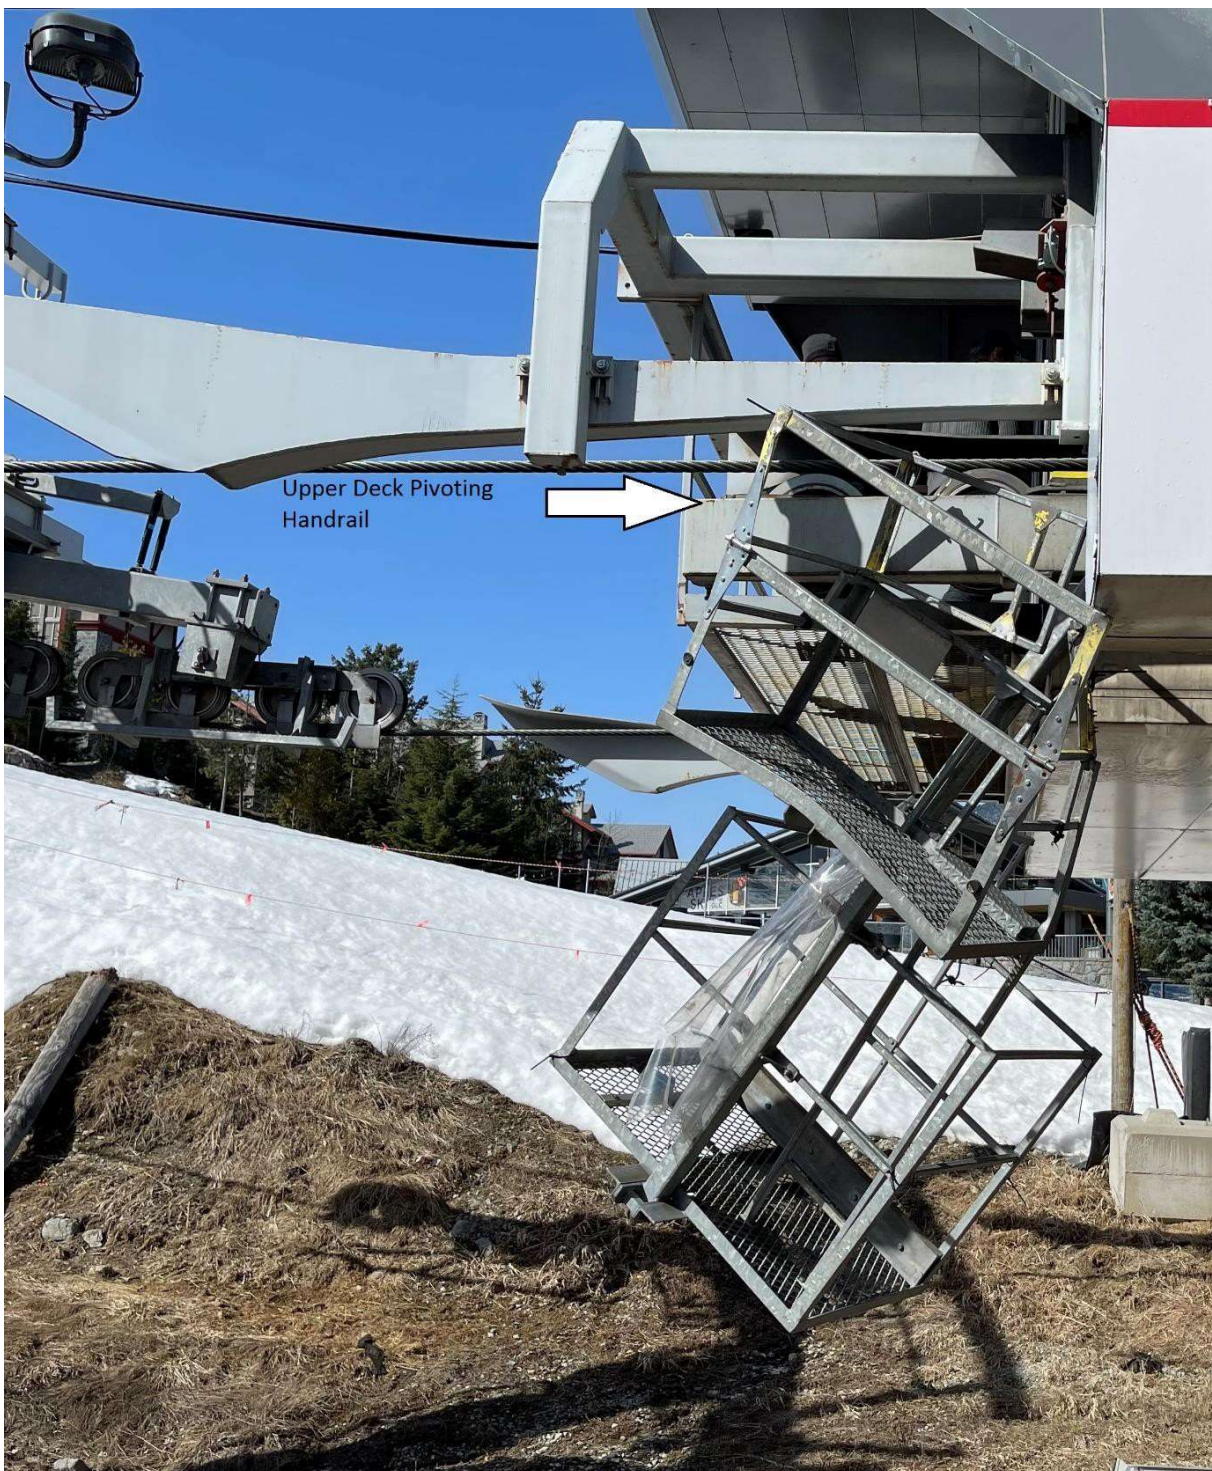
- Based on the request of the maintenance carrier crew member, the top operator initiated a reverse move of the ropeway.
- With the ropeway running in reverse, the maintenance carrier upper deck handrail (still in the up position) became entangled with the station equipment.

It is certain that the cause of the damage to ropeway equipment was due to the maintenance carrier being moved into the station with the upper deck handrail in the up position.

Photo of Entangled/Jammed Maintenance
Carrier
