Incident Summary #II-1748898-2024 (#50469) (FINAL)

SUPPORTING INFORMATION	Incident Date		August 13, 2024
	Location		Kootenays, BC
	Regulated industry sector		Amusement Devices - Amusement ride
	Impact Injury	Qty injuries	2
		Injury description	Rider #1 – Concussion, 5cm bump, bruising and hematoma. Rider #2 - Whiplash, headache and soreness in hips.
		Injury rating	Moderate
	Damage	Damage description	N/A
		Damage rating	None
	Incident rating		Moderate
Incident overview		Several coaster carts operated by individual riders were on a mountain amusement track which allows the customer to travel up to 40-50 kph. One individual stopped their cart at the start of the braking area as required, but the second rider did not apply their brake and collided into the first at full speed resulting in injury to both individuals.	
INVESTIGATION CONCLUSIONS	Site, system and components	<p>The mountain coaster (toboggan) installed in 2016 is an amusement device where a rider sits on a cart that travels down a set course attached to a rail. Used in the spring, summer and warmer fall they are stored over the winter. They are powered by gravity and the operator controls the deceleration and stopping wit

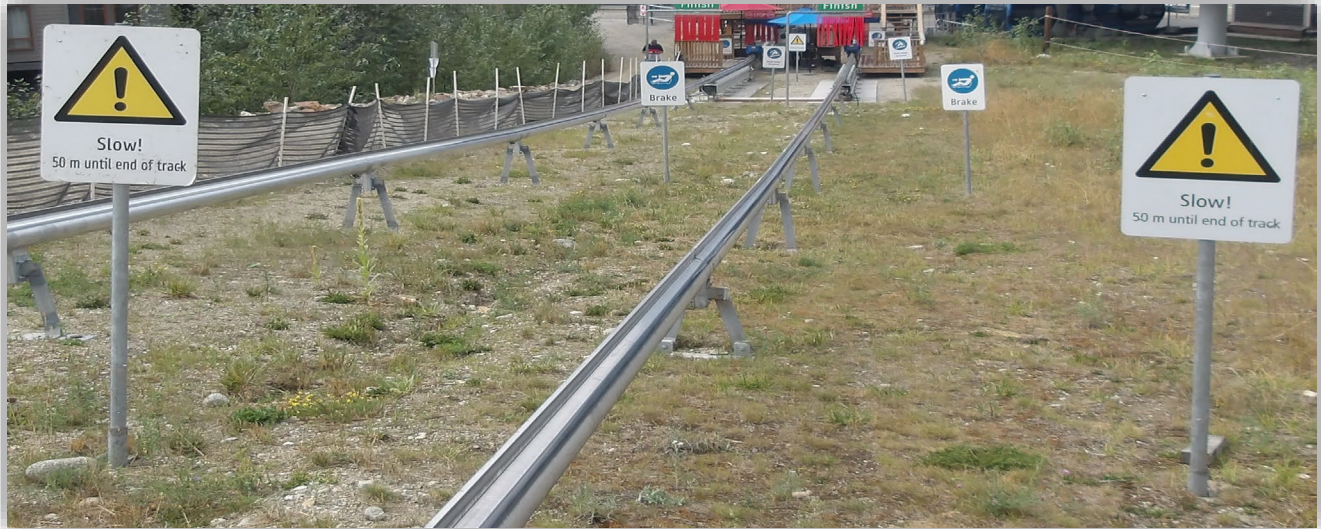
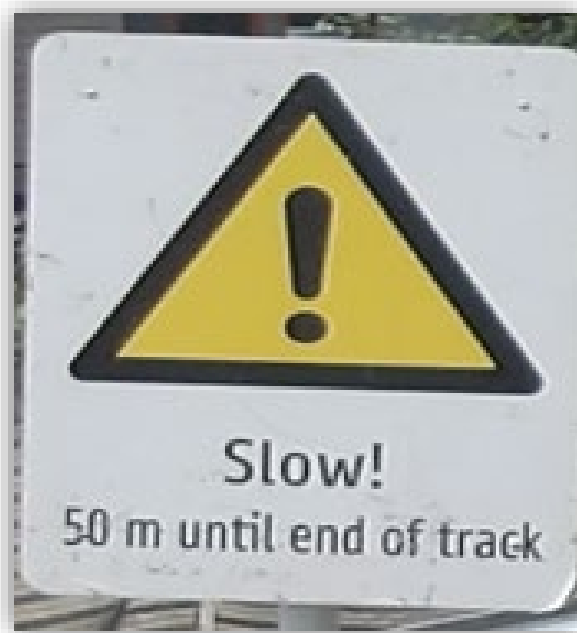
At the bottom of the track prior to the brush braking band, there are a series of signs ([Image 1](#) & [Image 2](#)) telling the rider that they are approaching the end of the track and to slow down.

Image 1 - Bottom of track approaching Brush Braking Band "SLOW!! 50m until end of track".

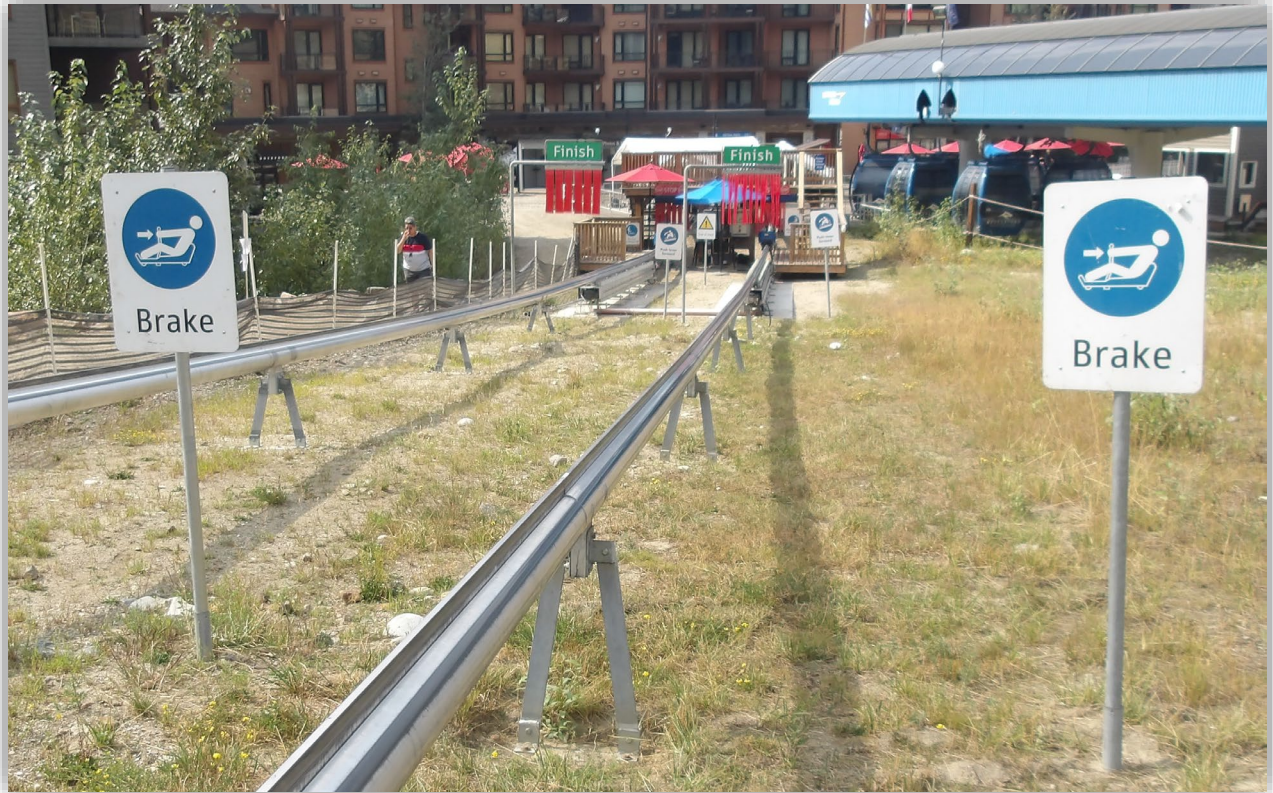
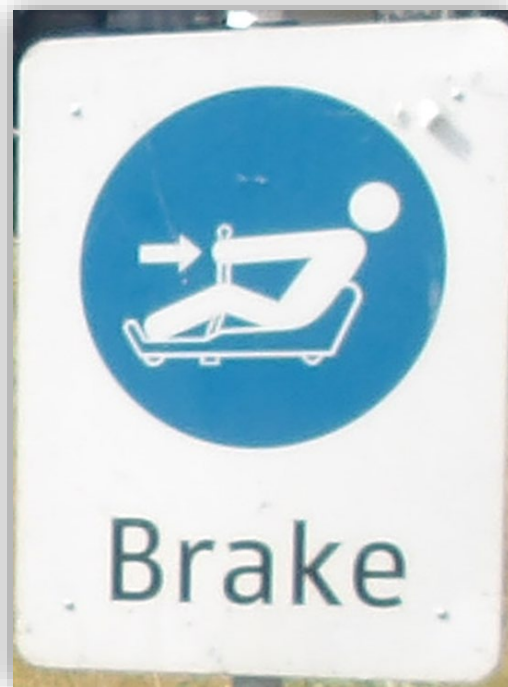
Then signs ([Image 2](#)) tell an exact distance to the brush braking band and indicate it is time for the rider to actively brake the cart. However, final signage at finish says push lever forward, which is the opposite of previous signage coming into the area ([Image 3](#)).

Image 2 - Signage further downhill.

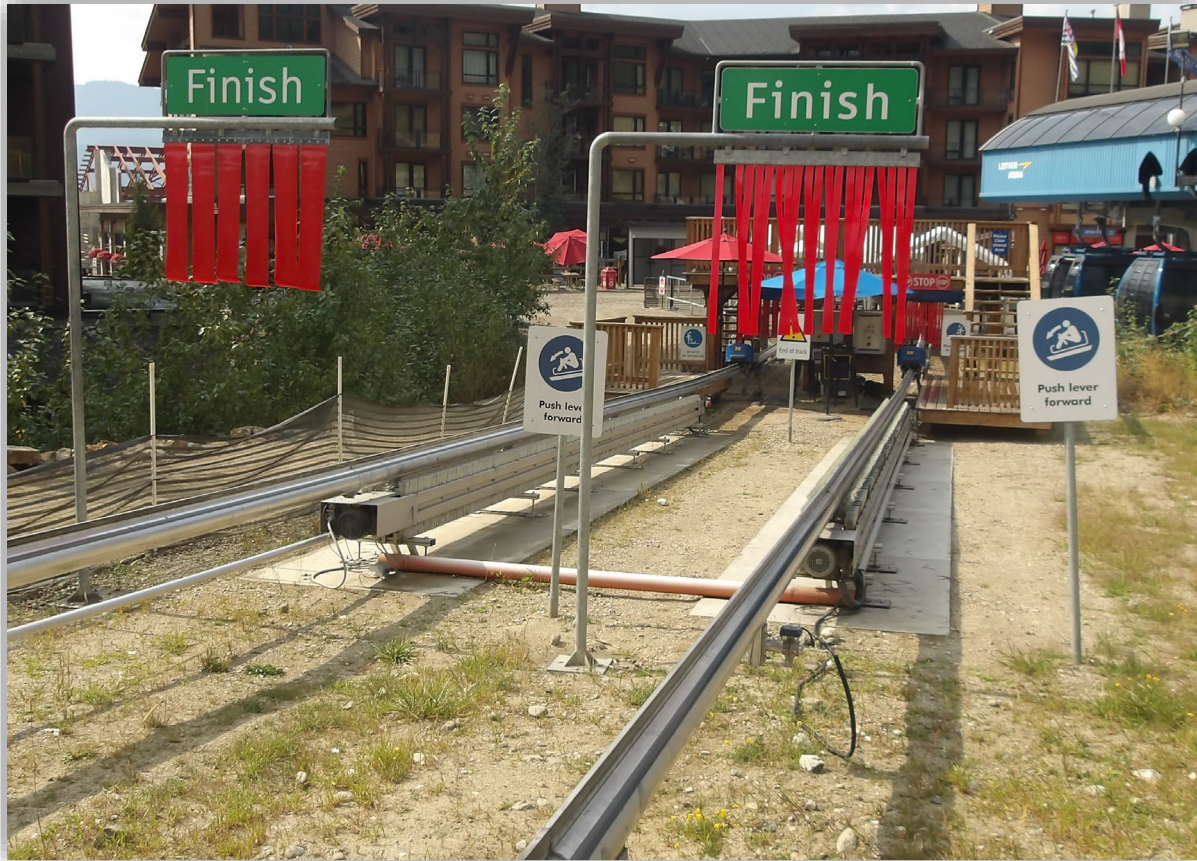
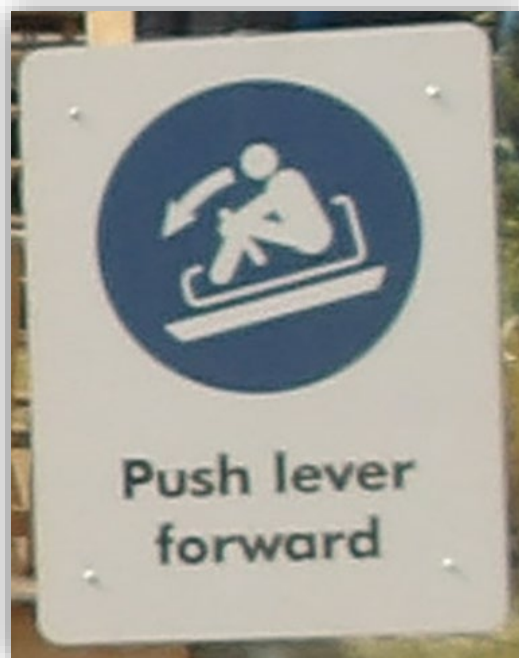
Image 3 - Final signage before Brush/Conveyor “Push Handle Forward” instructions for Brush Braking Band to function. Signage shows same signage which indicates push to accelerate at finish.

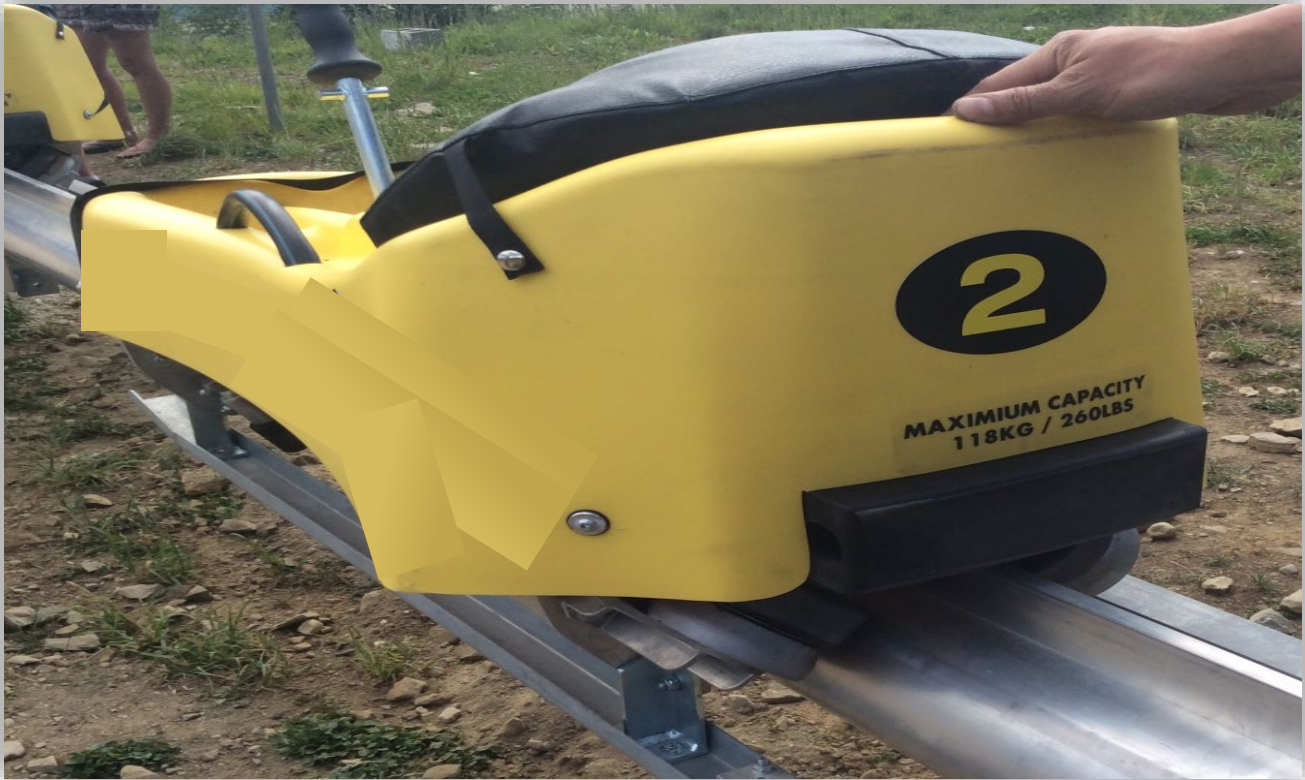
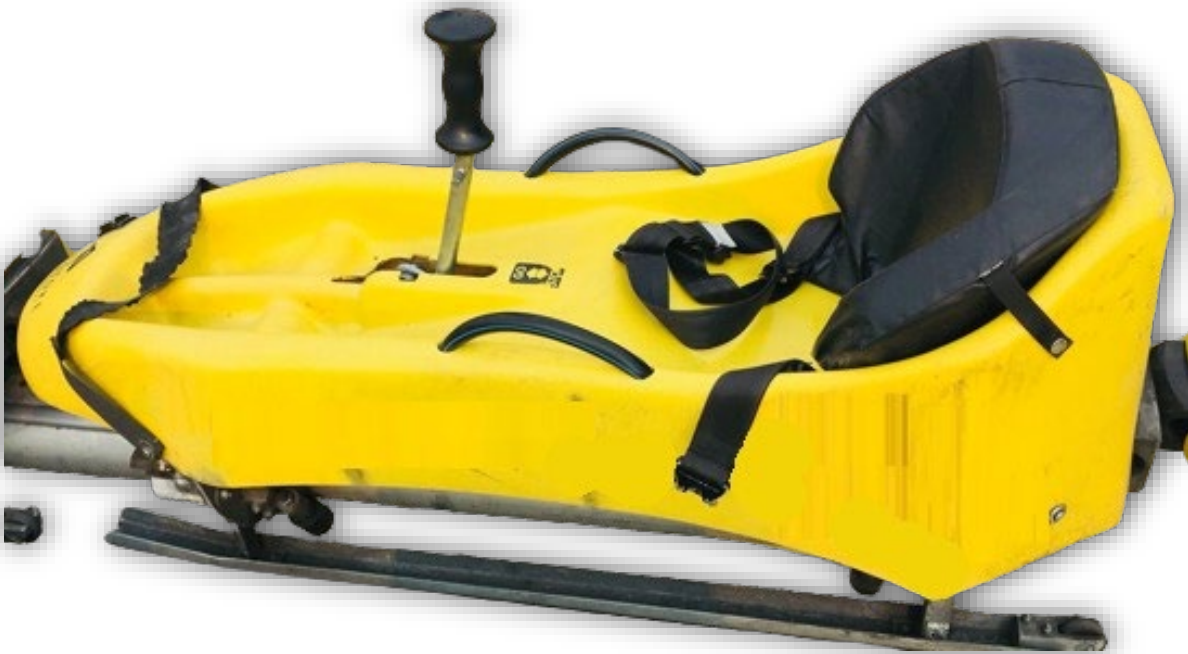
- Wasn't allowed back cushion on last ride.
- At no time were the riders told the ride would be affected by rain or what track changes could be like.

Image 5 – Seat showing no head rest (Below shows same manufacturer has design incorporating backrest.)
Although backrest shown not every rider gets a backrest.
