Incident Summary #II-802909-2019 (#10709) (FINAL)

SUPPORTING INFORMATION	Incident Date		January 21, 2019	
	Location		Penticton B.C.	
	Regulated industry sector		Electrical - Low voltage electrical system (30V to 750V)	
	Impact	Injury	Qty injuries	0
			Injury description	None
			Injury rating	None
		Damage	Damage description	The heater and element tube has been destroyed along with the branch circuit wiring and controlling thermostat. The resulting fire has caused damage to the structure and all materials stored within the warehouse area.
			Damage rating	Moderate
			Incident rating	
Incident overview		A Coloritech “OKB593C6” electric Infrared heater element tube produced an arc from the accumulation of moisture within which resulted in a fire that damaged the branch circuit wiring, the structure, and all materials stored within the warehouse.		
INVESTIGATION CONCLUSIONS	Site, system and components		The Caloritech electric infrared heater comes with a replaceable heater tube which consists of an element encapsulated by an insulating material and overall metal covering. If moisture penetrates the metal covering an arcing can occur between the element and metal covering. Externally p

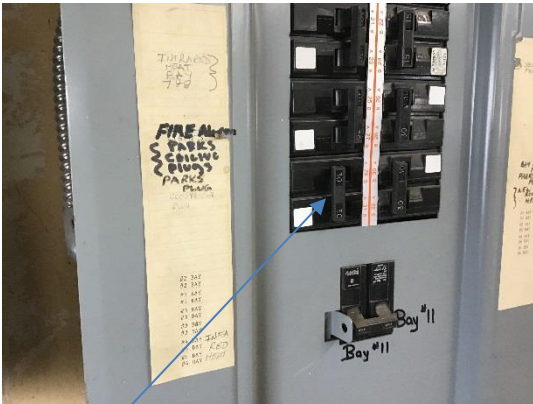
Photo#1: Branch circuit breaker

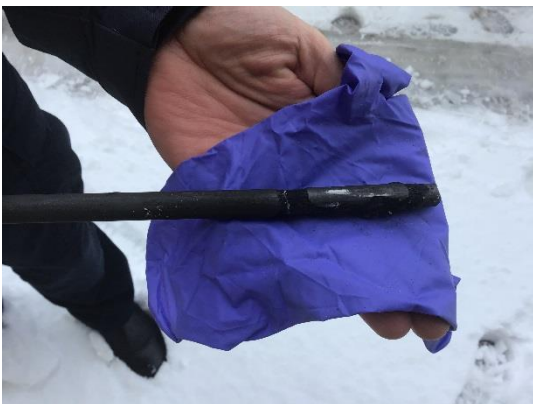
Causes and contributing factors		It is probable that moisture in the air from the drying of equipment and environmental conditions penetrated the heater tube. This caused arcing between the heating element and the metal covering of the tube (as determined by the manufacturer). Without the external GFCI protection of the heater, as required per manufacturer installation instructions, the arcing would not trip a standard breaker as it is not a direct short to ground. This arcing will turn the metal covering of the heater element

into molten metal which dripped onto the wooden lunch table and paperwork below. The heat from the molten metal would have been enough to ignite the table and the paperwork on the table which in turn ignited surrounding items.

Photo #2: Heater element with dripping metal

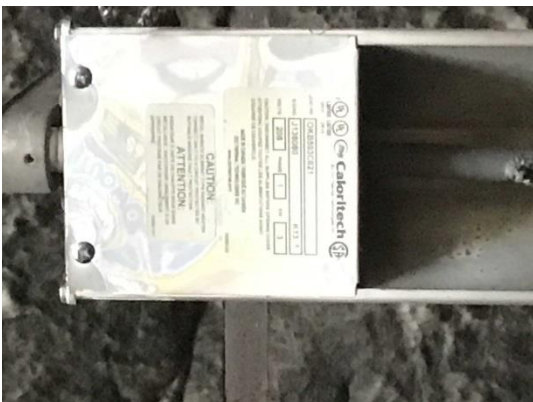
Photo #3: Heater specifications

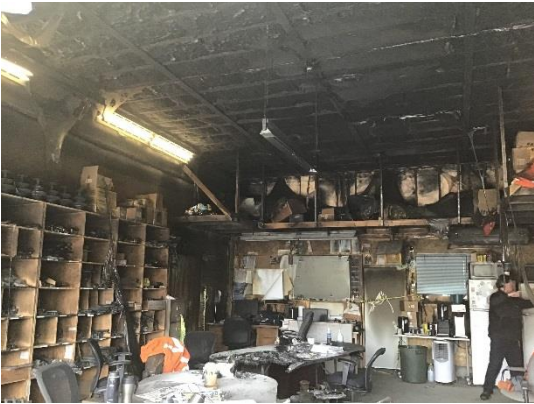
Photo #4: Warehouse area showing ceiling.

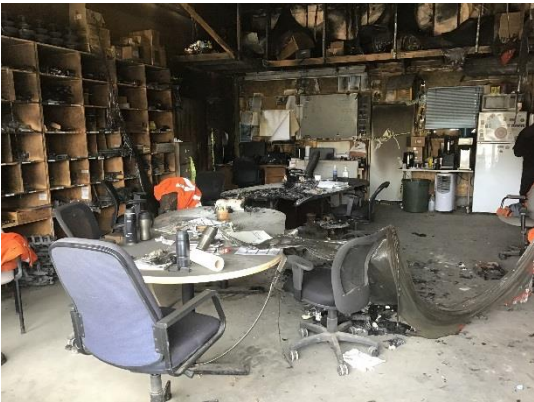
Photo #5: Warehouse area showing table locations.
