## Incident Summary #II-964050-2020 (#16298) (FINAL)

| | Regulated industry sector | | Boilers, PV & refrigeration - Boiler and pressure vessel system | |

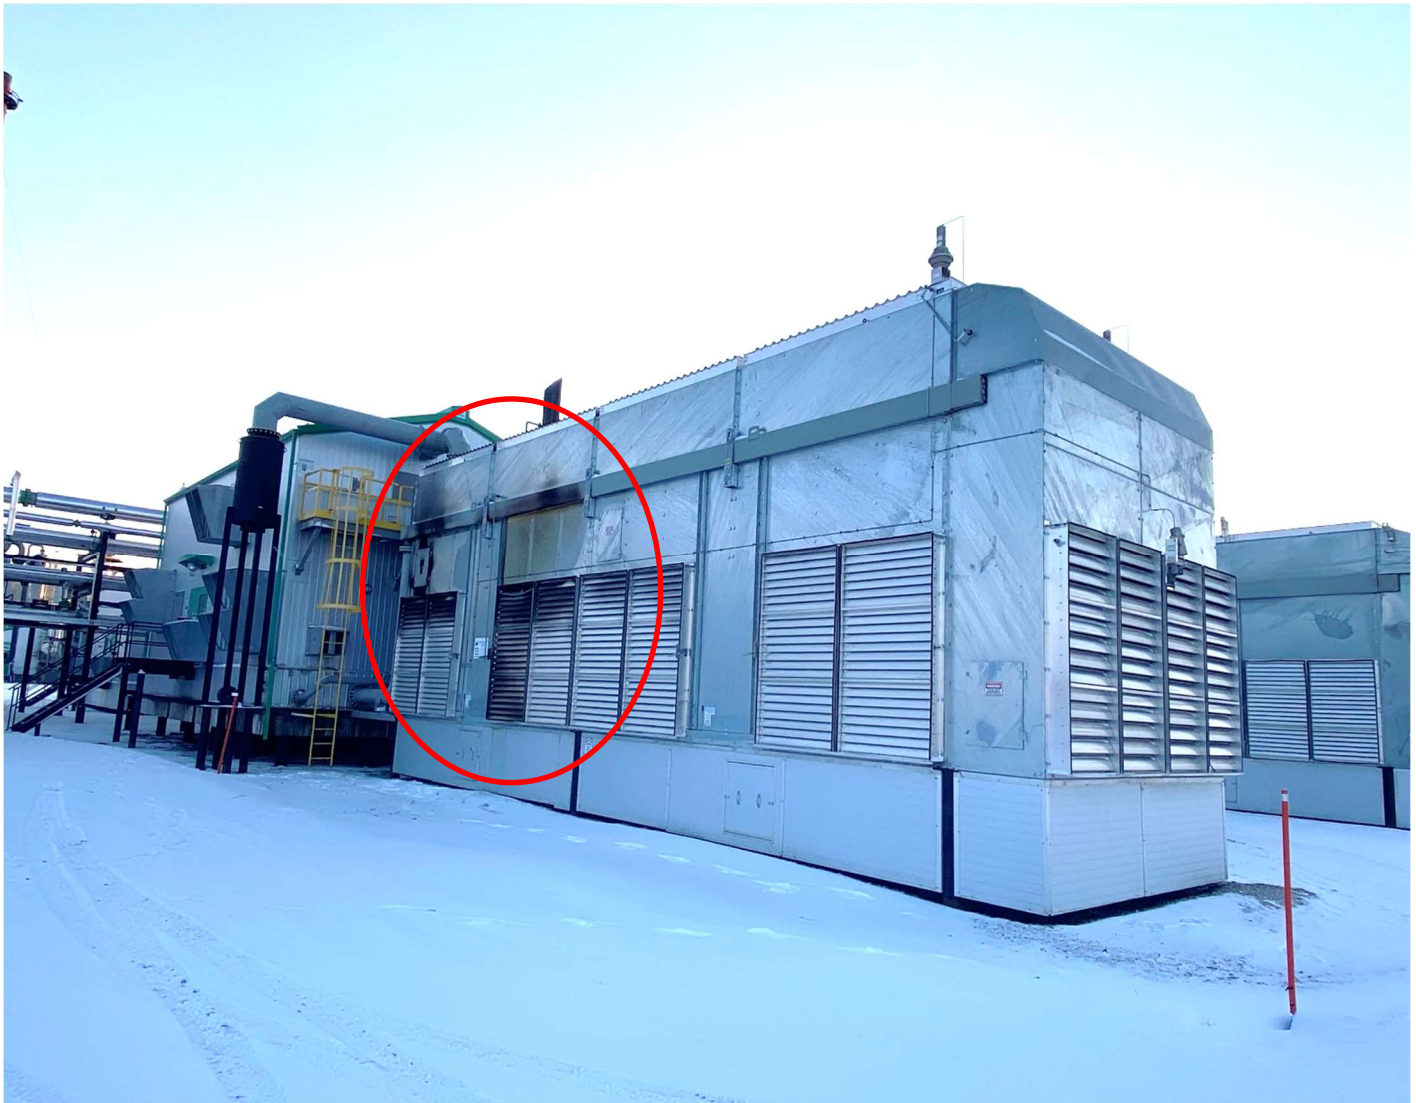
**Compressor Building (Left) with Cooler Fan Compartment (Right)**

**Red circle outlines area of fire damage**

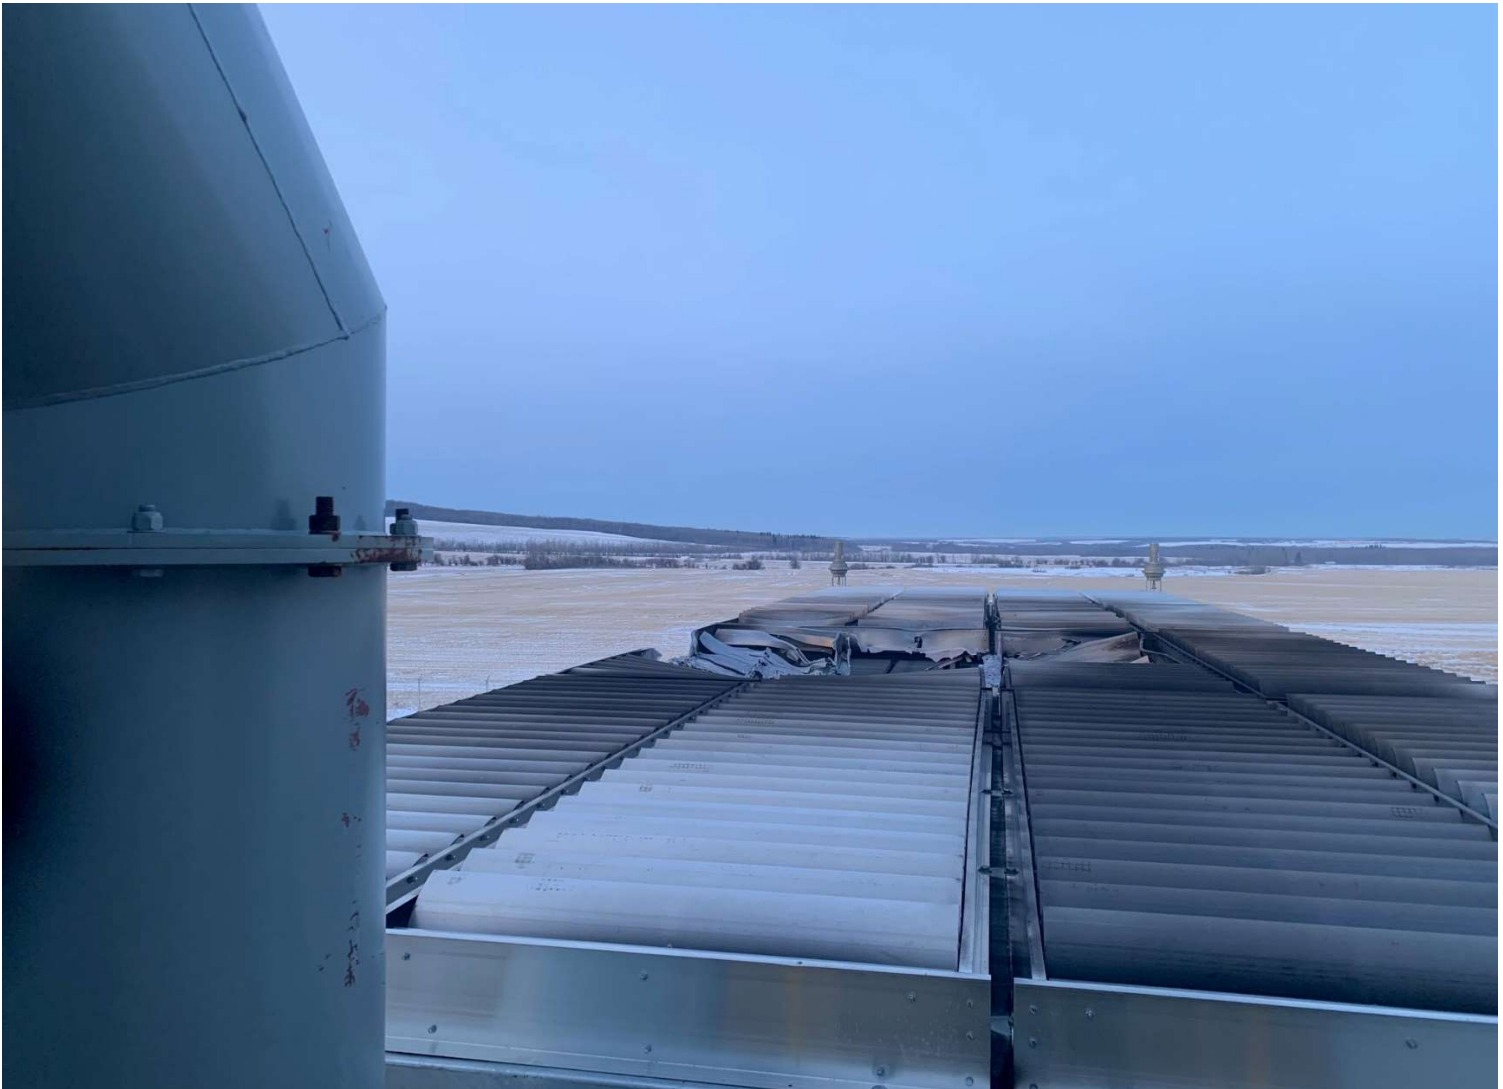
| | <ul style="list-style-type: none"> <li>- A third-party investigator reported that the vents on top of the cooler were in the closed position during the colder temperatures, and may have provided a path for the leaking gas to circulate down towards the electrical fan motor which was likely the source of ignition.</li> <li>- The fan motor was reported to be class 1 division 2 rated and although weatherproof, was not explosion proof.</li> </ul> |

**Top of Cooler View**

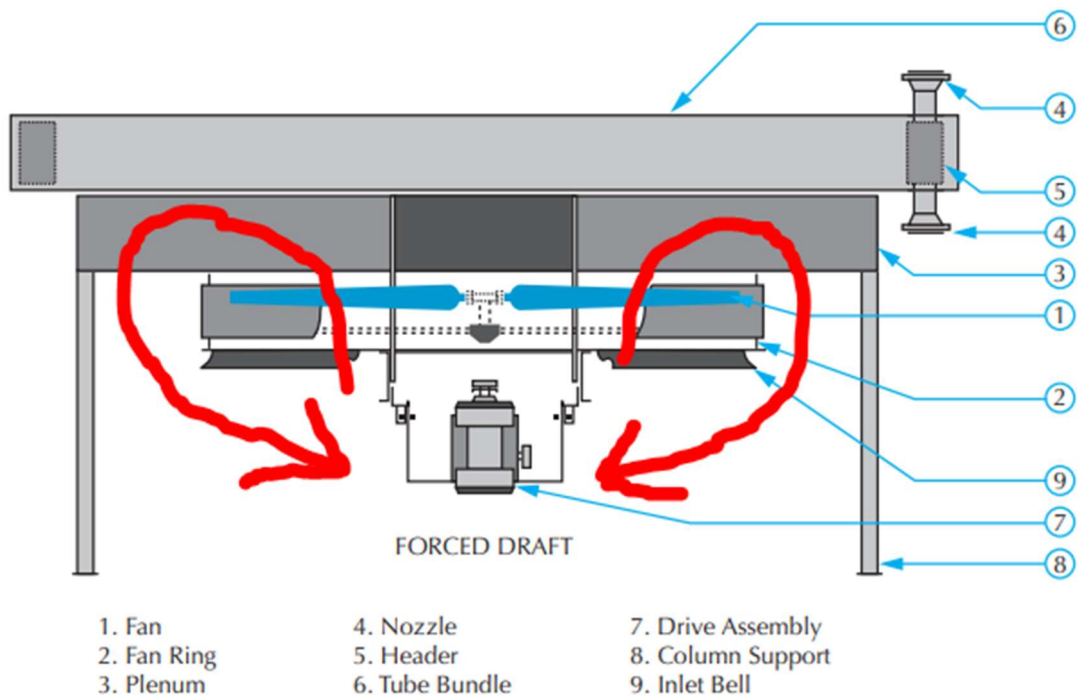
**Possible airflow with louvers closed – air directed back to electric motor/drive assembly**

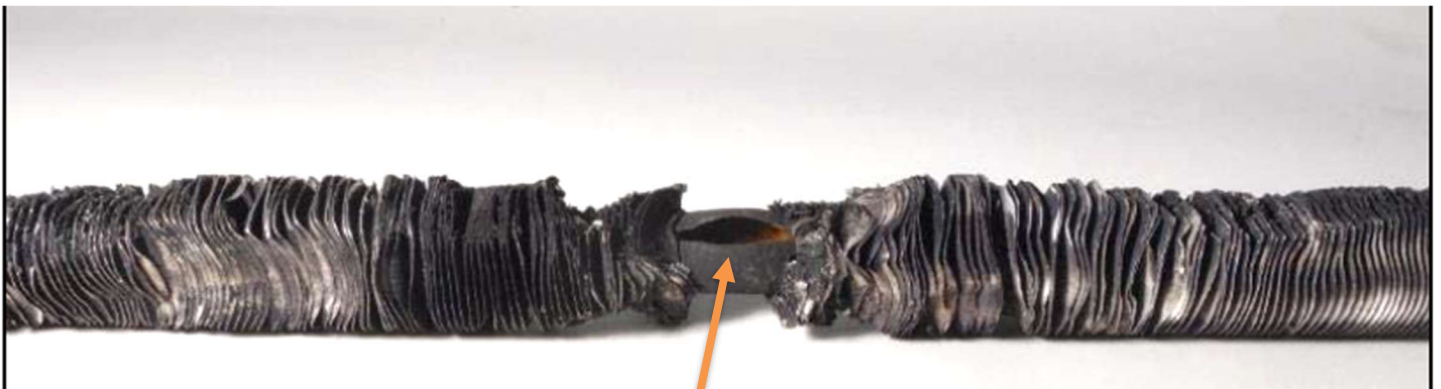
| | Failure scenario(s) | | A tube ruptured in an aerial cooler connected to a compressor unit, releasing combustible gas which then contacted an electric motor and ignited, causing a fire. Summary of possible contributing factors: <ul style="list-style-type: none"><li>- Ambient temperatures may have contributed to freezing of the cooler tubes</li><li>- Gas leaking from the tube may have been ignited by the electric motor</li><li>- Fan motor was not designed as an explosion proof fan</li></ul> | |
| | Facts and evidence | | Summary of evidence and facts determined in the investigation of this incident: <ul style="list-style-type: none"><li>- Site temperatures on the day of the incident were reported between minus 30 and minus 40 degrees centigrade.</li><li>- A metallurgical was engaged to conduct failure analysis. The metallurgical engineer reported that it is likely that the tube rupture was due to condensate freezing inside the tubes which contributed to the failure of the tube.</li></ul> | |

| <b>Causes and contributing factors</b> | <p>It is probable that low ambient temperatures contributed to the freezing of the cooler tube resulting in the tube failure. It is also plausible that the electric motor not being rated as explosion proof also contributed to the gas ignition resulting in fire damage.</p> |

Tube Rupture

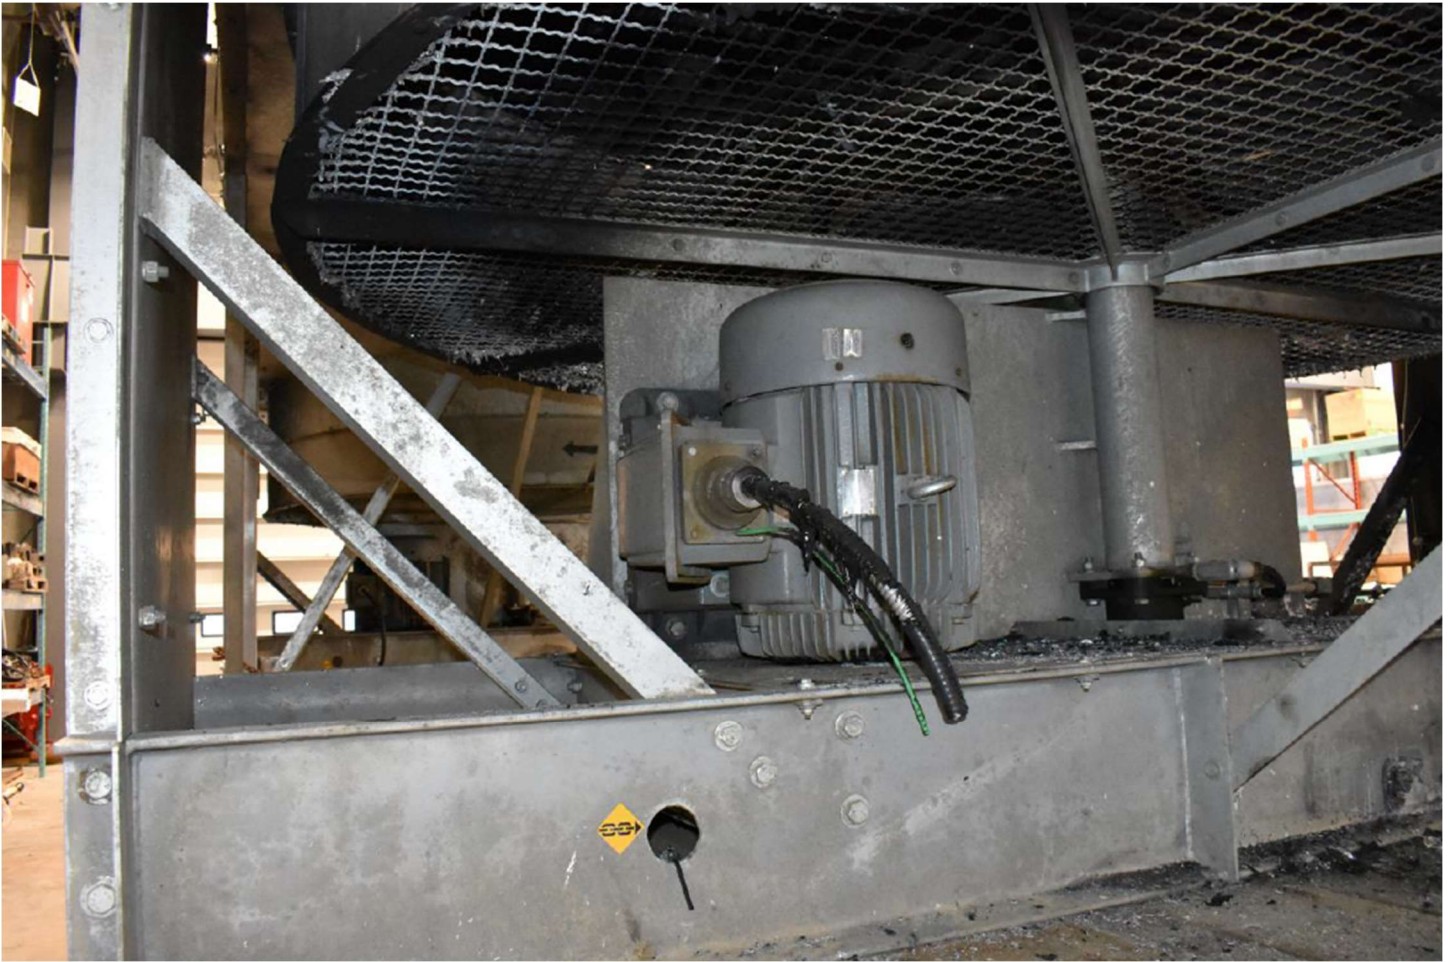
**Electric Fan Motor below tubes- wires cut for removal of Cooler**
