Incident Summary #II-956289-2019 (#16161) (FINAL)

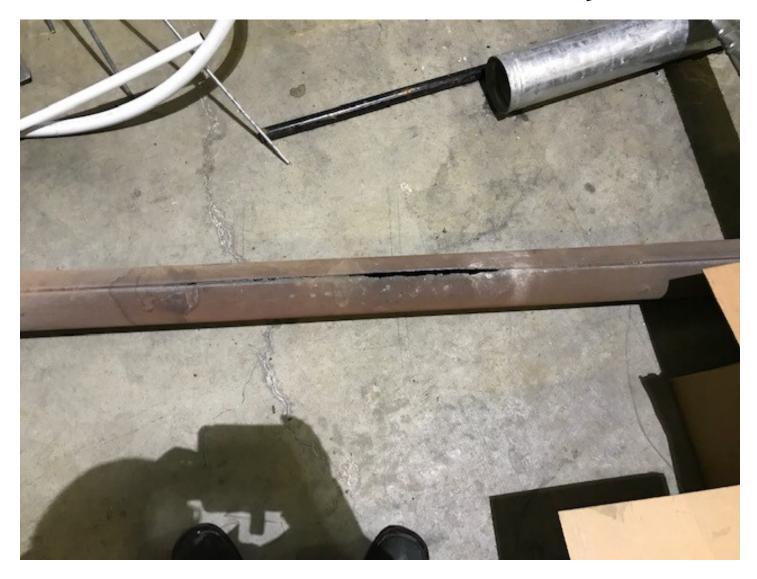
Incident Date	December 15, 2019
SUPPORTING INFORMATION	Location	Prince George BC
	Regulated industry sector	Gas - Natural gas system
	Qty injuries Injury description	0
		None
	Injury rating	None
	Damage description Damage rating	First section of heat tube failed and split along a welded seam
	Damage rating	Minor
	Incident rating	Minor
	Incident overview	Infrared radiant tube heater heat tube failed allowing flame to burn uncontrollably and thus igniting the shops plywood ceiling.
INVESTIGATION CONCLUSIONS	Site, system and components	 •Infrared radiant tube heater primary heat source to shop. •The infrared heater is fueled using natural gas. The hot temperatures are generated by burning fuel inside the unit, a steel tube within the heater. The heat from this surface is then emitted in the form of infrared radiant energy. Reflectors direct the infrared radiant energy downward to ultimately warm the floor and objects in the room. •The first section of the burner tube is closest to the heat source and thus is subjected to the highest direct temperature.

Failure scenario(s)	Incorrectly installed tubes, welded seams of the tubes are to be positioned downward. Lack of regular maintenance of the heating equipment.
	Facts and evidence	Installation manual states: Make sure the welded seams at bottom of tube pointing down towards the floor when installed. In this installation the seams were installed on the top. The first section of the burner tube had split along the welded seam. Owner of the equipment was unable to provide any maintenance records of the heating equipment.
	Causes and contributing factors	The fire was very likely caused by the lack of maintenance of the heating equipment, and the improper installation orientation of the tubes.

First section of heat tube

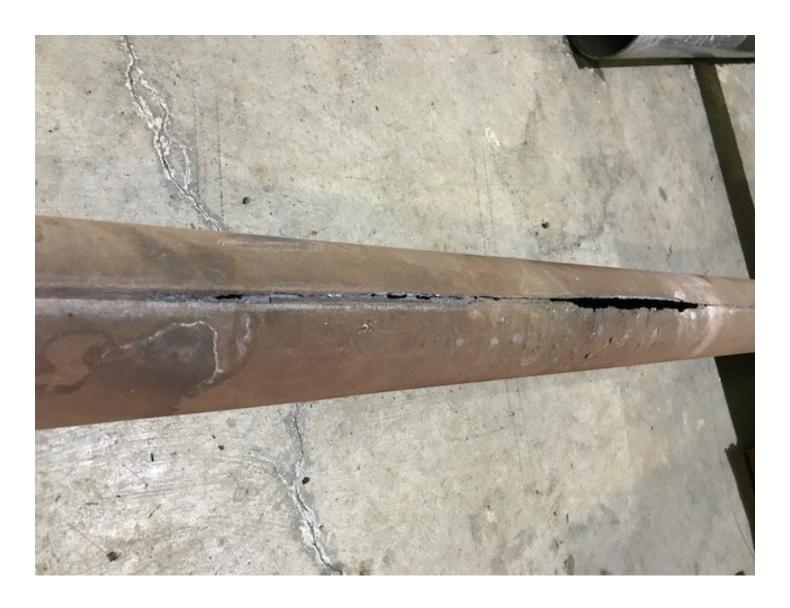
First section of heat tube, close up view

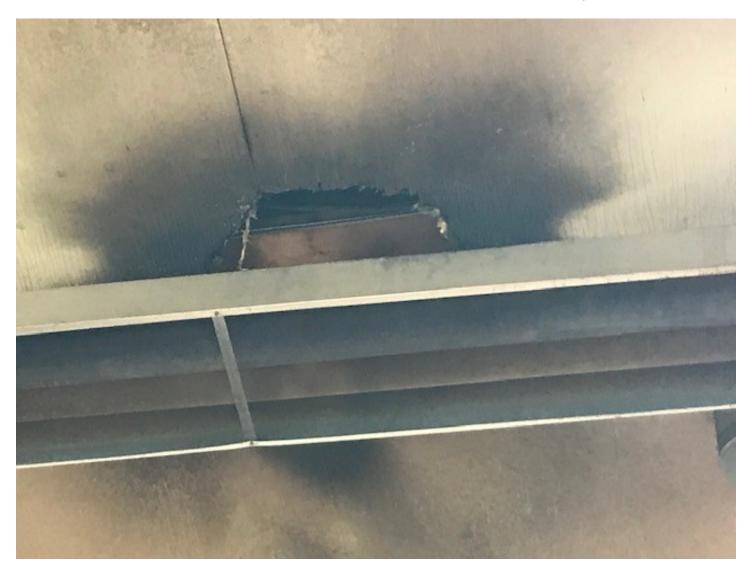
Overview Burnt ceiling

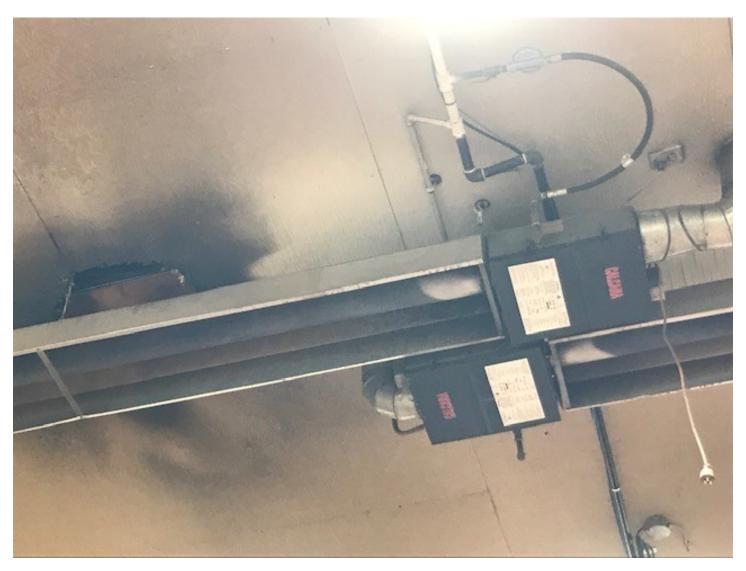
Heater in place, hole burnt through plywood ceiling
