Incident Summary #II-1457097-2022 (#30224) (FINAL)

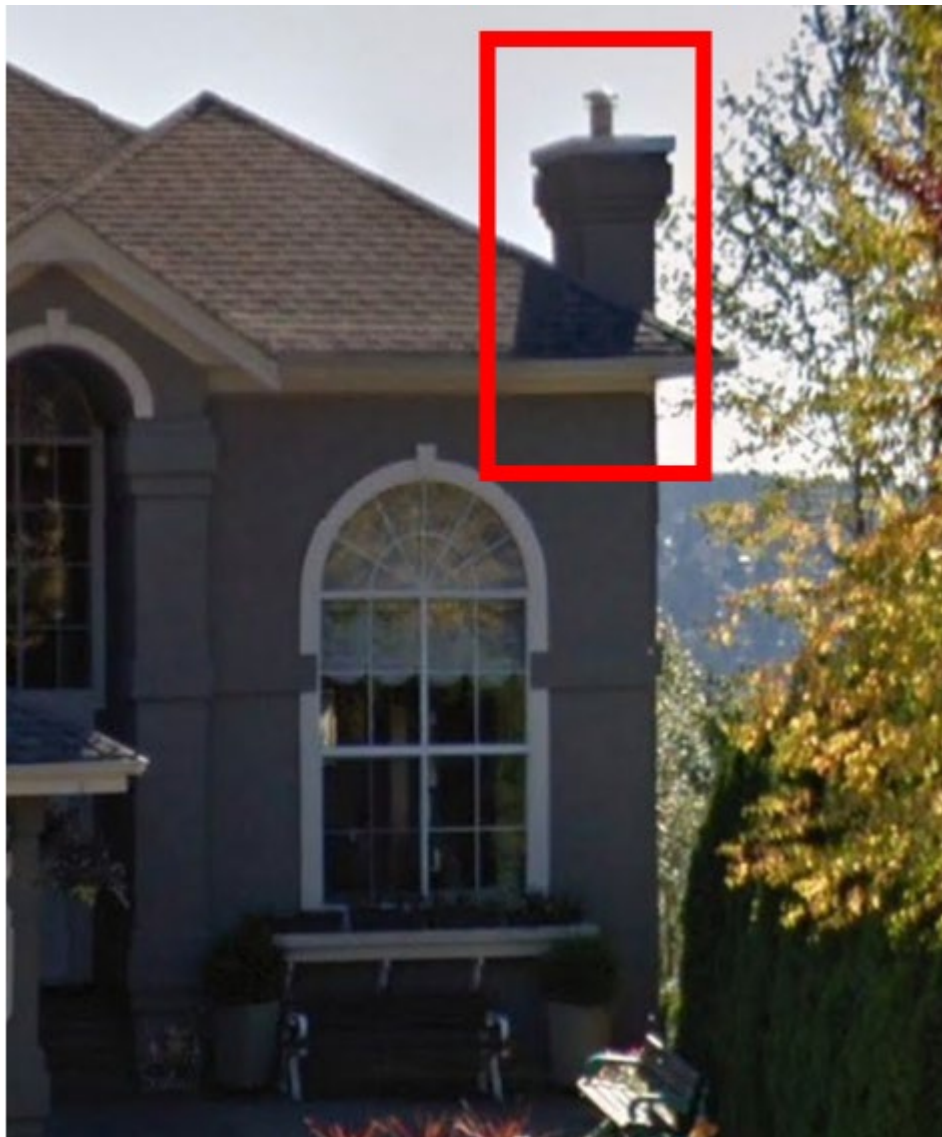
Photo 1 – Street View from Google Maps with **RED** box showing the fireplace venting before the incident.

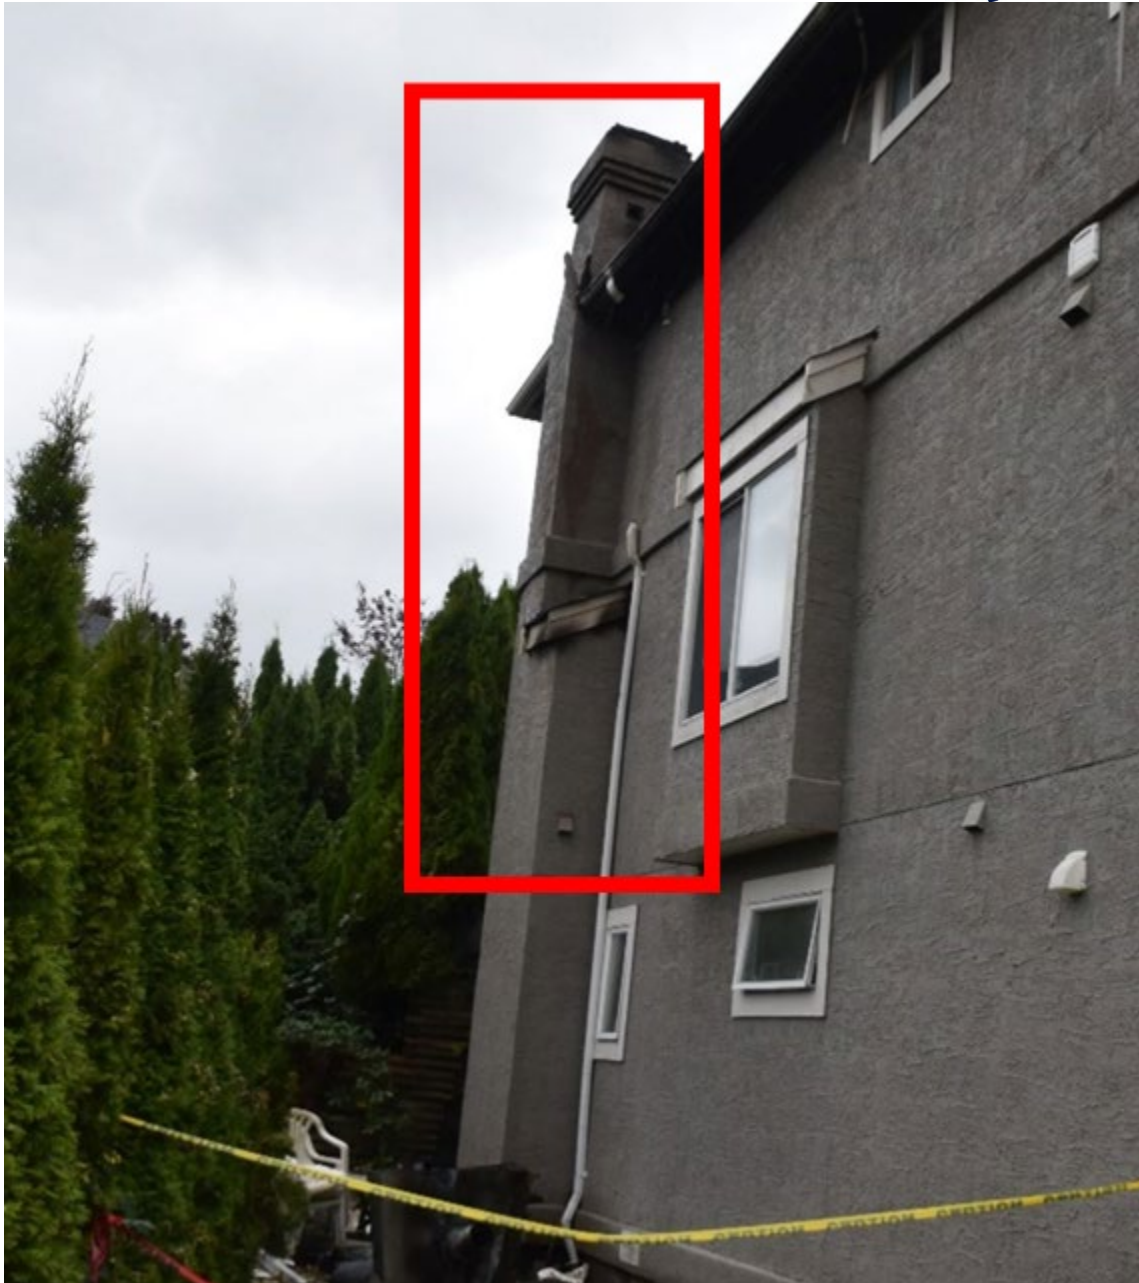
Photo 2 – RED box showing gas fireplace venting chase after the incident.

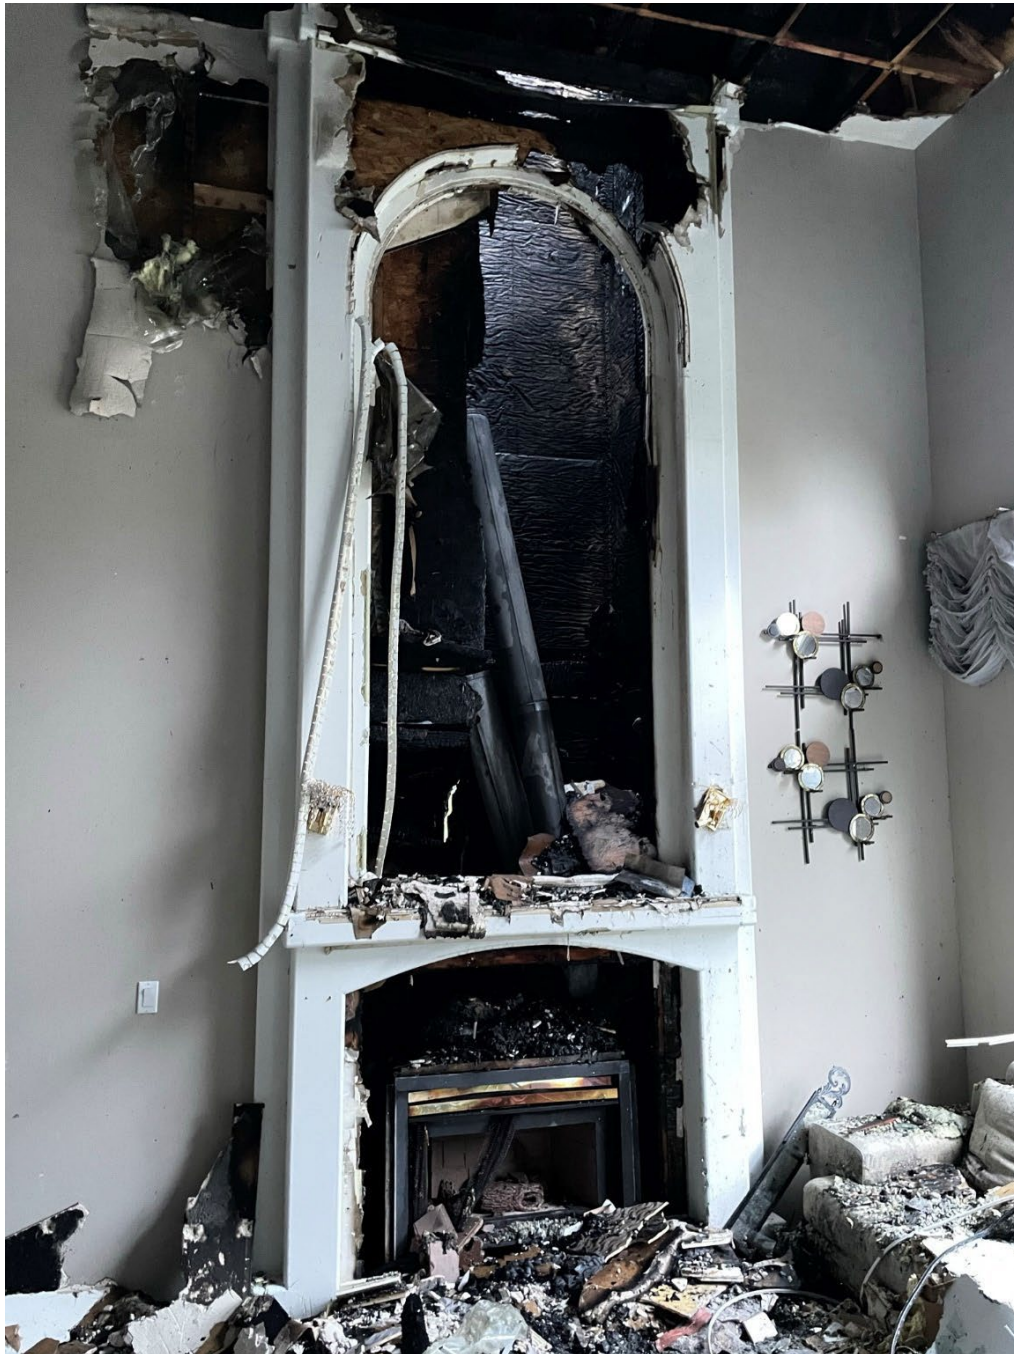
Photo 3 – Gas fireplace and damaged venting and vent chase.

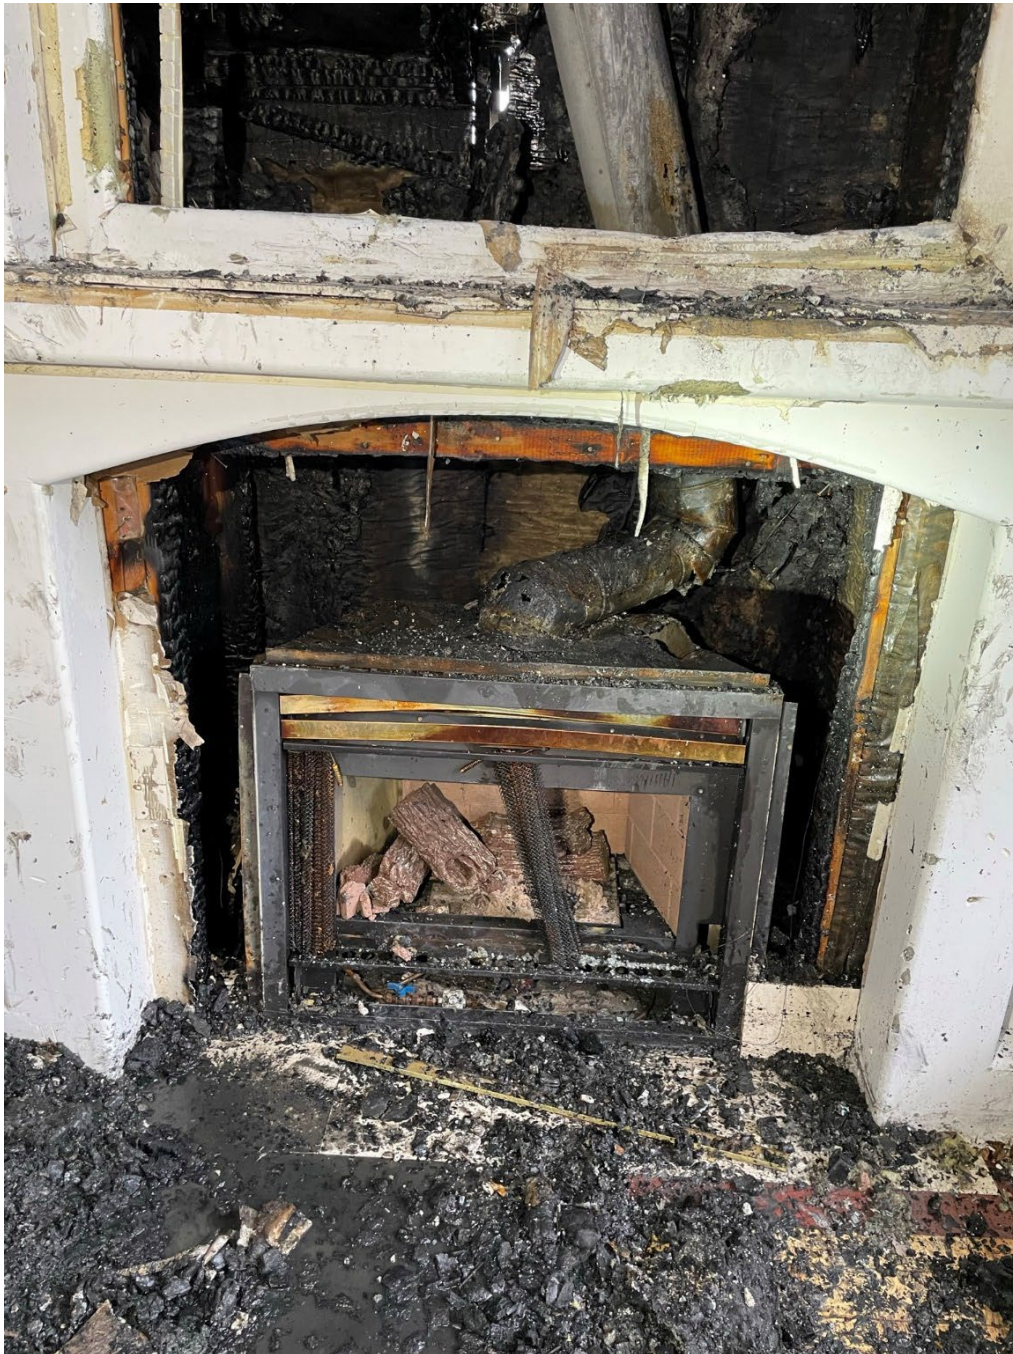
- The venting for the furnace had collapsed and effectively separated ([Photo 4-5](#)).
- The venting elbow connecting to the fireplace and the top of the fireplace enclosure had corrosion holes ([Photo 5-6](#)).

Photo 4 - Gas fireplace showing fire damage and collapsed venting.

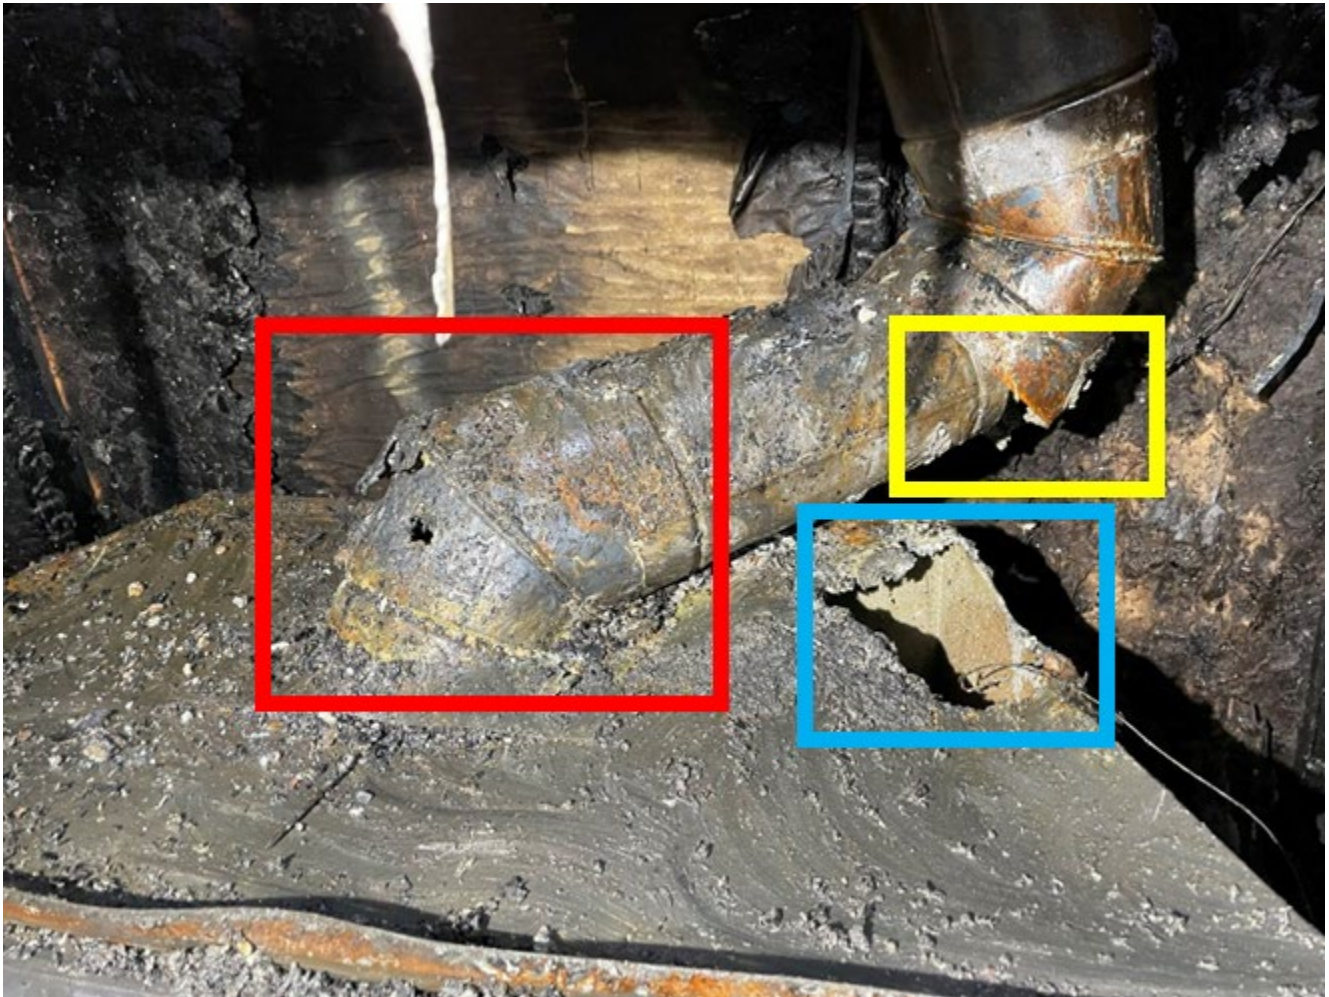
It is highly likely a failure of the building envelope allowed water and condensation to enter the enclosed wall cavity which caused damage to the wooden venting support structure and corrosion of the vent which compromised its strength causing it to collapse and separate. The separated vent allowed escaping heat and flue gases to start the fire.

Photo 5 – Top of fireplace and venting. **RED** box showing corrosion holes in venting elbow. **BLUE** box showing corrosion hole in fireplace outer cabinet. **YELLOW** box showing separation of venting pipe from piping elbow.

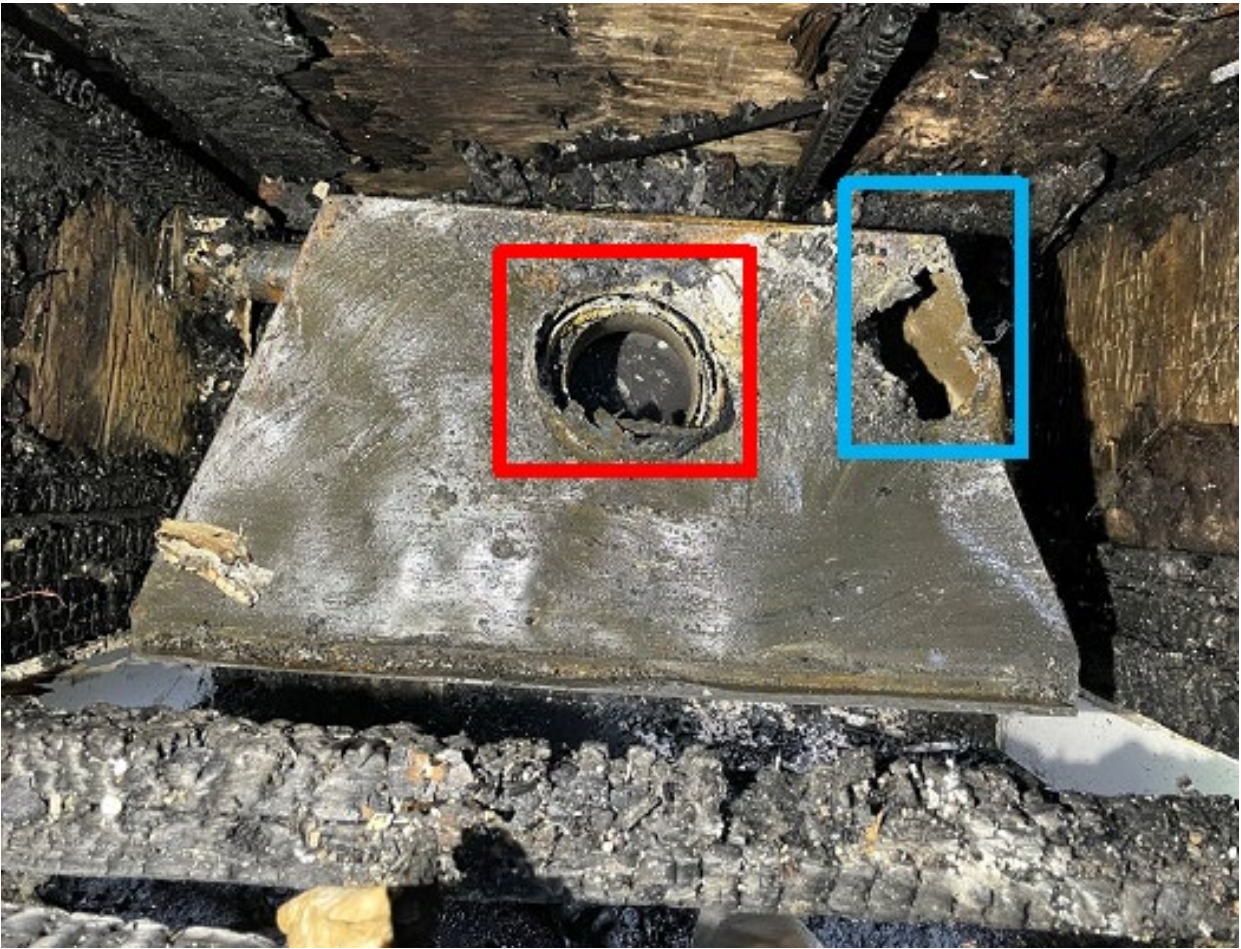
Photo 6 – Top of fireplace with venting removed. **RED** box showing corroded venting outlet. **BLUE** box showing corrosion hole in the fireplace outer cabinet.

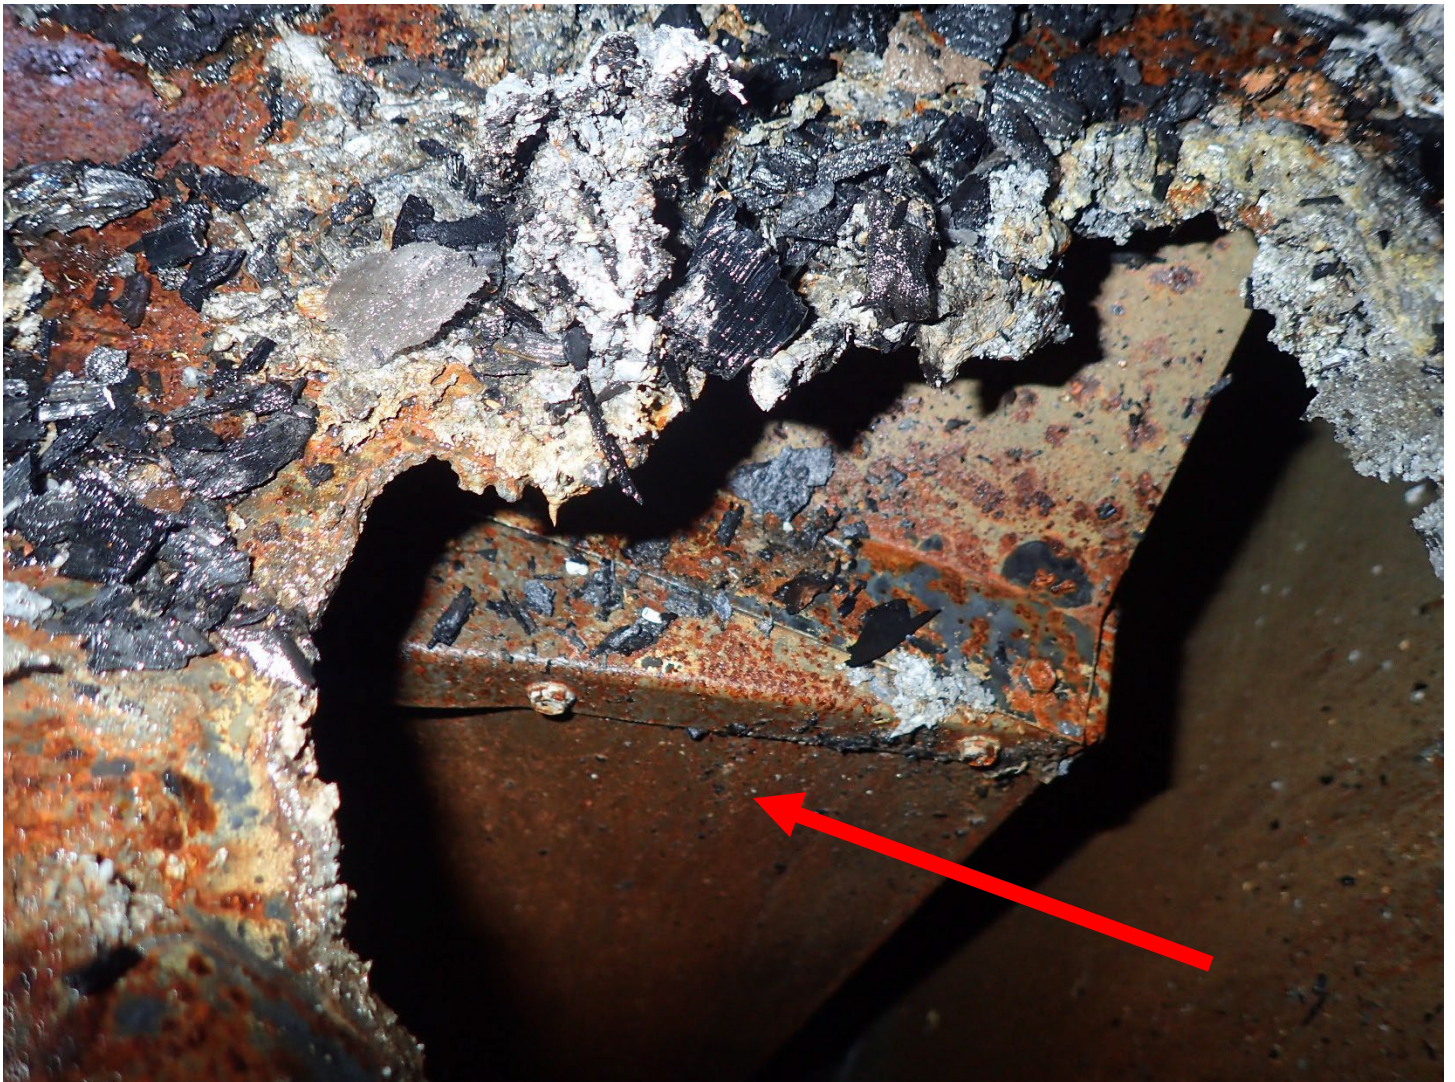
- A large corrosion hole was observed on the top left of the fireplace outer casing, but the inner metal firebox was still intact ([Photo 7](#)).
- A decal on the fireplace identified the age of the appliance as 30 years old

Photo 7 – Closeup of the corrosion hole in fireplace outer cabinet. **RED** - shows undamaged internal metal firebox.

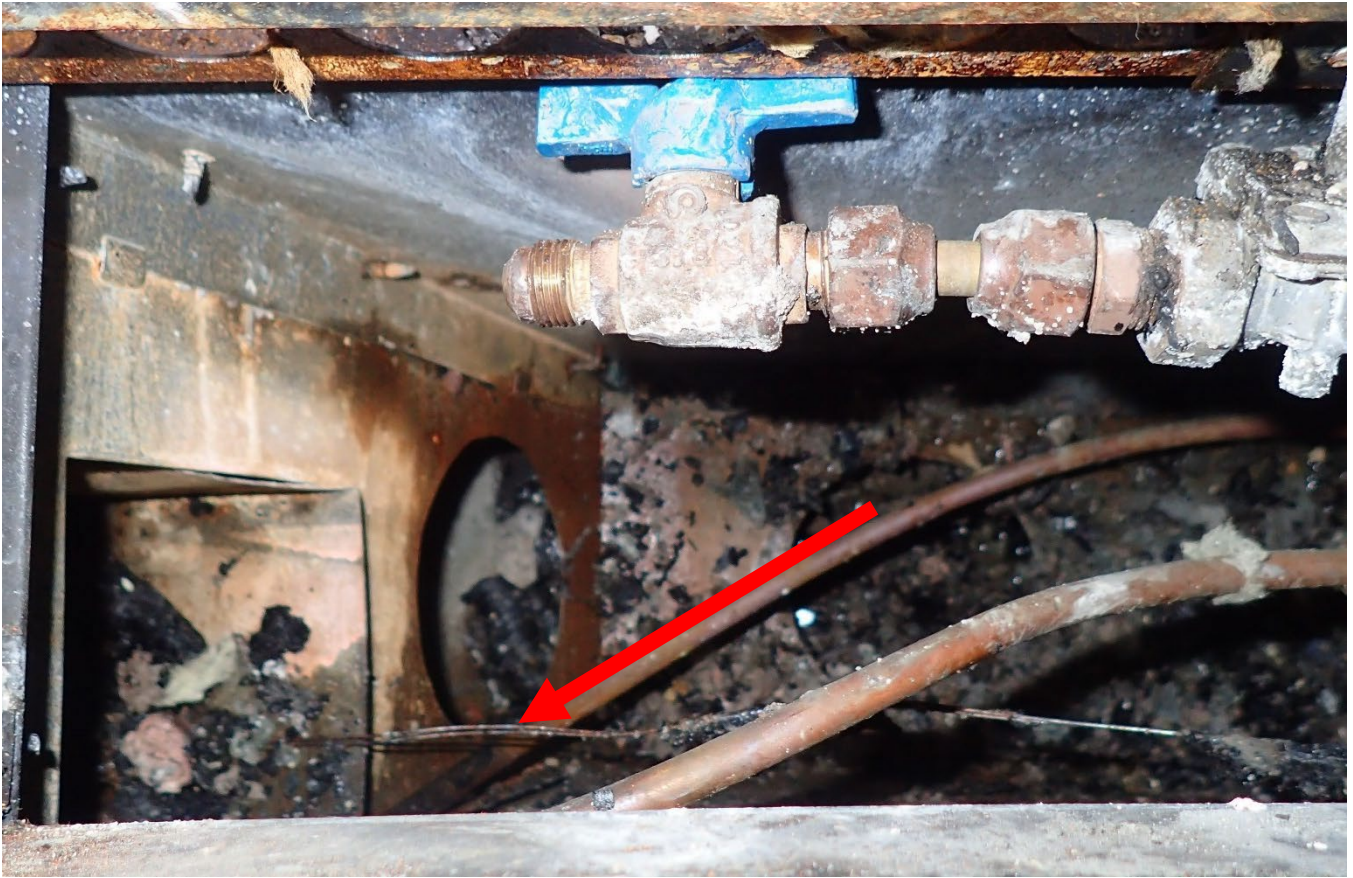
- Some of the remaining undamaged wood construction within the wall cavity space showed evidence of rot from moisture and condensation over time.
- The thermostat wires from the wall switch to the gas valve were observed to have the insulation melted away and the bare conductors contacting each other.

It is probable that heat in the wall cavity caused the thermostat wire insulation to melt and the bare conductors to contact each other which contributed to the incident by allowing the fireplace to continue operating when the wall switch was turned off.

Photo 8 – The gas fireplace lower opening. **RED** - shows the thermostat wires from the wall switch to the gas valve with the outer insulation melted and bare wires contacting each other.

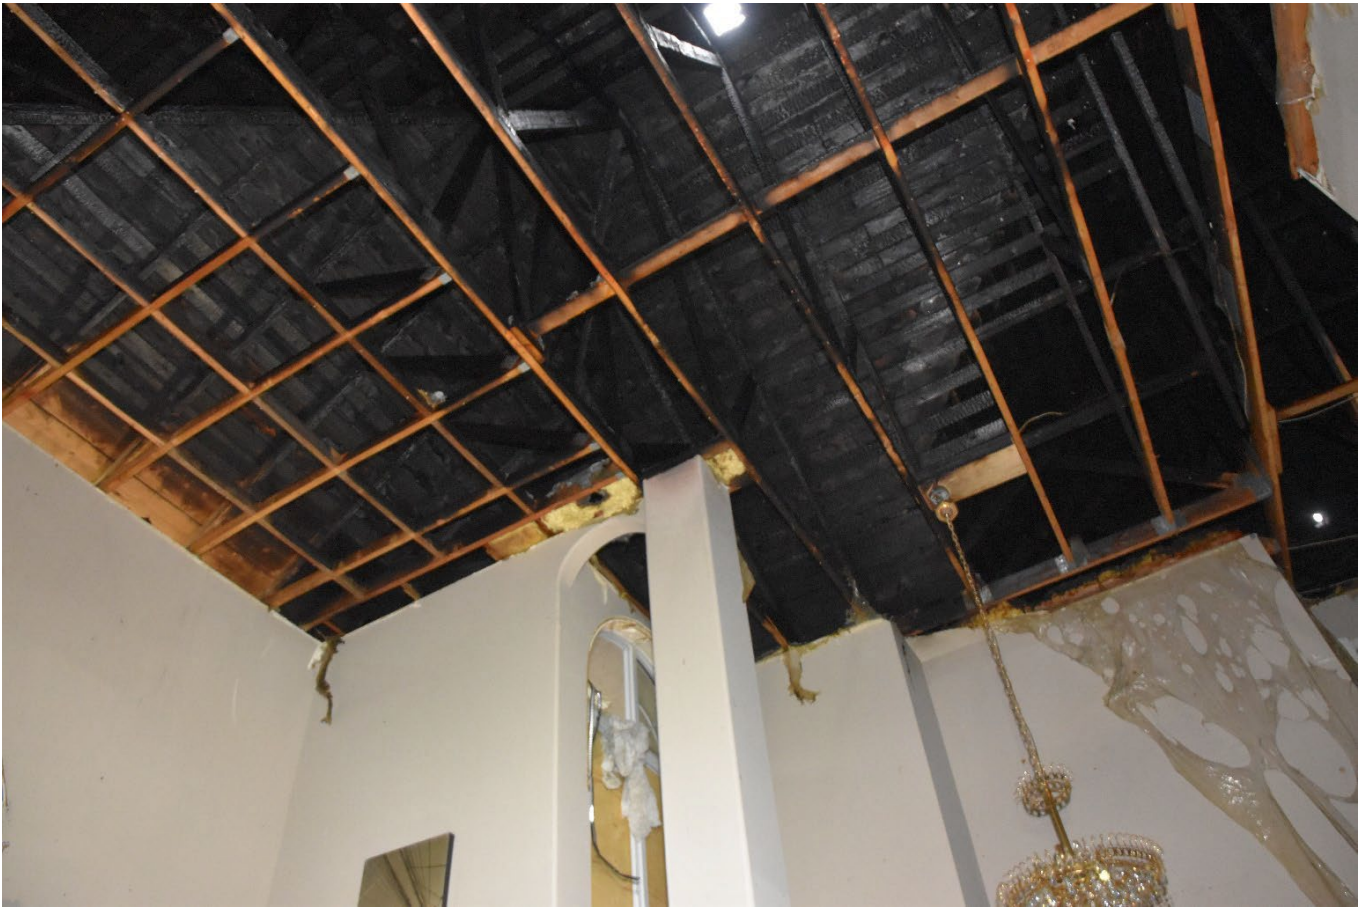
As the fire progressed up the enclosed space, gases produced by the fire accumulated in the attic space and eventually ignited causing an explosion which forced the ceiling drywall down on top of fire fighters inside the home ([Photo 9](#)).

Photo 9 – Ceiling space above the fireplace showing the result of the explosion forcing the drywall and insulation down and subsequent fire damage.
