## Incident Summary #II-1665021-2024 (#43737) (FINAL)

SUPPORTING INFORMATION	Incident Date	January 10, 2024	
	Location	North Eastern, BC	
	Regulated industry sector	Boilers, PV & refrigeration - Boiler and pressure vessel system	
	Impact	Qty injuries	0
		Injury description	N/A
		Injury rating	None
	Damage	Damage description	Fire inside boiler cabinet from boiler combustion chamber melted the boiler fan, gas valve and pressure switch assembly.
		Damage rating	Moderate
Incident rating	Moderate		
Incident overview	Hospital staff called facility maintenance indicating a smell of smoke. Maintenance personnel traced the smell of smoke to one of the heating boilers. Initial indication was that the fan inside the No.5 boiler housing caught fire. The smoke was contained to the inside of the boiler cabinet and there was no external damage beyond the boiler.		
INVESTIGATION CONCLUSIONS	Site, system and components	<p>One of the institutions' boilers which provides heat to the facility exchangers (combustion chamber) refractory became dislodged. This allowed hot combustion gases to escape around the refractory and through the fan motor/lid gasket and melted the boiler fan and exposed the gas v

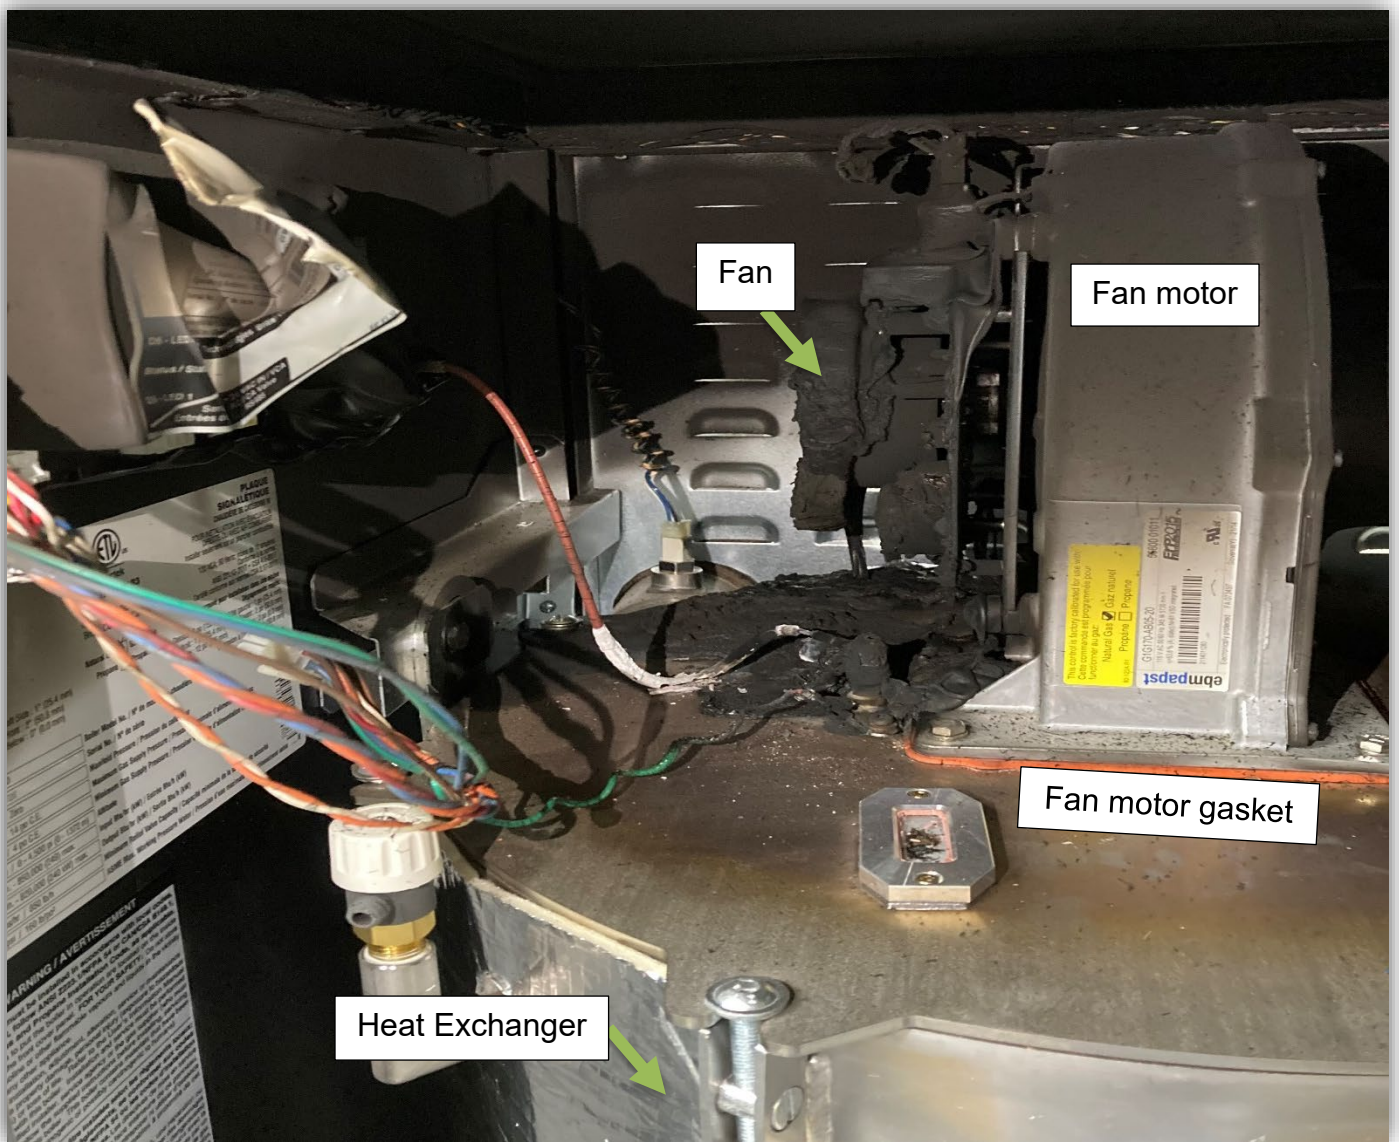
Image 1 - Heat Exchanger and fan motor assembly melted.

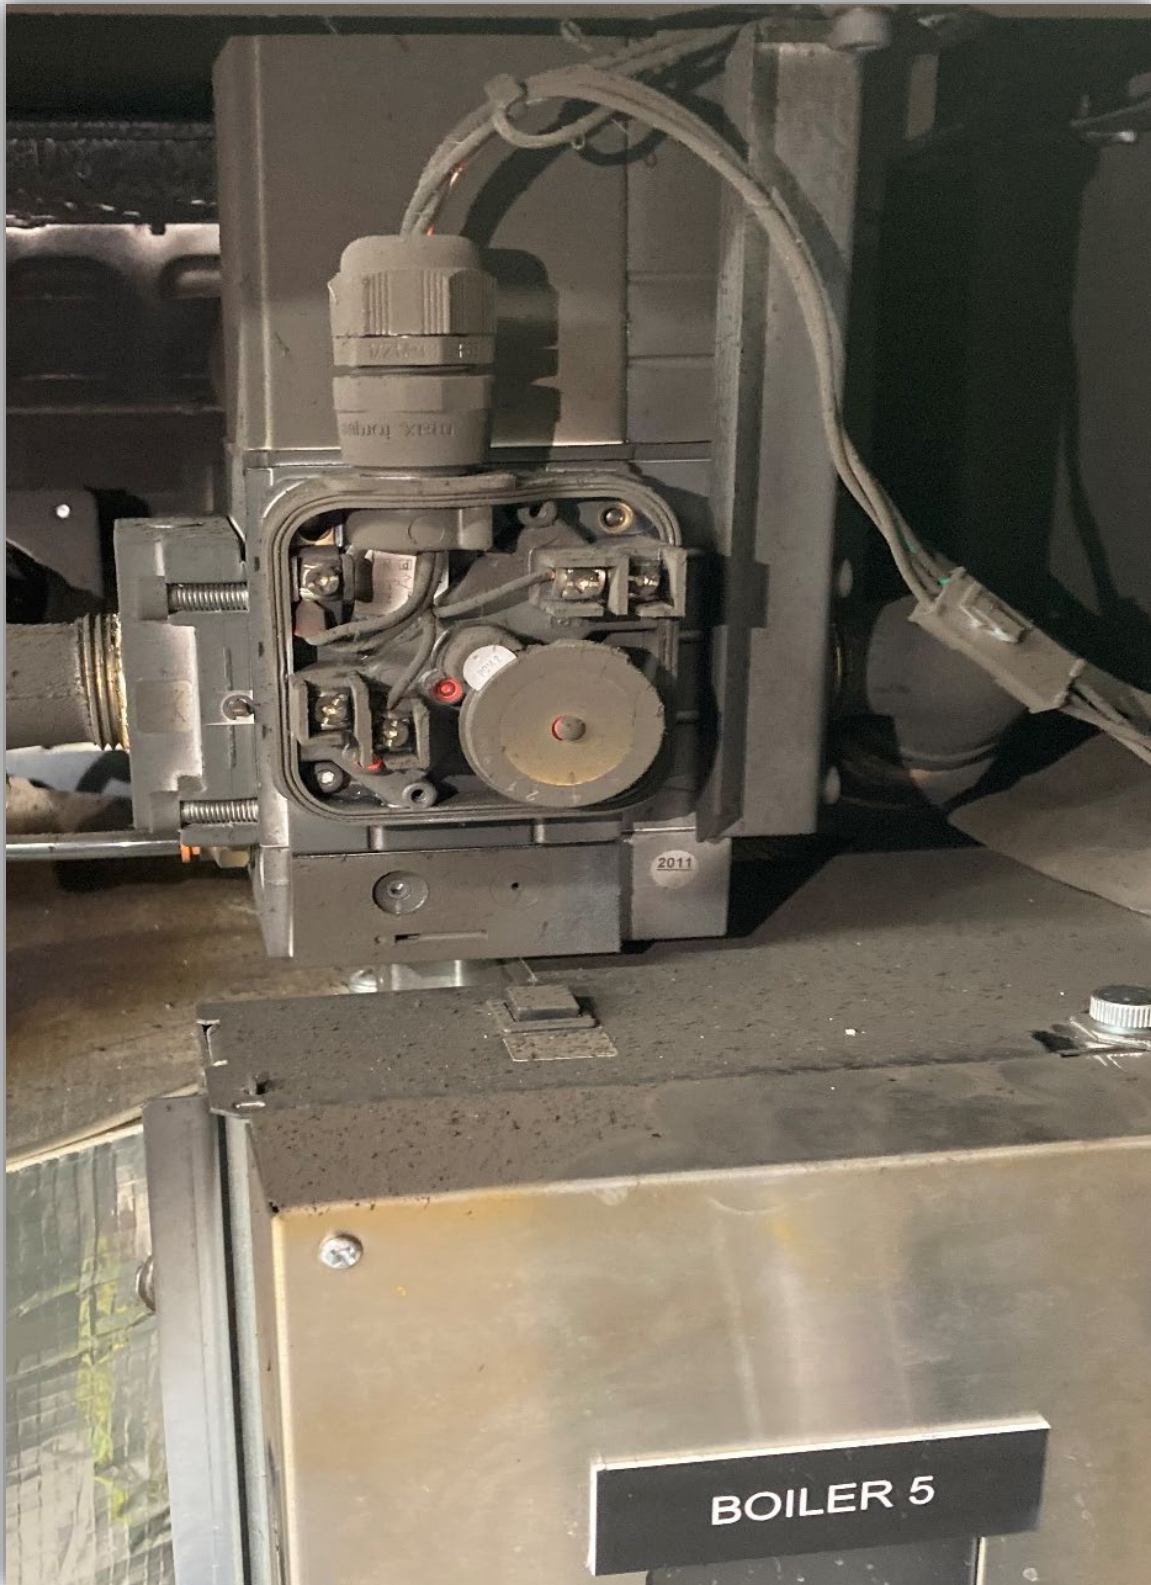
Image 2 - Gas valve and pressure switch assembly (right of fan motor).

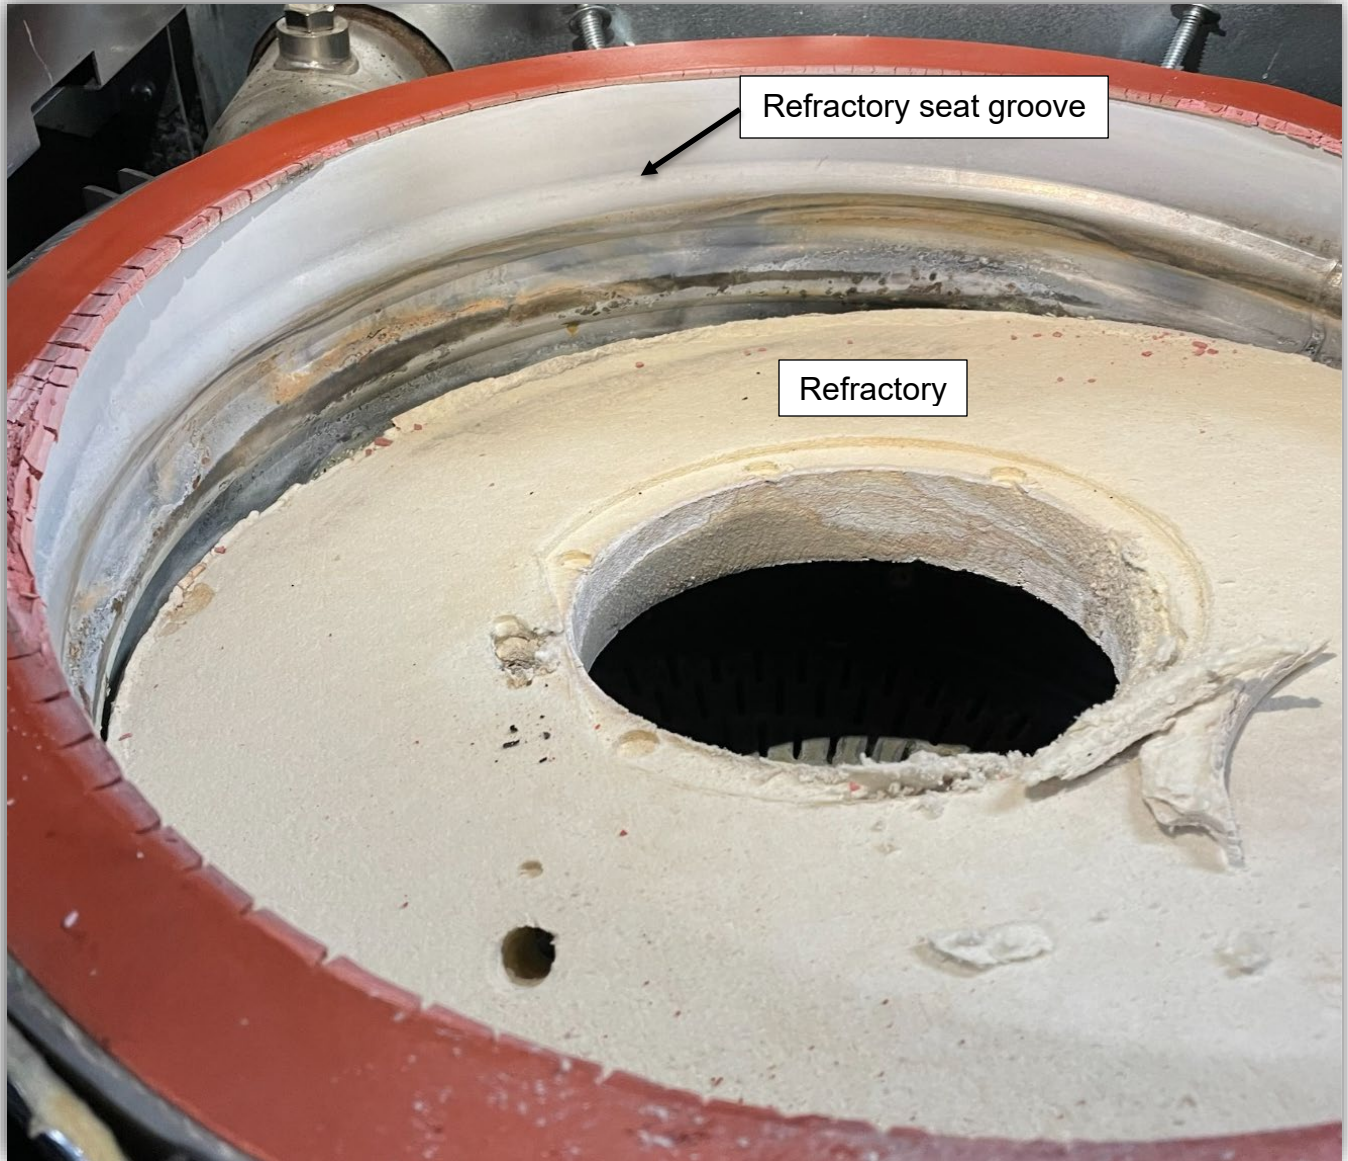
<p>Failure scenario(s)</p>	<ul style="list-style-type: none"> <li>• During operation, the refractory moved out of its designed position exposing the silicone combustion chamber gaskets to heat from the combustion gases. Eventually, the gaskets degraded resulting in combustion heat escaping out of the combustion cylinder lid melting the fan motor housing and associated gas control switch.</li> <li>• History: Boiler No.5 manufactured in 2021, along with the rest of the boilers (1 to 5) were originally installed in November 2021 by a licensed Class A contractor.</li> <li>• The Manufacturer released a public product upgrade notice on October 21, 2022, indicating that this boiler model EX850 had a new exchanger lid design revising the refractory and lid assembly so that the refractory is bolted to the combustion chamber lid instead of the previous design where the refractory was set within recessed grooves located just below the lid.</li> <li>• The newly updated lids and refractory kits were made available and recommended by the manufacture to be installed at the next boiler service interval.</li> <li>• Communication of the updated lids and refractory kits appeared to only be communicated on the manufacturer's website under product upgrades and not identified as a recall notice.</li> <li>• According to the Owner's site representative no annual service has been conducted since installation prior to the event.</li> </ul>

The cause of the fire in the boiler was a displaced refractory which resulted in damage to the silicone gaskets, and leaking combustion gases.

Image 3 - Refractory dislodged inside heat exchanger.

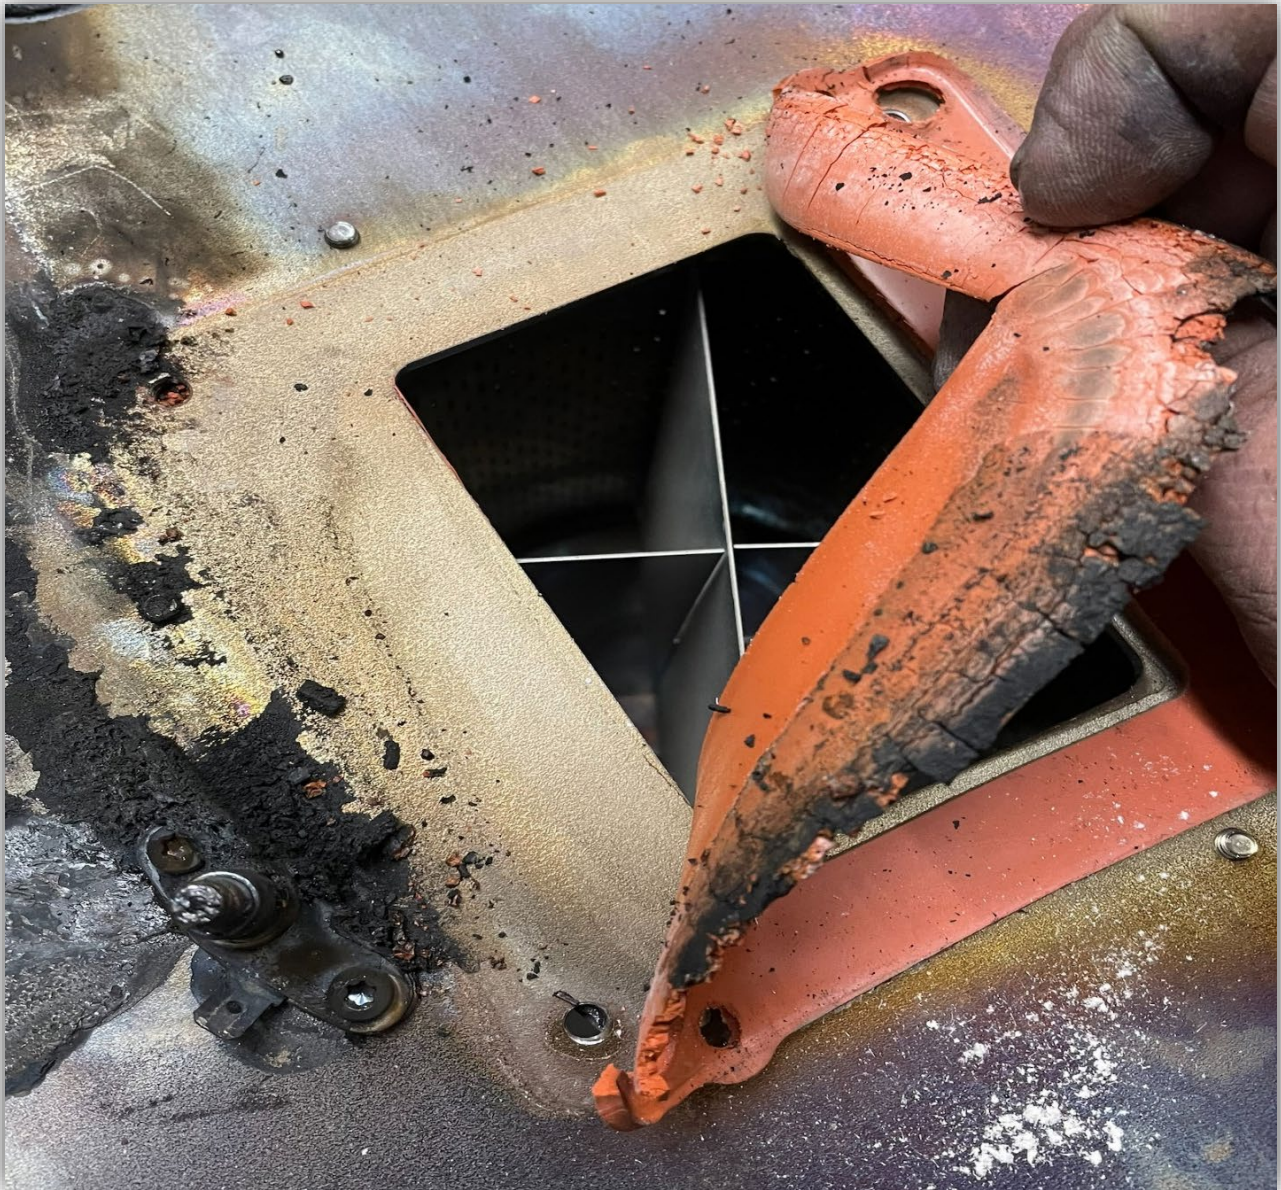
Image 4 - Fan motor gasket (orange) where combustion flame contacted the heat exchanger lid. Hot combustion gases escaped through the heat exchanger lid gasket melting the fan motor and exposing heat and smoke to the gas assembly.
