Incident Summary #II-1074170-2020 (#19295) (FINAL)

SUPPORTING INFORMATION	Incident Date		September 21, 2020
	Location		Vancouver
	Regulated industry sector		Elevating devices - Elevator
	Impact Damage Injury	Qty injuries	0
		Injury description	None
		Injury rating	None
		Damage description	Damage to variable frequency drive (VFD) unit and regenerative drive unit
		Damage rating	Moderate
	Incident rating		Moderate
	Incident overview		A fire started at the variable frequency drive (VFD) unit and spread to the regenerative drive unit, in a multi-residence/commercial building. No one was using the elevator at the time of fire. The incident occurred at around 2AM, when a worker smelled smoke. The fire department was called and extinguished the fire.
INVESTIGATION CONCLUSIONS	Site, system and components		The variable frequency drive unit receives commands from the controller, which provides power to accelerate, run and decelerate the elevator as the elevator travels up and down the elevator shaft. The controller is a self-contained metal unit located in the elevator machine room, and provides commands to a single elevator unit. VFDs are periodically replaced due to component failure.

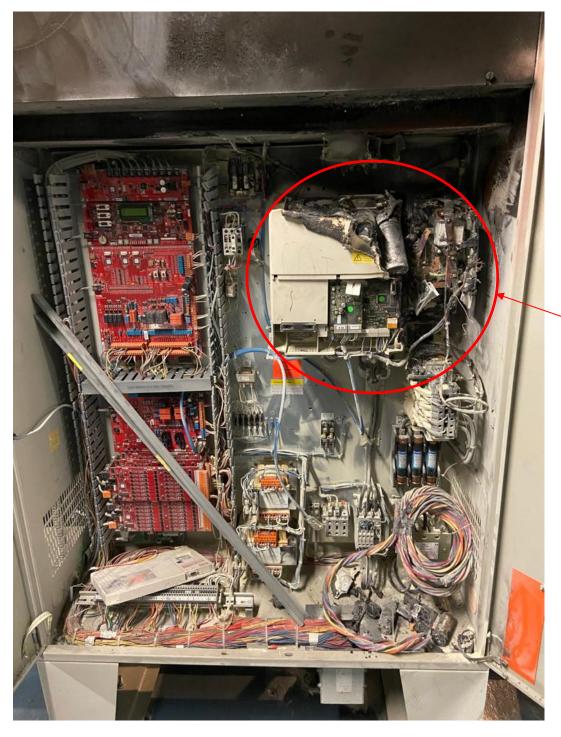
Figure 2 – Controller

See Figure 3 for close-up

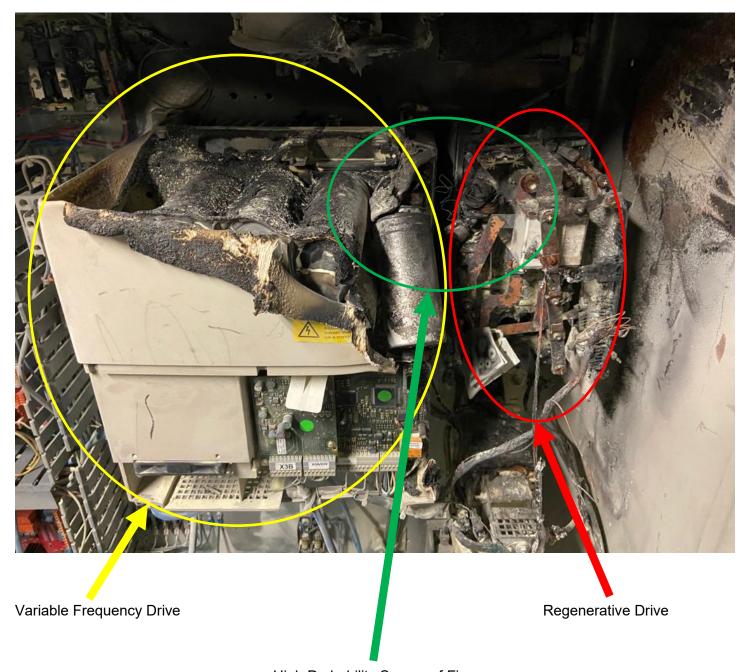
Figure 3 – Drive

Causes and contributing factors		Unable to determine the cause of the fire. Based on the amount of heat damage contained in the vicinity of the VFD and regenerative drive unit, plus the paint damage on the door, it is plausible that these units were the original source of the fire. It is possible that the failure of the VFD unit was due to age or manufacture defect.

High Probability Source of Fire

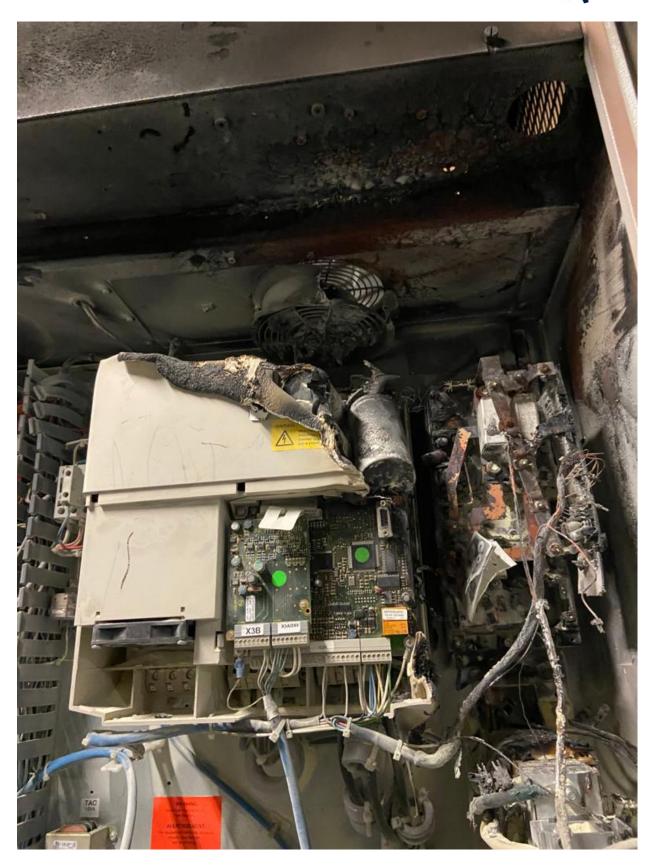
Failure scenario(s)		A fire started on the VFD which spread to the adjacent regenerative drive unit. Both the VFD and the regenerative drive unit sustained catastrophic failure. All other components did not sustain any damage. Damage confined to inside the controller (see figure 4 & 5).
	Facts and evidence		 Elevator controller is a self-contained metal unit within the machine room (Figure 1) VFD and regenerative drive unit are contained within the controller (Figure 2/3) Incident occurred in a multi-residence building with housekeeping workers Fire department called when a worker smelled smoke around 2AM Elevating maintenance contractor arrived to site later that morning. Safety officer attended site the following day Maintenance contractor shut down unit and sourced the components that failed Safety officer confirmed routine maintenance was being done by maintenance contractor Unit had undergone a modernization in 2010

Figure 4 – Damage around VFD and Regenerative Drive Units

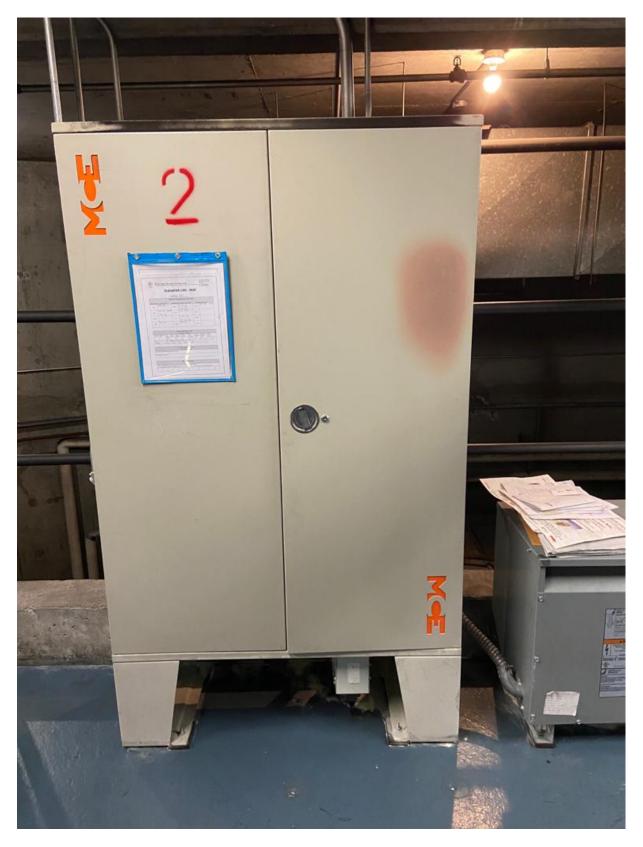
Figure 5 – Damage to the exterior of controller.
