Incident Summary #II-1568737-2023 (#36372) (FINAL)

SUPPORTING INFORMATION	Incident Date	June 22, 2023	
	Location	Richmond	
	Regulated industry sector	Electrical – Low voltage electrical system (30V to 750V)	
	Impact	Qty injuries	1
		Injury description	Electric shock to young worker. Individual was treated for shock at hospital.
		Injury rating	Moderate
	Damage	Damage description	None
		Damage rating	None
	Incident rating	Moderate	
Incident overview	Failure of a battery charger installation cord at an indoor electric go-kart facility resulted in an electric shock to a young worker at the facility.		
INVESTIGATION	Site, system and components	<p>The warehouse facility was upgraded to accommodate electric go-karts and an indoor track in 2016. To accommodate the electric charging of the go-karts, a 150KVA – 600-to-480-volt transformer and load centre was installed. The branch circuits from this new load centre feed multiple 480-volt 3phase twist lock receptacles in between the go-kart lanes. Battery chargers are plugged into these receptacles to facilitate the charging. The battery chargers and the associated charging cables are left in position in between the lanes (Image 1). The go-k

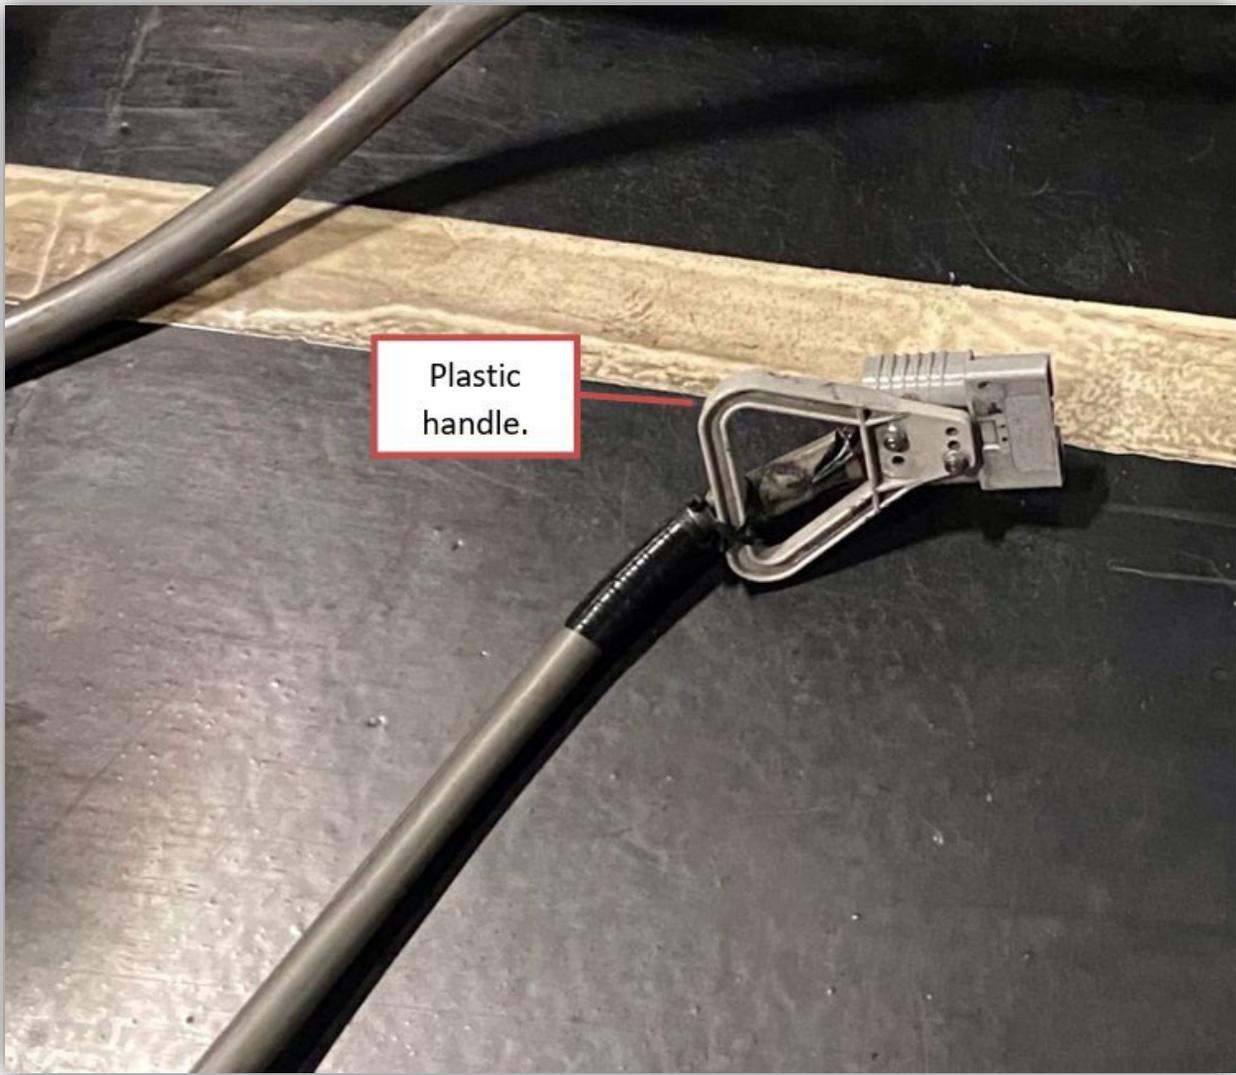
Image 2 - Battery charging cable. Visible female cord end with handle.

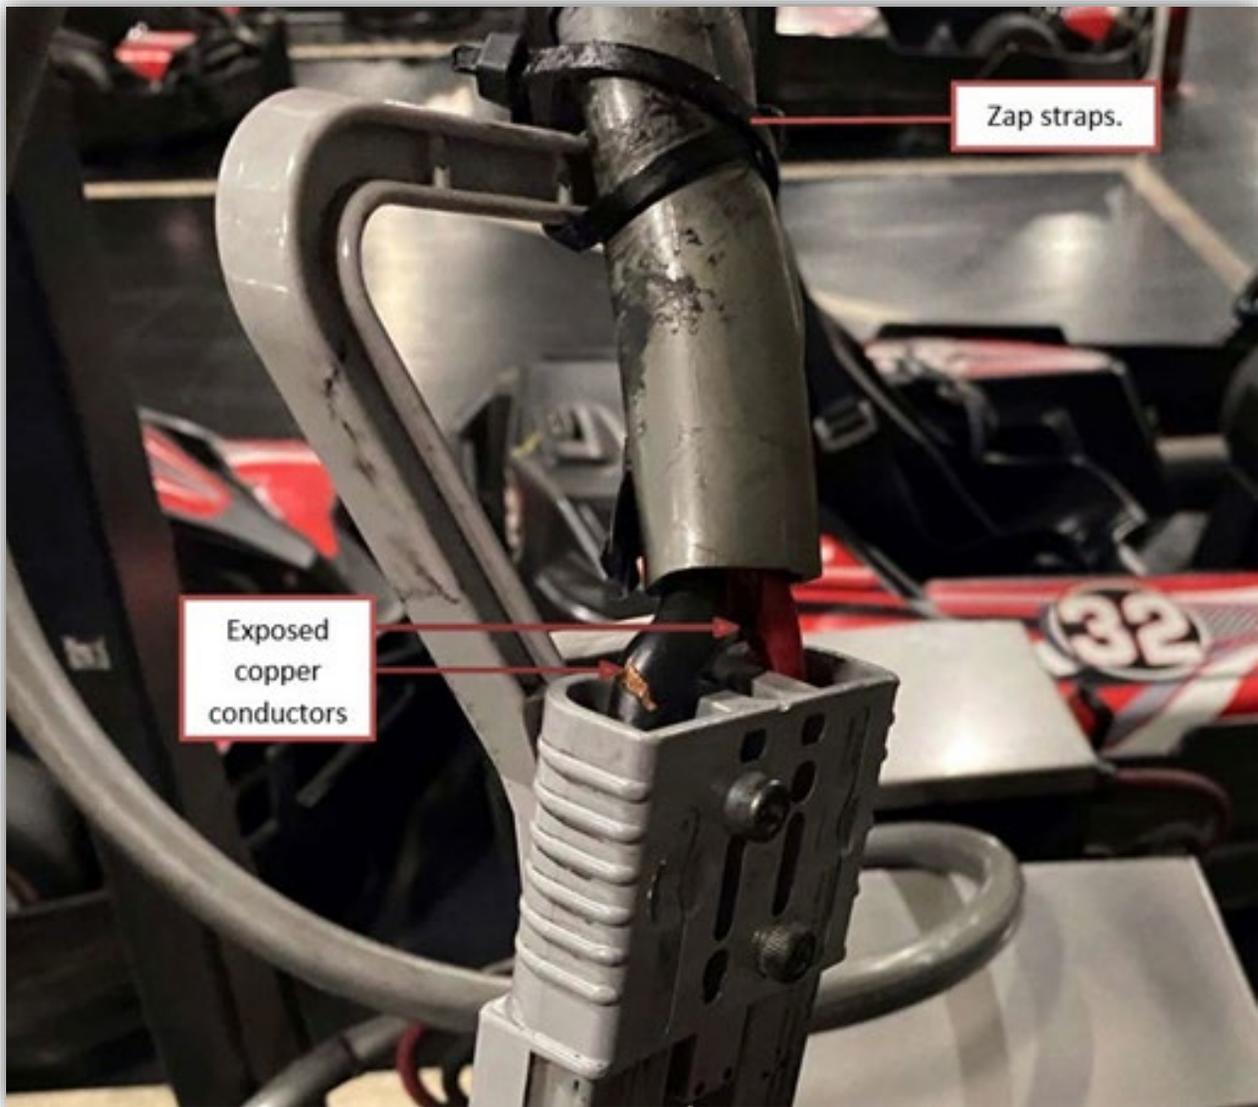
<p>Causes and contributing factors</p>	<p>Years of repetitive motion to the charging cable against the plastic female end has caused the insulation of the copper cable to split open and expose the copper conductor. While picking up the cable and cord end, the workers right-hand contacted both conductors thus closing the circuit.</p> <p>The likely cause of the electrical shock incident was damage to the charging cable at the female end with years of little or no maintenance.</p>

Image 3 - Visible female cord end with handle. Zap straps installed for stability. Exposed copper wire.

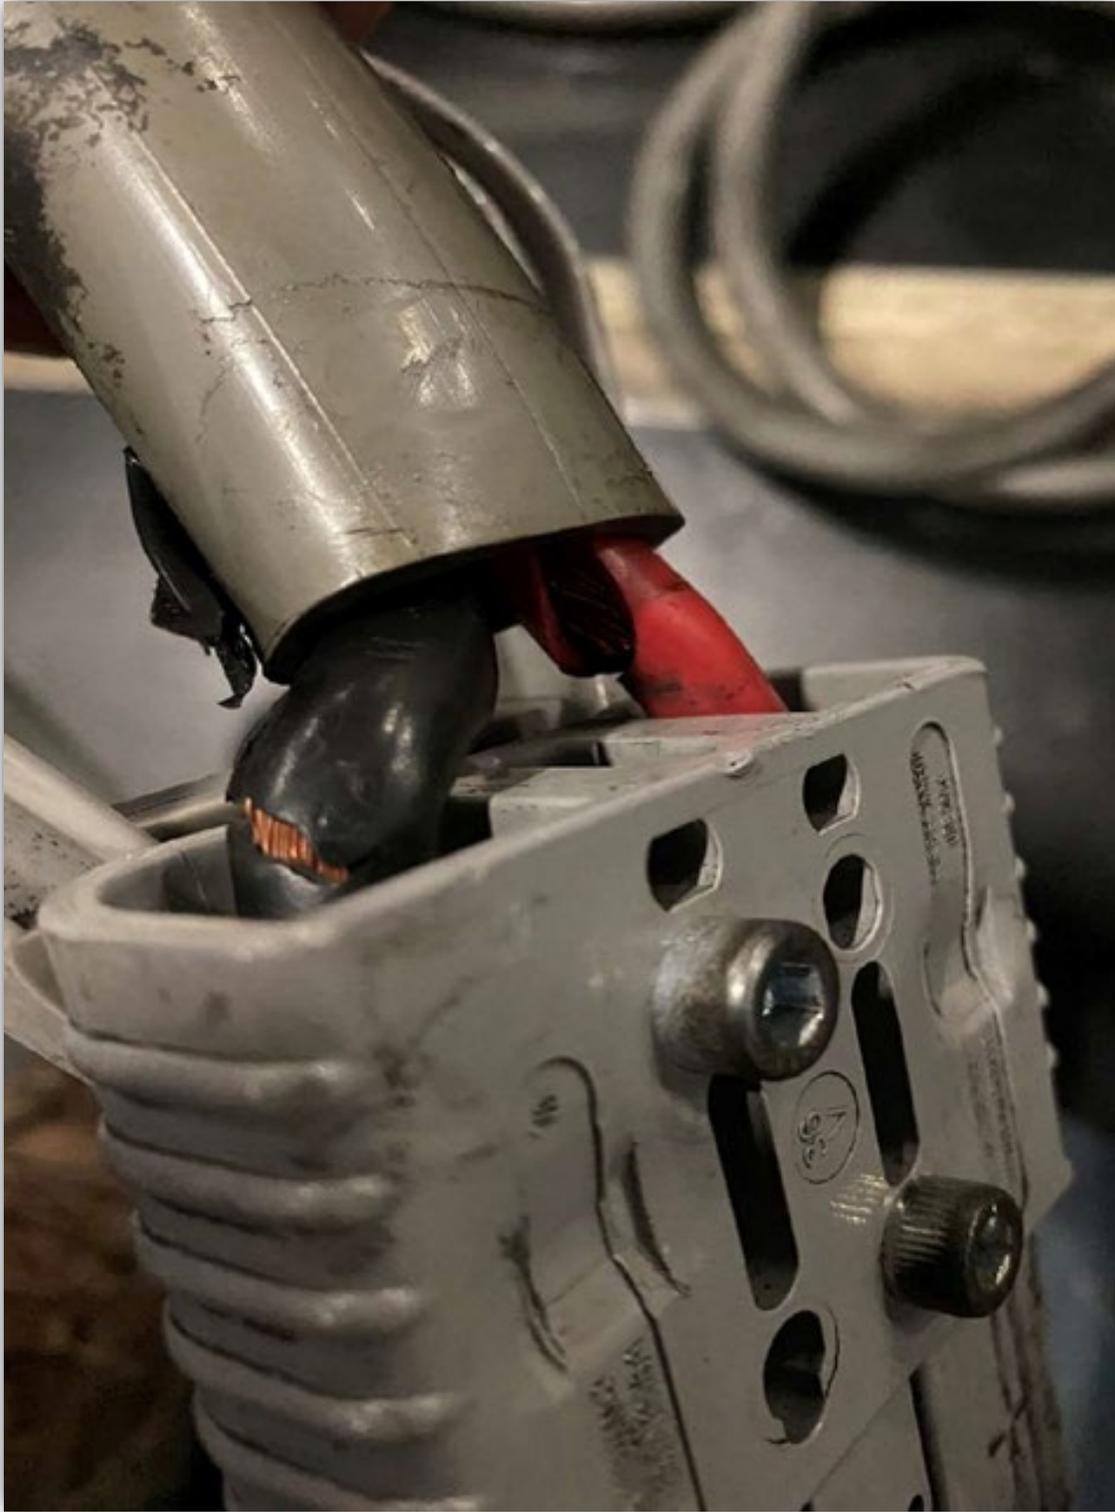
Image 4 - Close view of exposed copper wire.
