Incident Summary #II-1748998-2024 (#50512) (FINAL)

Incident Date		August 16, 2024
SUPPORTING INFORMATION	Location		Hope, BC
	Regulated industry sector		Electrical - Low voltage electrical system (30V to 1000V)
		Qty injuries	1
	Injury	Injury description	Minor scrapes and abrasions.
	<u>ਰ</u>	Injury rating	Insignificant
	Impact Damage	Damage description	Arc flash burn marks to the vehicle, complete destruction of the electric vehicle charger adaptor. Damage to the charging cable and internal components of the commercial electrical vehicle charger.
	ă 	Damage rating	Major
	Incident rating		Major
	Incident overview		While charging a Tesla EV at a non-Tesla commercial electric vehicle charger, a short circuit between the charging cable of the charger and an after-market charging adaptor resulted in an arc-flash.
INVESTIGATION CONCLUSIONS	Site, system and components		Commercial electric vehicle (EV) charging stations are available for public use at select locations such as gas stations, shopping malls and in other locations. In North America there are three primary styles of charging plugs and sockets depending on vehicle manufacture and charging station output. AC charging stations ty

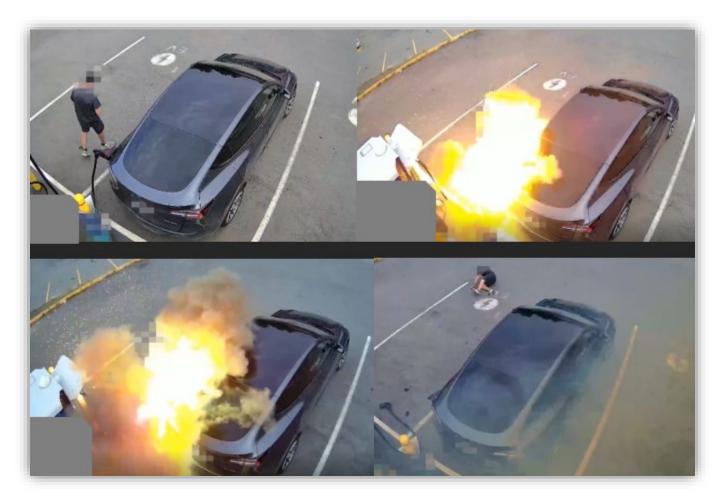
Failure scenario(s)	They had used the adapter to charge the vehicle several times in the past without any previous issues. They stopped at a non-Tesla 200kW max DC fast charging station and connected the charger to their vehicle with the adapter. Using an application on their phone, they initiated the charger. The owner was standing next to the charging port, and a passenger was inside the vehicle. During initial startup of the charger a DC arc-fault occurred in the adapter creating a large arc-flash which knocked the owner to the ground, blew apart the adapter, and caused heat and burning damage to the vehicle, charging cable, connector and internal components of the commercial electrical vehicle charger.
		Video: Uncertified EV Adapter Use with Tesla Causes Explosion
		 Vehicle owner statement: They had used the adaptor was approximately 50 times without incident. They plugged in the charger to the car with the adapter and initiated the charger from their phone. As they were walking away from the charging port, they saw a bright flash and heard a loud bang and were knocked to the ground. Their spouse was in the passage seat of the car at the time.

Image 1 – Stills take from security camera footage of the incident.

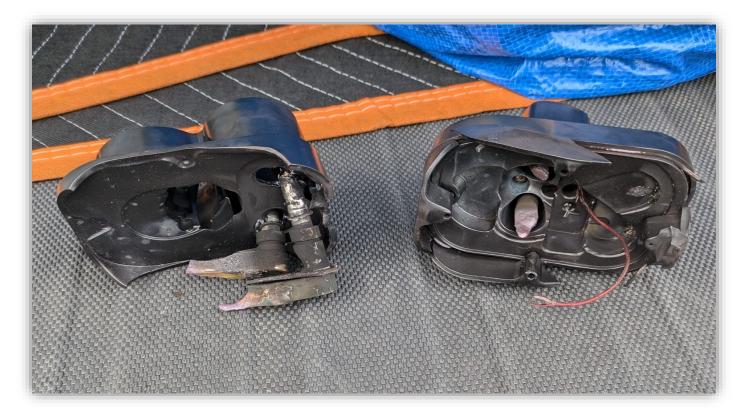
Facts and evidence	 Technician Statement: The failure occurred between the adaptor and the EV charger charging cable. The adaptor was blown in half, significantly melted and damaged. A short circuit appears to be between terminals and communication cable in the adaptor. Multiple components in the EV charger were observed to have electrical burn damage.

- Analysis of the damaged components lead them to believe that when the charger started the isolation test, the contactors on the vehicle were closed and the station was open for the isolation test. Even with the low power flowing through it was able to start to generate enough heat via resistance in the DC pins on the CCS adapter to allow them to start to deform. This could have led to the buss bars beginning to deform and become closer together. When the station ramped up to pack voltage for the isolation test (which we don't have the data for but know that it must have got there) the short occurred to ground and was able to transfer full pack isolation voltage via the GND pin back to the station.

A short circuit in the caused an arc-fault and arc-flash in the adapter damaging electrical components and injuring the owner. It could not be determined if the initial short circuit originated in the charger or the adapter due to damage from the incident.

Image 2 - Adaptor blown in half with terminals showing signs of extreme heat.

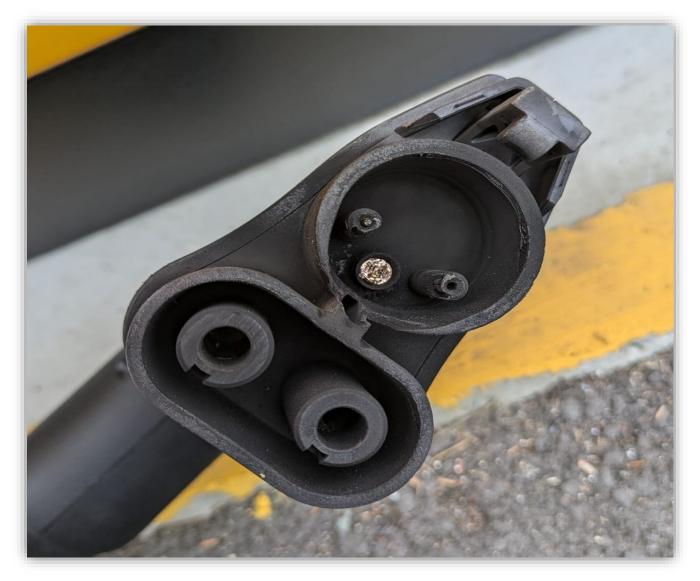
- Significant scorching was observed at the charging port of the EV.
- The terminal of the EV charger cable and the adaptor show signs of melting.
- The circuit board in the EV charger is severely burned.
- There were multiple burned components inside the EV charging station.
- Photos of the adaptor show severe damage.
- Security footage showed a large flash, knocking the EV owner to the ground.
- There were no signs of damage to vehicle terminals.
- The adaptor was not approved for use in Canada.

Image 3 - The ground terminal on the charging cable melted away.

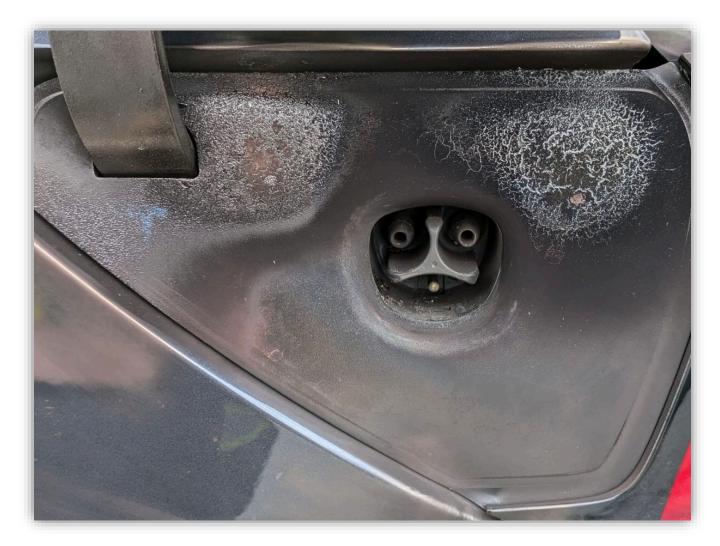
Image 4 - Electrical burn marks on the vehicle but charging terminals show little sign of damage.

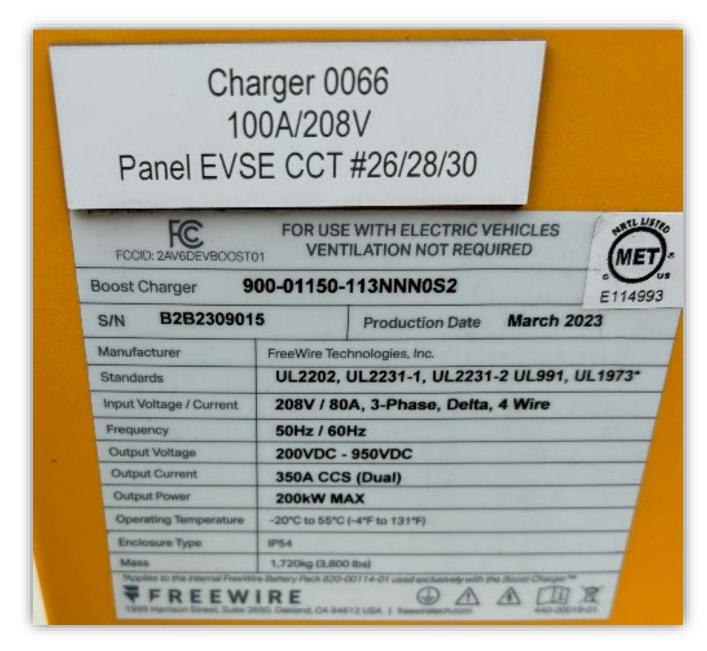
Image 5 – Data tag for the charging station showing 200kW maw power output.
