## Incident Summary #II-1748998-2024 (#50512) (FINAL)

| | Regulated industry sector | | Electrical - Low voltage electrical system (30V to 1000V) | |
| Incident overview | | While charging a Tesla EV at a non-Tesla commercial electric vehicle charger, a short circuit between the charging cable of the charger and an after-market charging adaptor resulted in an arc-flash. | | |

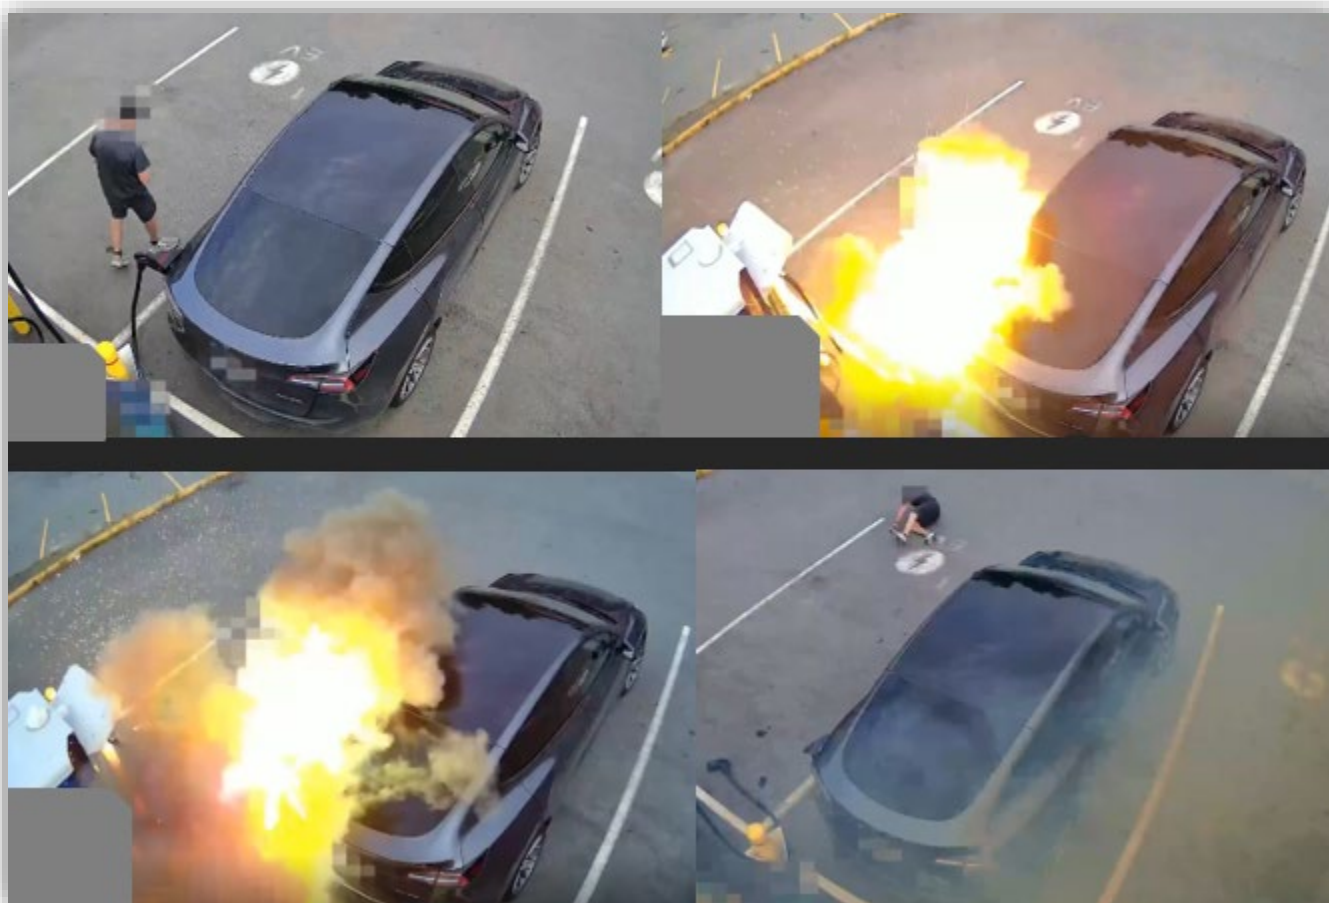
Image 1 – Stills taken from security camera footage of the incident.

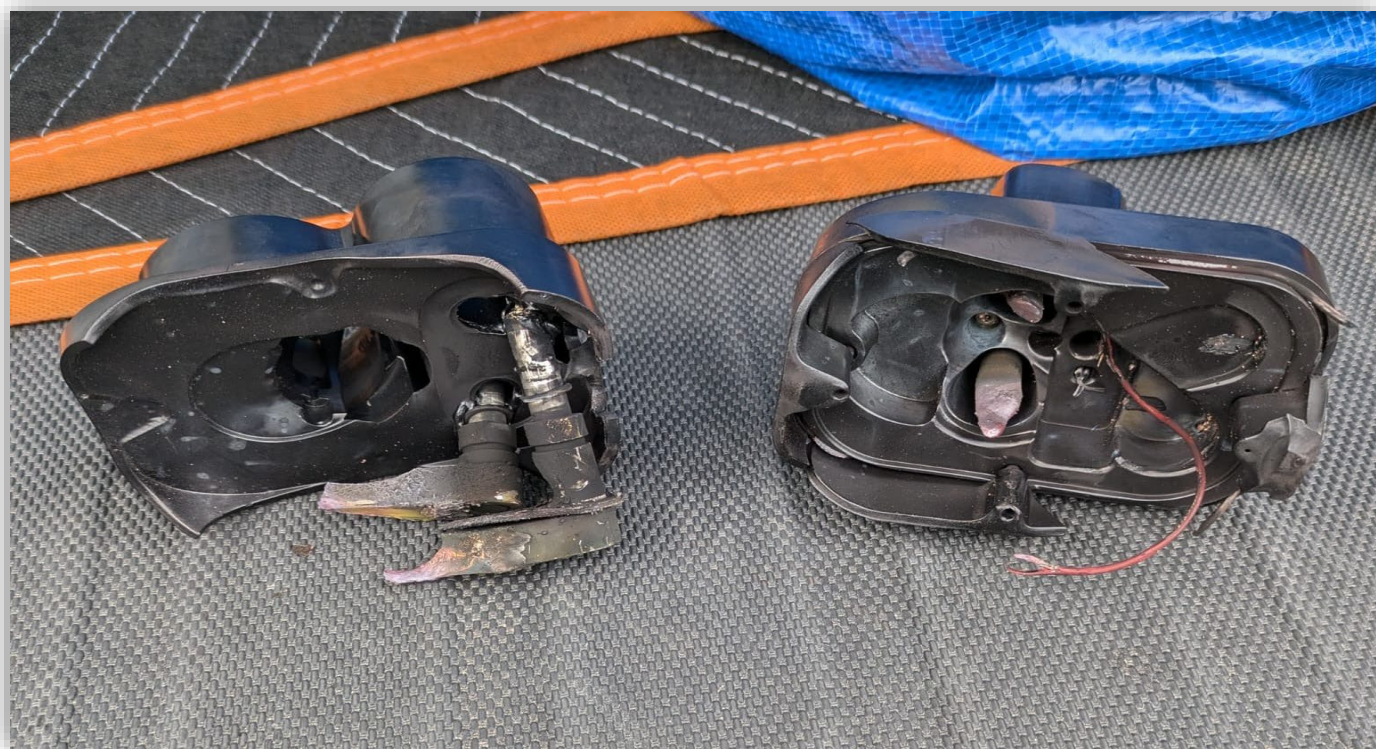
A short circuit in a battery module occurred in the charger resulting in abnormal voltage being sent through the charger adapter. Subsequently the charger adapter experienced an internal arc fault and explosion which damaged the adapter and vehicle.

Image 2 - Adaptor blown in half with terminals showing signs of extreme heat.

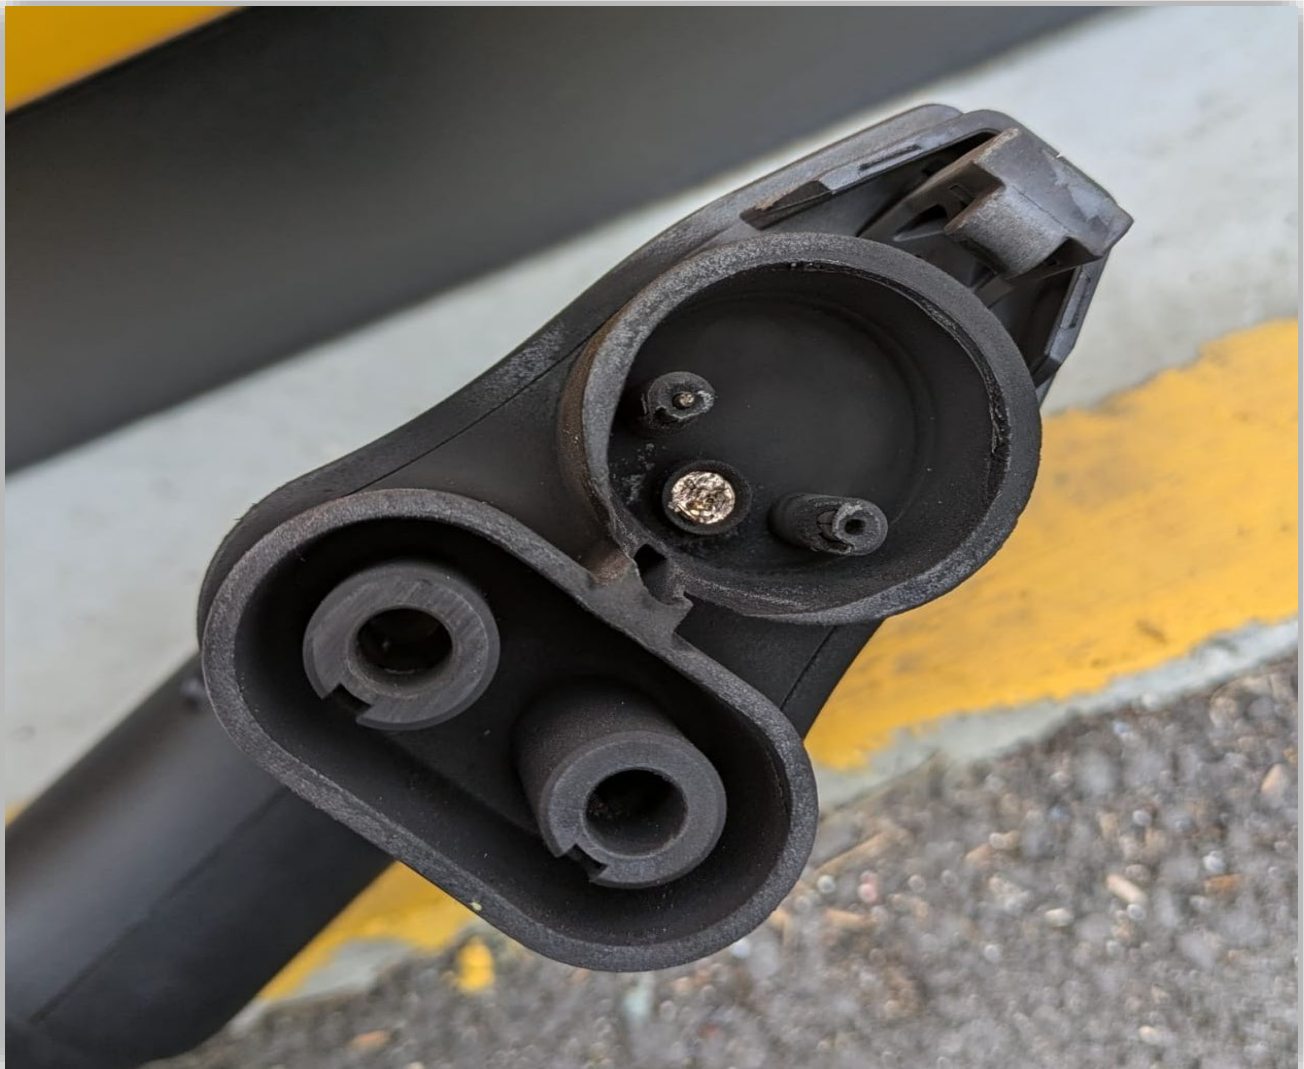
Image 3 - The ground terminal on the charging cable melted away.

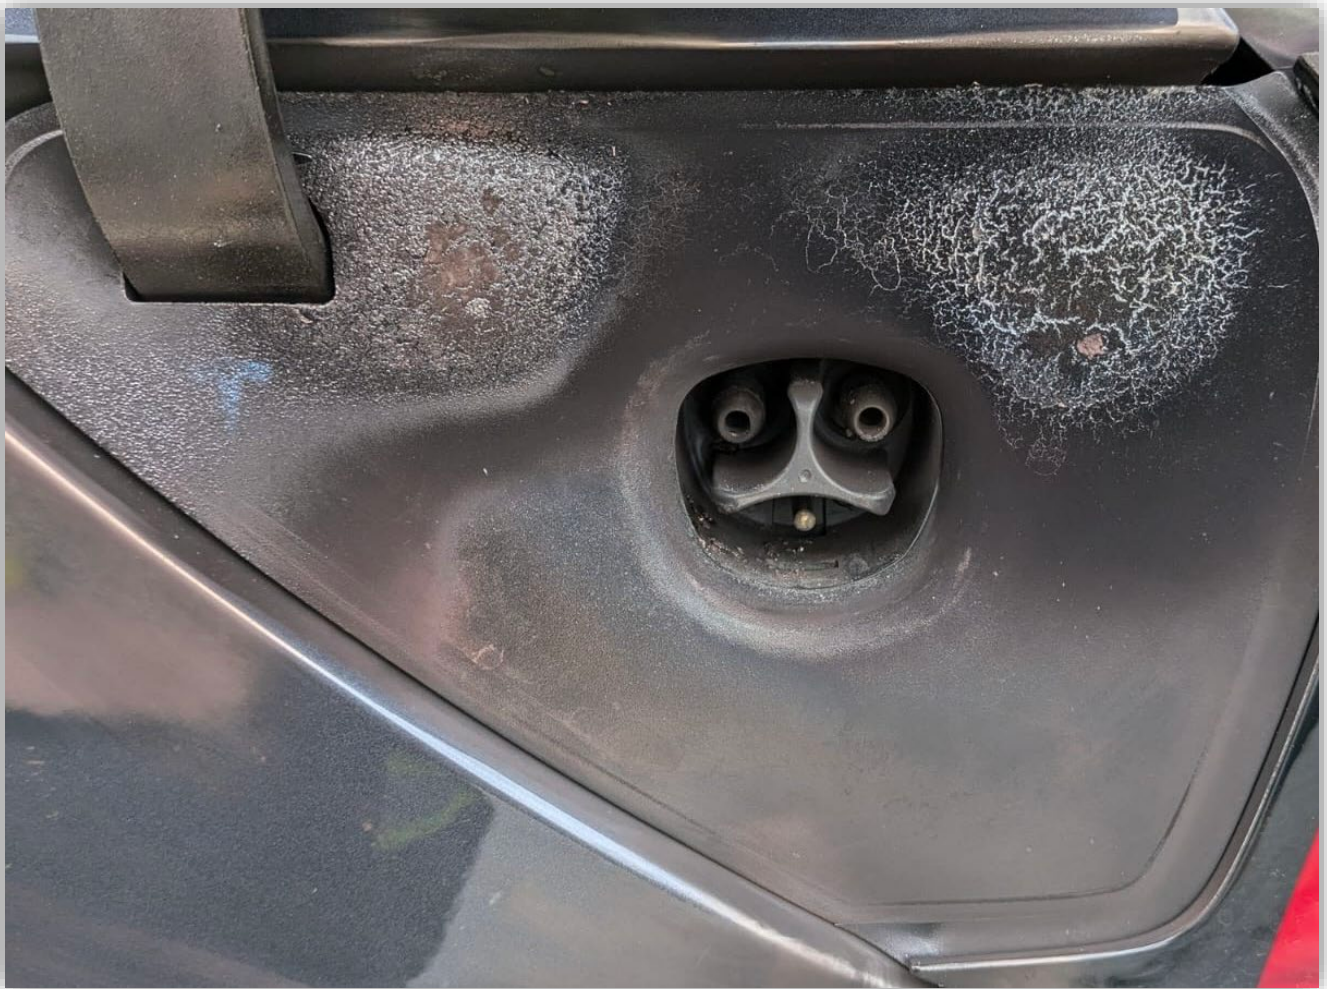
Image 4 - Electrical burn marks on the vehicle but charging terminals show little sign of damage.

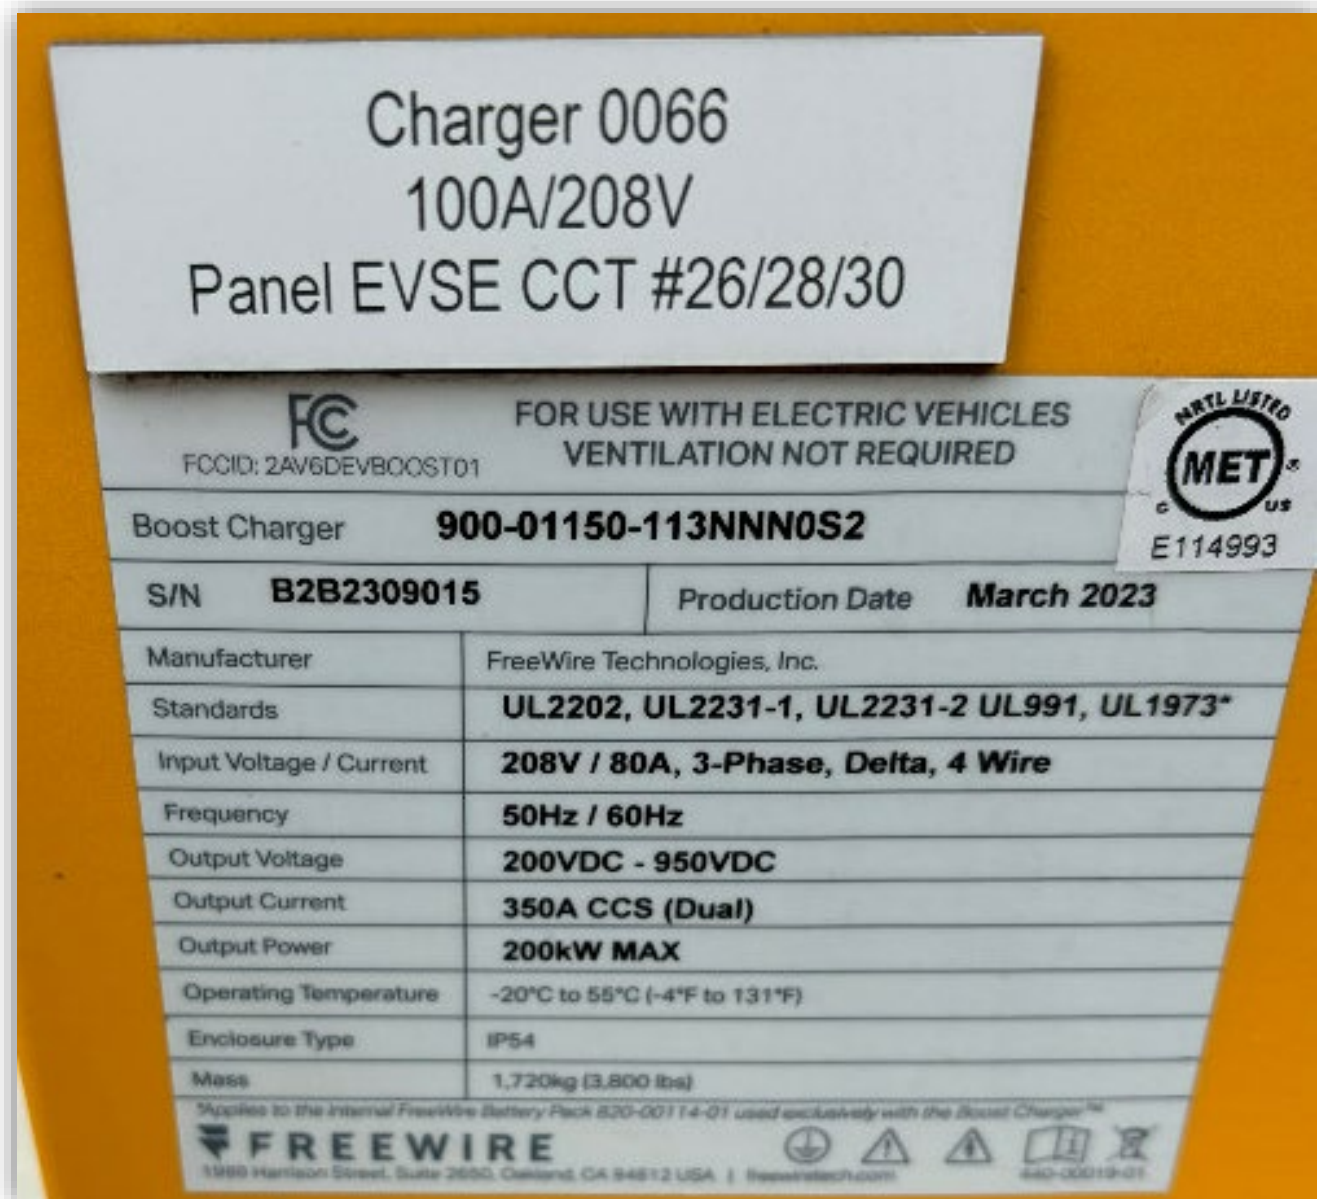
Image 5 – Data tag for the charging station showing 200kW max power output.
