Incident Summary #II-1875297-2025 (#56698) (FINAL)

SUPPORTING INFORMATION	Incident Date	February 27, 2025
	Location	Prince George
	Regulated industry sector	Gas - Natural gas system
	Injury Qty injuries	0
	Injury description	N/A
	Impact Injury rating	None
	Damage Damage description	Three out of four lower burner wind boxes were fire damaged, requiring partial replacement.
	Damage rating	Moderate
	Incident rating	Moderate
	Incident overview	Three out of four hearth burner wind boxes on a recovery boiler were damaged by fire. The natural gas fired hearth burners were operated in a retracted position within their respective wind boxes. Two wind box casings had holes burnt through them and a third sustained minor fire damage.
INVESTIGATION CONCLUSIONS	The industrial facility utilizes the Kraft pulp manufacturing process featuring a recovery boiler, and a high-pressure steam boiler that generates heat through black liquor combustion. The boiler's furnace produces smelt by fusing inorganic compounds from the black liquor, primarily sodium carbonate and sodium sulfide.

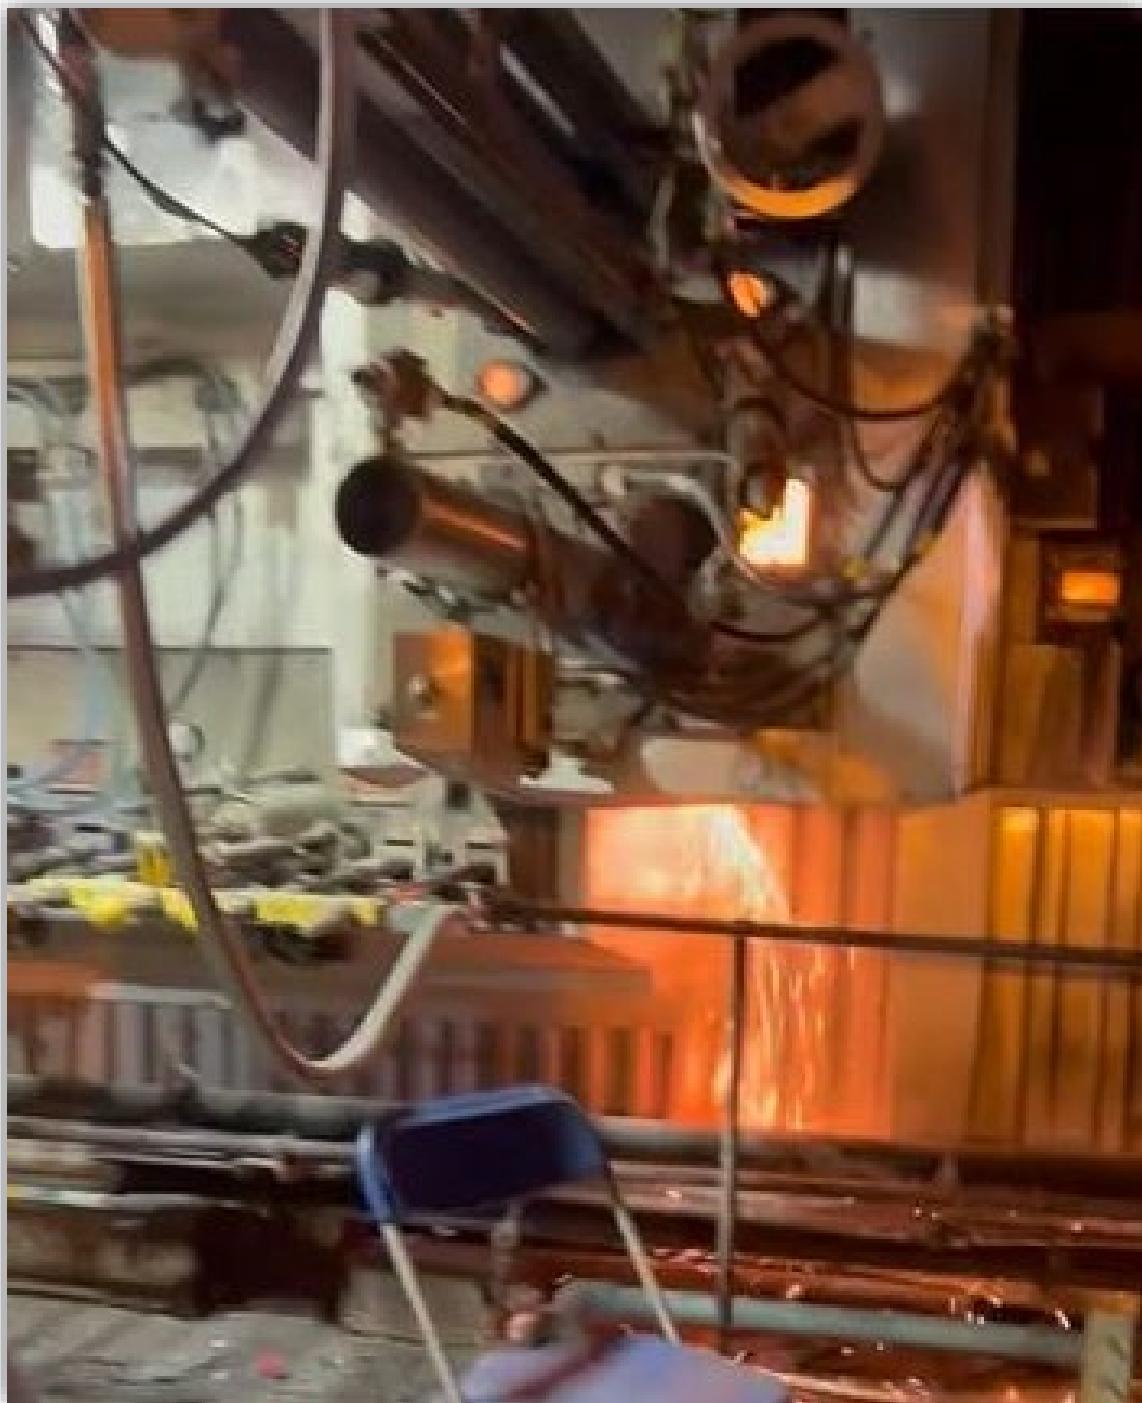
Causes and contributing factors	<p>The incident occurred when flames impinged on the wind boxes, leading to fire damage.</p> <p>Contributing factors to the incident include:</p> <ul style="list-style-type: none"> • The burners were left in a partially retracted position with limit switches overridden, allowing gas to flow while the burners were not fully deployed. • Inadequate operator training. • Procedural gaps and cultural normalization of bypassing safety limits.

Image 1 - Flames exiting hearth burner wind box through melted hole.

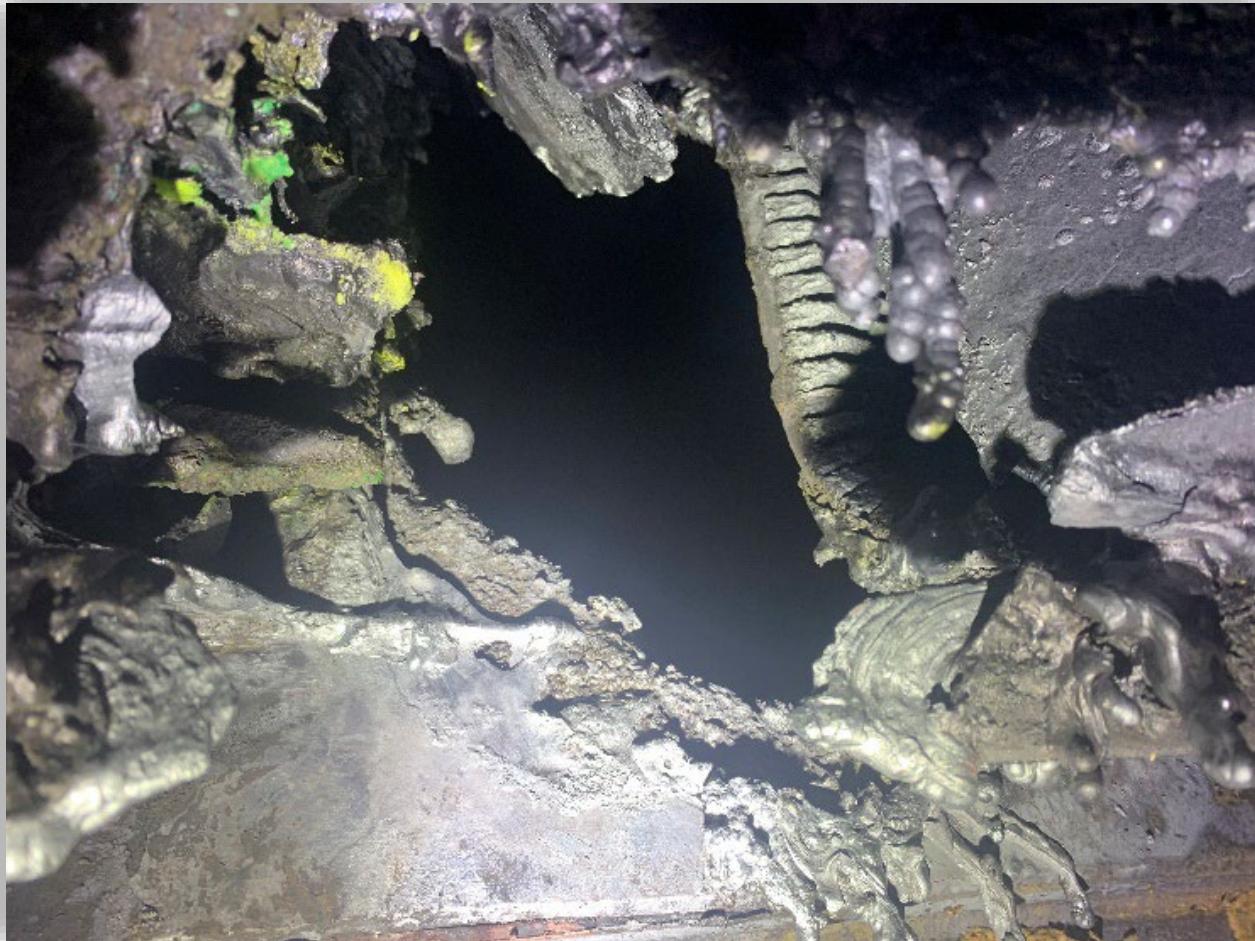
Image 2 – Melted hole in hearth burner wind box.

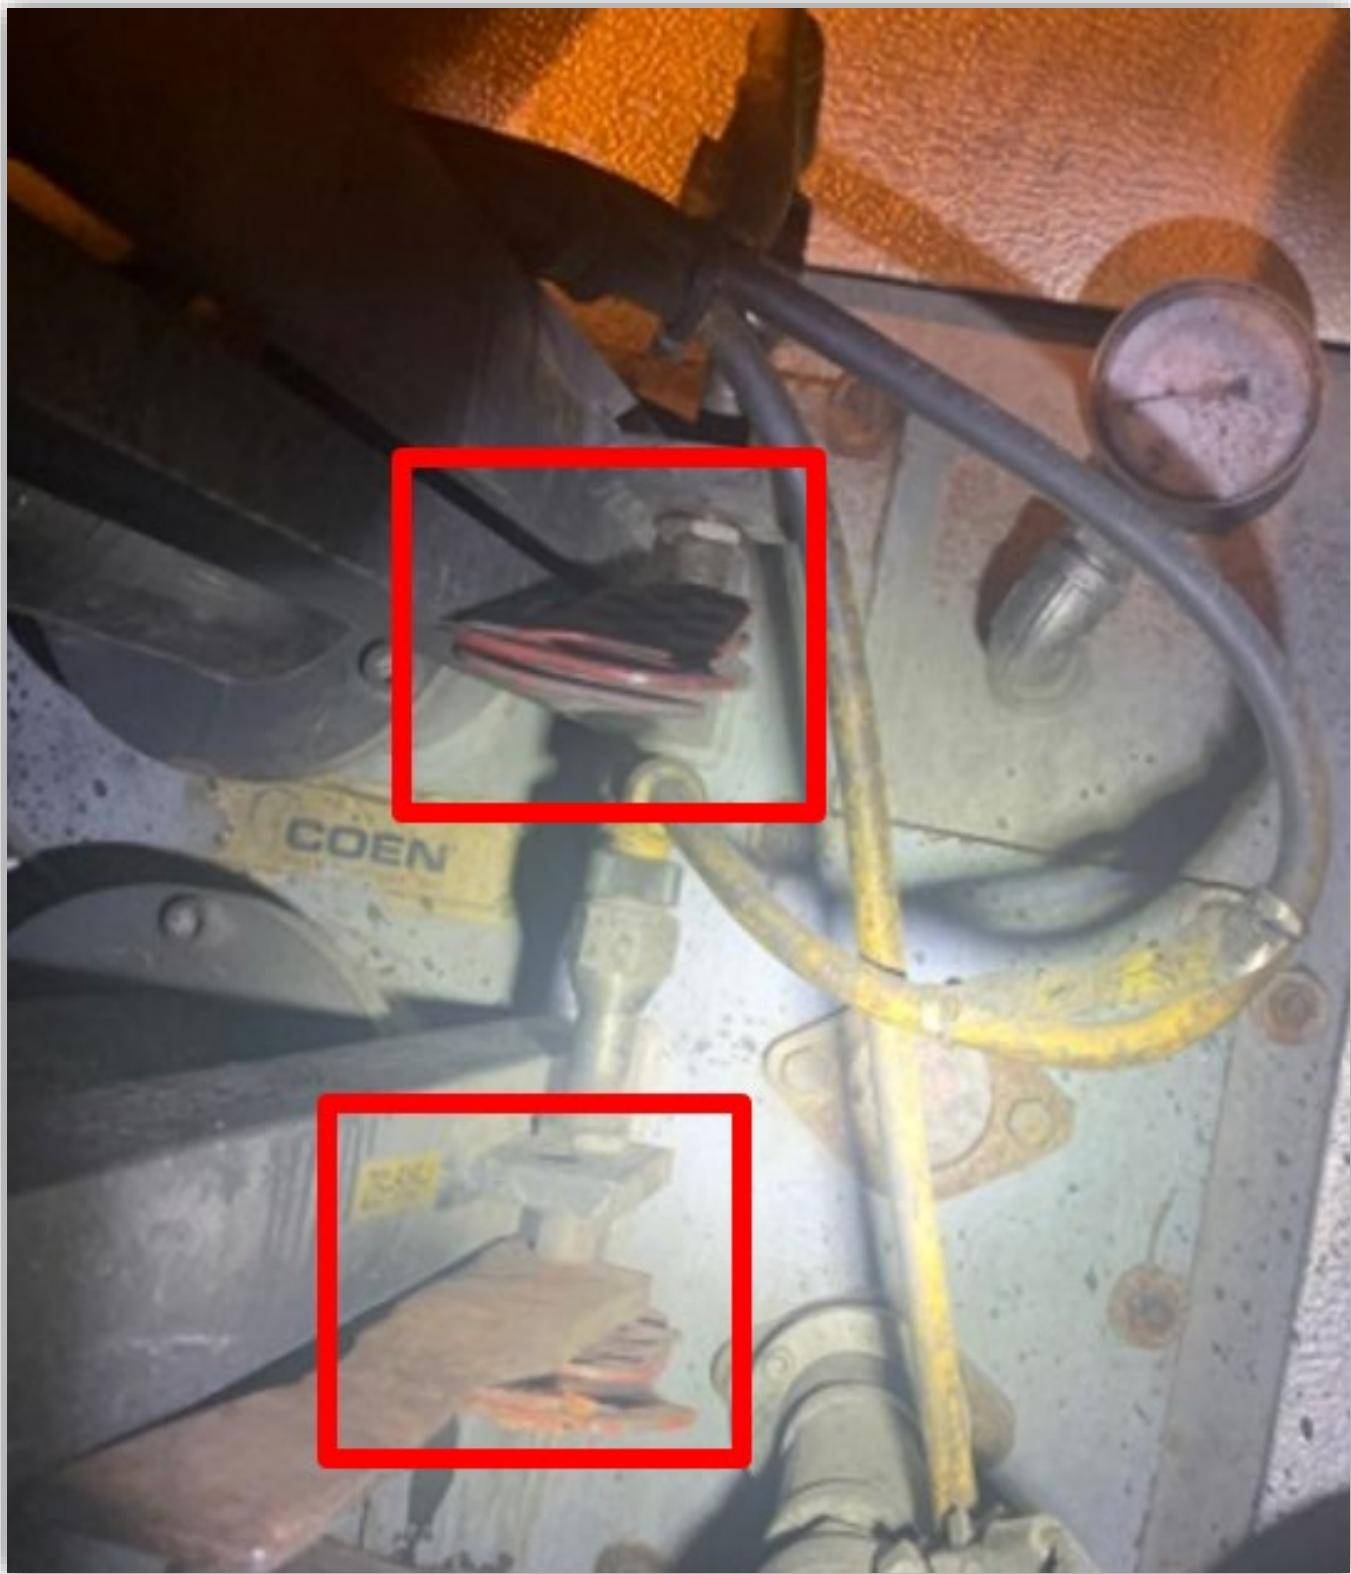
Failure scenario(s)	<p>High draft turbulence at the inserted burners made lighting the pilot flame difficult. To reduce air turbulence and achieve a stable pilot flame, Operators used metal clamps/shims to override the insertion limit switches, allowing burners to operate while partially or fully retracted. With the insert limit bypassed the main burner could be fired in the retracted position if an operator neglected to re-insert the burner.</p> <p>The operator assumed the burners were functioning correctly based on panel lights rather than verifying physical insertion. Three hearth burners were not fully inserted during ignition, leaving flames concentrated in the wind box instead of the furnace.</p>
Facts and evidence	<p>Metal shims and lockout scissors were found inserted in limit switches shortly after the incident. Fire damage patterns showed scorching/warping inside the wind box.</p> <p>Operator testimonials reported:</p> <ul style="list-style-type: none"> • Turbulent airflow in wind box made ignition difficult; retraction was a "necessary workaround." Operators reduce airflow by closing dampers, but the ID fan cannot be lowered enough without tripping. • A standard operating procedure for starting the burners was in place but operators did not adhere to it due to difficulties lighting the burners. Some operators had not received refresher training in years. • Peer to peer mentoring was the primary form of training and included bypassing the limits. <i>"Everyone did this for years—we just wanted to keep running".</i> • On the day of the incident, the operator stated that he relied on the panel's green lights indicating proper burner function. He did not visually verify the physical insertion of the burners, assuming the system was functioning correctly.

Image 3 – Shims used to bypass the safety limit switches.

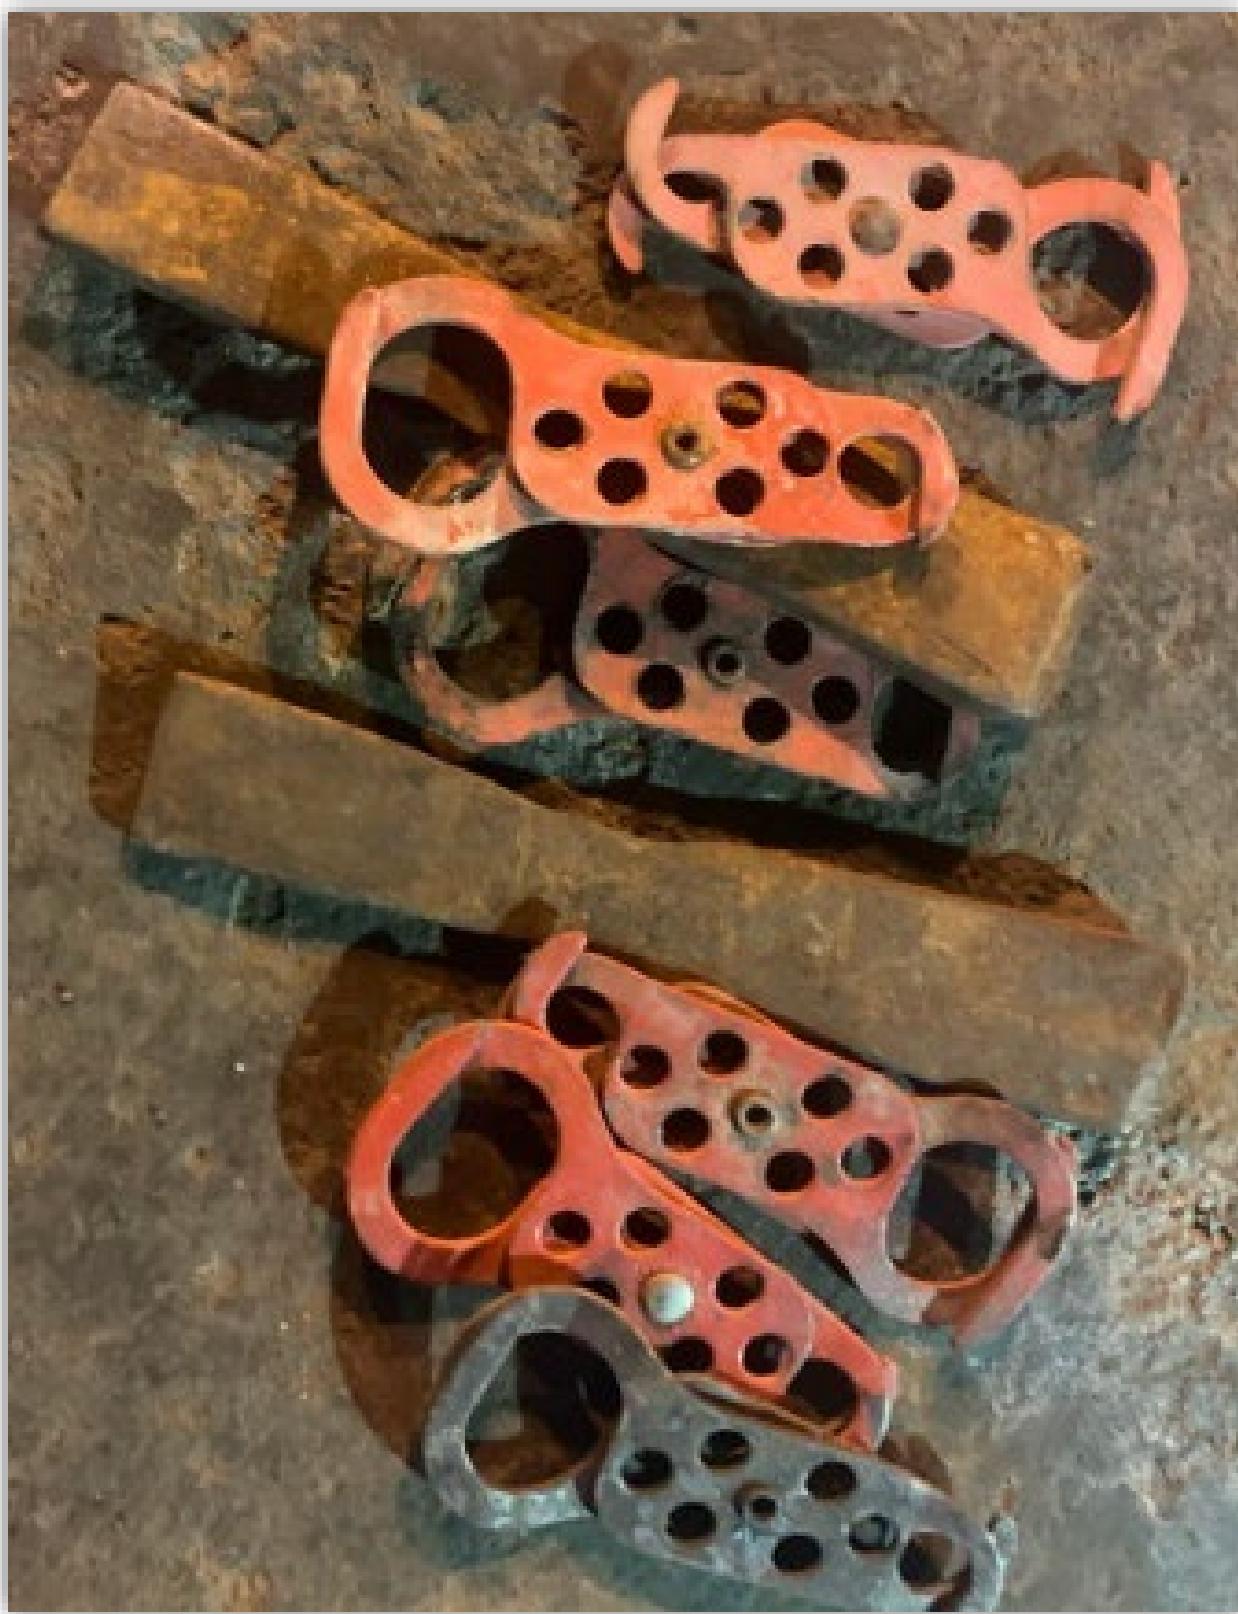
Image 4 – Shims removed from limit switches.

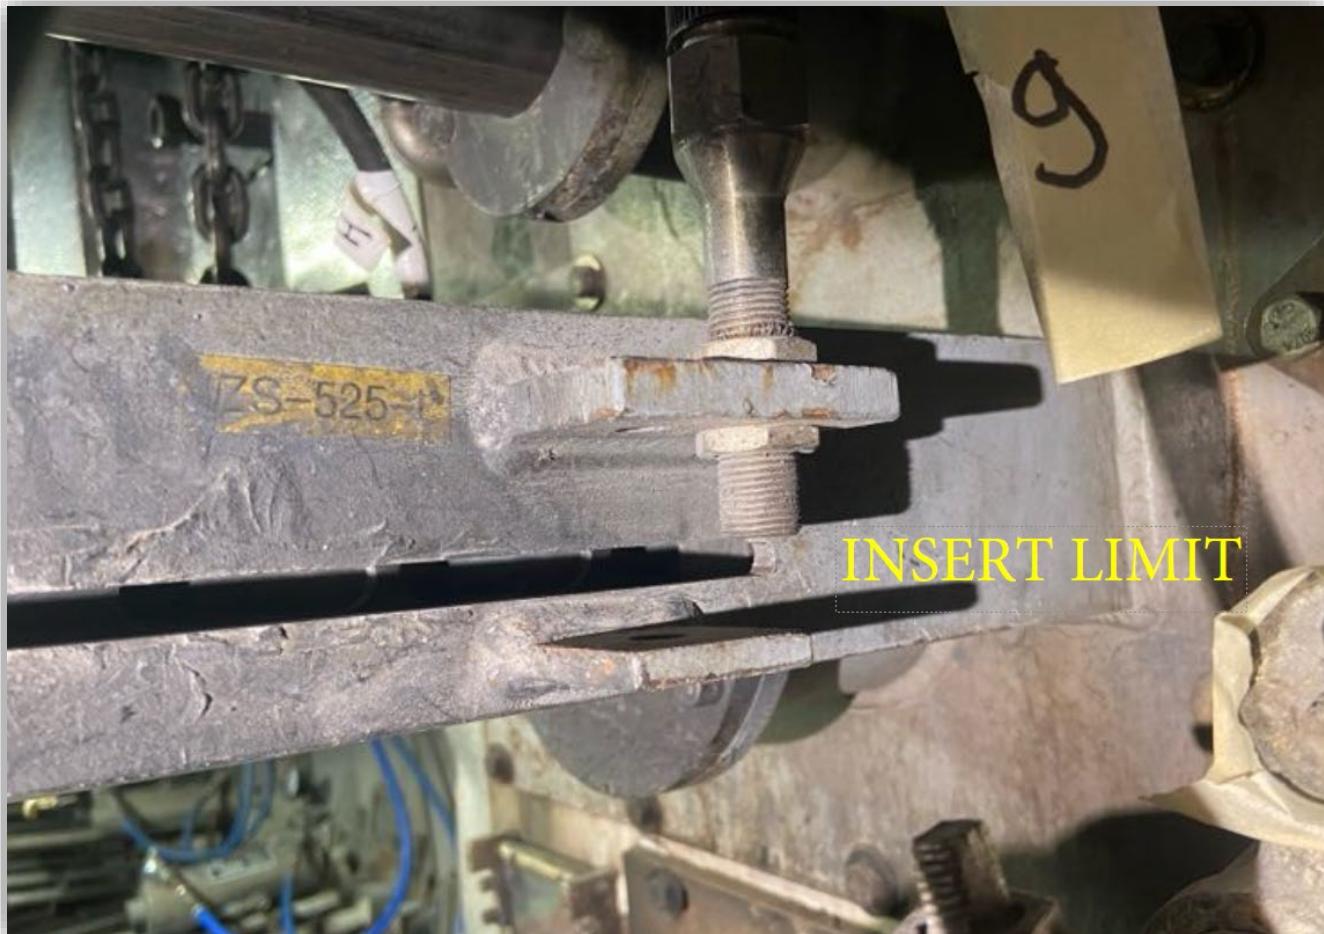
Image 5 – Limit switch without shims.
