## Incident Summary #II-980960-2020 (#16635) (FINAL)

| | Regulated industry sector | | Elevating Devices – B44 Freight Hydraulic |
| Incident overview | | An outdoor freight elevator with steel wire enclosure has corrosion throughout. One panel of the enclosure had multiple broken brackets leaving the panel only supported on one side. Access into the hoistway created through the compromised panel being movable. | |

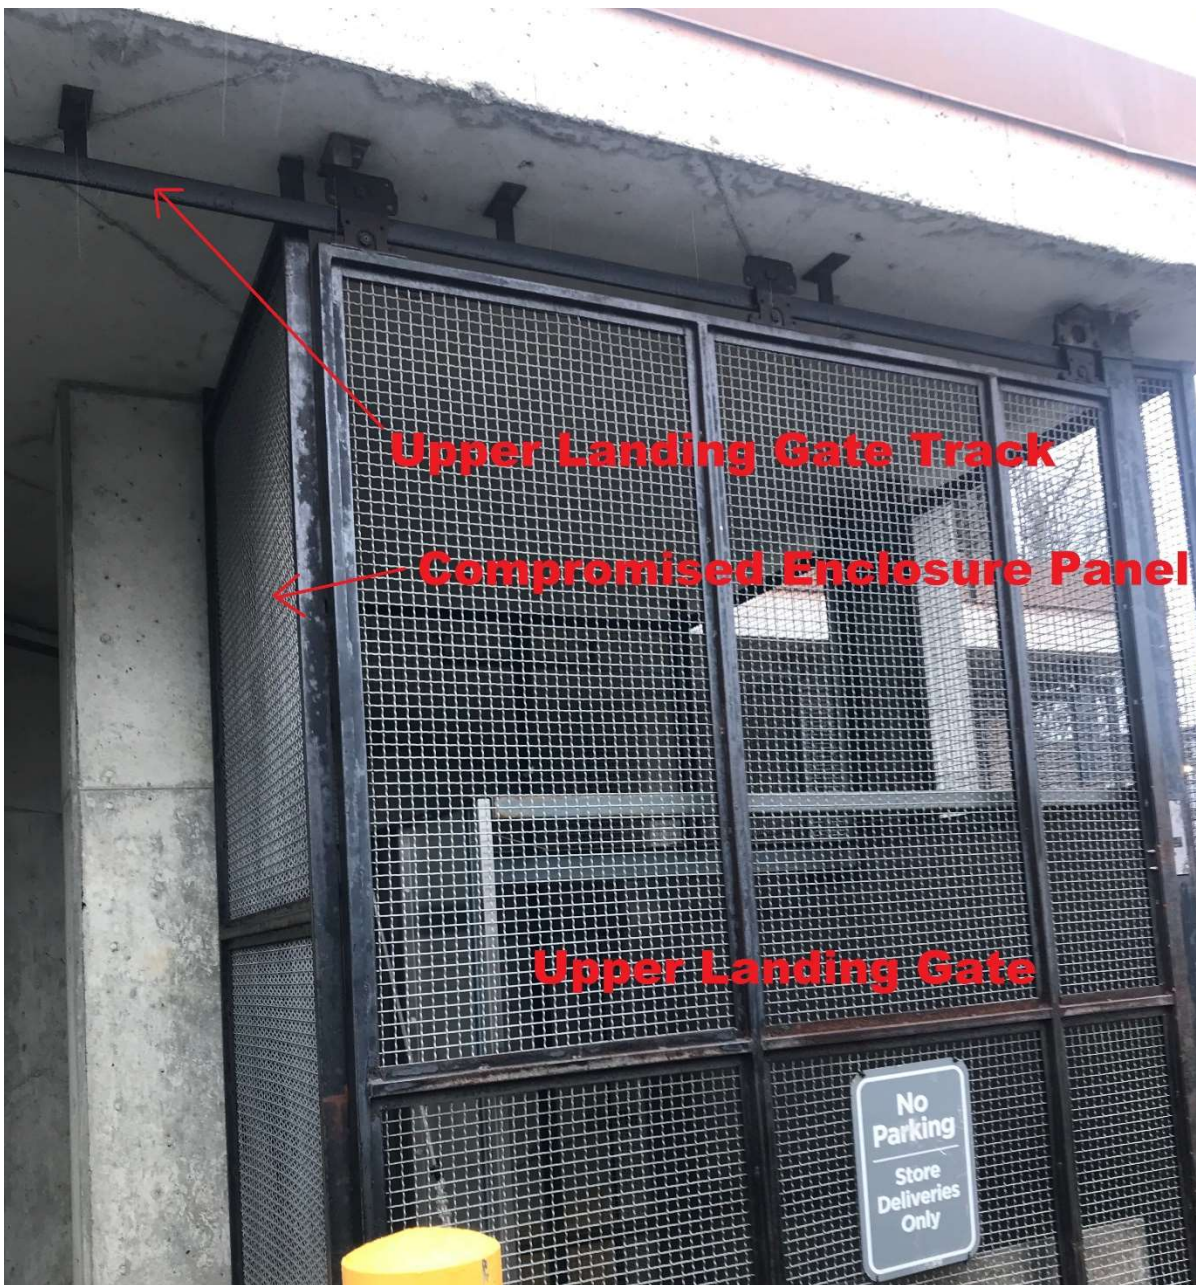
| Failure scenario(s) | <p>The top landing gate being struck by pallets of delivered goods caused the gate to become bowed over time, which reduced the clearance of the gate to the adjacent rigid enclosure panel. When the gate is opened the reduced clearance caused the gate to strike the adjacent panel. Corrosion of the enclosure and steel brackets combined with the repeated impacts caused the adjacent rigid panel to have its brackets break, leaving only one side of the panel being supported.</p> |

Photo 1 – Upper landing gate with roller guide track and damaged enclosure panel

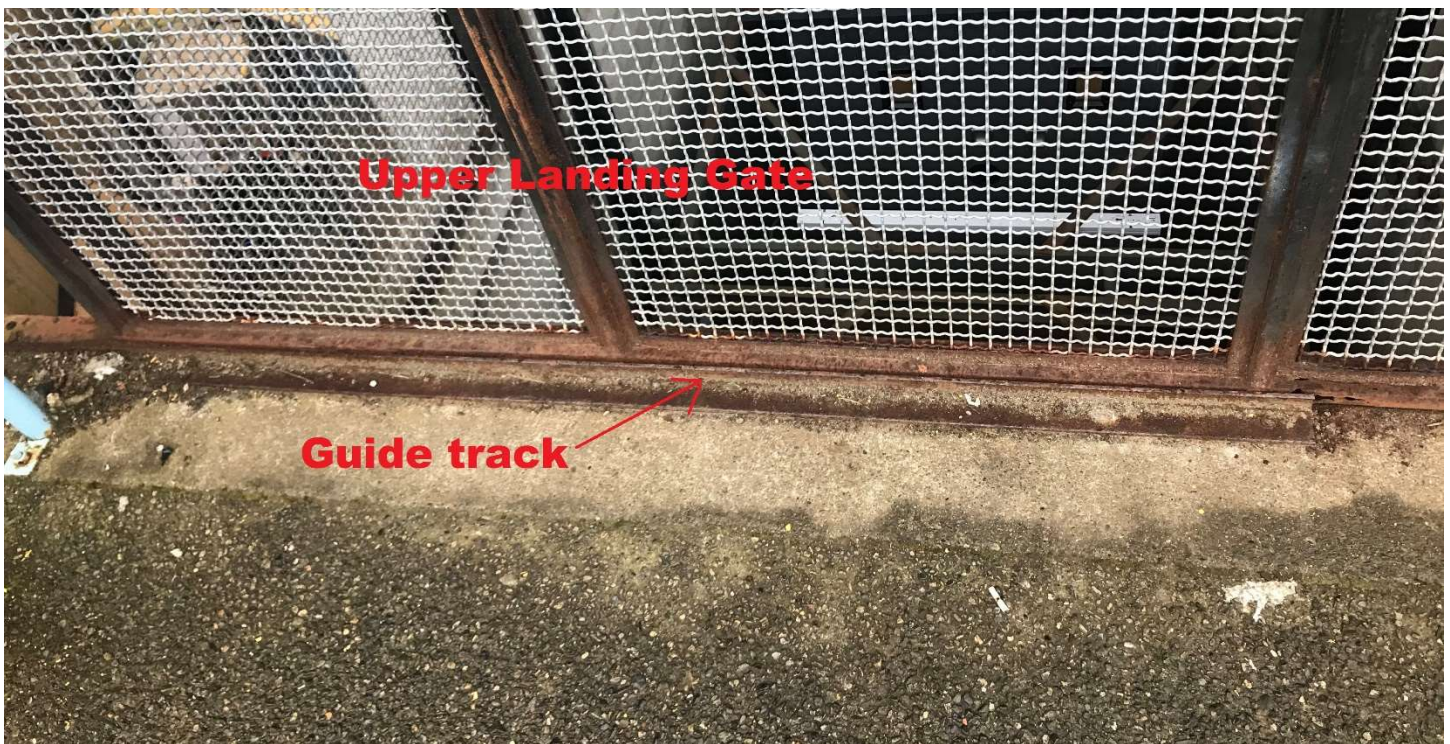
Photo 2 – Bottom of upper landing gate

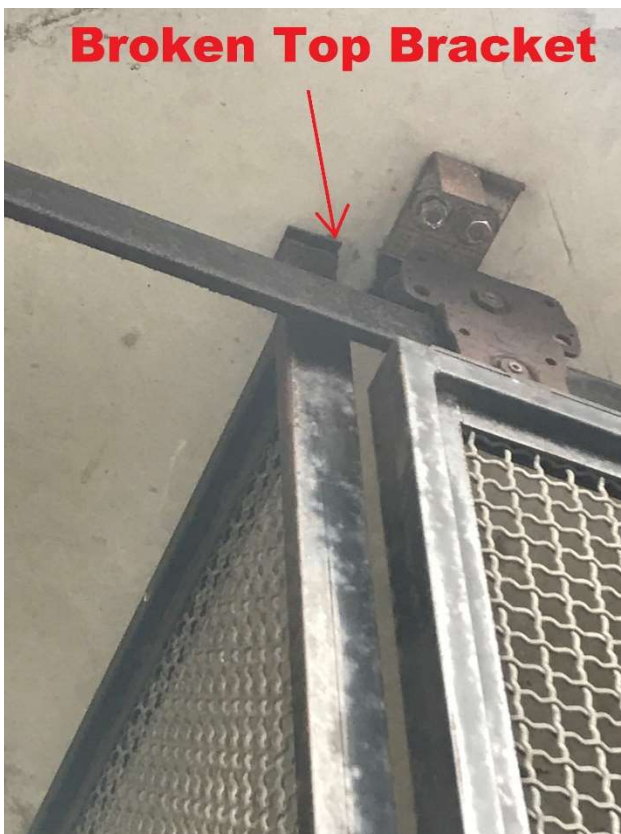
Photo 3 – Broken top bracket of compromised enclosure panel

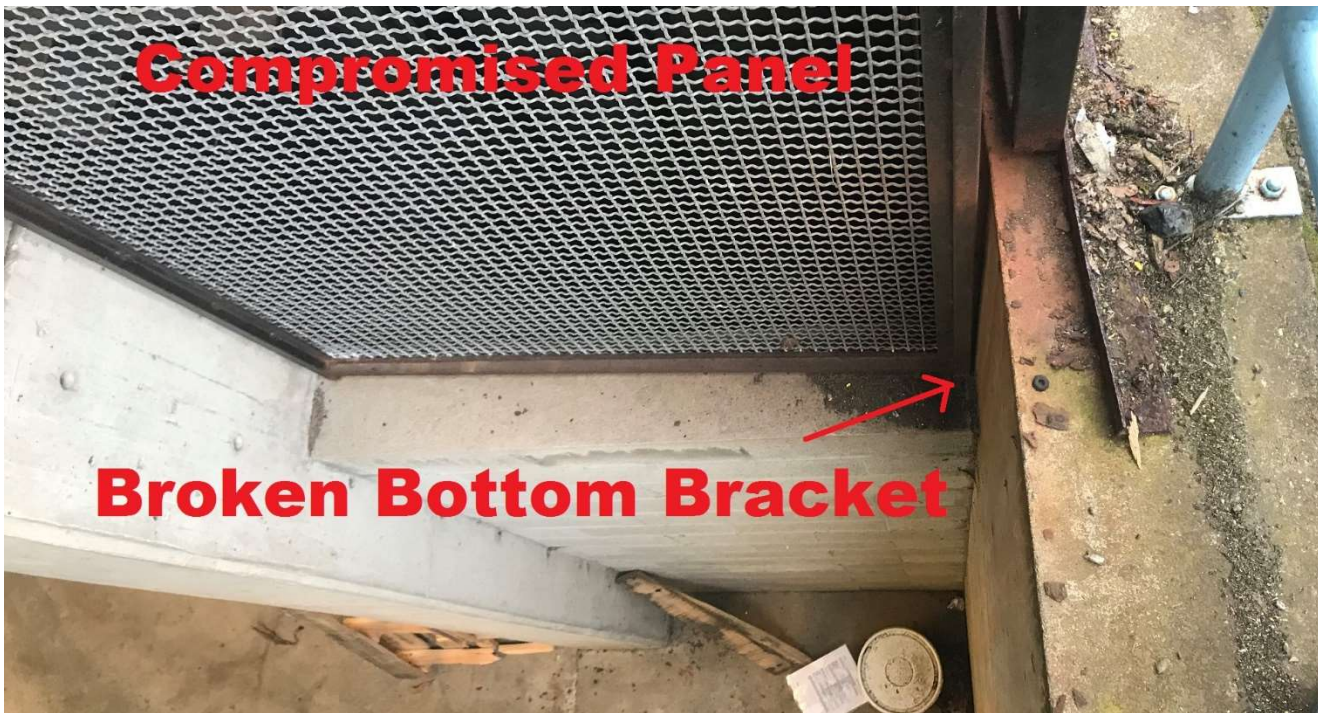
Photo 4 – Broken bottom bracket of compromised enclosure panel
