## Incident Summary #II-717029-2018 (#7943) (FINAL)

SUPPORTING INFORMATION	Incident Date		June 10, 2018	
	Location		Kelowna, BC	
	Regulated industry sector		Gas - Natural gas system; Boilers, PV, Refrigeration - Boiler and pressure vessel system	
	Impact	Injury	Qty injuries	0
			Injury description	No injuries
			Injury rating	None
	Damage	Damage	Damage description	Fire damage to a hot water boiler combustion chamber and fire damage to integral control circuits located on the boiler.
			Damage rating	Moderate
	Incident rating		Moderate	
Incident overview		A clogged flue chamber created a buildup of unburnt (raw) gas, when ignited caused an internal explosion in the combustion chamber. This caused excessive internal heat and damaged the boiler external control wiring.		
canINVESTIGATION CONCLUSIONS	Site, system and components		A hot water fire tube boiler uses an ignited mixture (premix) of natural gas. This ignition will heat the boiler water for the purpose of maintaining and warming of the piping system for the buildings air temperature. An ignitor is used to ignite these gases within a combustion chamber where a fan blows the heat down internal fire tubes. The equipment uses the

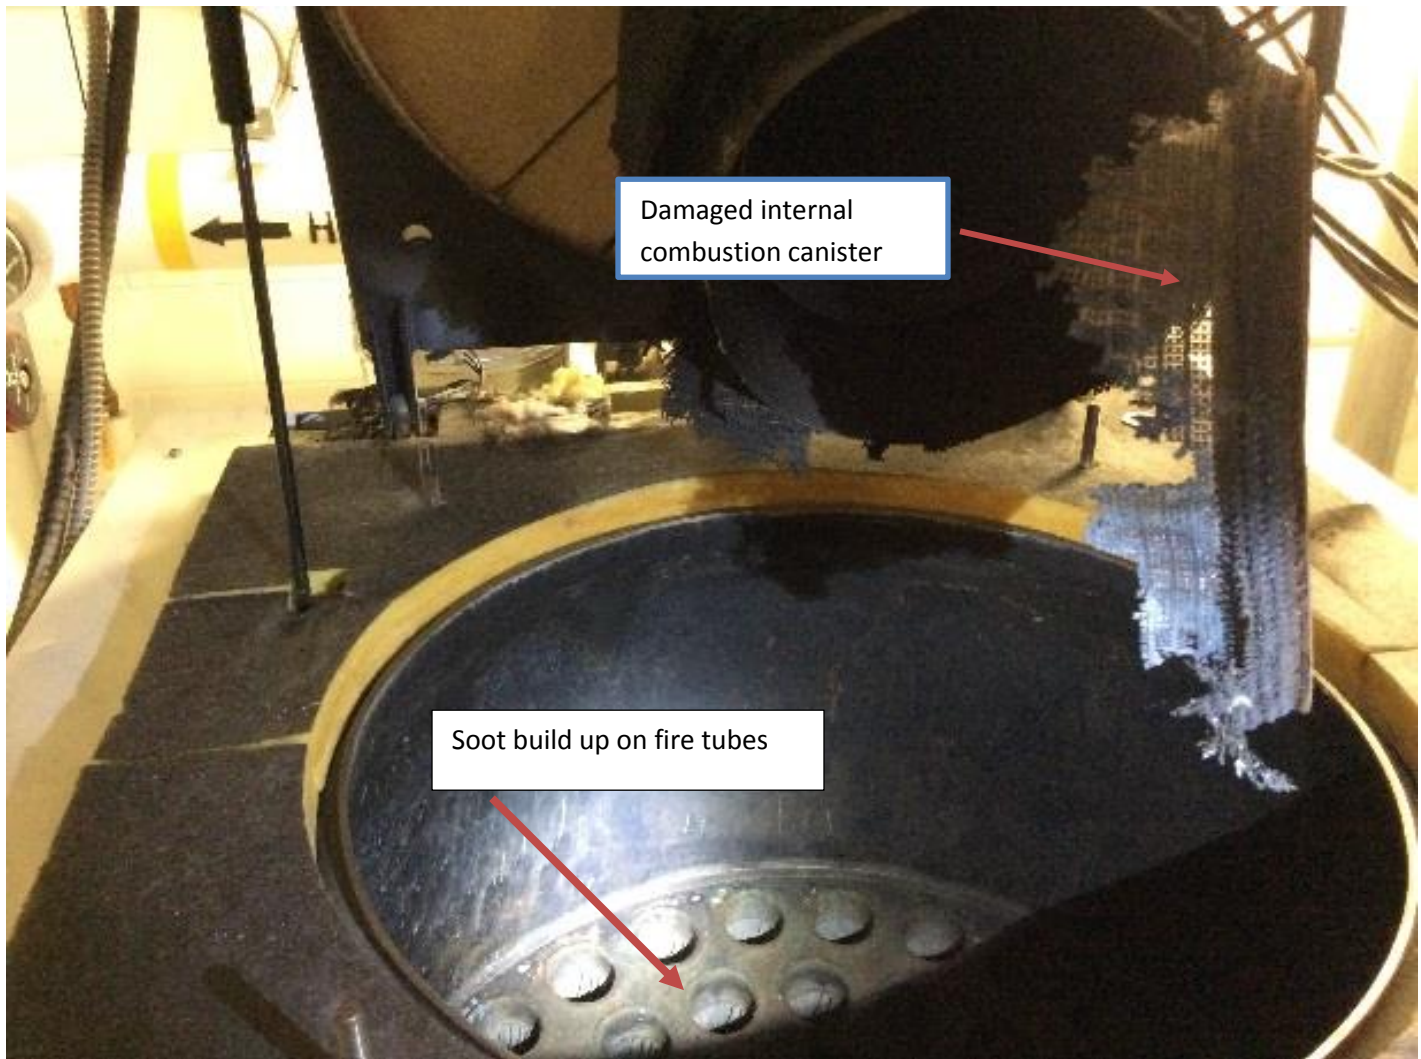
Facts and evidence		<p>Upon investigation the area within the internal combustion chamber where the fire tubes are located were found heavily clogged with soot.</p> <p>These areas of high soot potentially reduced the of ignited gas flow into the fire tubes.</p> <p>Also the ignitor probe was noted to be out of position where it created time for gas to flow without being ignited. When the gases were ignited it likely created an internal explosion in the combustion chamber.</p>

The areas of heavy soot within the combustion chamber contributed to the lowered efficiency of the combustion air movement. This required maintenance to correct. During this maintenance the combustion chamber was not cleaned of soot and the ignitors were reinstalled improperly causing a delayed ignition. This, combined with the sooted fire tubes, caused a buildup of raw unignited gas that when finally ignited caused the blowback. The delayed ignition of gas was restricted from traveling down the tubes due to soot buildup and resulted in detonation causing the damage to the equipment and control wiring.

Photo 1: Burnt vent canister & sooted fire tubes

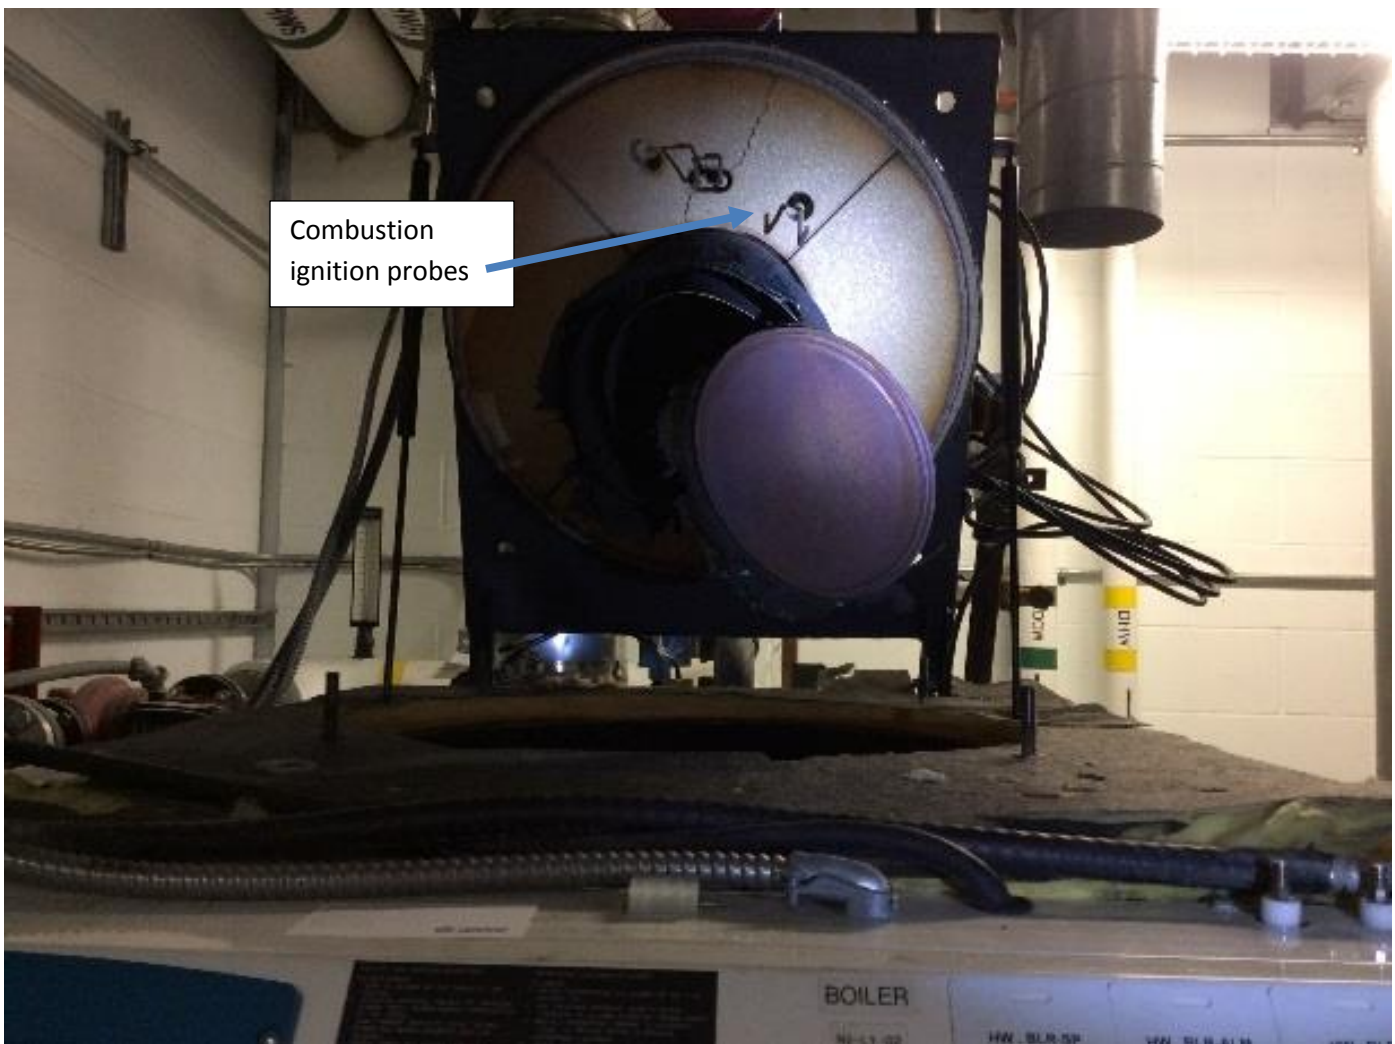
Failure scenario(s)		A few days prior to the incident the combustion burner door was lifted off to access the motor fan blades for inspection as the air flow combustion efficiency had been noticeably reduced. At this time the ignition electrode probe was removed to be cleaned but may have been incorrectly installed by the operator. It was also noted by the operator that there was a build-up of soot on the fire-tubes openings, but no maintenance was completed to clean the tubes. The combustion burner door was then closed up and the boiler was returned to service. A few days later the combustion incident occurred. The way the ignitor probe was reinstalled could have allowed large amounts of unburnt gas into the combustion chamber before ignition could occur. Once ignited, the pressure created within the chamber had nowhere to go because of the clogged fire tubes. This created the blow back of the firing gases causing the damage to the internal canister and external control wiring.

Photo 2: Ignition probes - top end

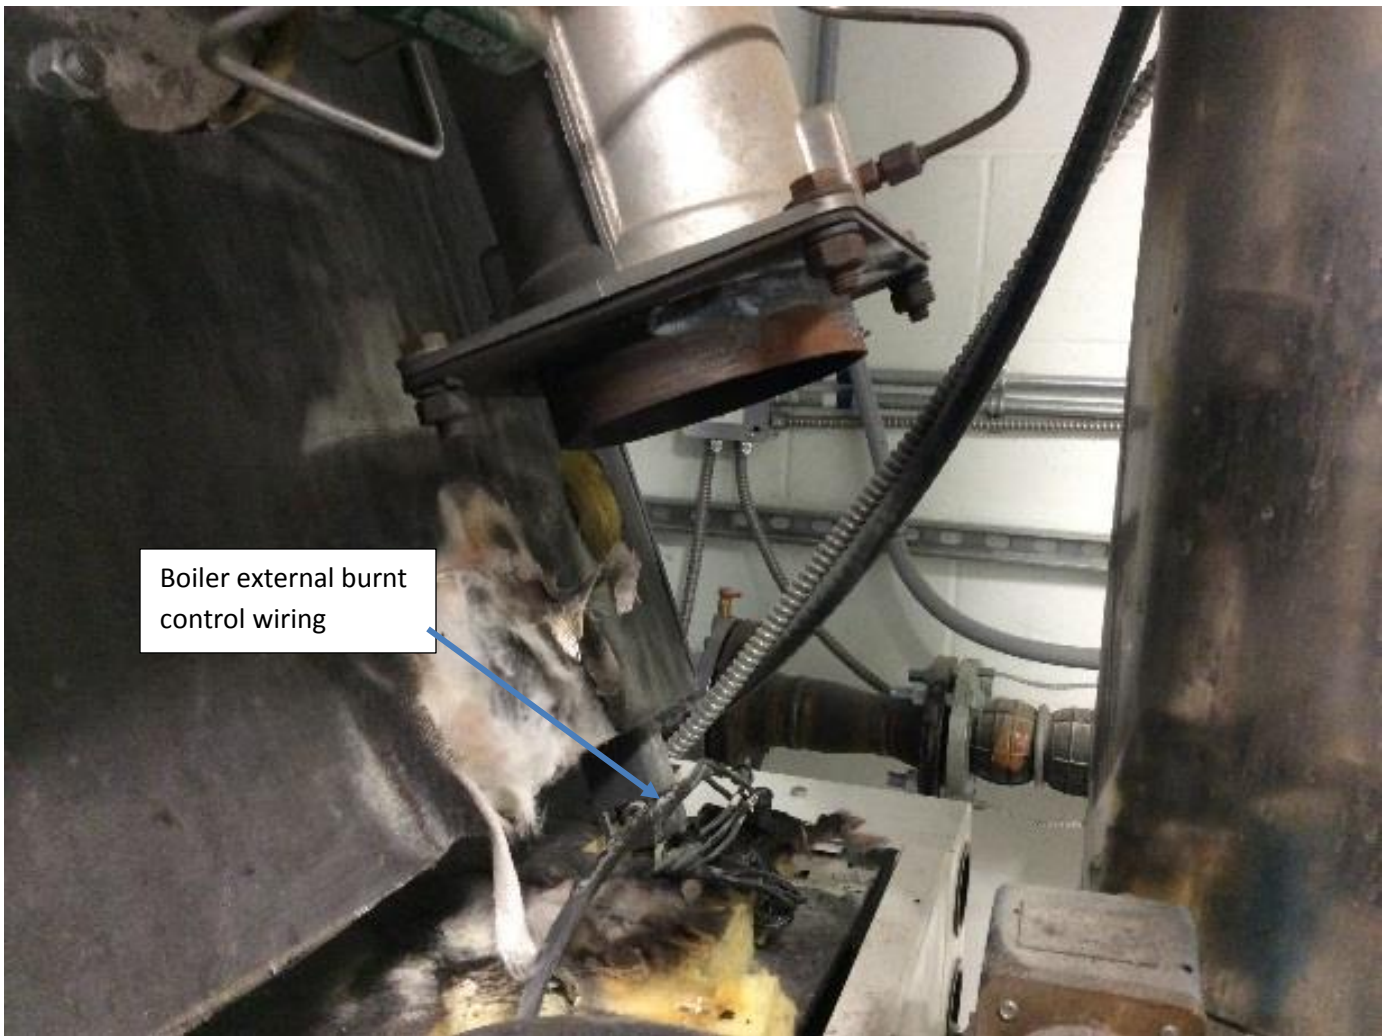
Boiler external burnt  
control wiring

Photo 3: Burnt wiring exterior top end

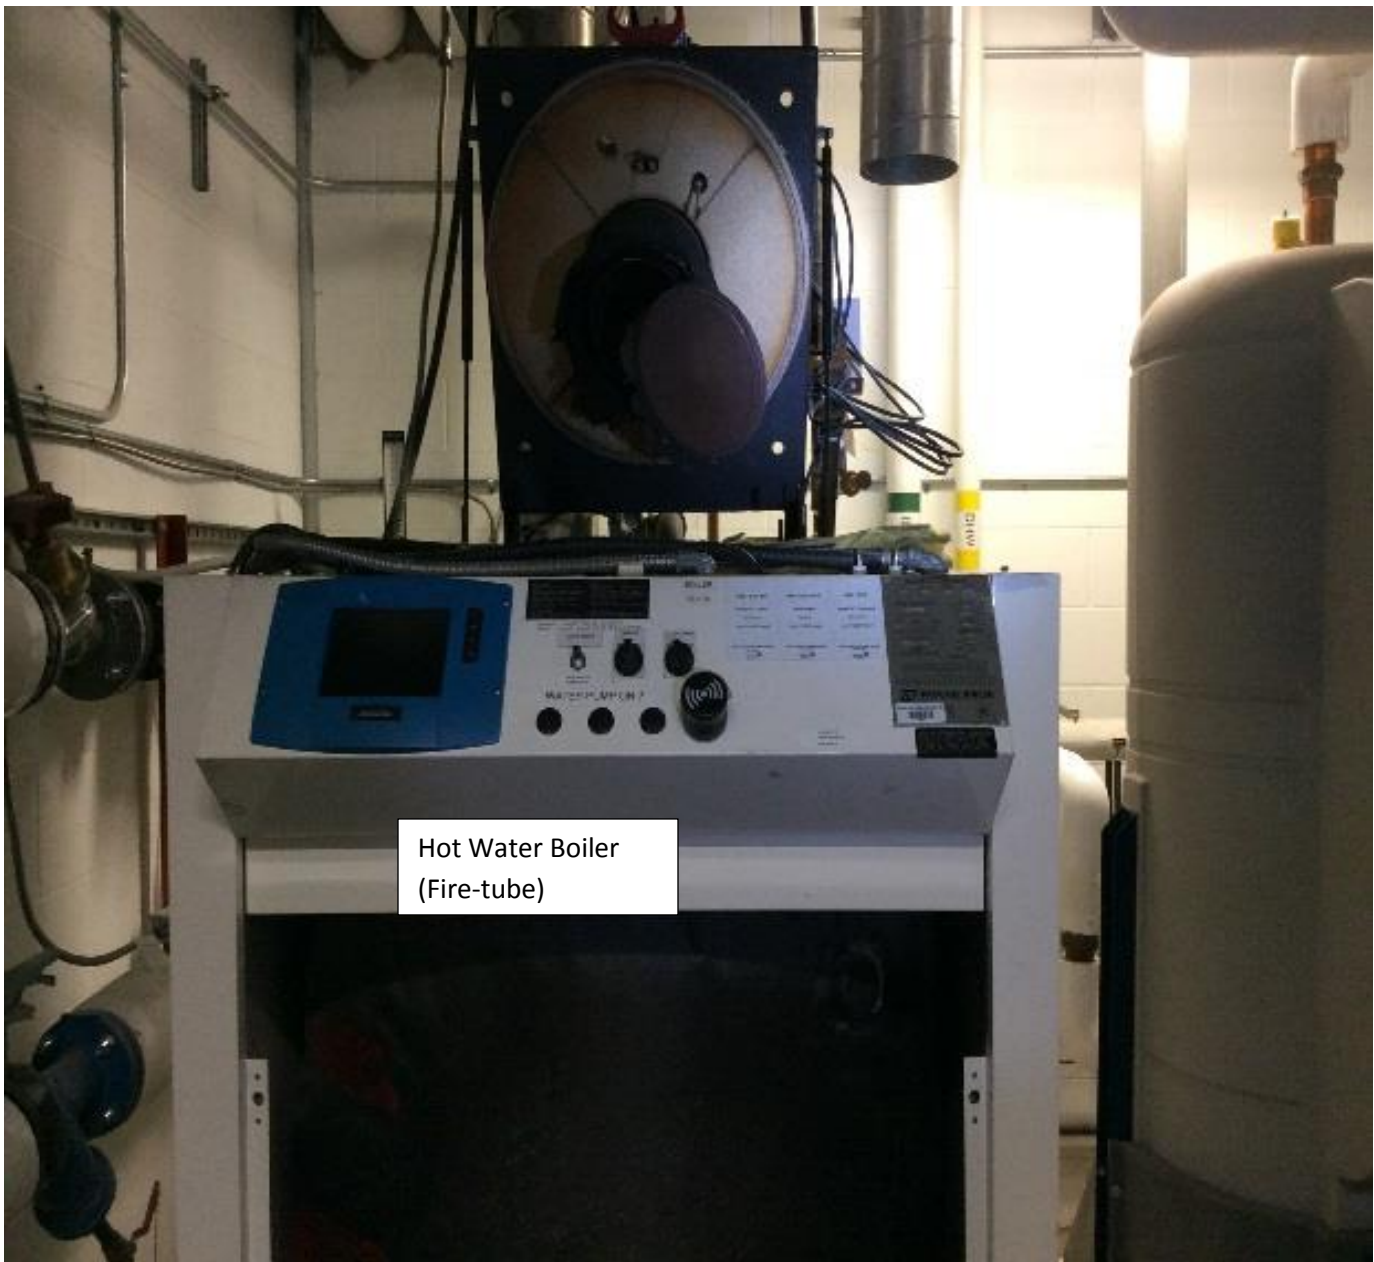
Photo 4: HW Boiler front & open combustion area
