## Incident Summary #II-1097148-2020 (#19770) (FINAL)

SUPPORTING INFORMATION	Incident Date	October 22, 2020	
	Location	Prince George, BC	
	Regulated industry sector	Boilers, PV & Refrigeration - Boiler and pressure vessel system	
	Impact	Qty injuries	0
		Injury description	N/A
	Damage	Injury rating	None
		Damage description	Cracks propagated through the pressure boundary of two vertical machine mounted air receiver heads.
		Damage rating	Moderate
	Incident rating	Moderate	
	Incident overview	<p>Two newly manufactured vertical machine mounted air receivers used for instrument air processes were installed at a wood treatment facility in November of 2020 by a licensed contractor.</p> <p>During a scheduled maintenance service after 8 months of operation, cracks were located on the top head of each vessel specifically at the head-to-bracket weld fillet welds. The cracking was in similar areas on both vessel heads being at the toe of the weld transverse to the weld start location.</p> <p>The facility Operations Dept. employees safely shutdown the equipment and removed them from service.</p>

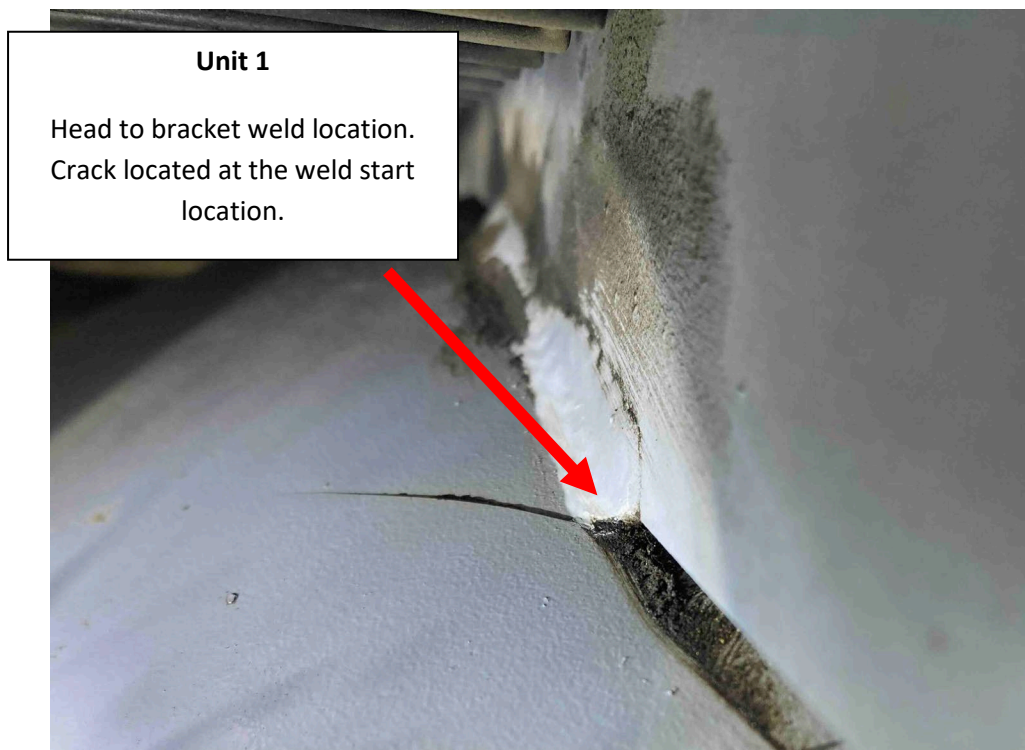
Photo 3: Pressure Vessel Head - Compressor Support Bracket

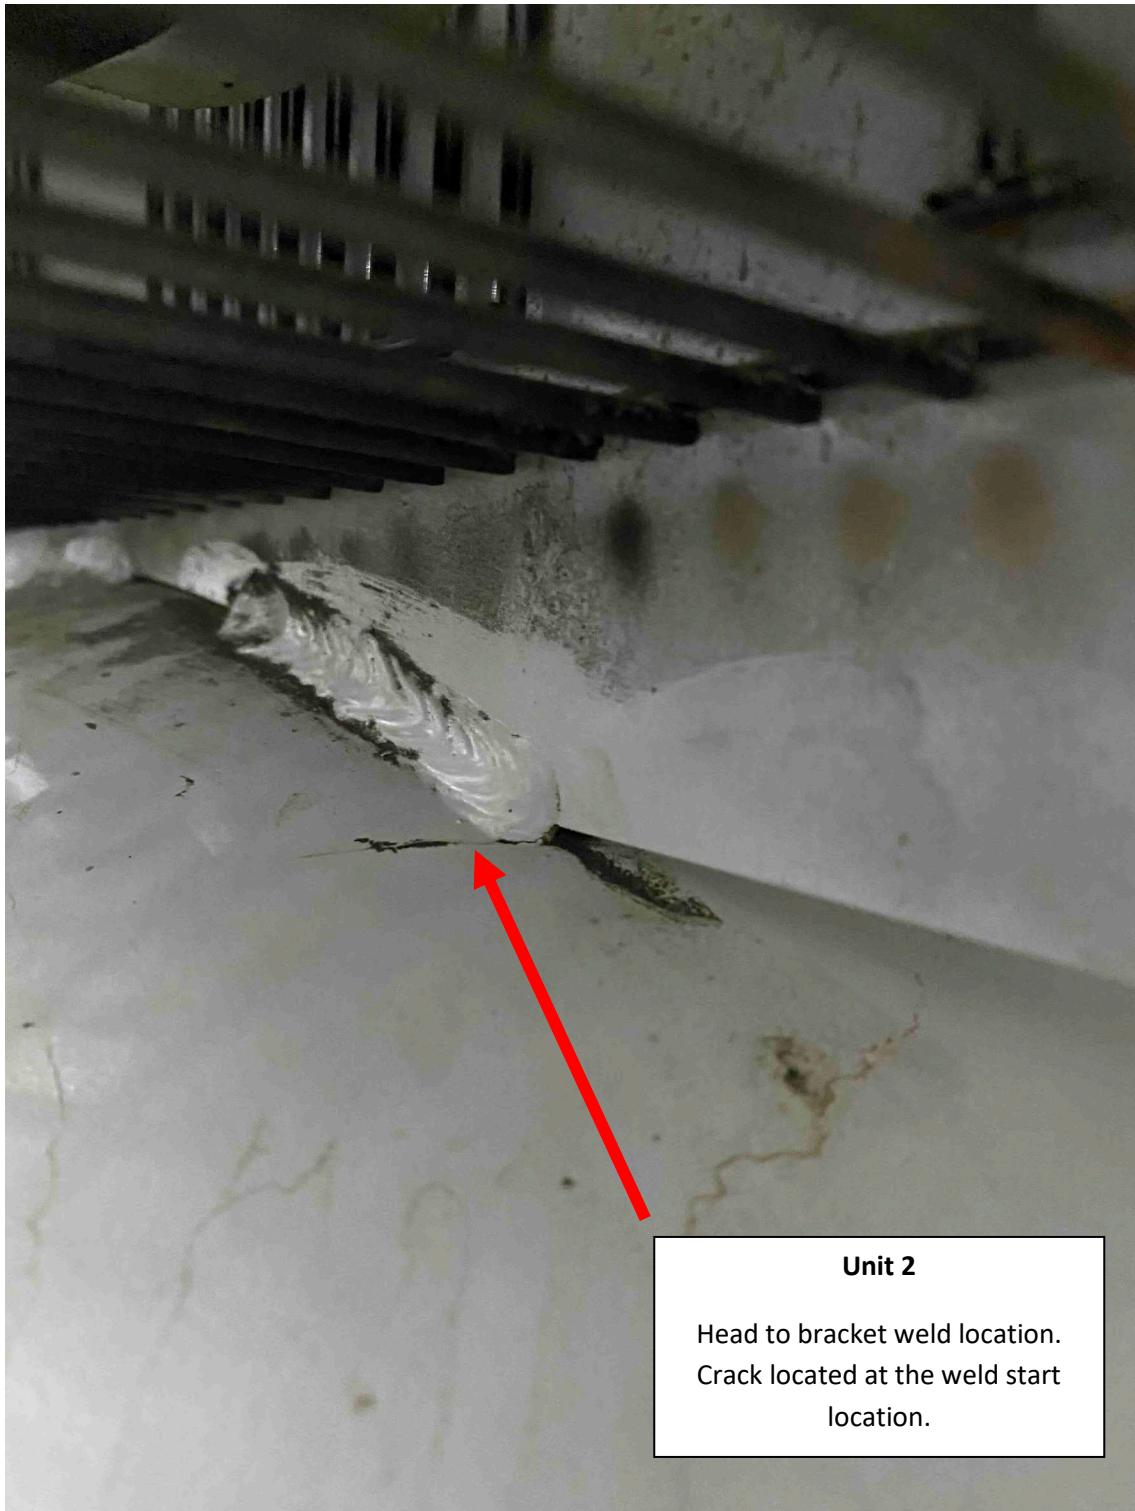
Photo 4: Pressure Vessel Head - Compressor Support Bracket
