Incident Summary #II-1768624-2024 (#52452) (FINAL)

Damage rating	Moderate
	Incident rating		Moderate
Incident overview		A vessel being used as an air receiver in an industrial compressed air system at a sandblasting shop experienced an over-pressure event, resulting in a catastrophic failure that propelled the vessel through the roof of the building.	
INVESTIGATION CONCLUSIONS which	Site, system and components		The incident occurred at a sandblasting and painting shop in a 10,000-square foot industrial space.
			The system included: a 60-horsepower fixed speed air compressor (575v / 3phase) that is meant to maintain a steady output of 125 psi. The compressor was connected to an electric dryer by a 2" ID flexible airline. The airlines were all contractor grade and had a pressure rating of 300 psi. There were ball-valve disconnects located on the intake and the output of the dryer, so it could be isolated from either the compressor or the rest of the system. The output from the dryer ran through a second 2" airline to a vertical air receiver, "Supply Tank 1". Supply Tank 1 was pressure vessel, with a maximum allowable working pressure (MAWP) of 200 psi, protected by a safety relieve

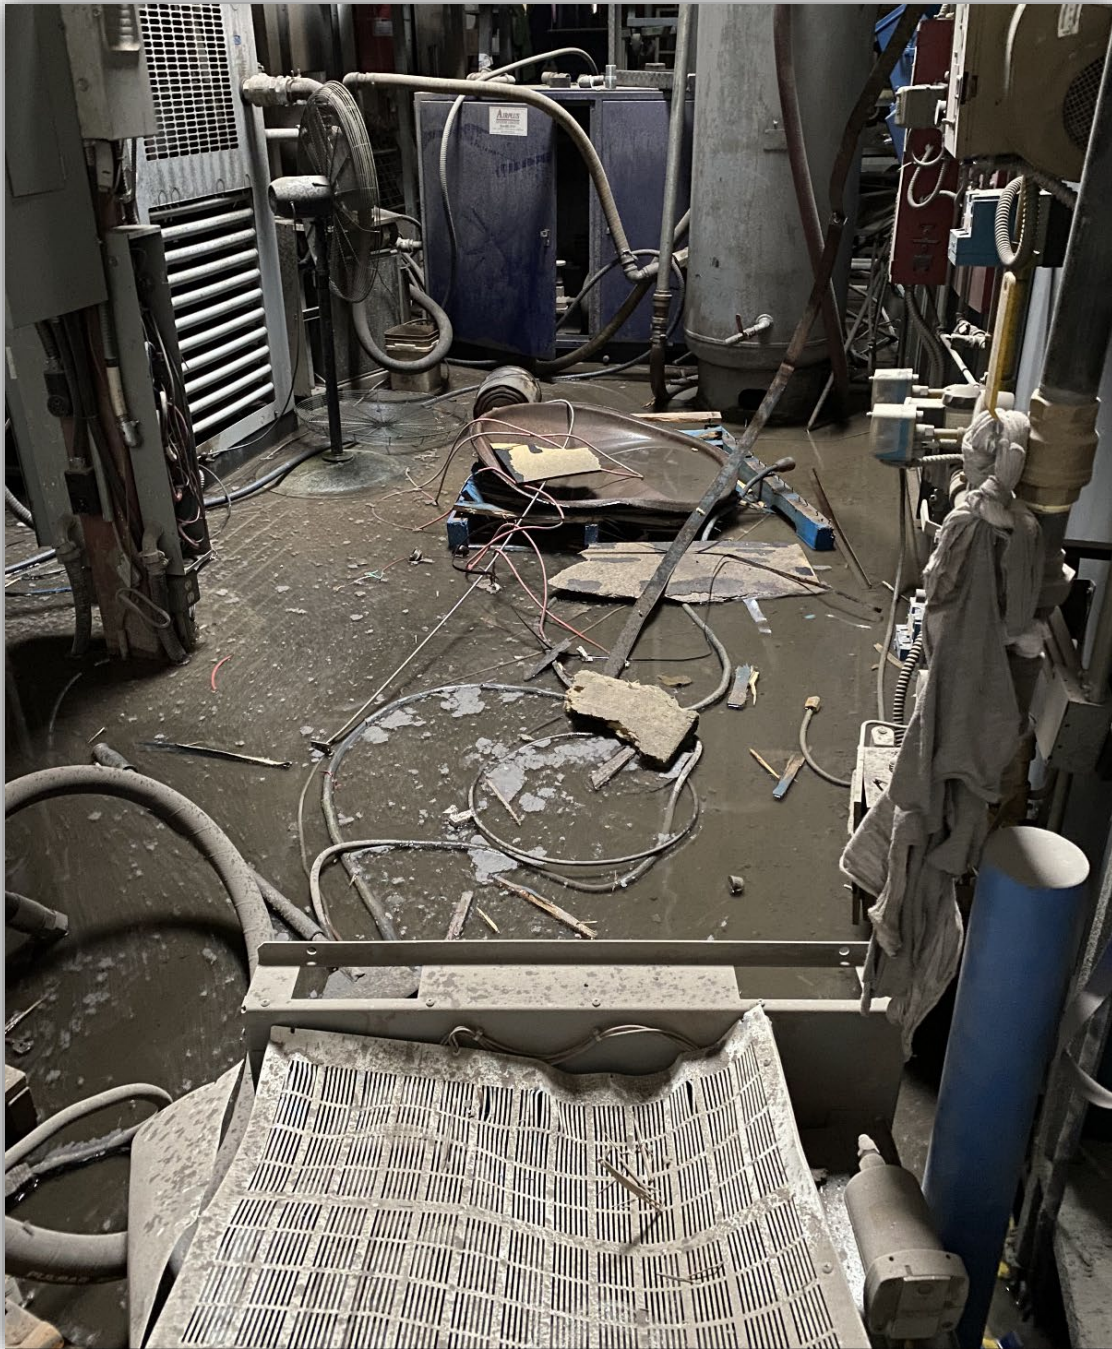
Image 4 - Supply Tank 1 and remains of Supply Tank 2. Manager was kneeling on other side of Supply Tank 1 during incident.

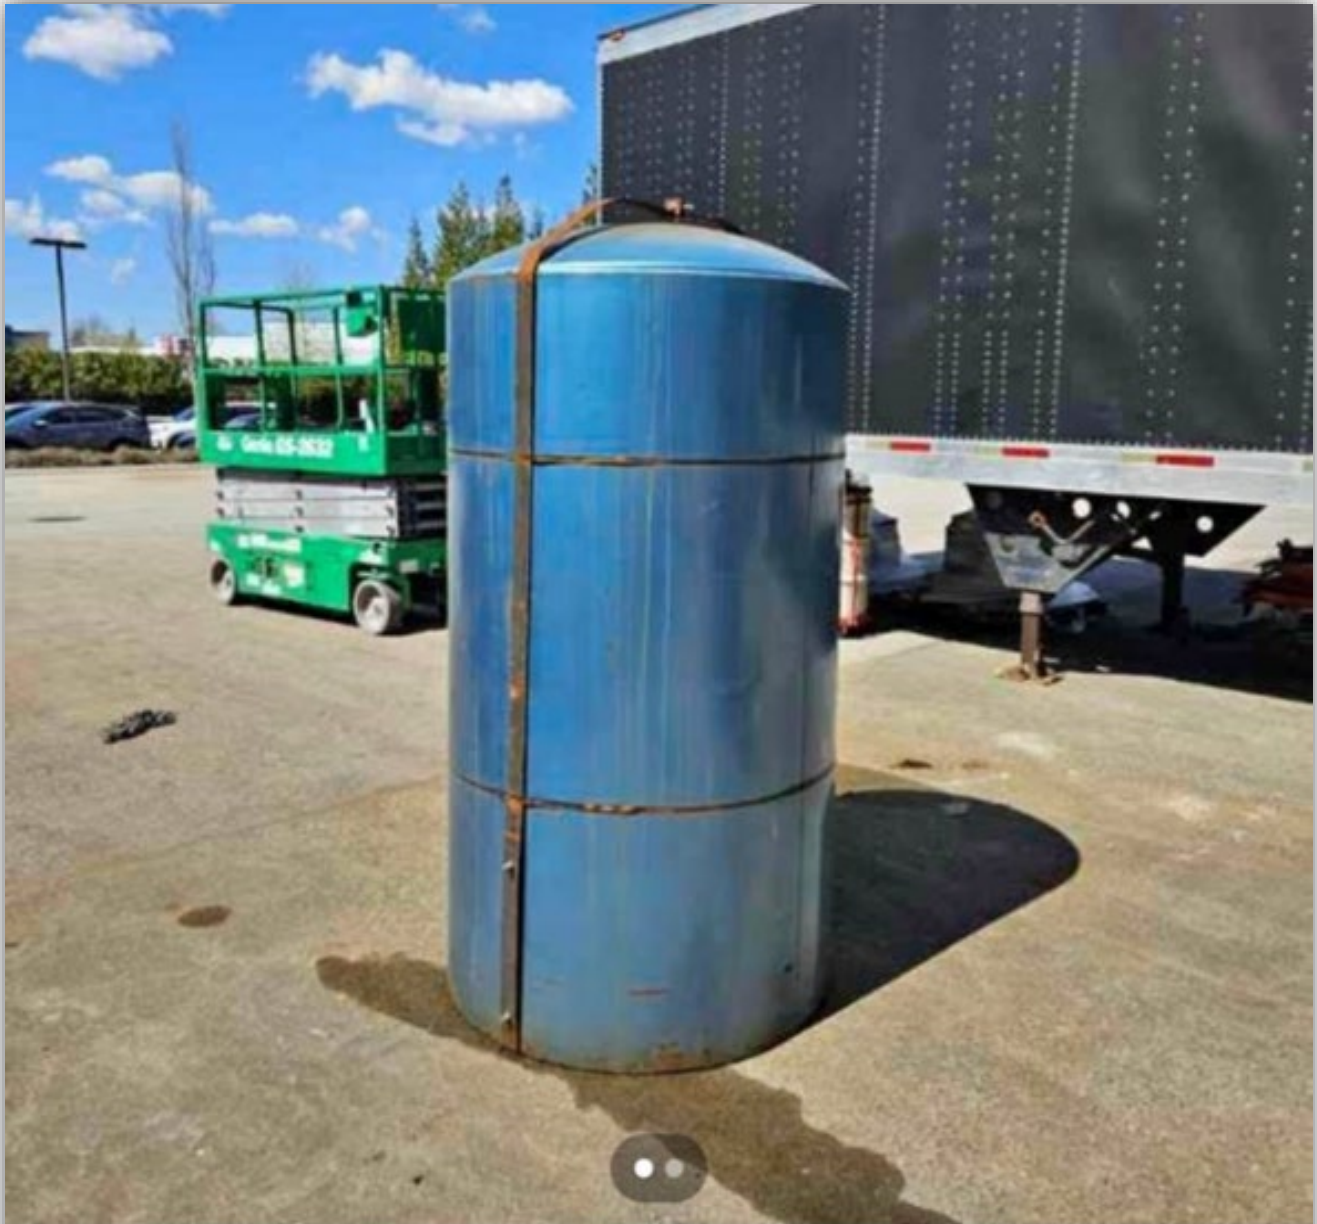
Image 5 - Online ad for Supply Tank 2, prior to failure. Note seller's description "Auxiliary Air Tank".

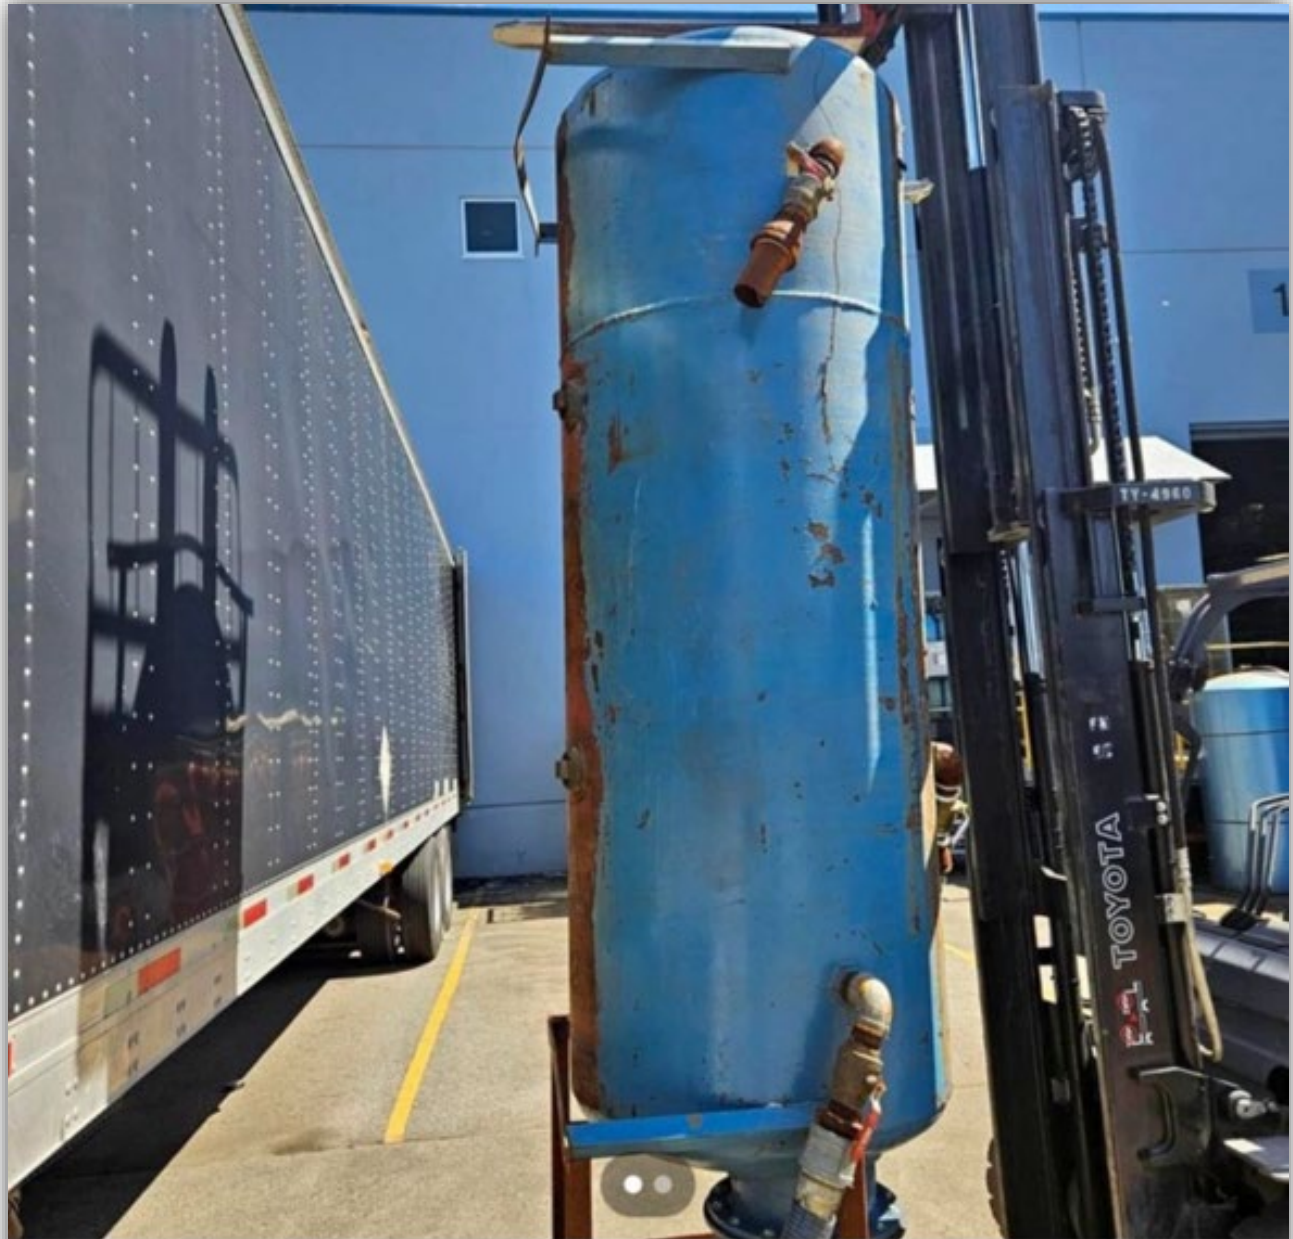
Image 6 - Supply Tank 3 from online ad. Note seller's description, "Vertical Auxiliary Air or Vacuum Tank".

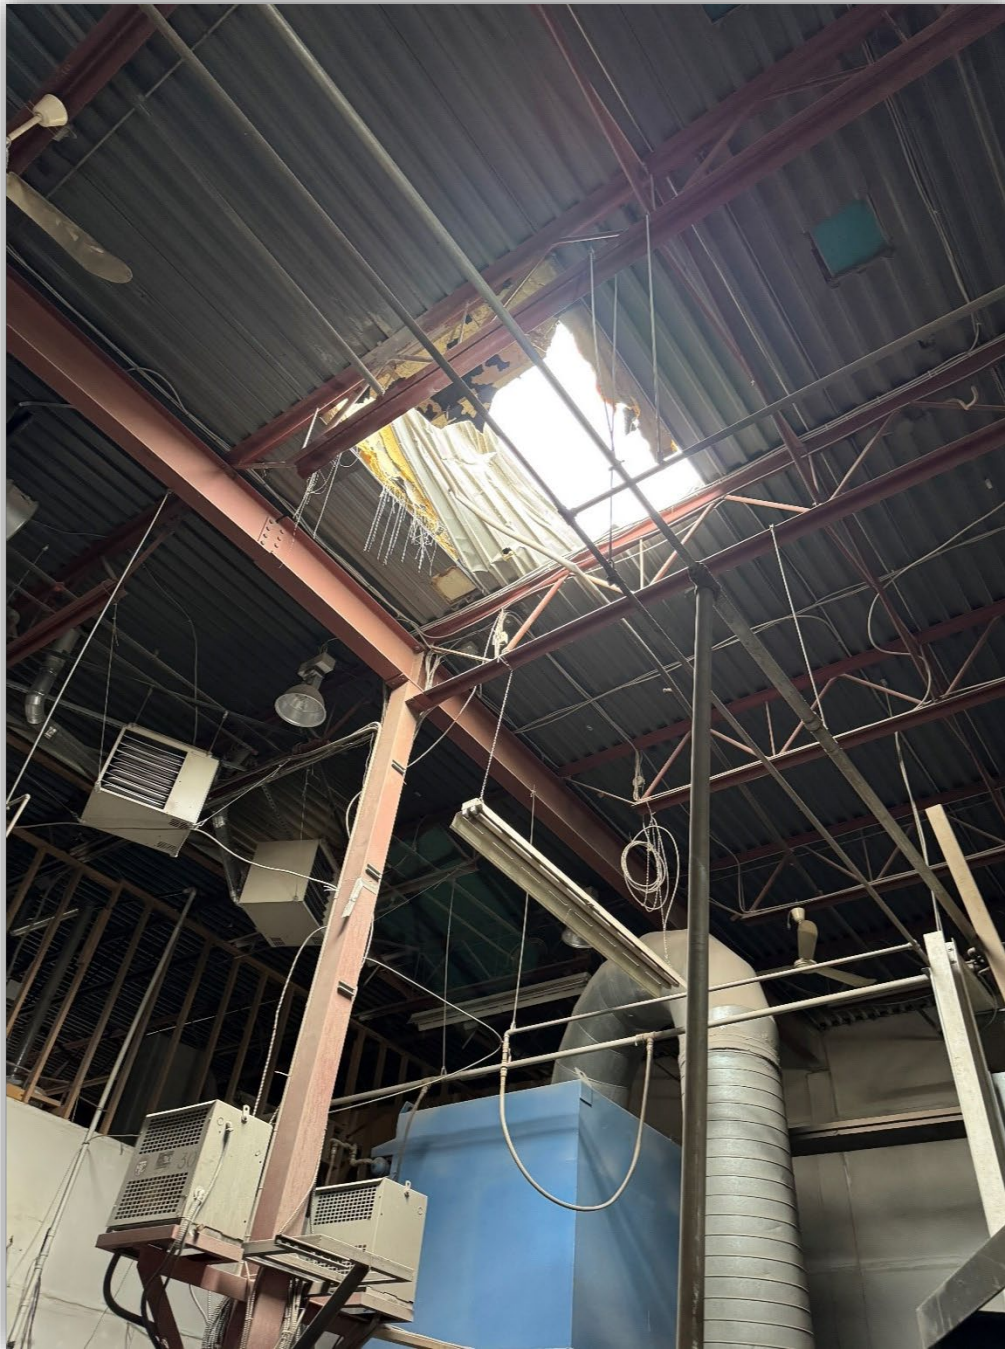
Image 8 - Hole in roof caused by tank failure.

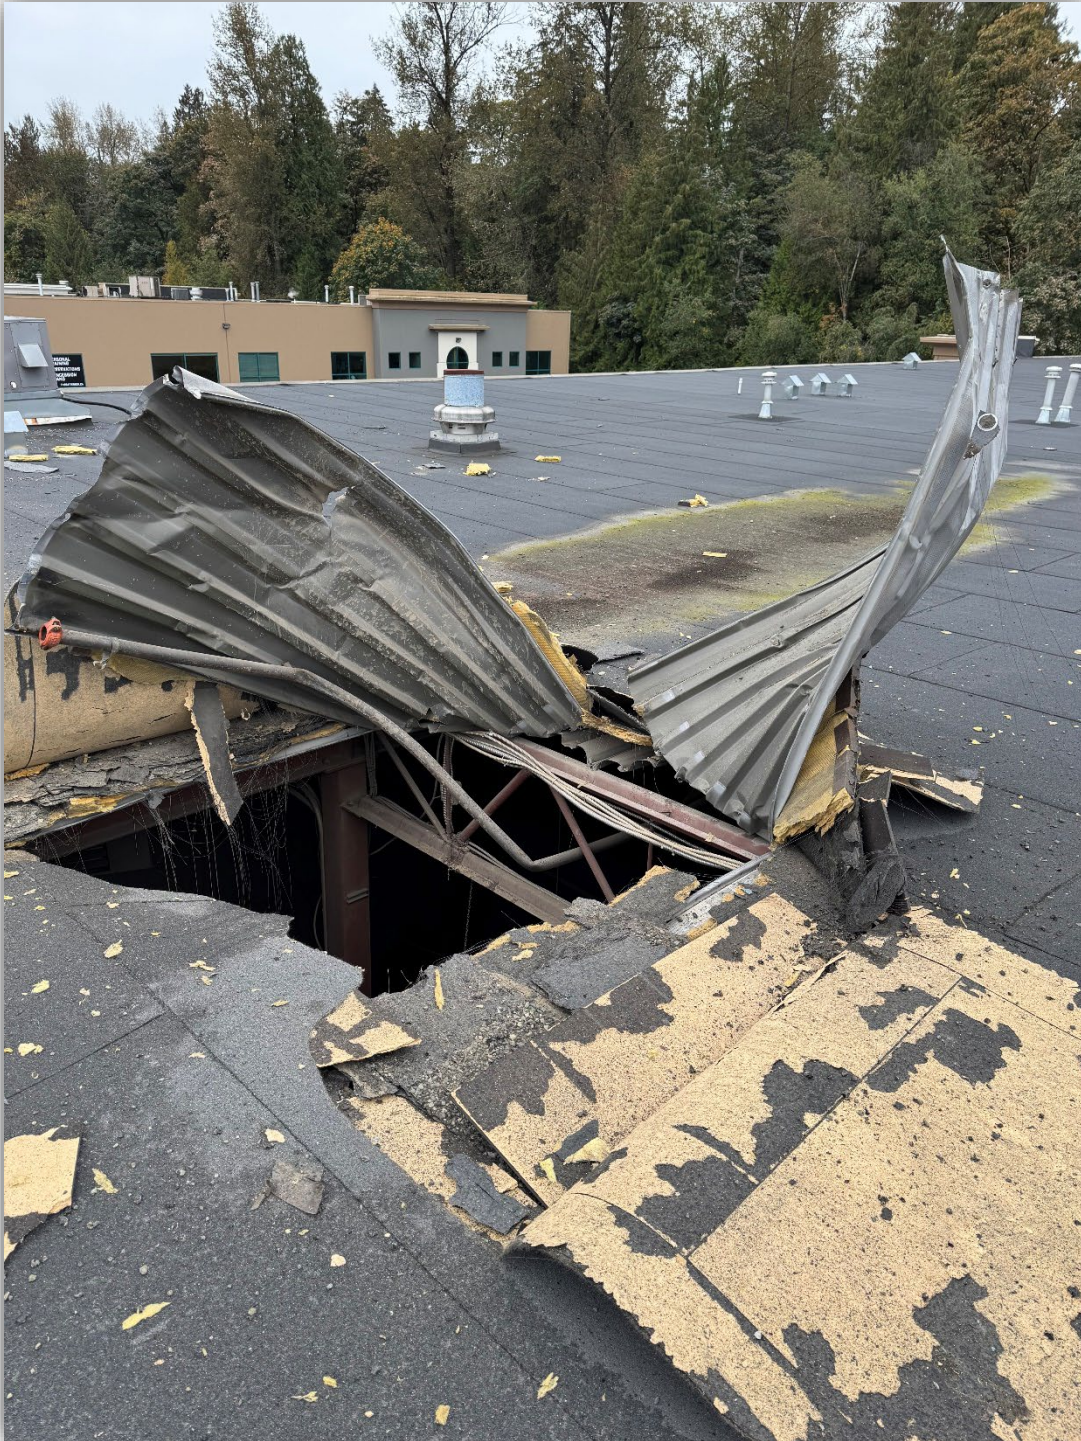
Image 9 - Hole in roof caused by tank failure, external view.

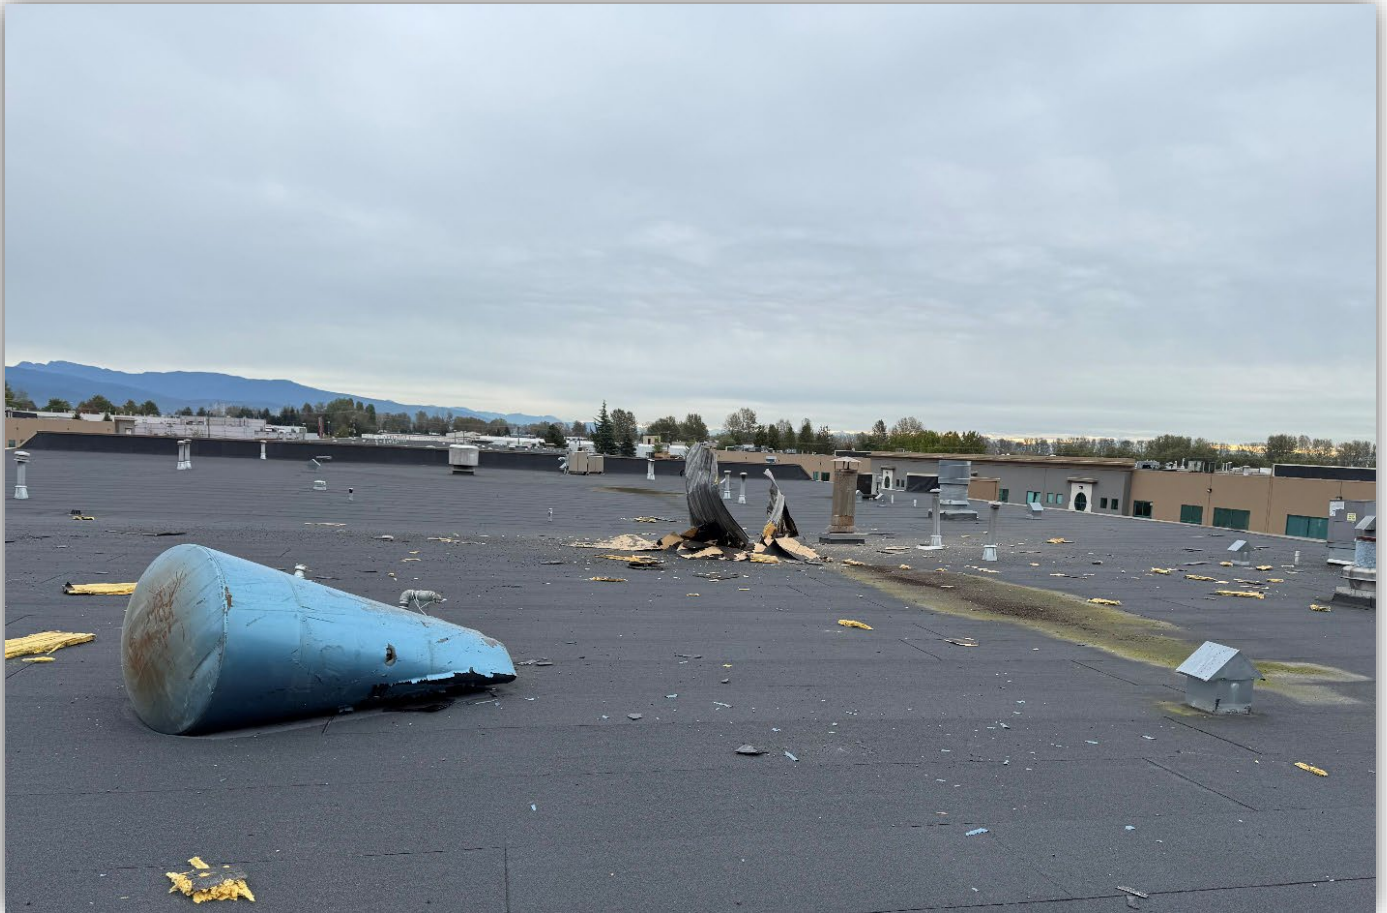
Image 10 - Tank landed 5 meters from hole.

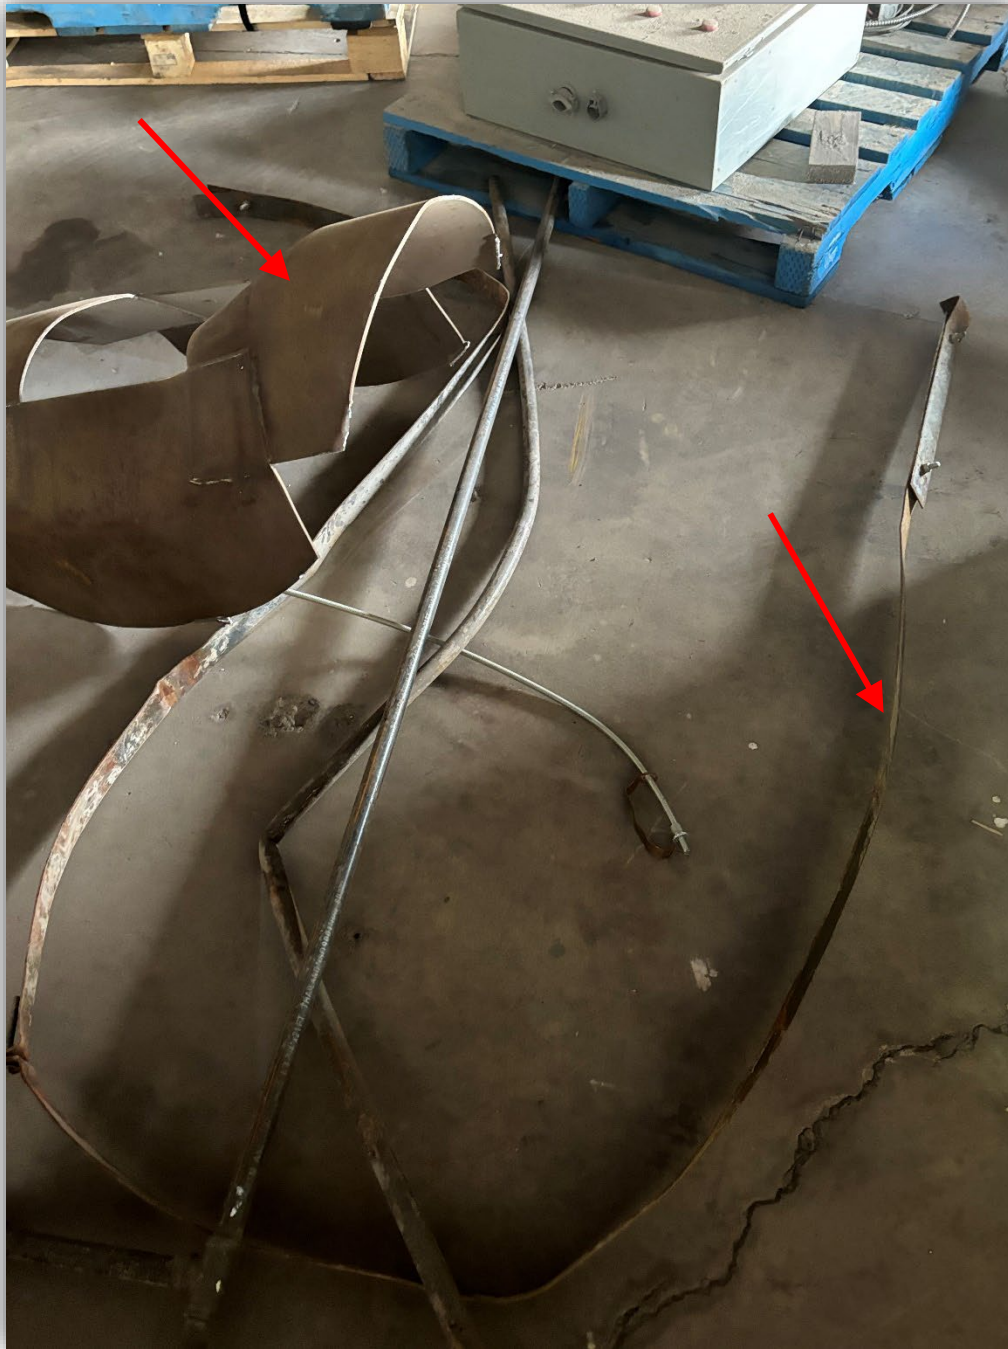
Image 11 - Internal baffle that was blown out of tank, and strap used to secure tank to pallet.

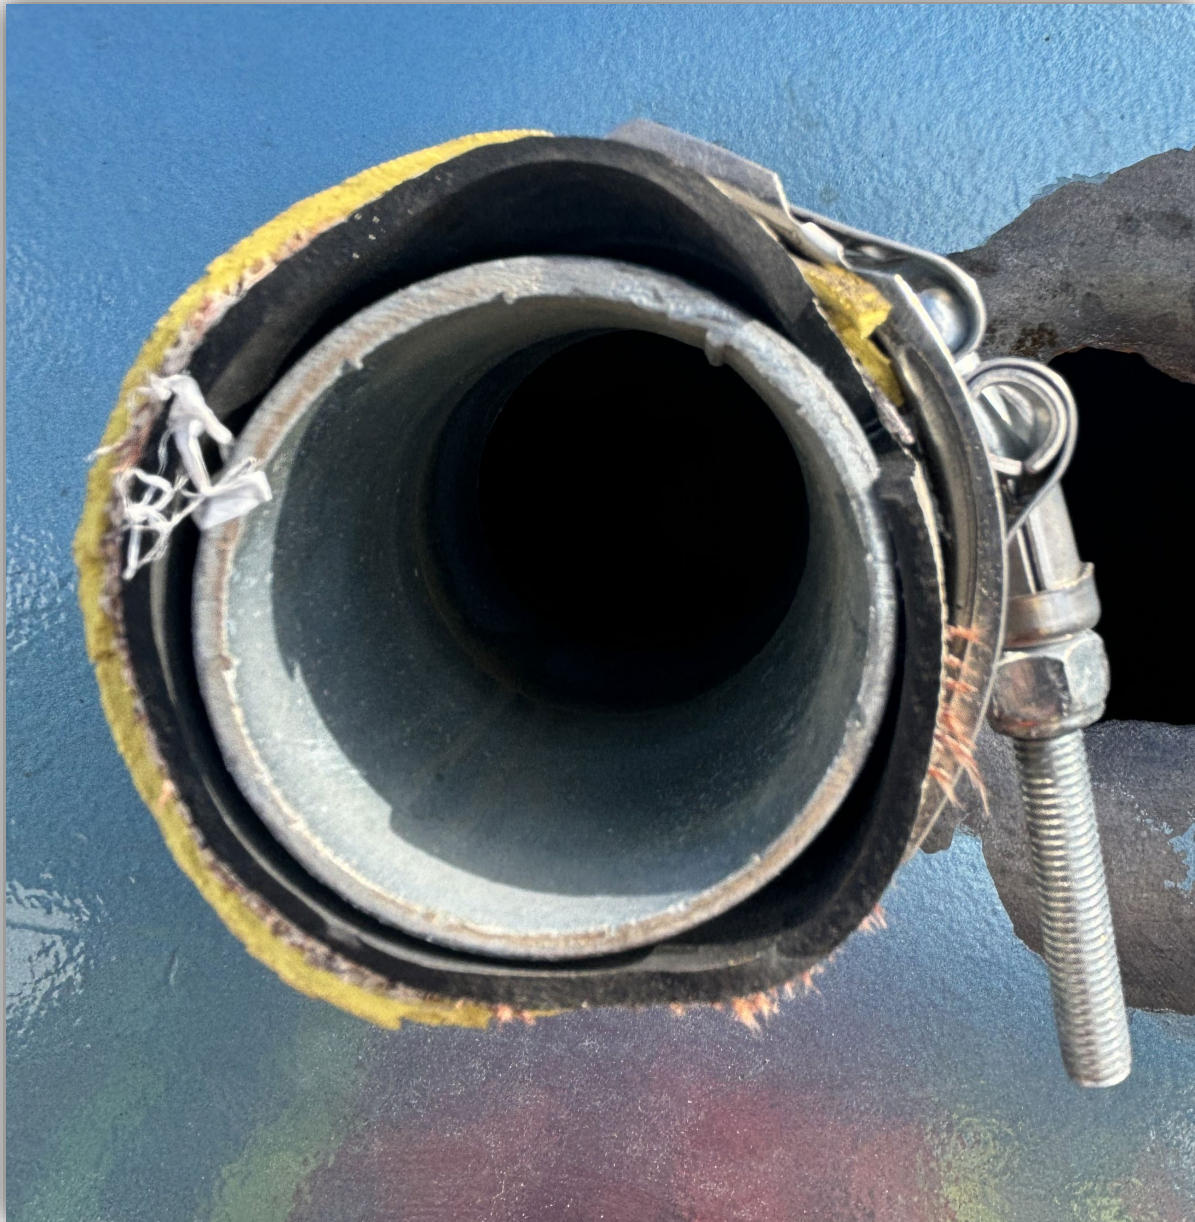
Image 12 - 300 PSI contractor grade 3" flexible airline, torn at attachment point.

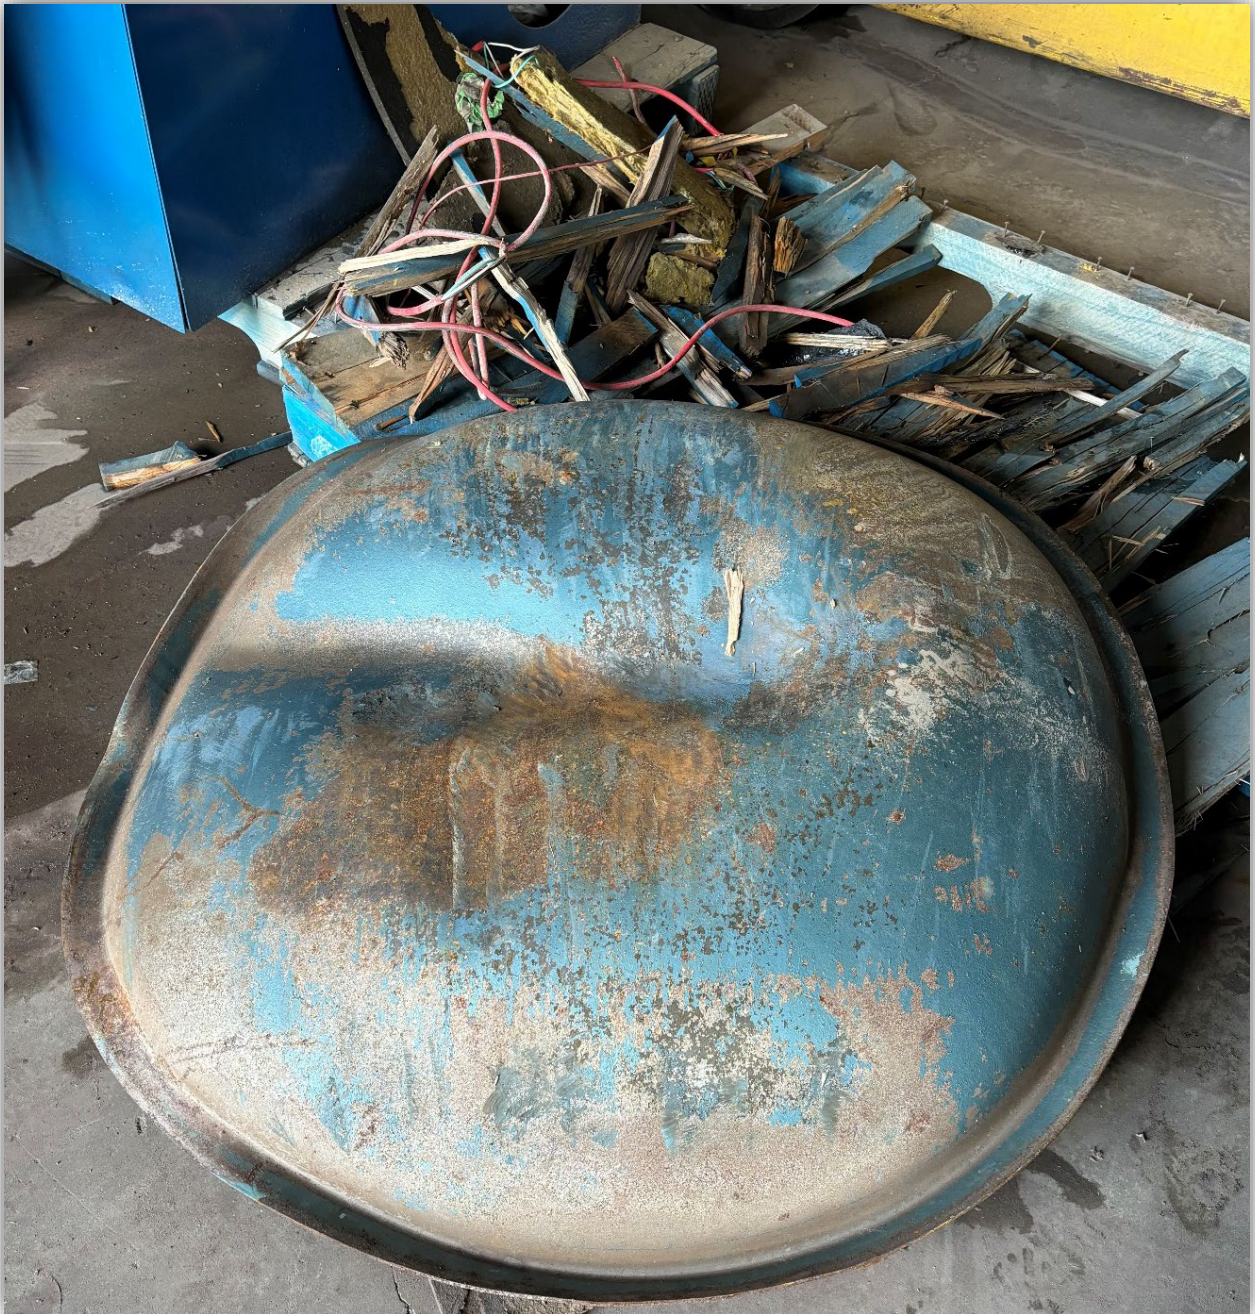
- The bottom head configuration was not immediately apparent because of the distortion, but it appears to have been a convex or concave piece with a factory break forming a rim around the circumference ([Image 10](#)). Marks on the shell and head indicate the head "rim" slid inside the vessel, and was seal welded with either a single-pass fillet weld or an edge weld.

Image 13 - Bottom head of Supply Tank 2 left on pallet, external view.

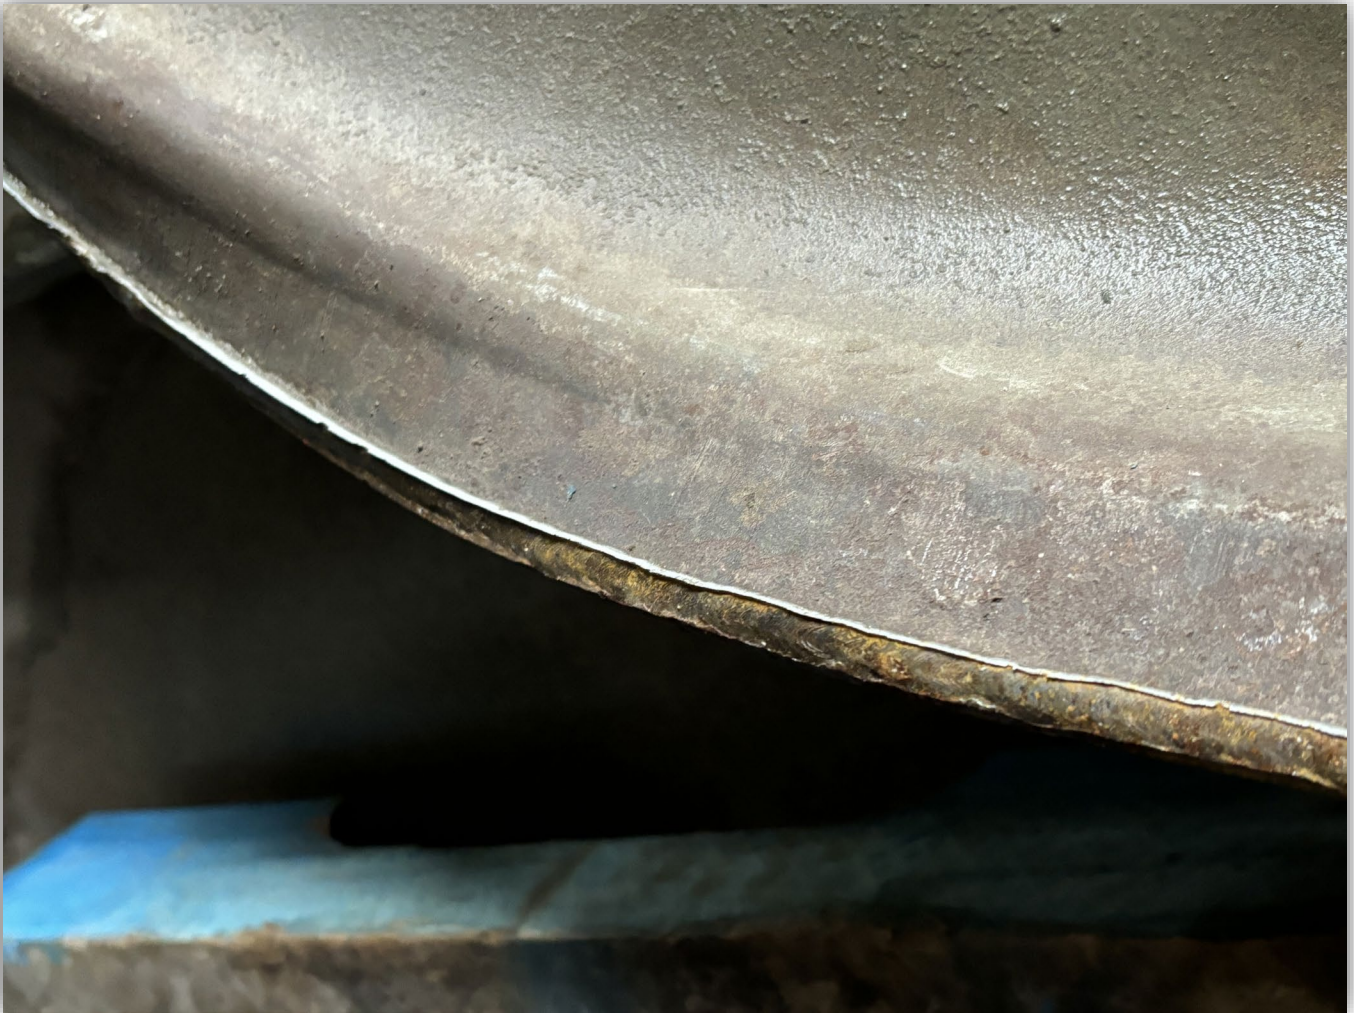
Image 14 - Failed weld on inside of bottom head of Supply Tank 2.

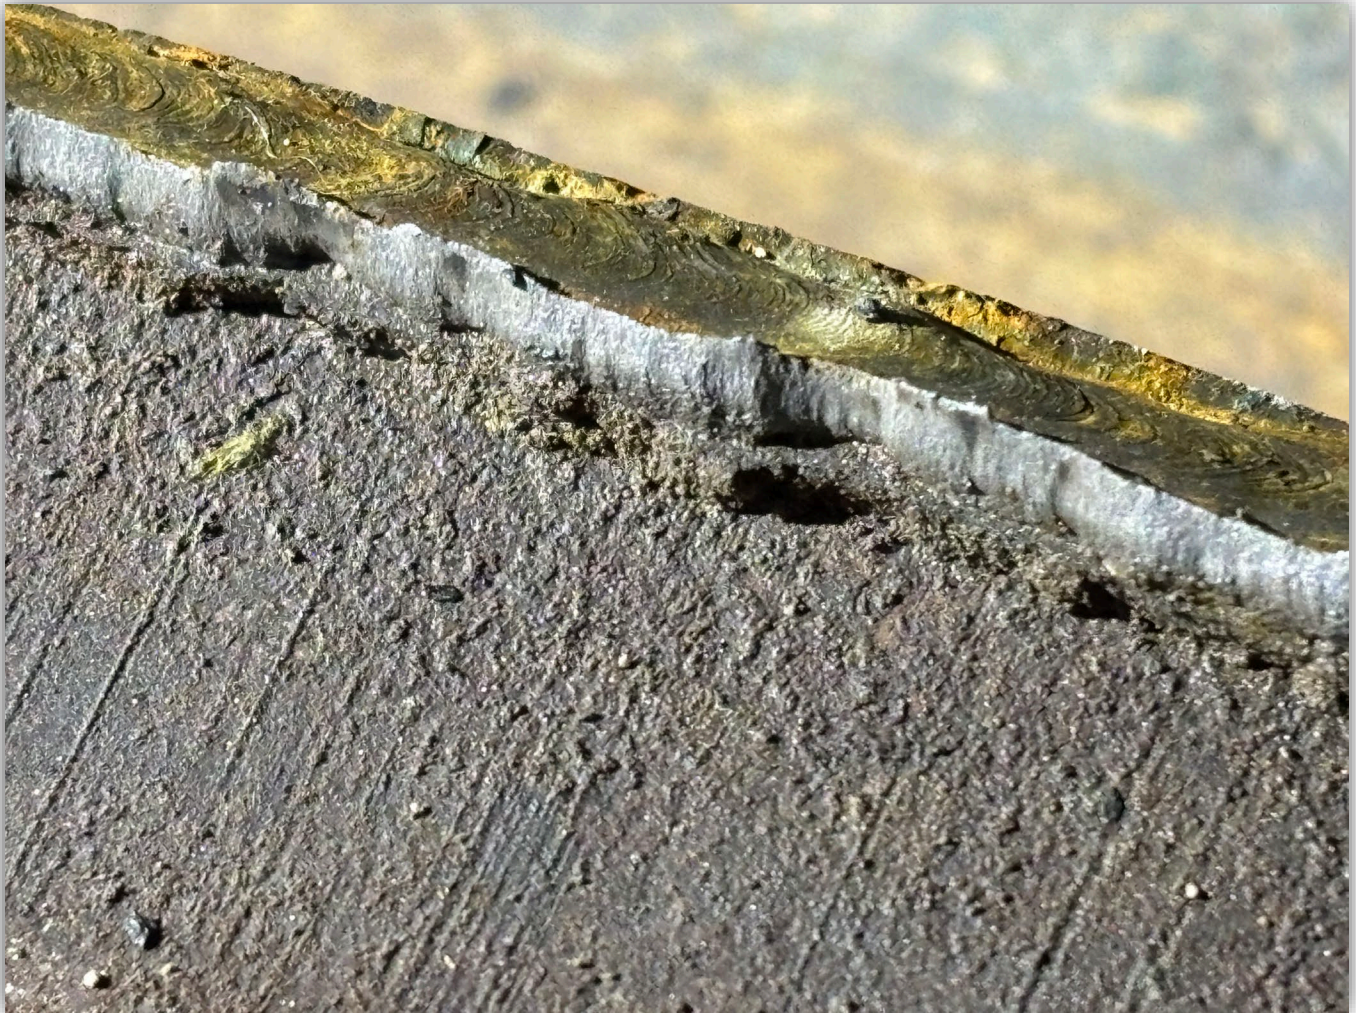
Image 15 - Close up of failed weld on inside of bottom head of Supply Tank 2.

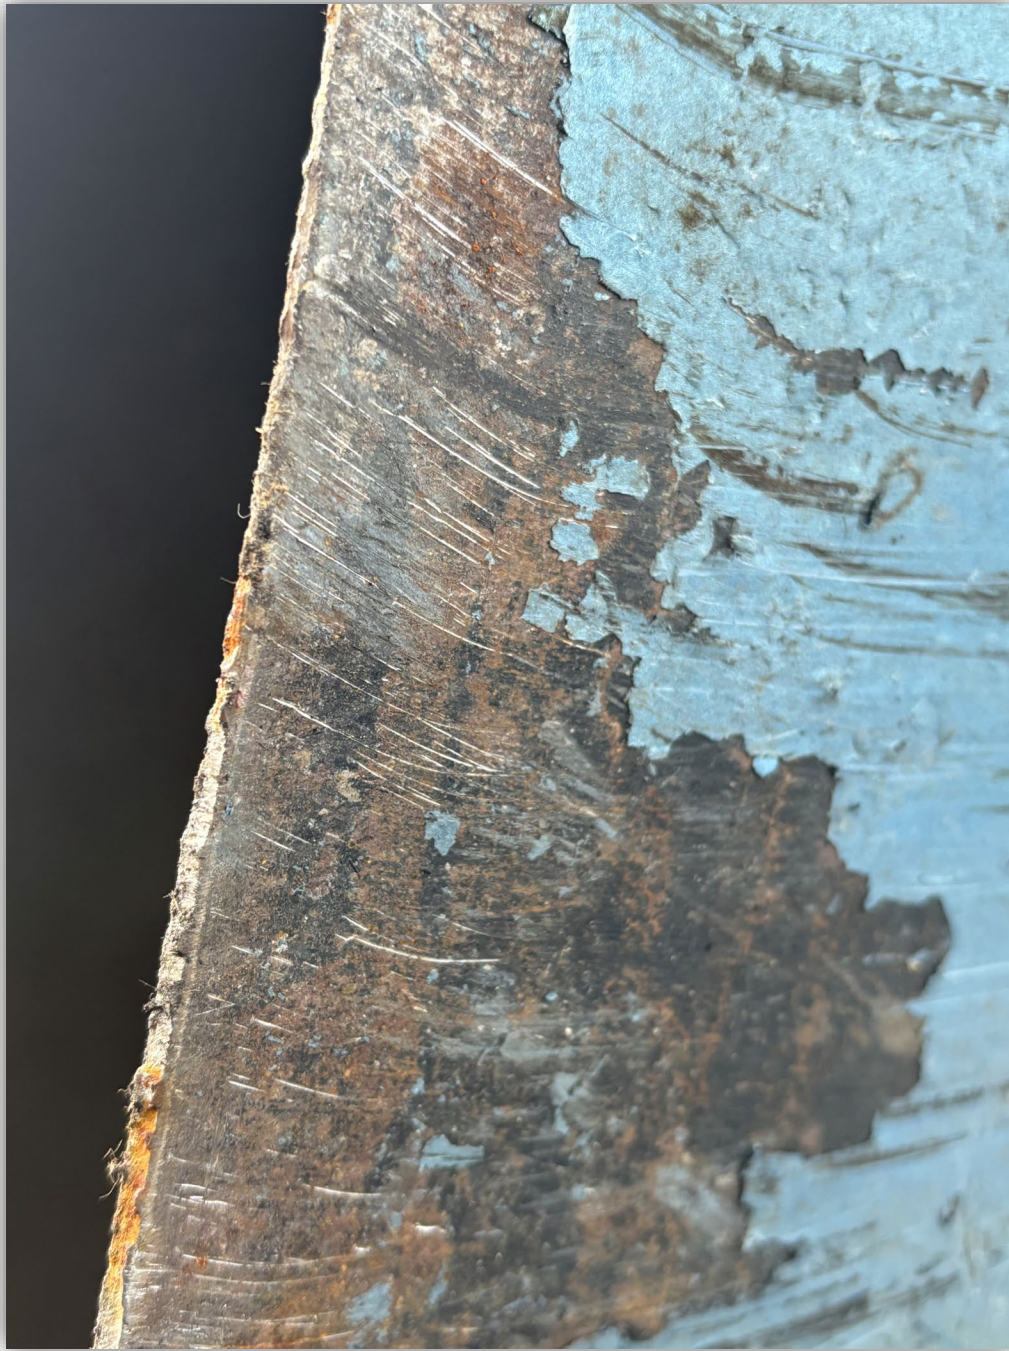
Image 16 - Failed weld on outside of shell of Supply Tank 2.

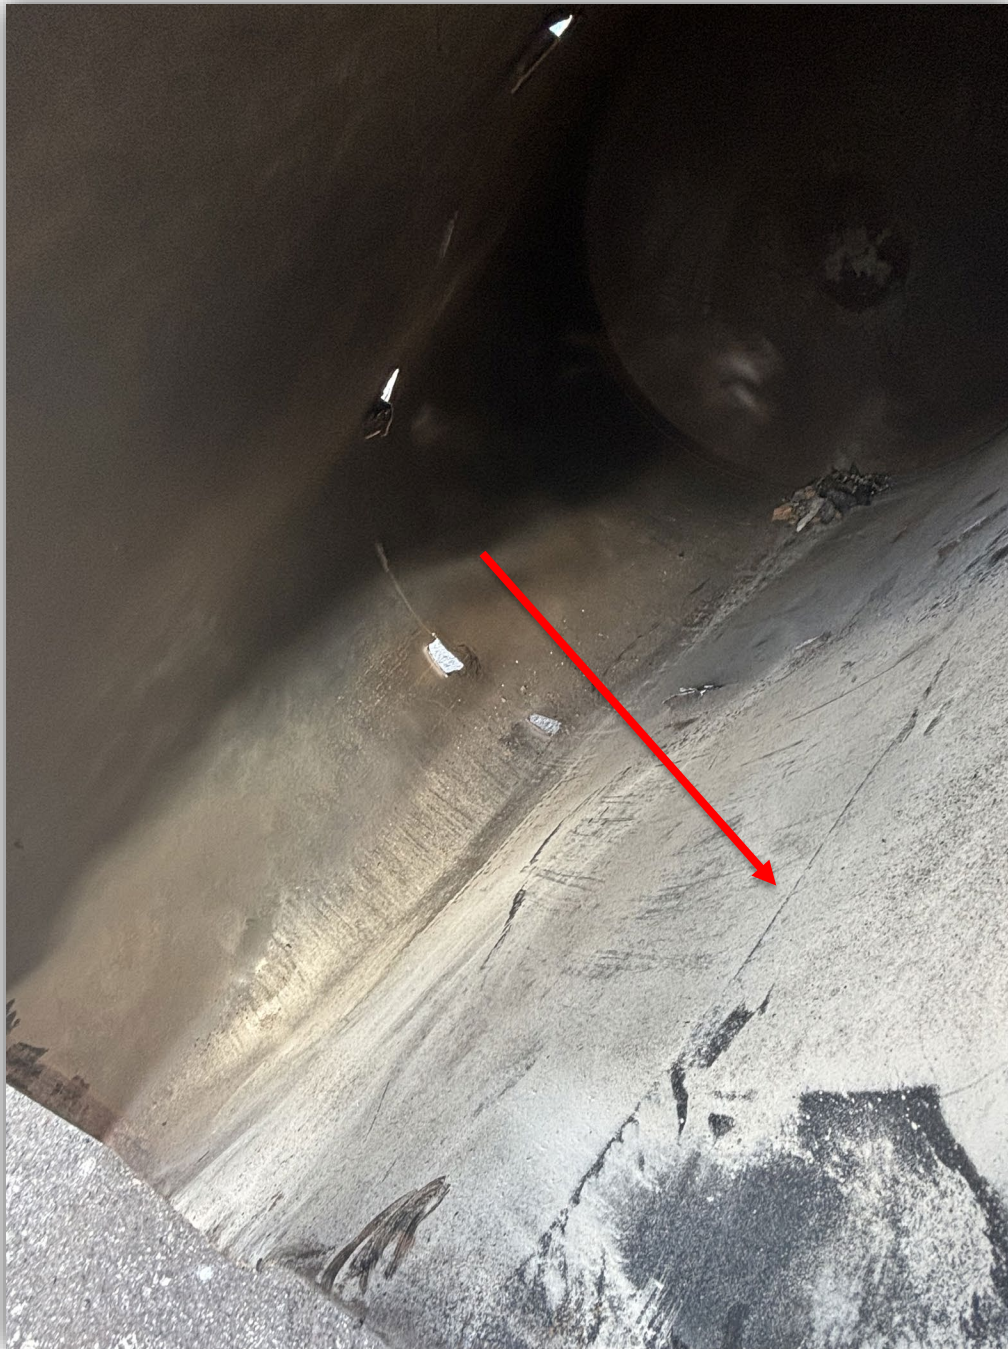
- The presence of an internal baffle plate suggests liquid service, and examination of the carcass suggests it was designed for low-pressure use.
- The longitudinal weld in shell seam was a single pass from the outside, with no gap and no penetration. It was not a "pressure" weld ([Image 13](#) & [Image 14](#)).

Image 17 - Inside of Supply Tank 2. Longitudinal weld seam indicates zero penetration and no welding from the inside of the vessel.

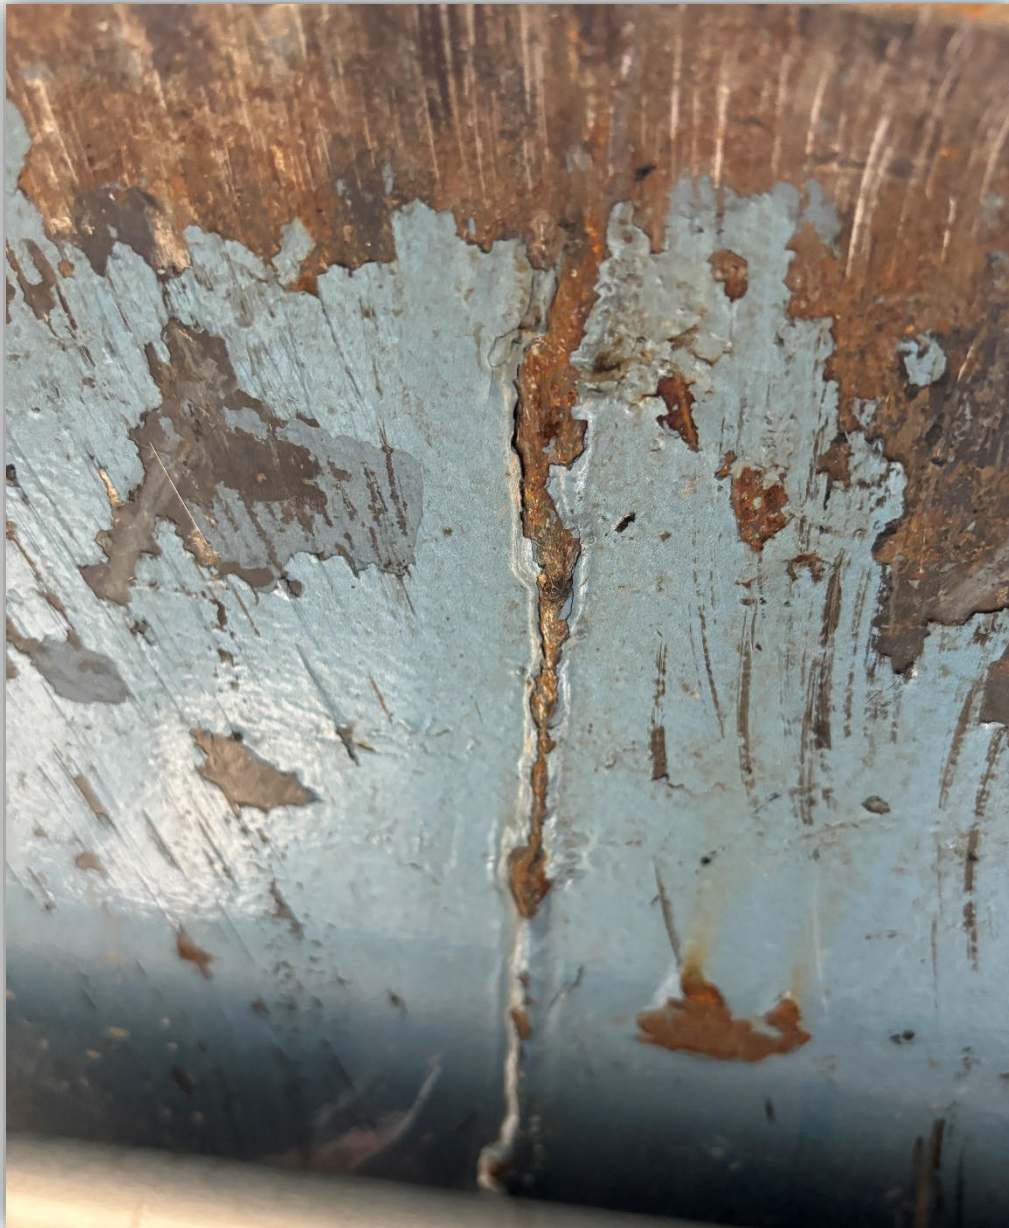
Image 14 - External weld of longitudinal seam.

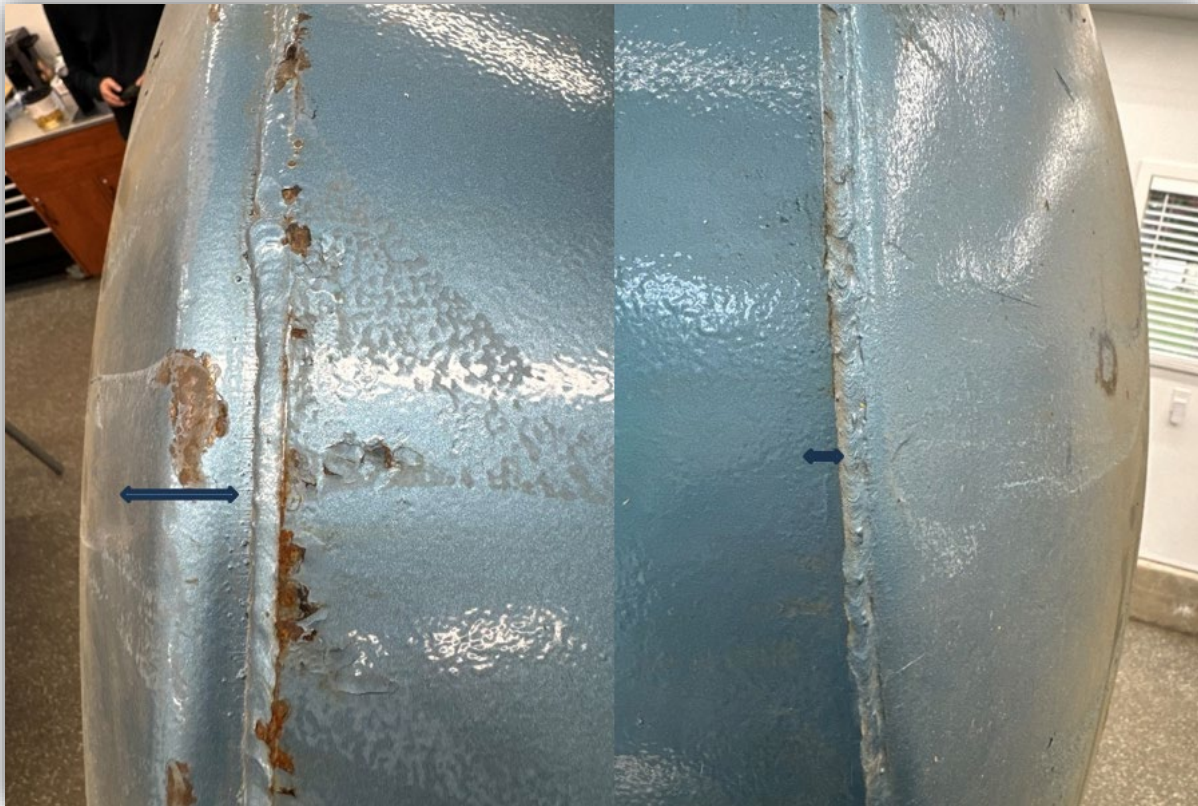
- Length, 72", diameter 42" to 44", distorted. Shell is 2.96mm thick (calipers)
- The heads did not correspond to ASME Section VIII div 1 design principles. The dimensions of the top head were asymmetrical, indicating a high margin of error ([Image 17](#)).

Image 20 - Upper head of Supply Tank 2 after failure. Note difference in distance between the circumferential weld and the break in the head, from left side to right side. Tank constructed outside of code requirements for margin of error.
