Incident Summary #II-1768624-2024 (#52452) (FINAL)

Damage rating	Moderate
	Incident rating		Moderate
Incident overview		A vessel being used as an air receiver in an industrial compressed air system at a sandblasting shop experienced an over-pressure event, resulting in a catastrophic failure that propelled the vessel through the roof of the building.	
INVESTIGATION CONCLUSIONS which	Site, system and components		The incident occurred at a sandblasting and painting shop in a 10,000-square foot industrial space.
			The system included: a 60-horsepower fixed speed air compressor (575v / 3phase) that is meant to maintain a steady output of 125 psi. The compressor was connected to an electric dryer by a 2" ID flexible airline. The airlines were all contractor grade and had a pressure rating of 300 psi. There were ball-valve disconnects located on the intake and the output of the dryer, so it could be isolated from either the compressor or the rest of the system. The output from the dryer ran through a second 2" airline to a vertical air receiver, "Supply Tank 1". Supply Tank 1 was pressure vessel, with a maximum allowable working pressure (MAWP) of 200 psi, protected by a safety relieve

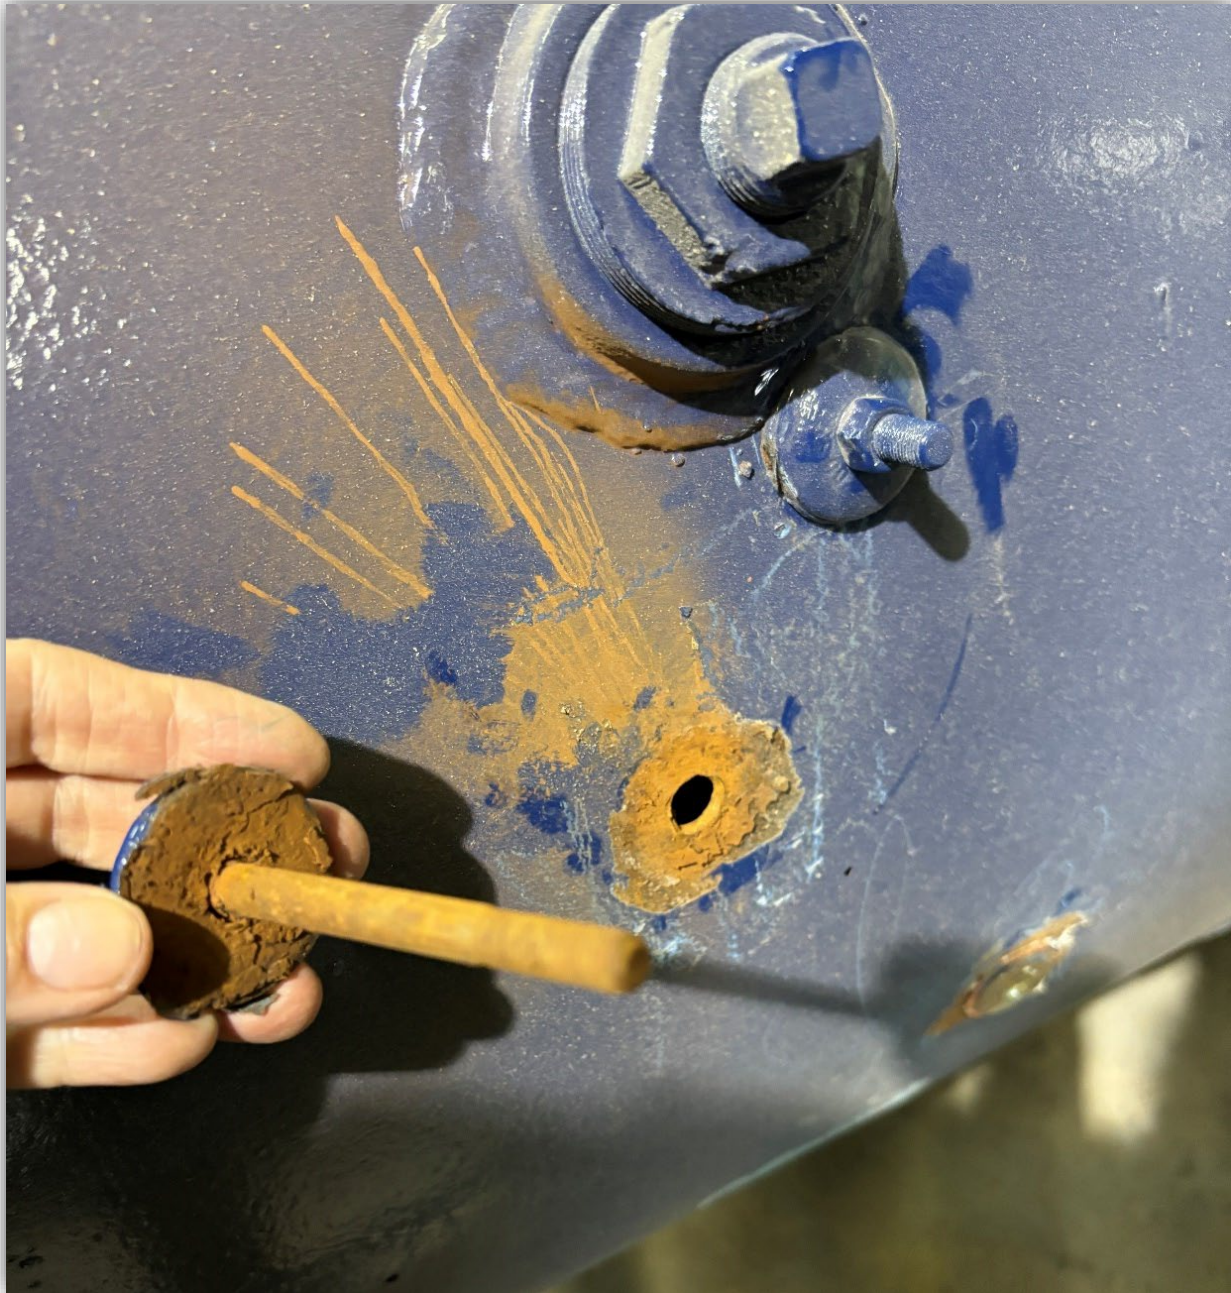
- Supply Tank 3 had holes drilled in the shell, that had been disguised by the insertion of bolts with wide washers, affixed with silicon. This is indicative

Image 24 - Supply Tank 3: owner discovered that three 3/8" decommissioning holes had been drilled in the tank in the past, then filled and hidden by inserting a bolt and washer and affixing with silicon.
