Incident Summary #II-740996-2018 (#8516) (FINAL)

Incident Date	September 6, 2018
Location	Deroche
Regulated industry sector	Gas - Propane system
Qty injuries	0
Injury description Injury rating	NA
	None
Damage description	An underground plastic gas line was punctured resulting in an uncontrolled release of propane gas. The line had to be cut and capped for future repair
Damage rating	Moderate
Incident rating	Moderate
Incident overview	A homeowner digging a hole for a protection post for the propane gas meter on his mobile home hit the underground line. The resulting gas leak required the gas to be shut off to the entire mobile home park.
Site, system and components	Gas distribution system The mobile home park where the incident took place has propane supplied to the 109 individual sites by a privately owned distribution grid. The grid is supplied by an 18,000 US Water Gallon propane storage tank. A gas fired propane vaporizer is installed in the system to heat liquid propane and convert it to propane vapour to ensure enough propane vapour can be supplied during the high demand cold winter season. During the lower demand warmer seasons the propane vaporizer is bypassed and propane v

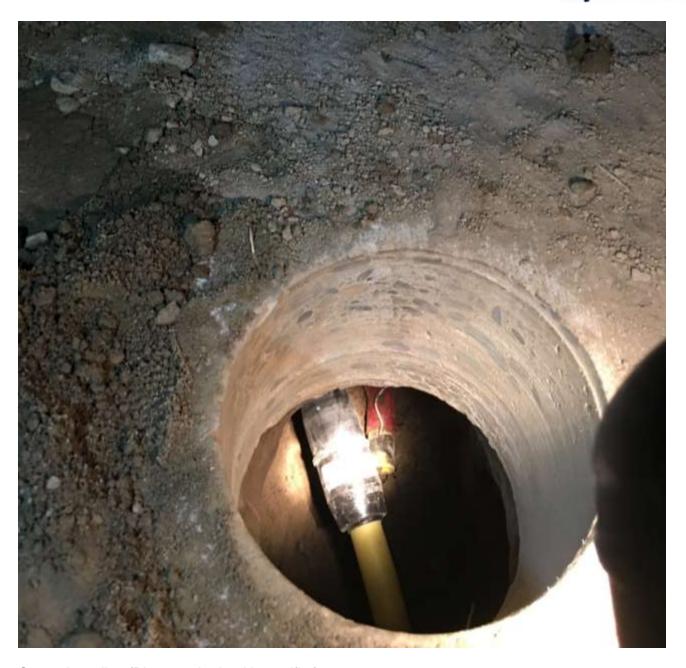
Capped gas line (Picture submitted by notifier)

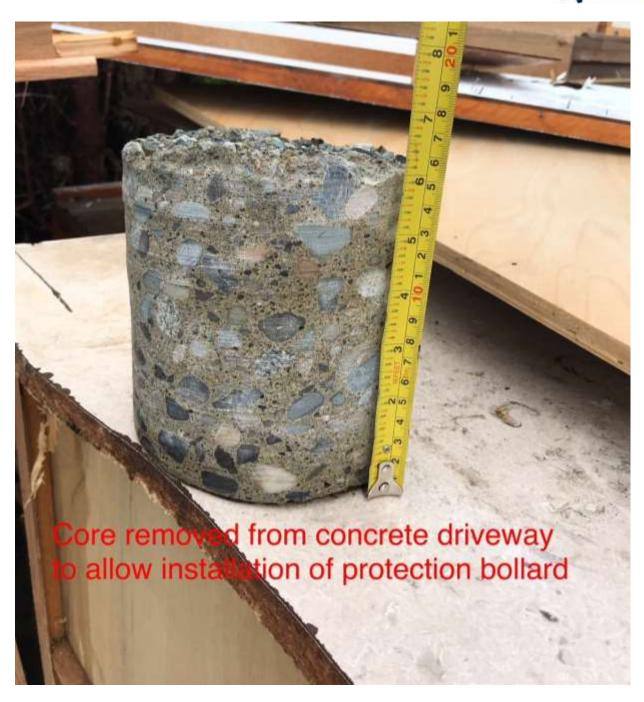
Concrete core

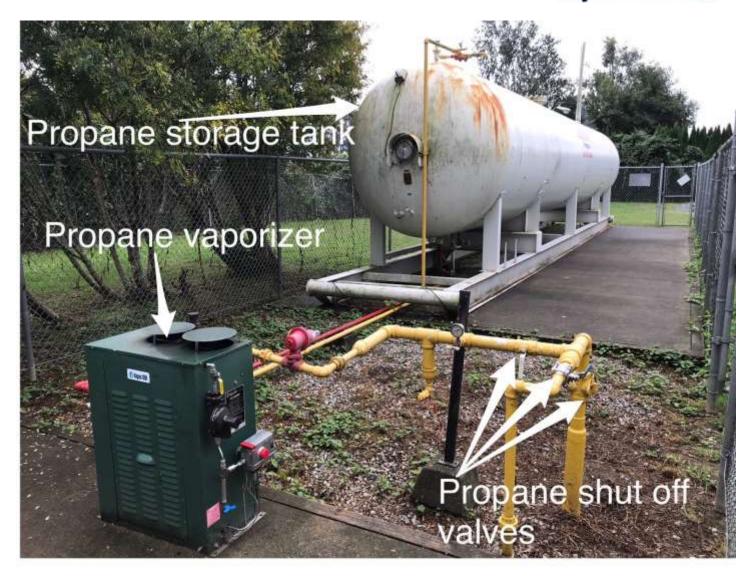
Propane storage tank and vaporizer location

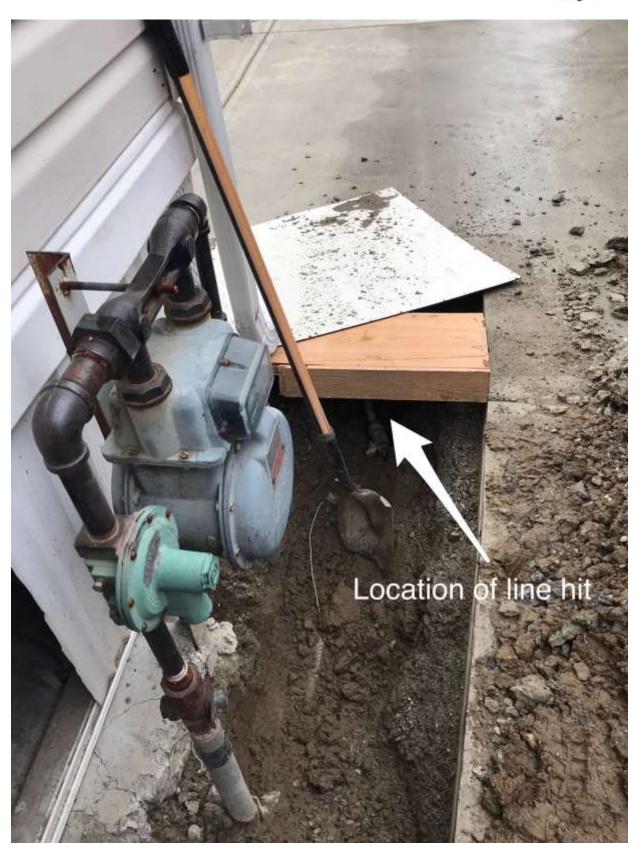
Failure scenario(s)	The owner of a mobile home in a mobile home park had a new concrete driveway installed earlier in the year. The owner was concerned that a vehicle may hit the gas meter for his mobile home while parking. He wanted to install a protection pipe known as a bollard next to the meter to protect it from potential vehicle contact. On Thursday September 6 th 2018 a hole was cored through the concrete driveway approximately 3' to the south of the gas meter. The hole was approximately 6" in diameter and was cored through a section of the concrete that was 6" thick. The gas meter was located on the Southwest corner of the mobile home. Due to some recent markings of gas line location on the street to the East of the mobile home, the owner assumed that the underground gas line from the meter traveled directly East from the meter to the marked location on the street. He did not ask the utility owner or the Park manager to identify or locate the underground line from his meter before excavating. After the hole in the concrete was cored, he augured a hole in the gravel approximately 12- 14" below the bottom of the 6" thick concrete. He did not spot a gas line in the hole. When the round steel post was inserted into the hole it stuck the plastic gas line and punctured a small hole in the side of it. Propane gas at a pressure of 10 Psi began to leak out of the hole in the gas line.

Propane gas meter and location of line hit.
