## Incident Summary #II-1613228-2023 (#39797) (FINAL)

SUPPORTING INFORMATION	Incident Date	October 2, 2023	
	Location	Kitimat	
	Regulated industry sector	Electrical - Low voltage electrical system (30V to 750V)	
	Impact	Qty injuries	1
		Injury description	1st and 2nd degree burns on the left wrist and hand, right wrist, and facial area.
		Injury rating	Moderate
	Damage	Damage description	Melted conductor and breaker switch terminal due to arc flash.
		Damage rating	Moderate
	Incident rating	Moderate	
	Incident overview	An electrician at a large industrial facility, completed electrical conductor checks inside equipment in a substation. The worker accessed a breaker bucket inside the substation and shorted phase to phase on the line side of the breaker switch that was energized at 347/600V. This resulted in an electrical short, creating an arc flash which caused burns to the worker. The worker was not contacted by electricity but received medical treatment for 1st and 2nd degree burns.

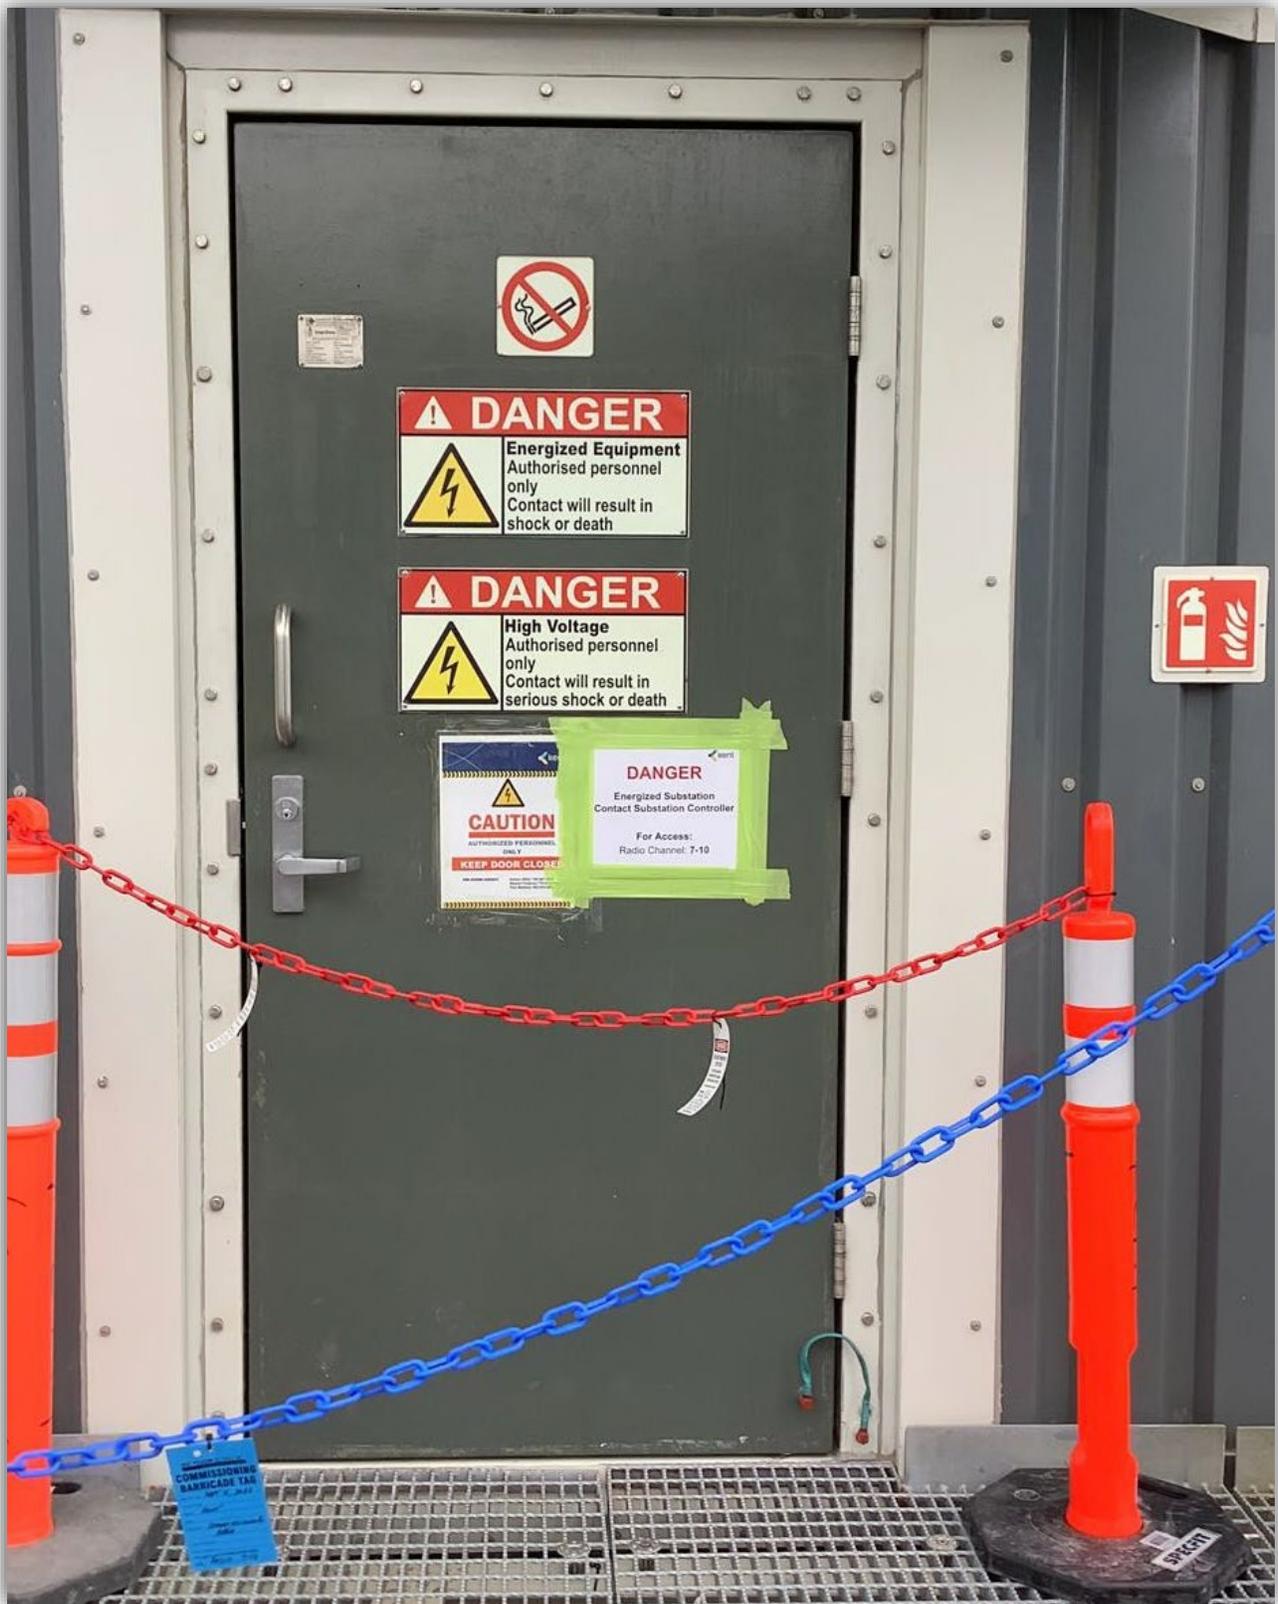
Image 1 – Access door into substation with warning signs.

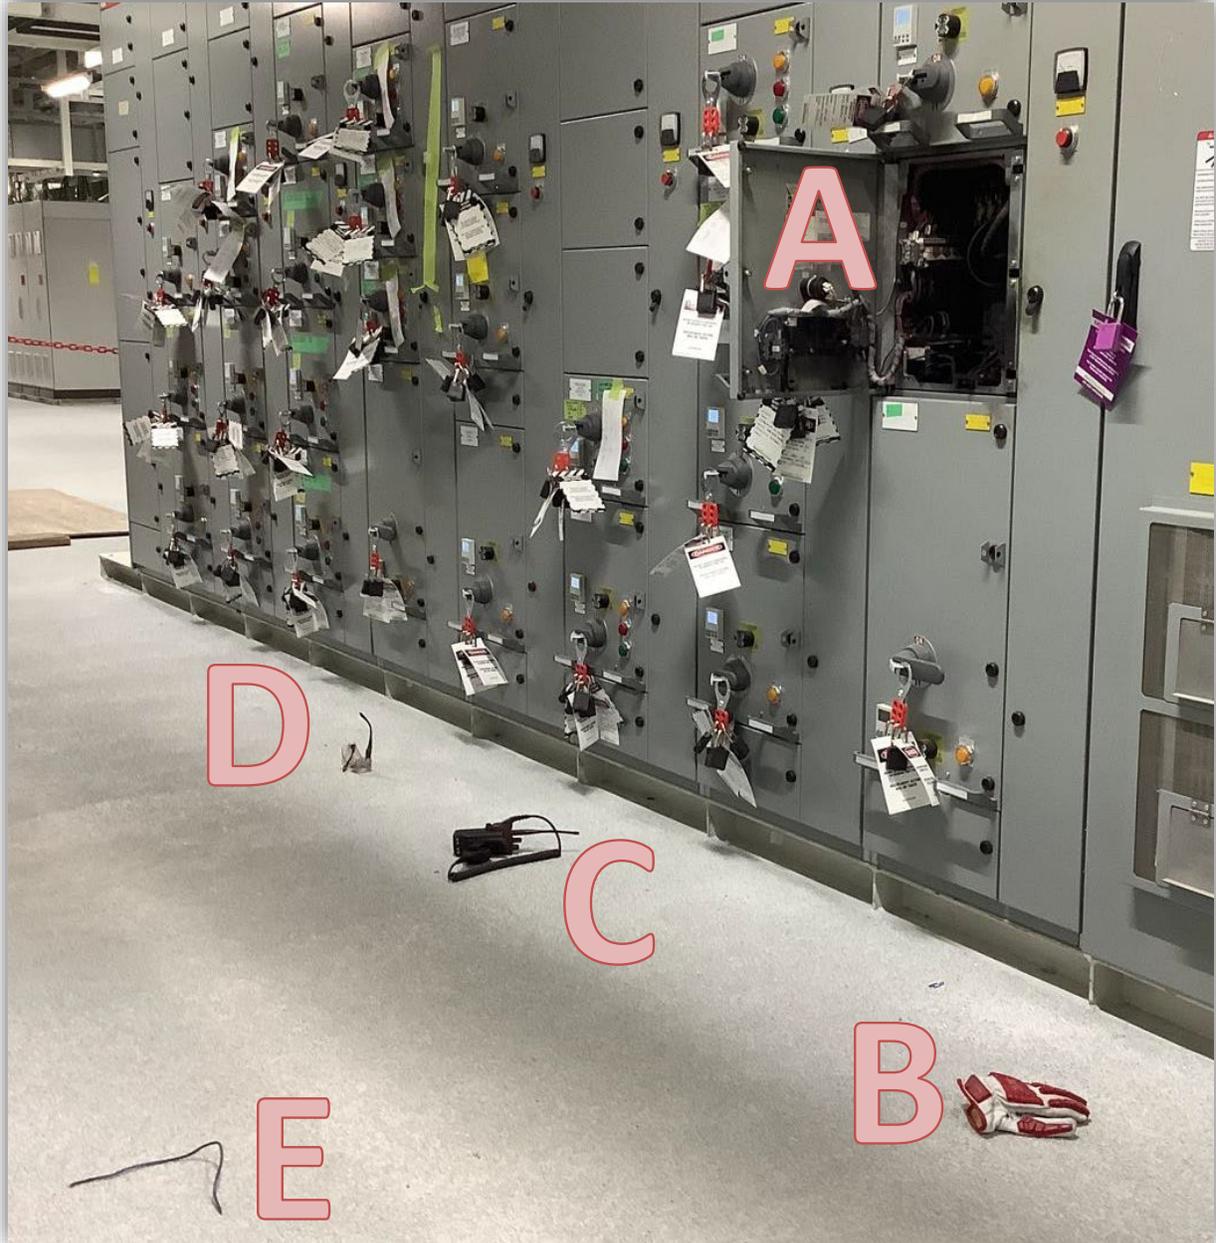
Image 2 – Substation electrical cabinets.

- [A] The MCC bucket where the arc flash occurred.
- [B] The left-handed glove removed by the worker before the incident.
- [C] The handheld radio the electrician was using to communicate to the other workers.
- [D] Safety glasses the electrician was wearing.
- [E] The jumper wire used to short across the two energized terminals.

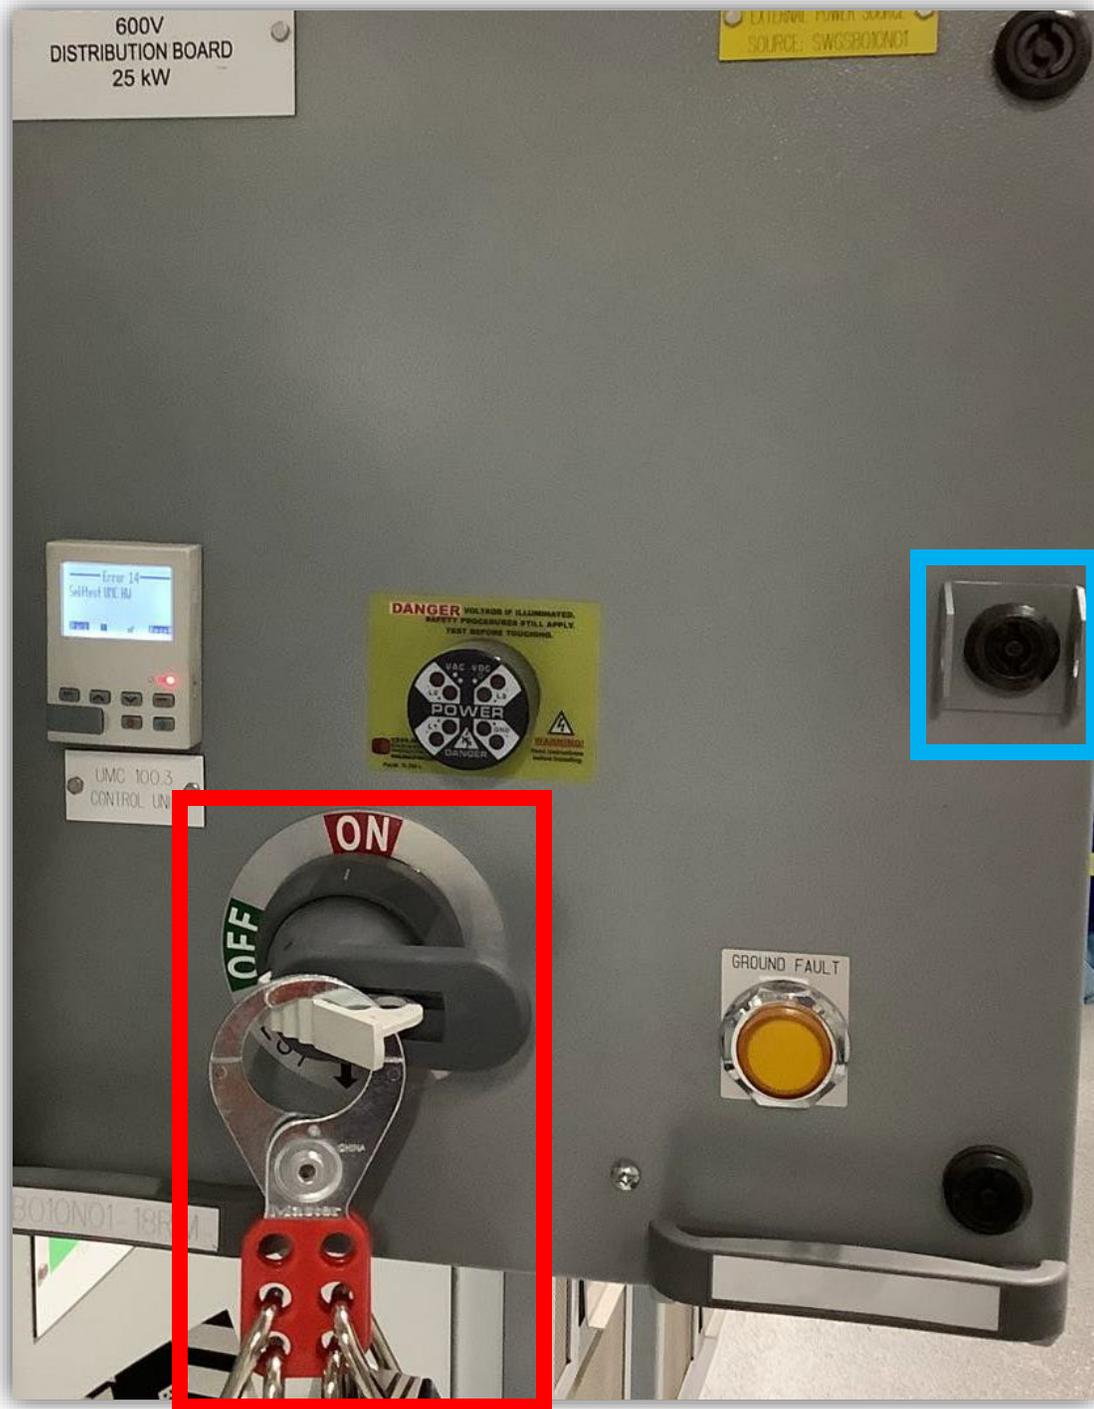
The load side conductors in the MCC had been terminated to the breaker switch by other electrical contractors before the field wiring was complete. The rotary handle on the MCC bucket was in the off position and had several lockout locks and tags affixed to it. The breaker switch in the off position disconnected power to the load side of the breaker switch while the line side of the breaker switch was still energized with 600V. The rotary handle in the off position does not prevent the cabinet door from being opened which allowed access to energized equipment. Opening of a cabinet that contained energized 600V equipment required arc flash resistant PPE. The electrician was not wearing arc flash resistant PPE but was wearing fire retardant coveralls, a hard hat, safety glasses and gloves.

Image 3 – The MCC bucket door open. [RED] The lockout hasp with multiple locks affixed to the breaker switch, and rotary handle in the off position. [BLUE] One of three, quarter turned door latches that has a bracket allowing for a lock to prohibit opening of the door.

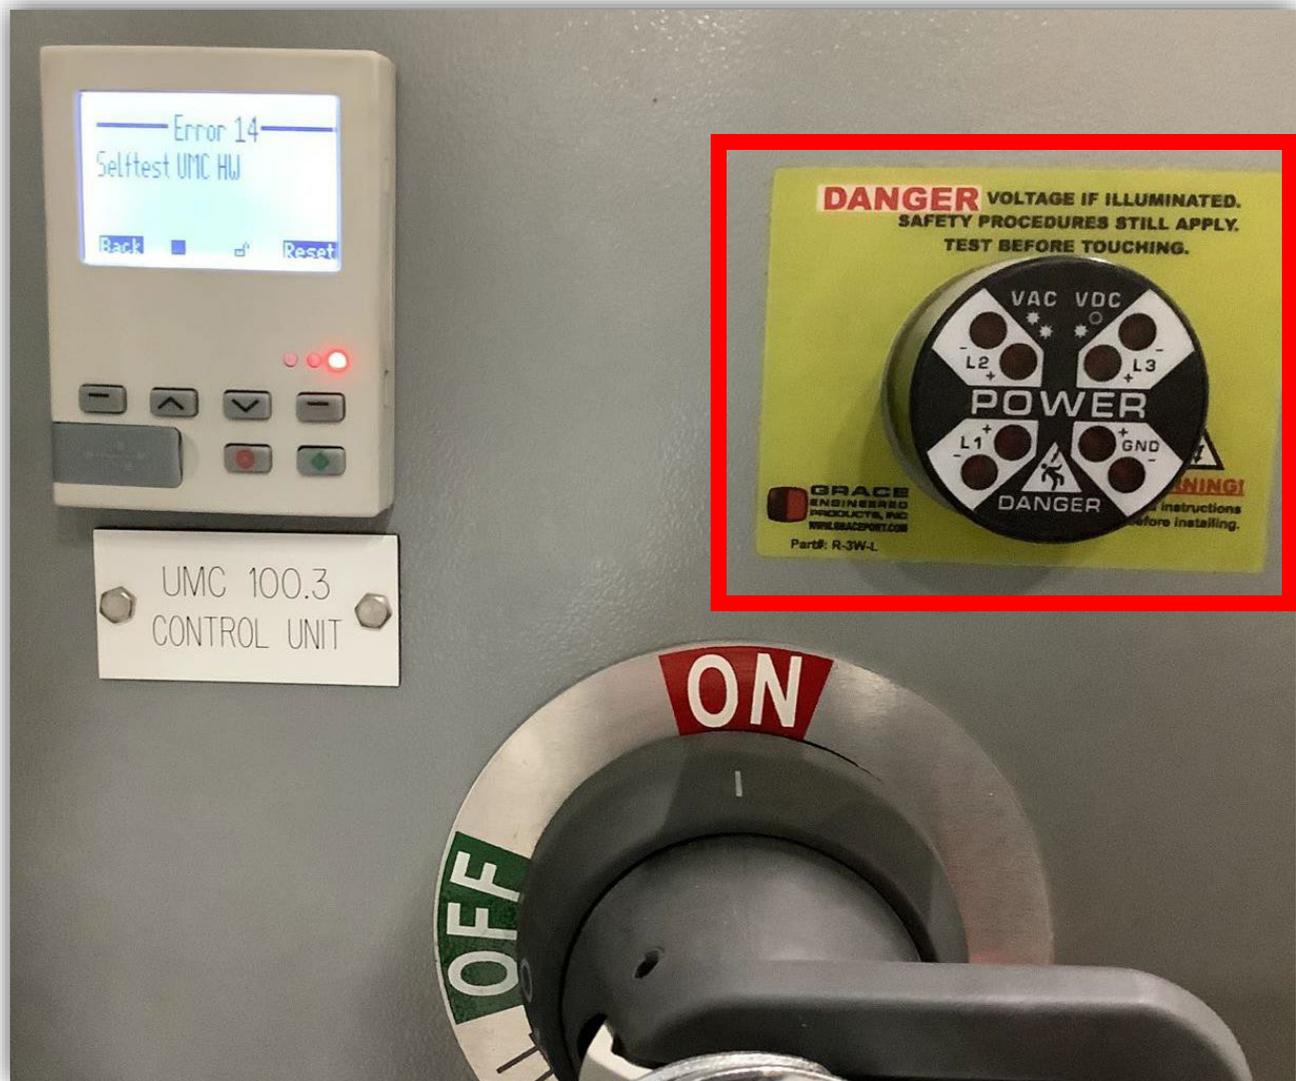
supplement for establishing electrically safe work conditions and are wired to show the presence of voltage. The typical installation of an indicator is to be wired downstream of the fused safety switch or breaker. With the breaker/switch closed “on” the indicator lights would be lit identifying dangerous voltage inside, but when the breaker/switch is off, the LED lights would not be lit or indicate dangerous voltage from the energized line side conductors which may be inside the enclosure.

Image 4 – Closeup of MCC bucket door. [BOX] The through door voltage indicator identifying voltage on the load side of the breaker switch inside the cabinet.

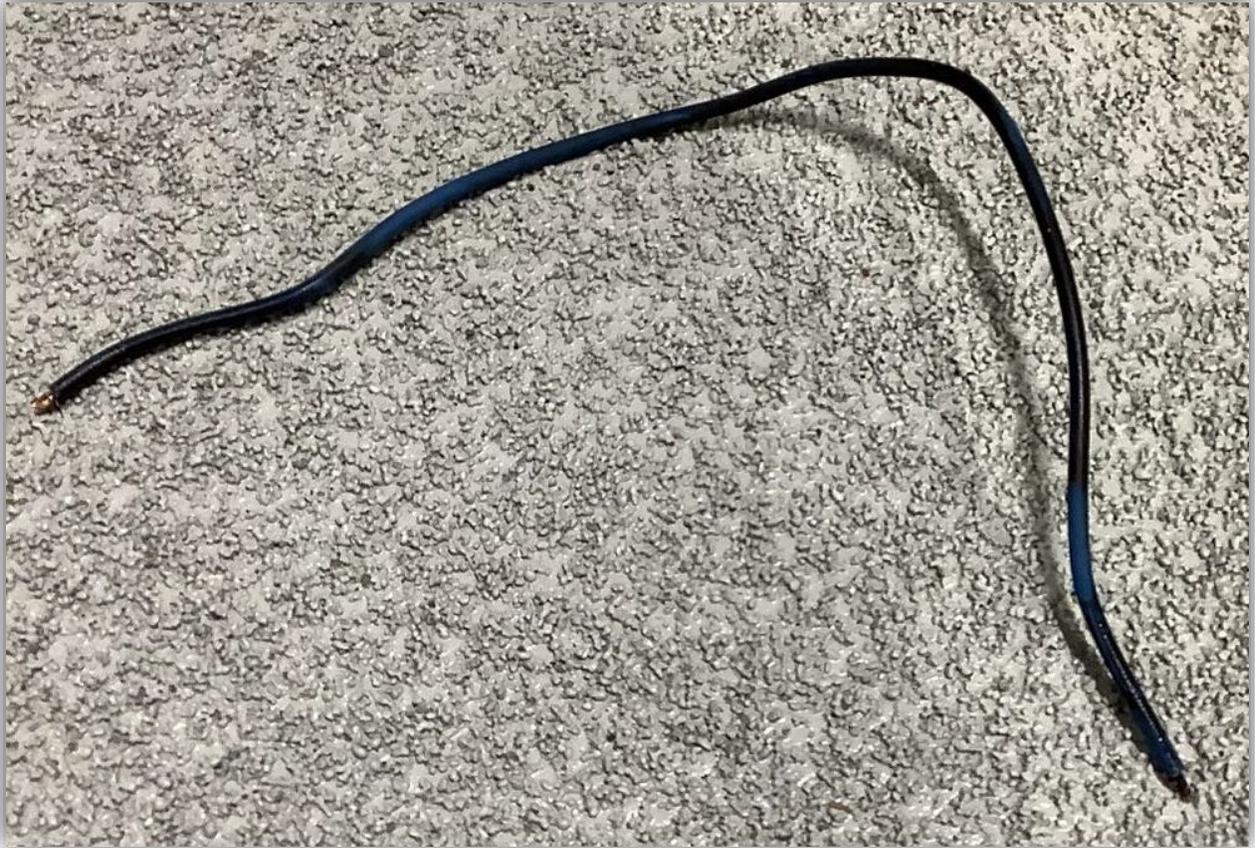
They removed their protective glove on their left hand because they found it difficult using the jumper wire with the gloves on. They intended to short the conductors on the load side of the breaker switch with a small jumper wire but mistakenly shorted the conductors on the energized line side. The shorting of the two 600V 3 phase conductors created an arc flash that expelled intense heat, gasses, and molten metal particles burning the individual.

Image 5 – Closeup of the jumper wire used to short across the energized line side terminals.

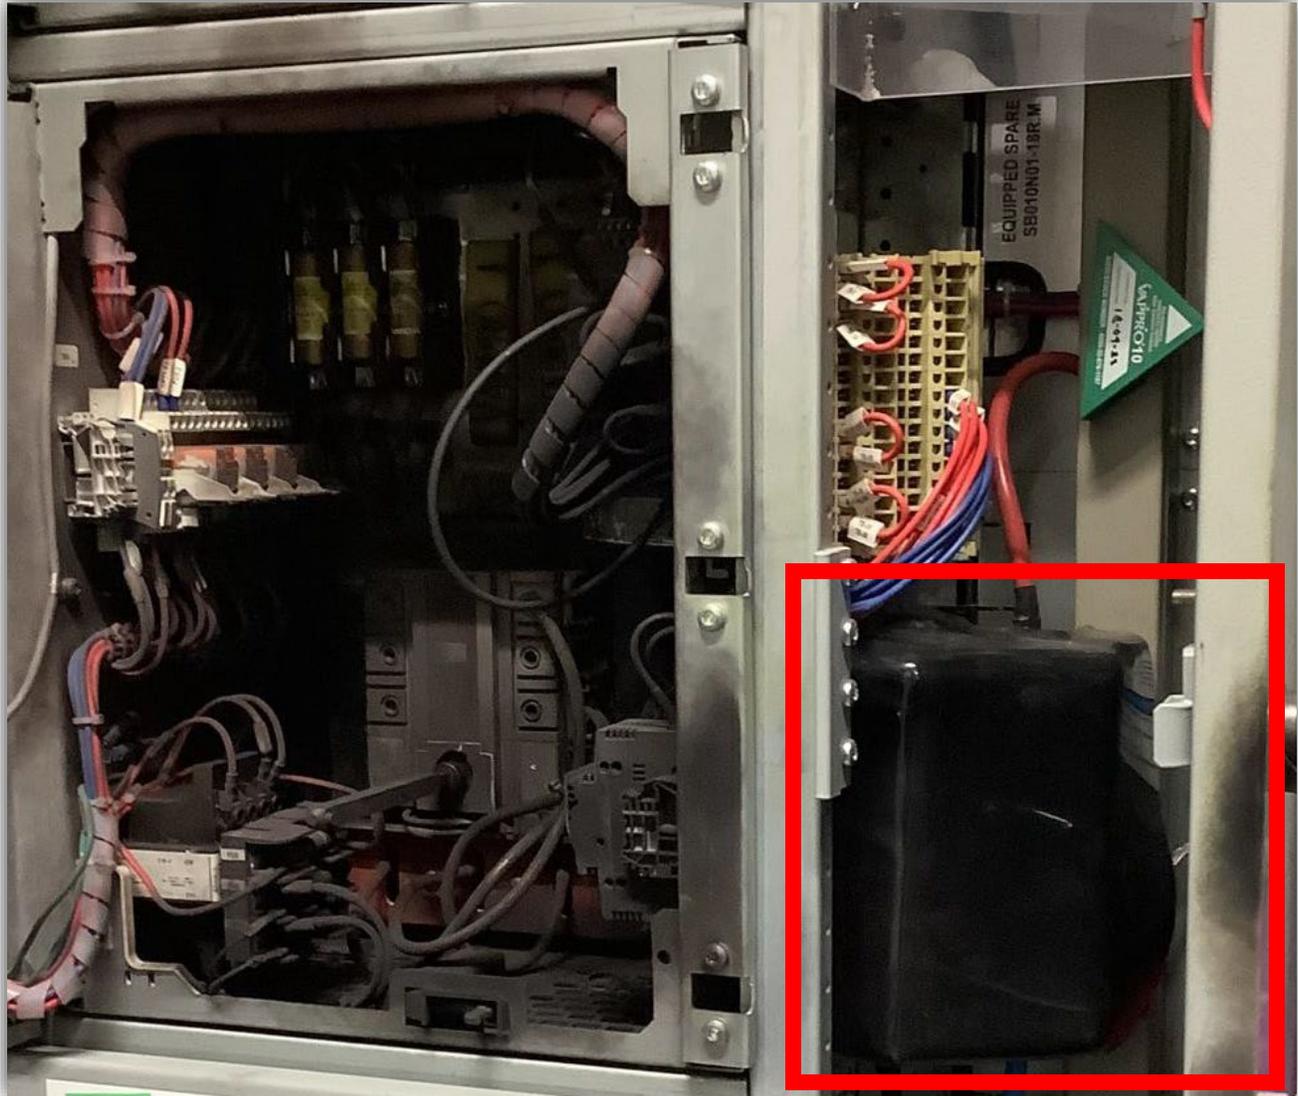
The orientation of the breaker switch was horizontal and had the line conductors on the right-hand side and the load conductors on the left-hand side. The correct location to test the load conductors was in an adjacent raceway cabinet on the right-hand side of the MCC bucket. Without testing the conductors before touching it may have been assumed the load side was on the right-hand side of the conductors when in fact it was the opposite.

Image 6 – Inside the MCC bucket showing black soot resulting from the arc flash. [BOX] The point-to-point testing should have taken place on the de-energized load side conductors inside the raceway to the right of the MCC bucket.

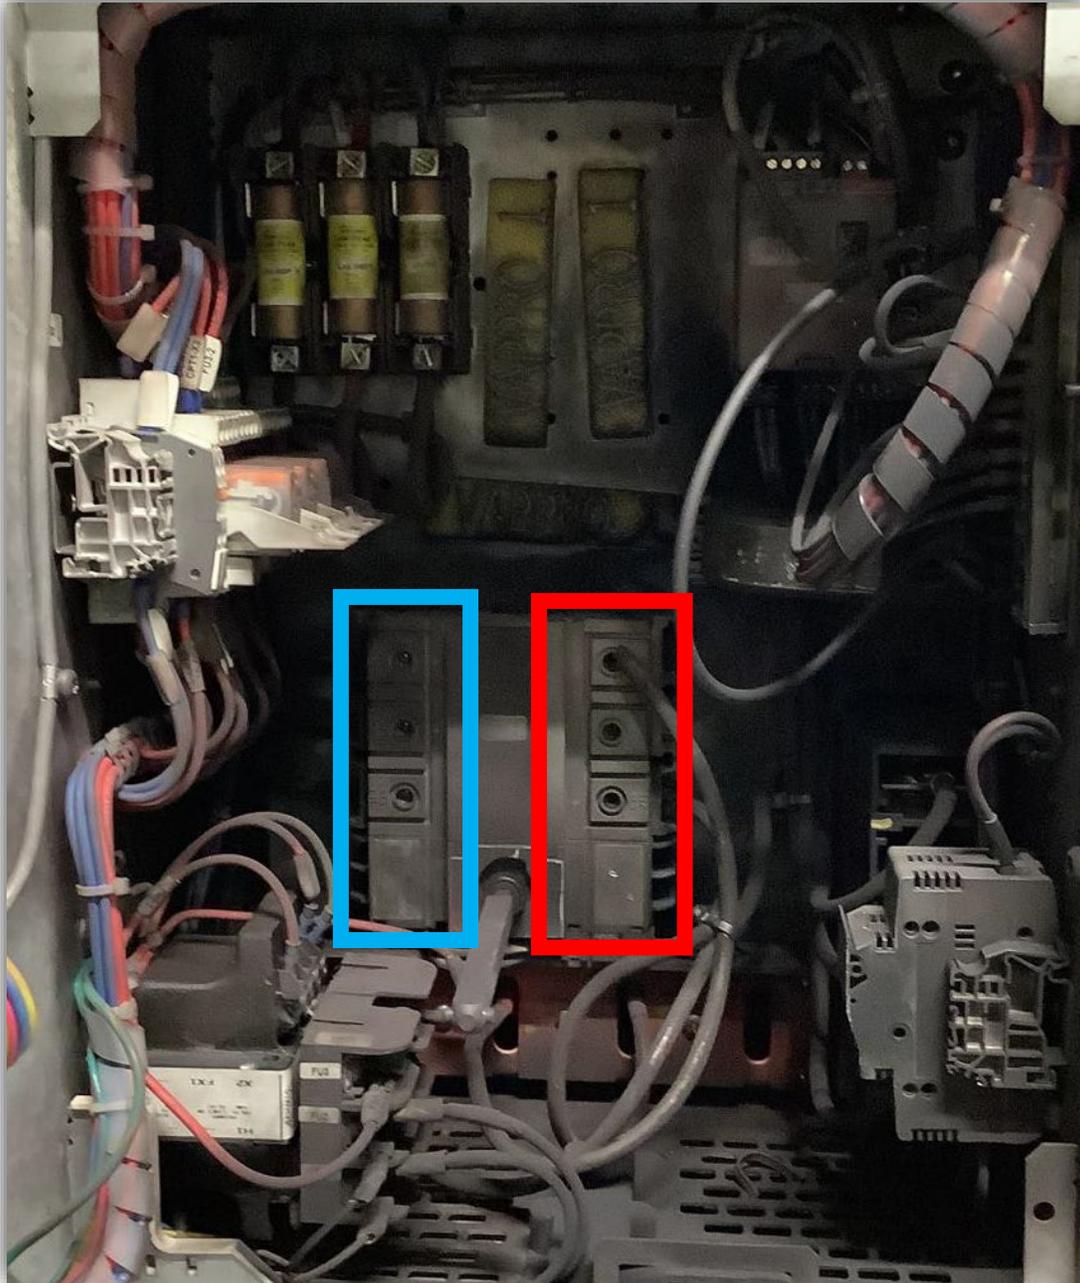
- B) The design of the electrical system and components.
  - The horizontal orientation of the breaker switch with the line side conductors connecting on the right side along with inadequate identification of the system components and locations relied on workers familiarity and testing to identify the present hazards.
  - The through door voltage indicator not identifying line side voltage present inside the MCC bucket contributed to the workers understanding that there were no energized components inside the cabinet.
  - The MCC bucket door latch not being locked allowing the cabinet door to be opened with breaker switch in the locked off position while still containing energized line side equipment allowed the worker to proceed with opening the cabinet and being exposed to hazardous energized equipment.

Image 7 – Inside the MCC bucket. **[LEFT]** The load side of the horizontally installed breaker switch (De-energized when breaker switch open “off”). **[RIGHT]** The line side of the horizontally installed breaker switch (Energized when breaker switch open “off”).

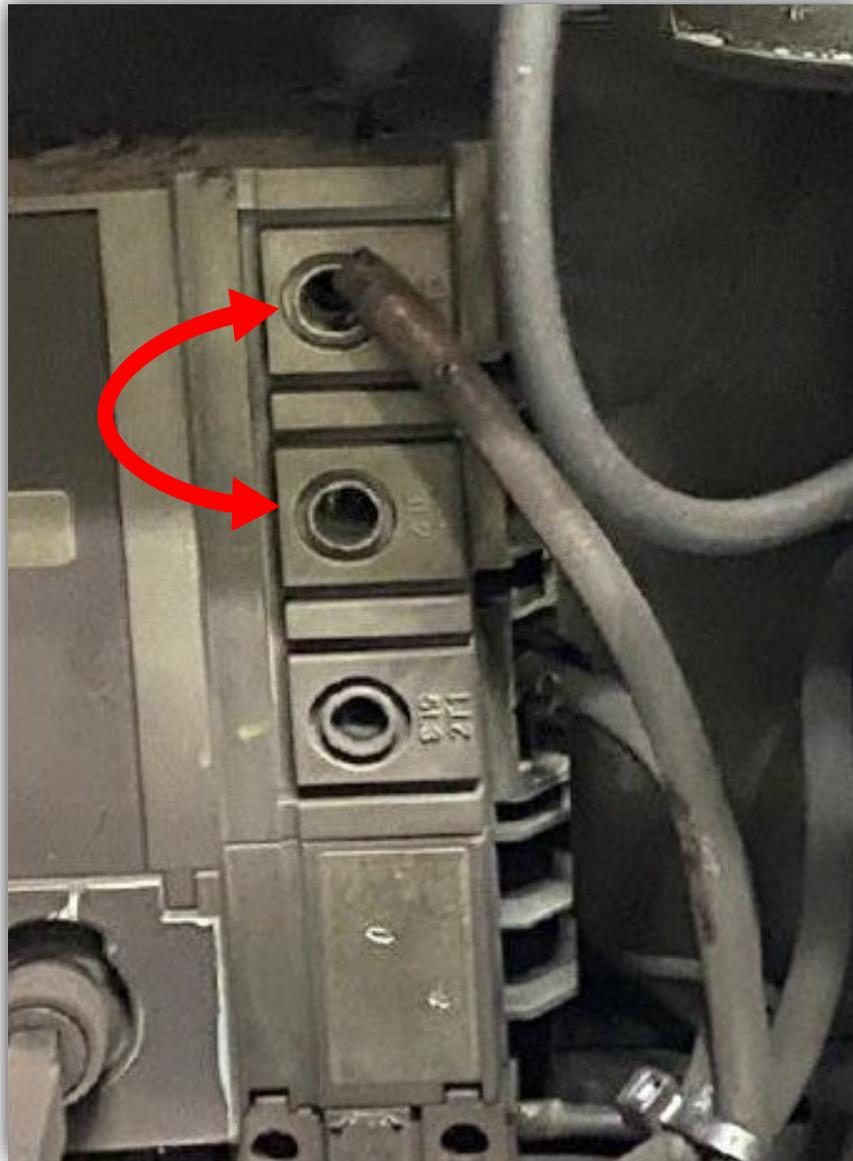
The electrician shorting out energized conductors on the line side of the breaker switch instead of the intended de-energized load side of the breaker switch caused the arc flash and injury.

Image 8 – Closeup of line side breaker switch terminals. [Arrow] The energized line side terminals the electrician shorted out with the jumper wire causing an arc flash. Conductor melted and disconnected from terminal due to arc flash.
