## Incident Summary (5613292) Final

| | Regulated industry sector | | Passenger ropeway, passenger conveyor | |
| | Incident overview | | While accessing the tail drum of a passenger conveyor in order to perform routine maintenance, the worker fell into the moving equipment. The worker was pulled between the belt and the snub pulley. The worker was reported to have died as a result of the injury. | |

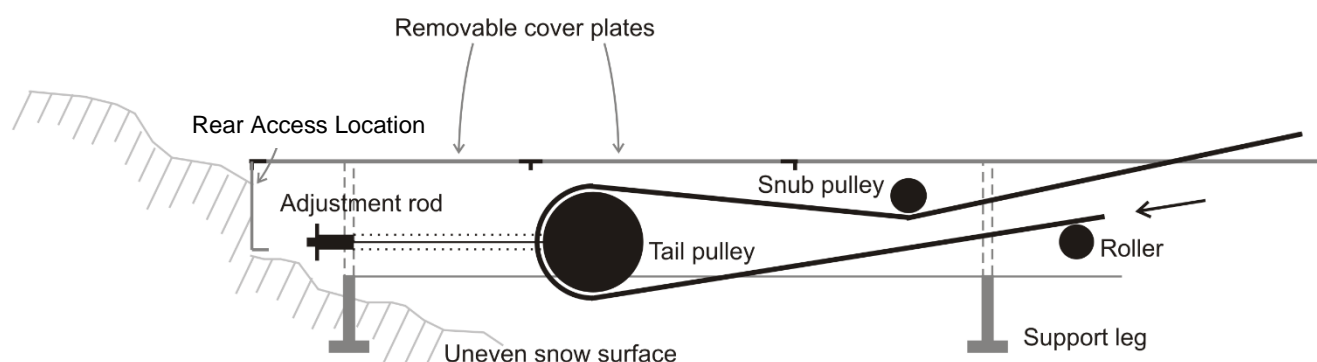
| | Facts and evidence | | <p>Physical condition of conveyor</p> <ul style="list-style-type: none"><li>- There was some build-up of snow in the tail unit and it was snowing lightly at the time of the incident</li><li>- The worker was reported to be found on his back between the conveyor belt and snub pulley (see Figure 1)</li><li>- Both cover plates at the tail drum were removed</li></ul> | |

Figure 1: Depiction of complete tail unit.

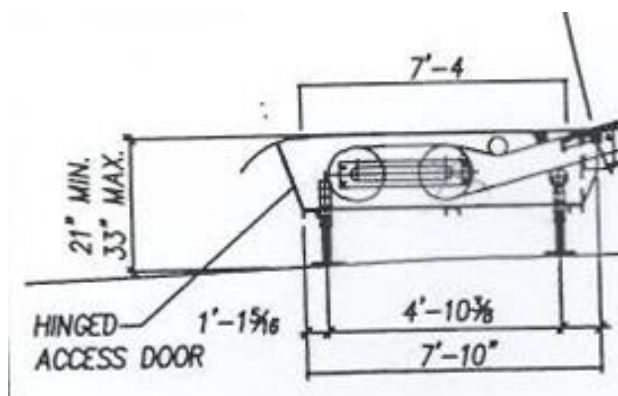
| Facts and evidence, continued | <p>The manufacturer's maintenance instructions and bulletins do not define an adjustment procedure and access locations other than shown on Figure 2.</p> <p>NOTE: Some of the procedures suggested by the manufacture may not be practicable due to the small work space and limited visibility of the tail drum through the hinged access.</p> <p>The worker:</p> <ul style="list-style-type: none"> <li>- was a licensed millwright with approximately 20 years of experience.</li> <li>- removed the panels prior to stopping the conveyor belt.</li> <li>- did not request the lift operator to stop the conveyor for maintenance</li> </ul> |

Figure 2: Portion of manufacturer's drawing indicating rear access to adjustment rods.

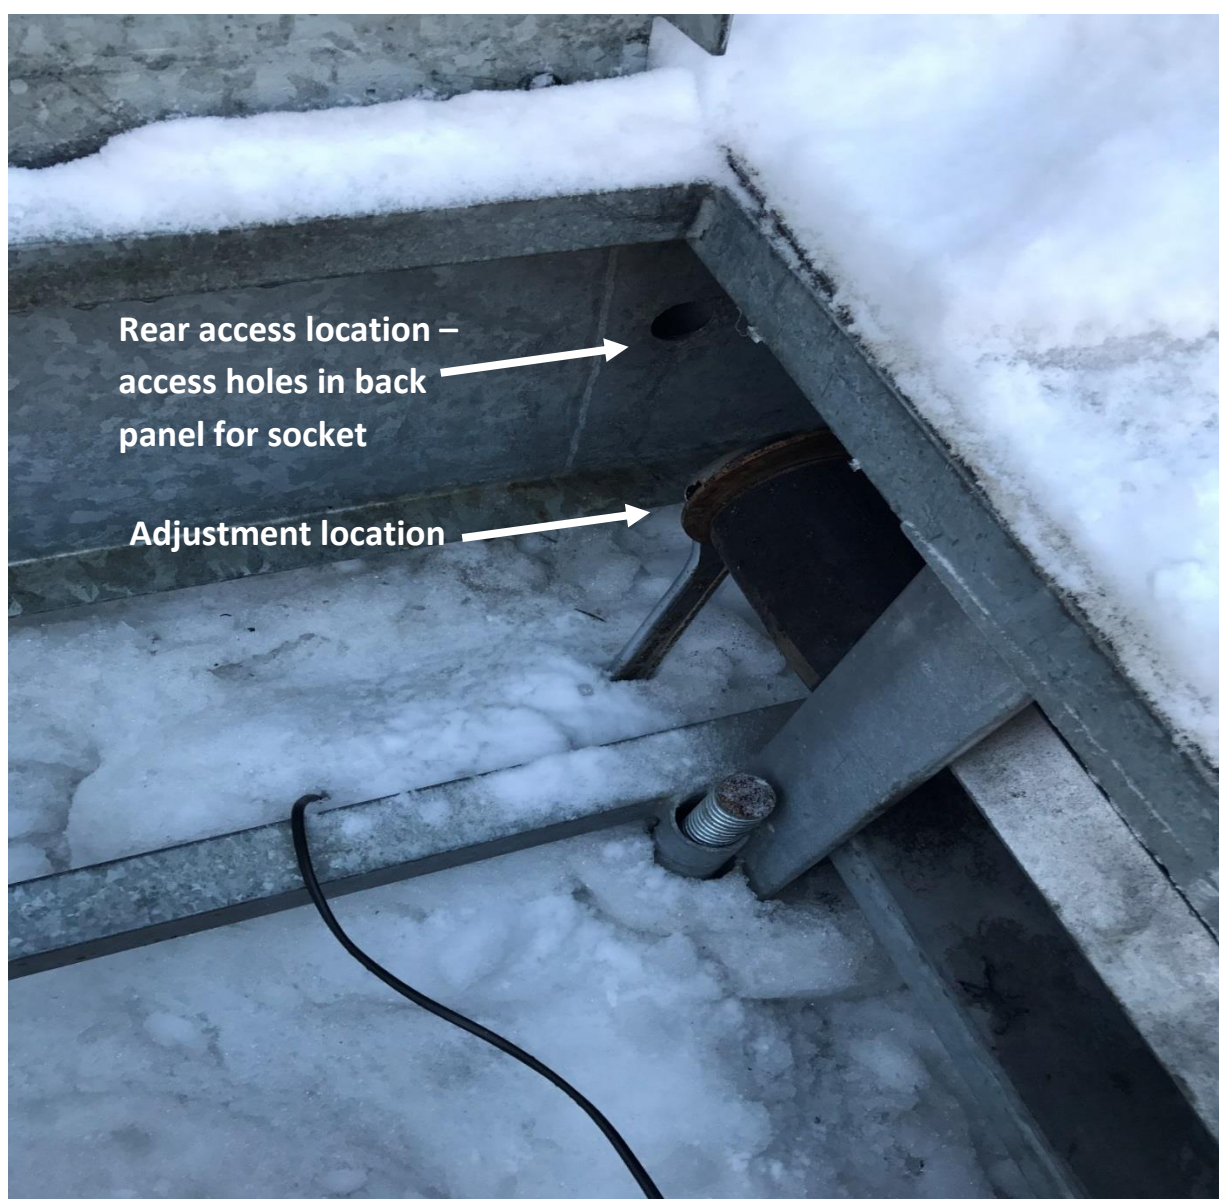
Figure 3: Adjustment rod with tension spring.

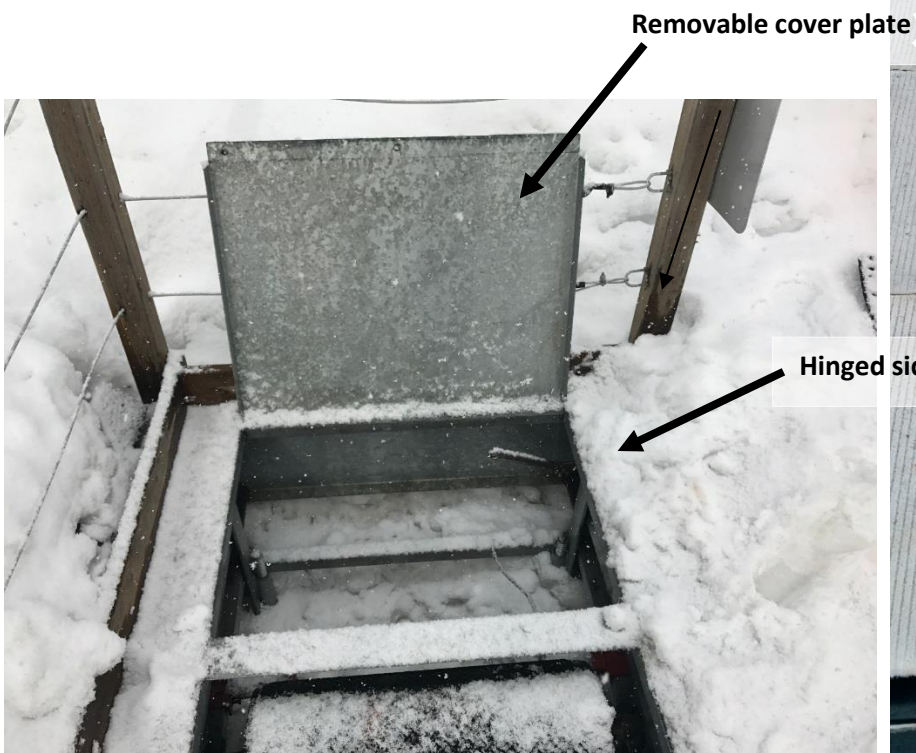
Figure 4: Opening of the tail unit

Figures 4 and 5 show the same hinged side panel. In Figure 4, the panel is closed and covered with snow.

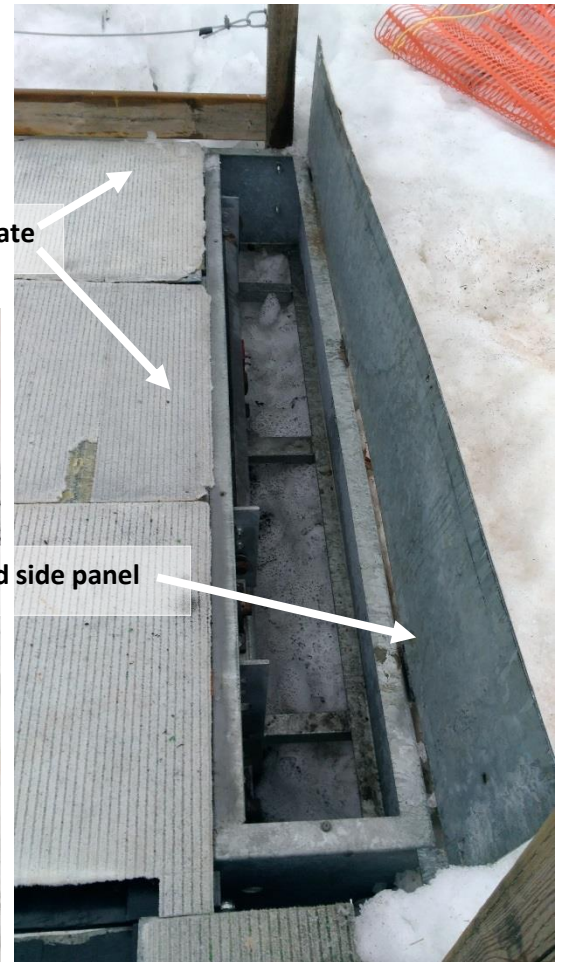
Figure 5: Hinged side panel open.

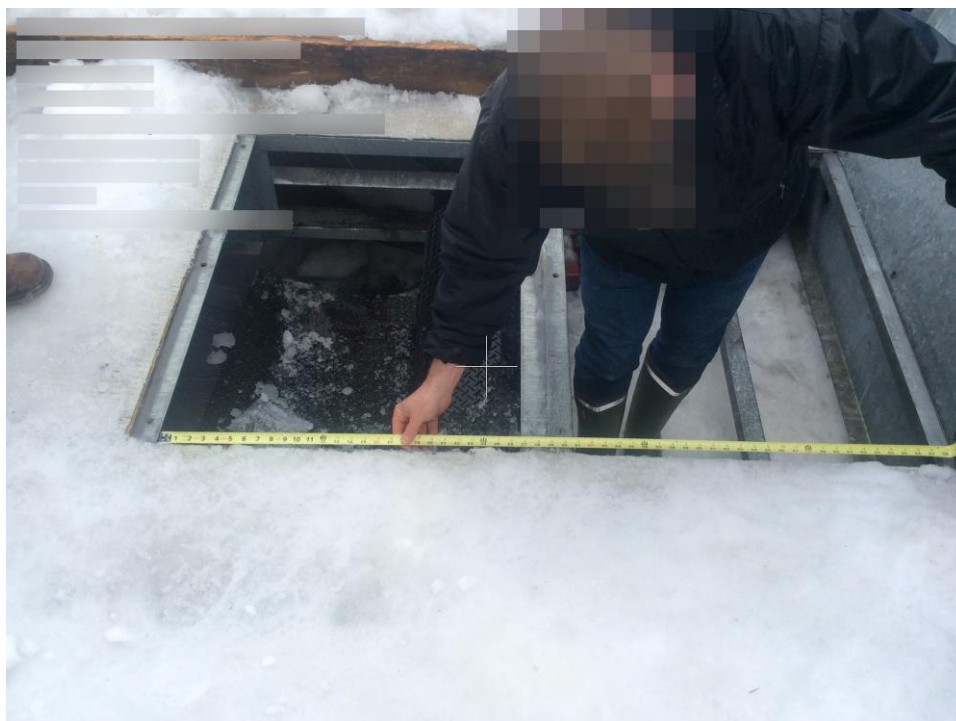
Figure 6: Tail unit, shows limited work space and tripping hazards when adjusting the belt.

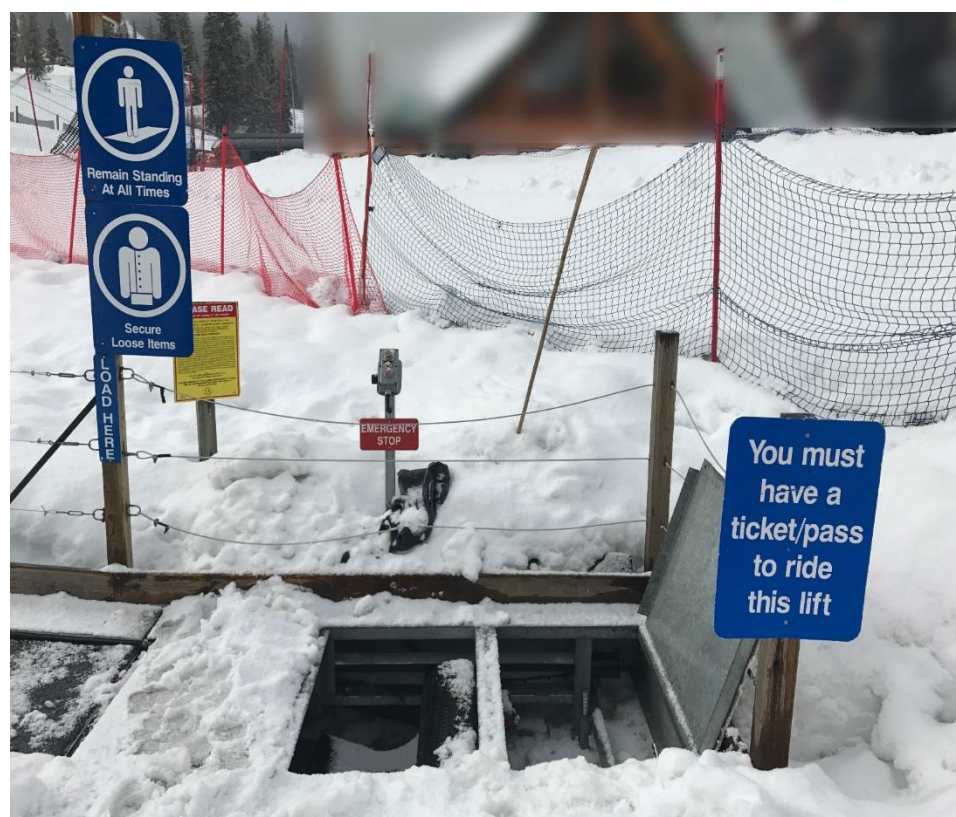
Figure 7: View of tail unit and drum. Snow covered and slippery surfaces. Tripping hazards.

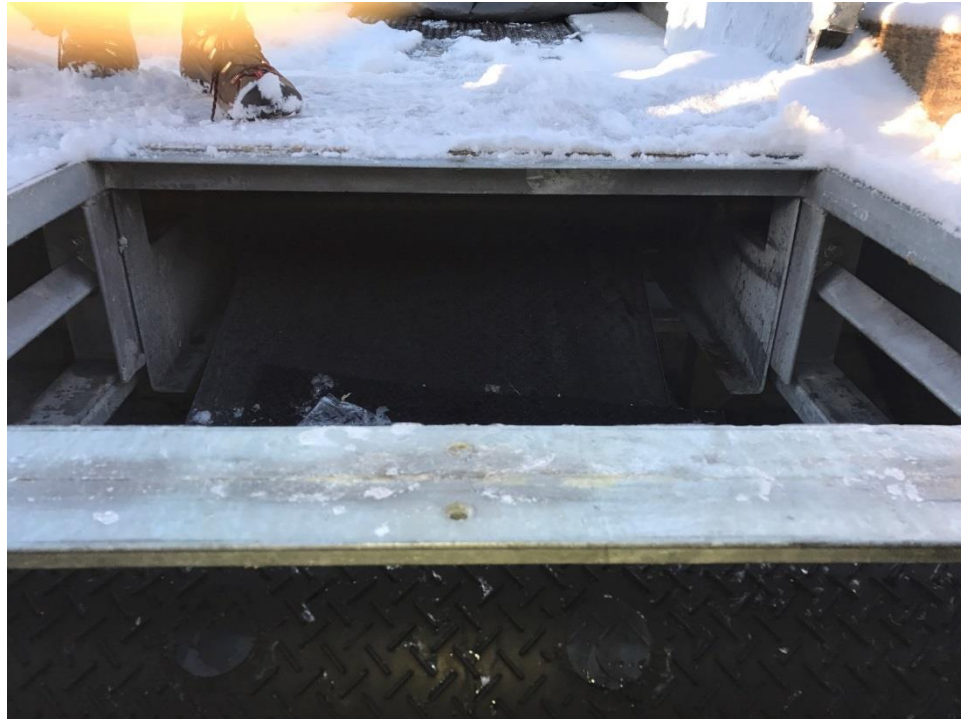
Figure 8: Belt entry where worker was found in equipment. Tripping hazard in foreground.
