## Kicking Horse Gondola Hanger Load Analysis

January 26, 2026 | Revision PA

Submitted to: Technical Safety BC  
Prepared by McElhanney Ltd.

On March 10<sup>th</sup> 2025 a gondola on Kicking Horse's Golden Eagle Express suffered a catastrophic failure of the hanger arm connecting the cabin to the grip assembly as it was leaving the lower station.

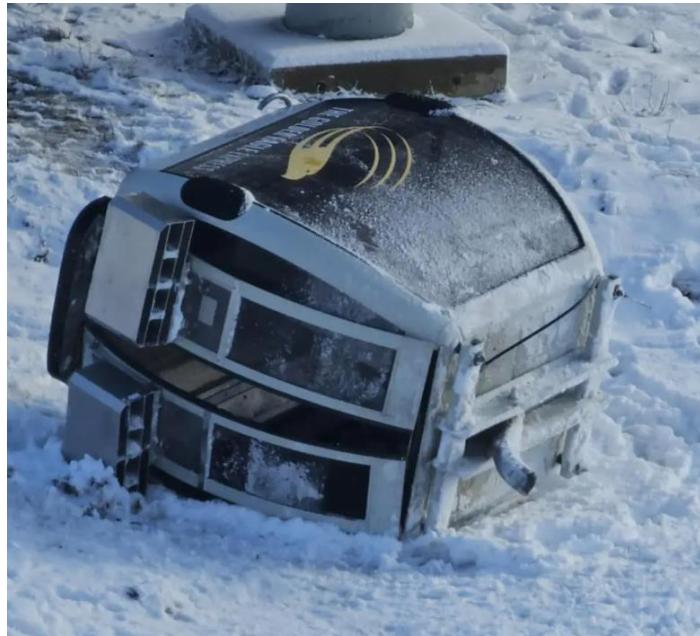
*Figure 1 - Gondola cabin that fell from Kicking Horse's Golden Eagle Express lift.*

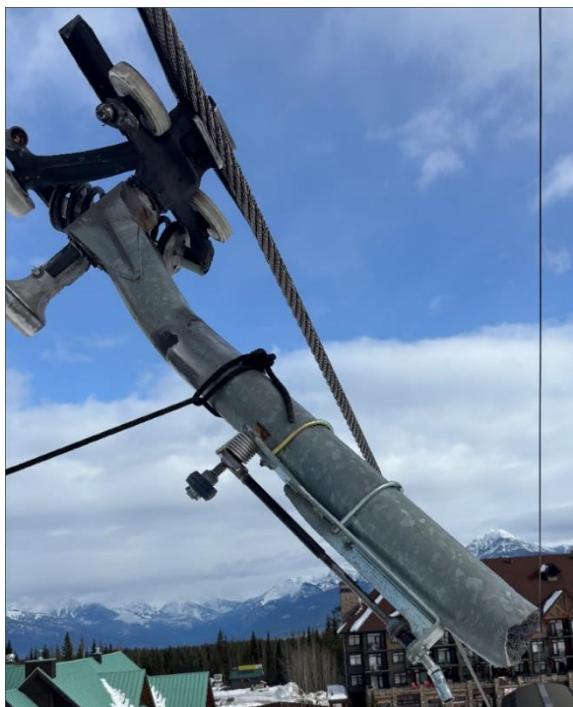
*Figure 2 - Upper portion of the broken hanger*

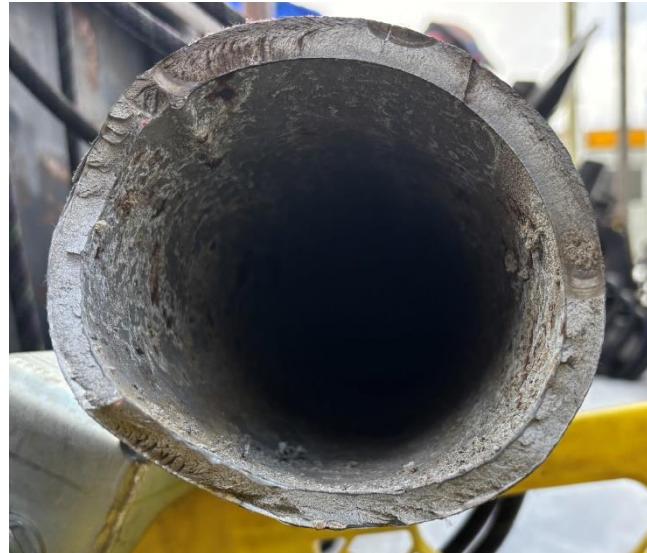
*Figure 3 - Failure surface of the broken hanger, with fatigue markings visible at the '1 o'clock' position*

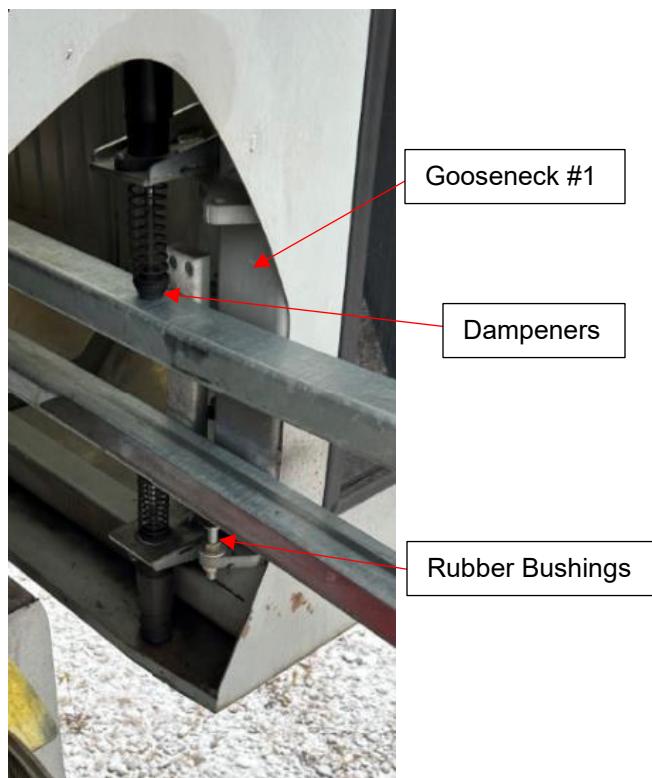
Based on the documentation provided by LPOA, the installed trumpet assembly should have two spring dampers and two rubber bumpers at gooseneck #1, and two rubber dampers at gooseneck #2. Inspection of the lift in the fall of the 2025 and review of previous photos showed that some of these were missing. It is unclear how long these were missing for.

The missing rubber dampeners would cause the trumpet to be more flexible and cause a couple of issues. The increased flexibility could cause lateral deflection that would result in the carrier missing the trumpet however this is less likely with the additional items added. Additionally, there is potential that the increased flexibility causes a larger rebound acceleration from the spring effect structure.

*Figure 10 - Missing Upper Bumper Return Entry*

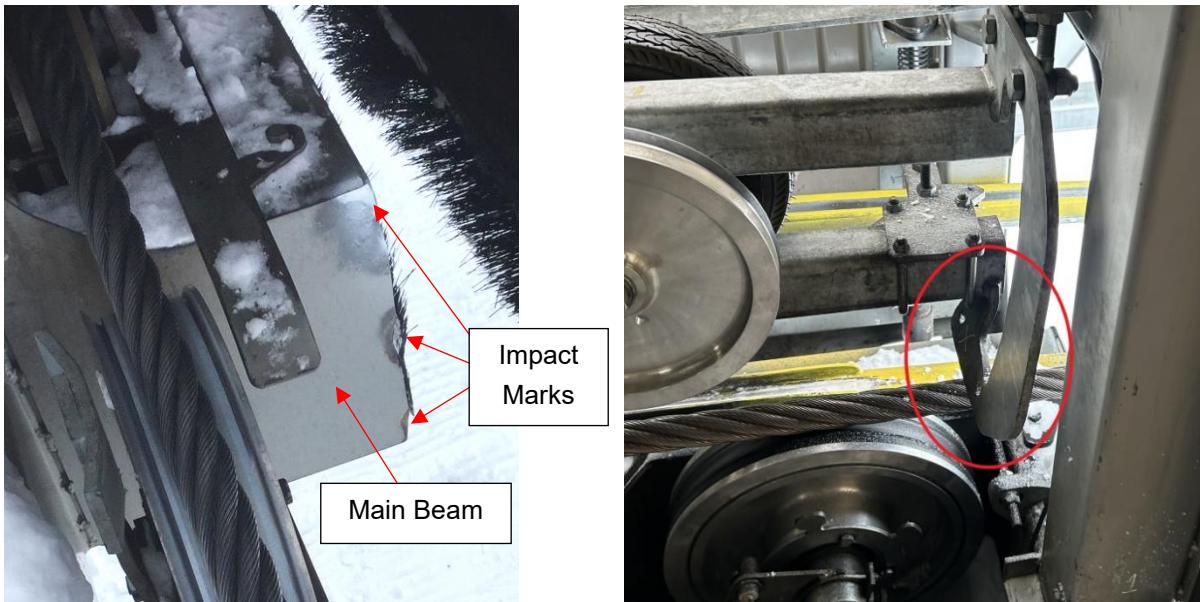
Shortly after installation of the gondola an issue with the terminal entry system was found. During certain conditions the lateral roller could miss the trumpet all together. This would result in the upper part of the hanger impacting the main beam. An impact of this nature would cause a large force that is difficult to estimate. Evidence of such impacts were still visible in the fall of 2025 in the form of marks on the edge of the main beams of the terminals, bending of the first tire beam supports and on the upper hanger's gussets, as shown in Figure 11.

The marks on the main beam of the upper terminal are more pronounced than on the lower terminal. There are a few reasons that could explain this:

- Higher winds at the top terminal, which would result in larger swing amplitudes.

- Unbalanced loads, due to uneven passenger loading, are experienced more often on the uphill line.
- The nearest support tower to the bottom terminal is very close so limited lateral rope deflection is possible as the gondola enters the lower terminal. At the upper terminal, however, the nearest tower is much further away, so more rope deflection is possible.

*Figure 11 - Left: Impact marks on the main beam of the upper terminal (arrival side)  
Right: Bending of the first tire beam support*

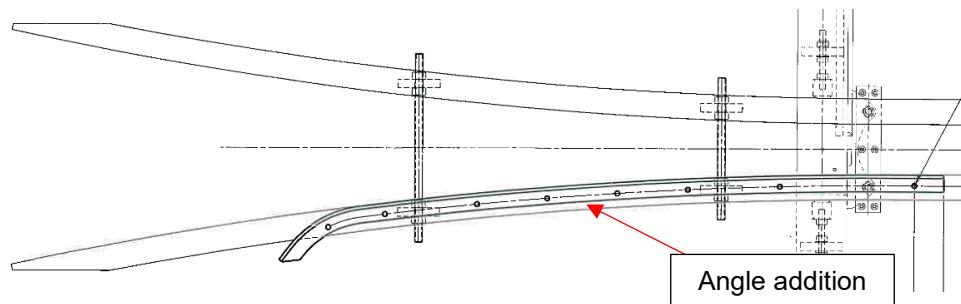
Figure 12 - Angle bracket added to trumpet rail

- March 12, 2002 – The first bulletin of lateral rail misses due to unbalanced loads was issued.
  - Drawing US3039.251 was issued to check the distance from rope to the inside edge or lateral rail.
  - Updated zone 1 switch and rope position drawings soon followed.
  - The bulletin provided no guidance on inspection criteria to carrier or terminals if an impact occurs.
- March 13/14, 2002 – Three new drawings were issued (US3039.250/252 and 253). These show the new zone proximity and rope position switches.
- April 1, 2003 – A new entry guide assembly drawing was created, as shown in Figure 12. This shows an additional bracket that mounts to main beam and directs any carriers into the station to avoid major contact.

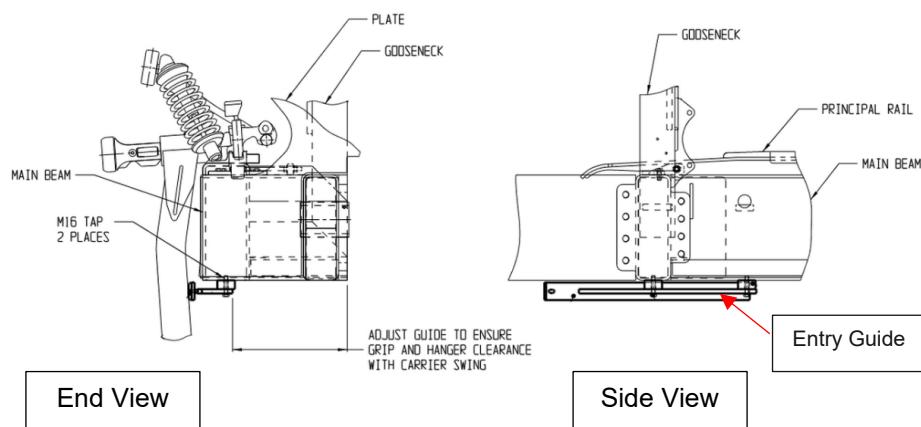
Figure 13 – Main Beam deflector

- February 2, 2007 – A second bulletin was issued for the addition of an angle-steel piece to widen the lateral rail as shown in Figure 13. The bulletin also reiterated the lateral alignment of the lateral rail indicated on the older bulletin.

The combination of ensuring correct setup, widening of the lateral rail and addition of the main beam deflector (entry guide) should ensure that no future major impacts are experienced.

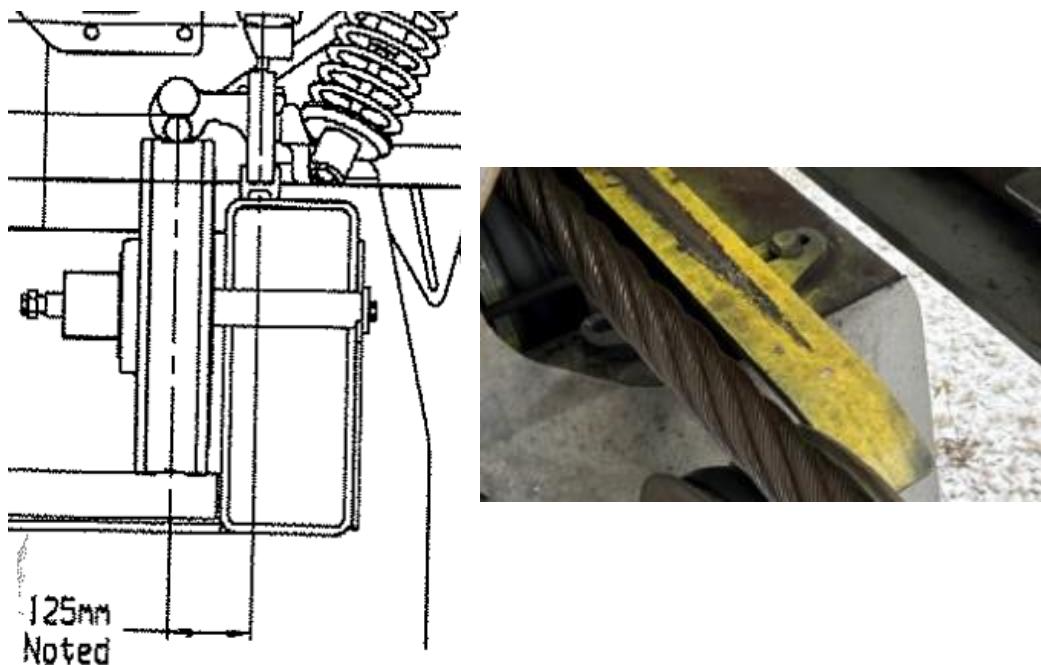
The measurement of the principal rail on the main beam from the rope is not specified. This location was observed to be in a different location on the main beam for all the entrance and exits of the terminals. LPOA may not intend for this spacing to be adjustable but the different locations of the principal rail suggests that it is. The clearance between the hanger and the main beam is very tight and based on the evidence of impacts this dimension should be clarified.

*Figure 14 - Principal Rail Adjustment*

The trumpet does not have much for lateral adjustment however there is not specification on the dimension to the lateral beam. This could cause issues with missing the trumpet and should be confirmed max and min dimensions.

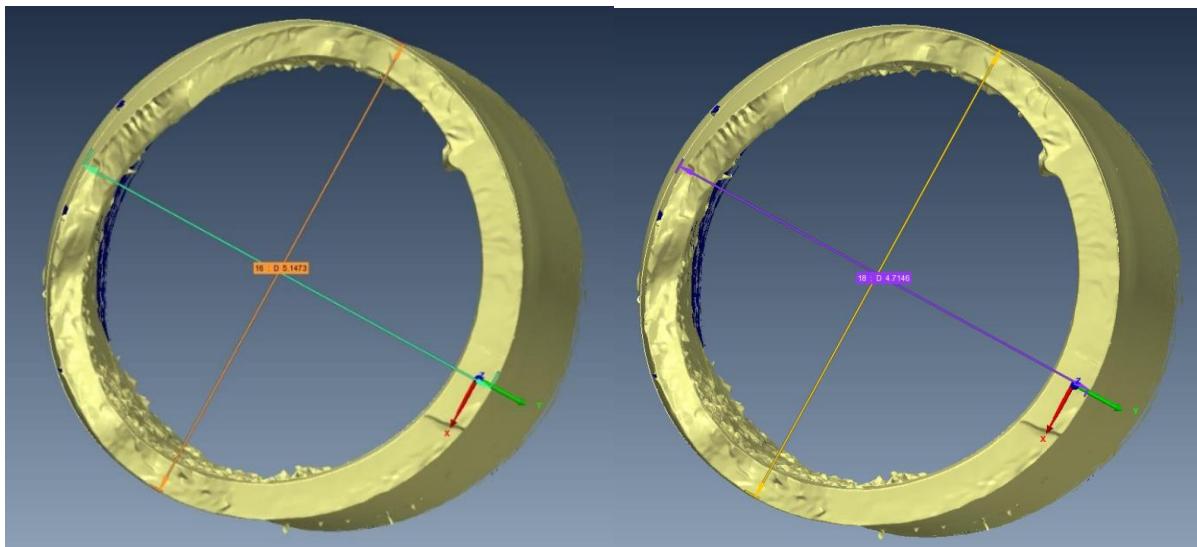
*Figure 15 - Pipe ovality at the crack location.  
(from Acuren Inc. report "Hanger Arm Failure", 18 Sept. 2025, p.10)*
