## Incident Summary #II-1460396-2022 (#30255) (FINAL)

SUPPORTING INFORMATION	Incident Date	October 31, 2022	
	Location	Chemainus, Vancouver Island	
	Regulated industry sector	Elevating Devices	
	Impact	Qty injuries	1
		Injury description	Lacerations to the face, bruising to the back, shoulder, and arms
		Injury rating	Moderate
	Damage	Damage description	N/A
		Damage rating	None
Incident rating	Moderate		
Incident overview	An unregistered, non-code compliant design and installation of a Dumbwaiter with an open carriage and landing doors that had no door locking devices was being used by a worker. The worker loaded the platform at the second level and tried to send the platform down – they heard unusual noises in the hoistway and opened the landing doors to investigate. A delivery basket was lodged in the system, and in attempting to dislodge the obstruction the worker lost their balance and fell down the shaft (9 feet) and landed on the platform which was at the first landing.

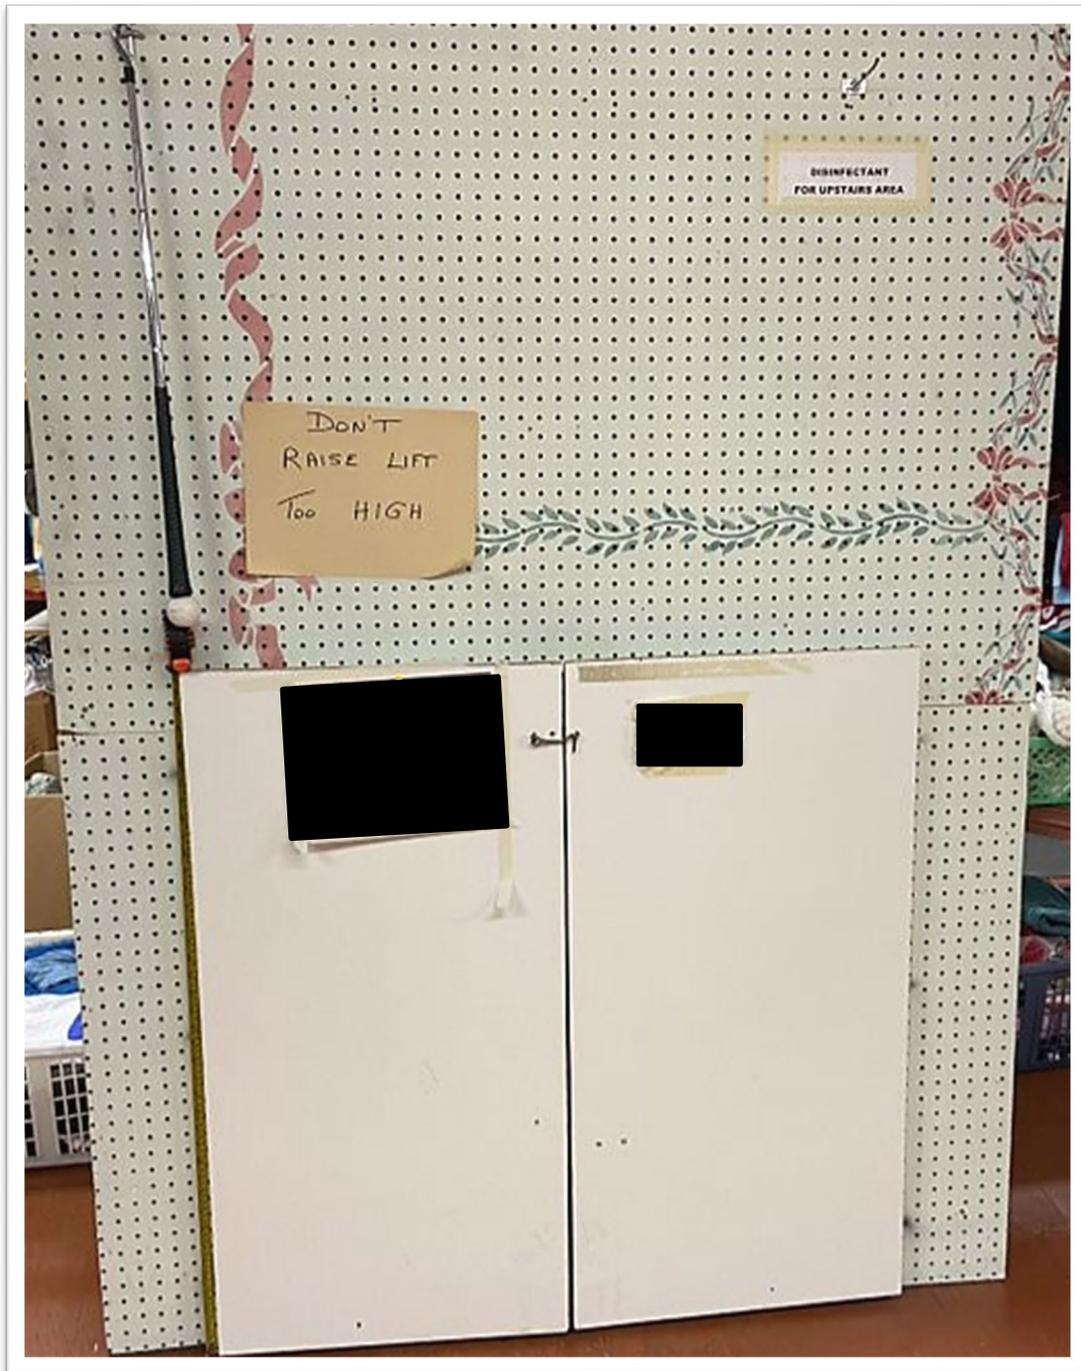
Photo 1 – Second floor landing's hoistway and door openings.

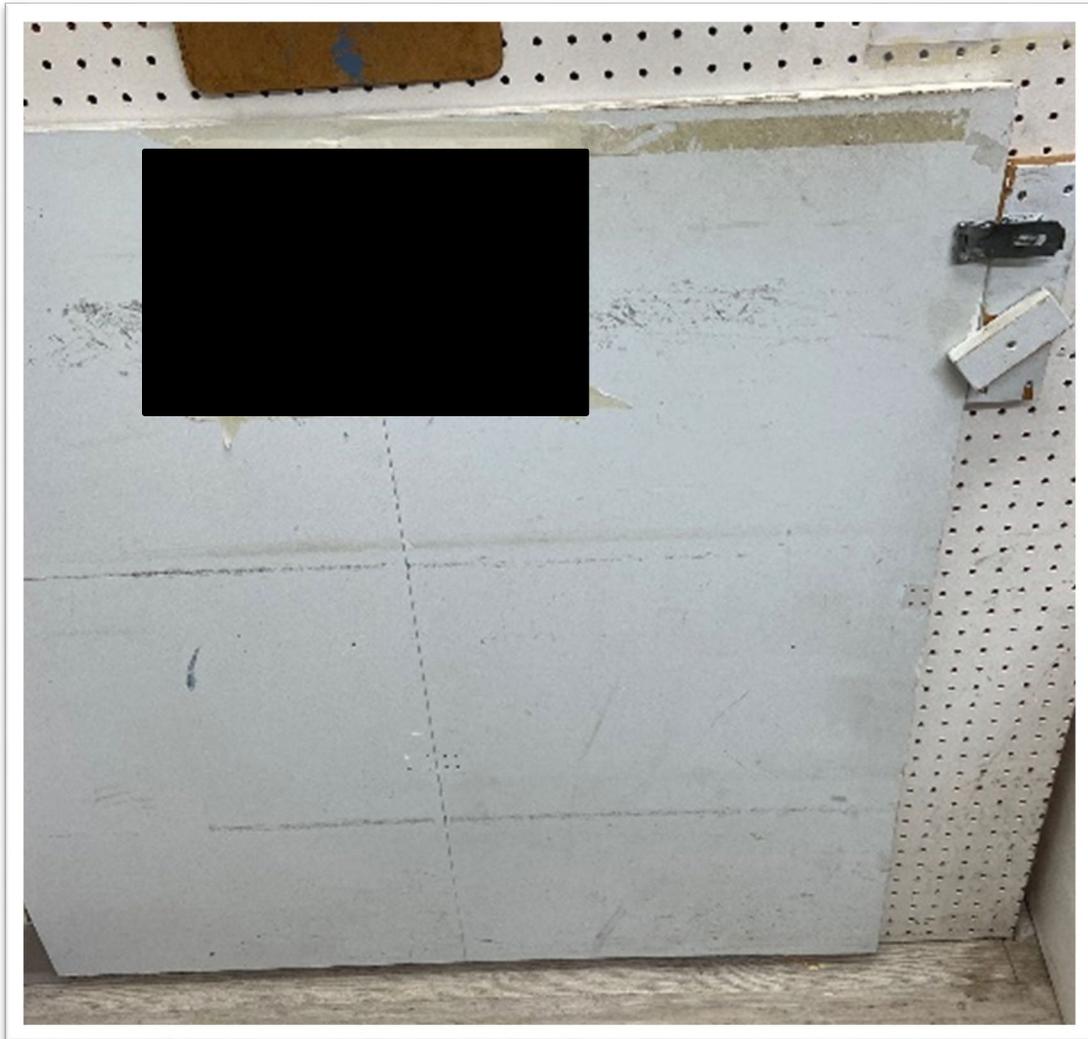
Photo 2 – First floor landing’s hoistway and door opening.

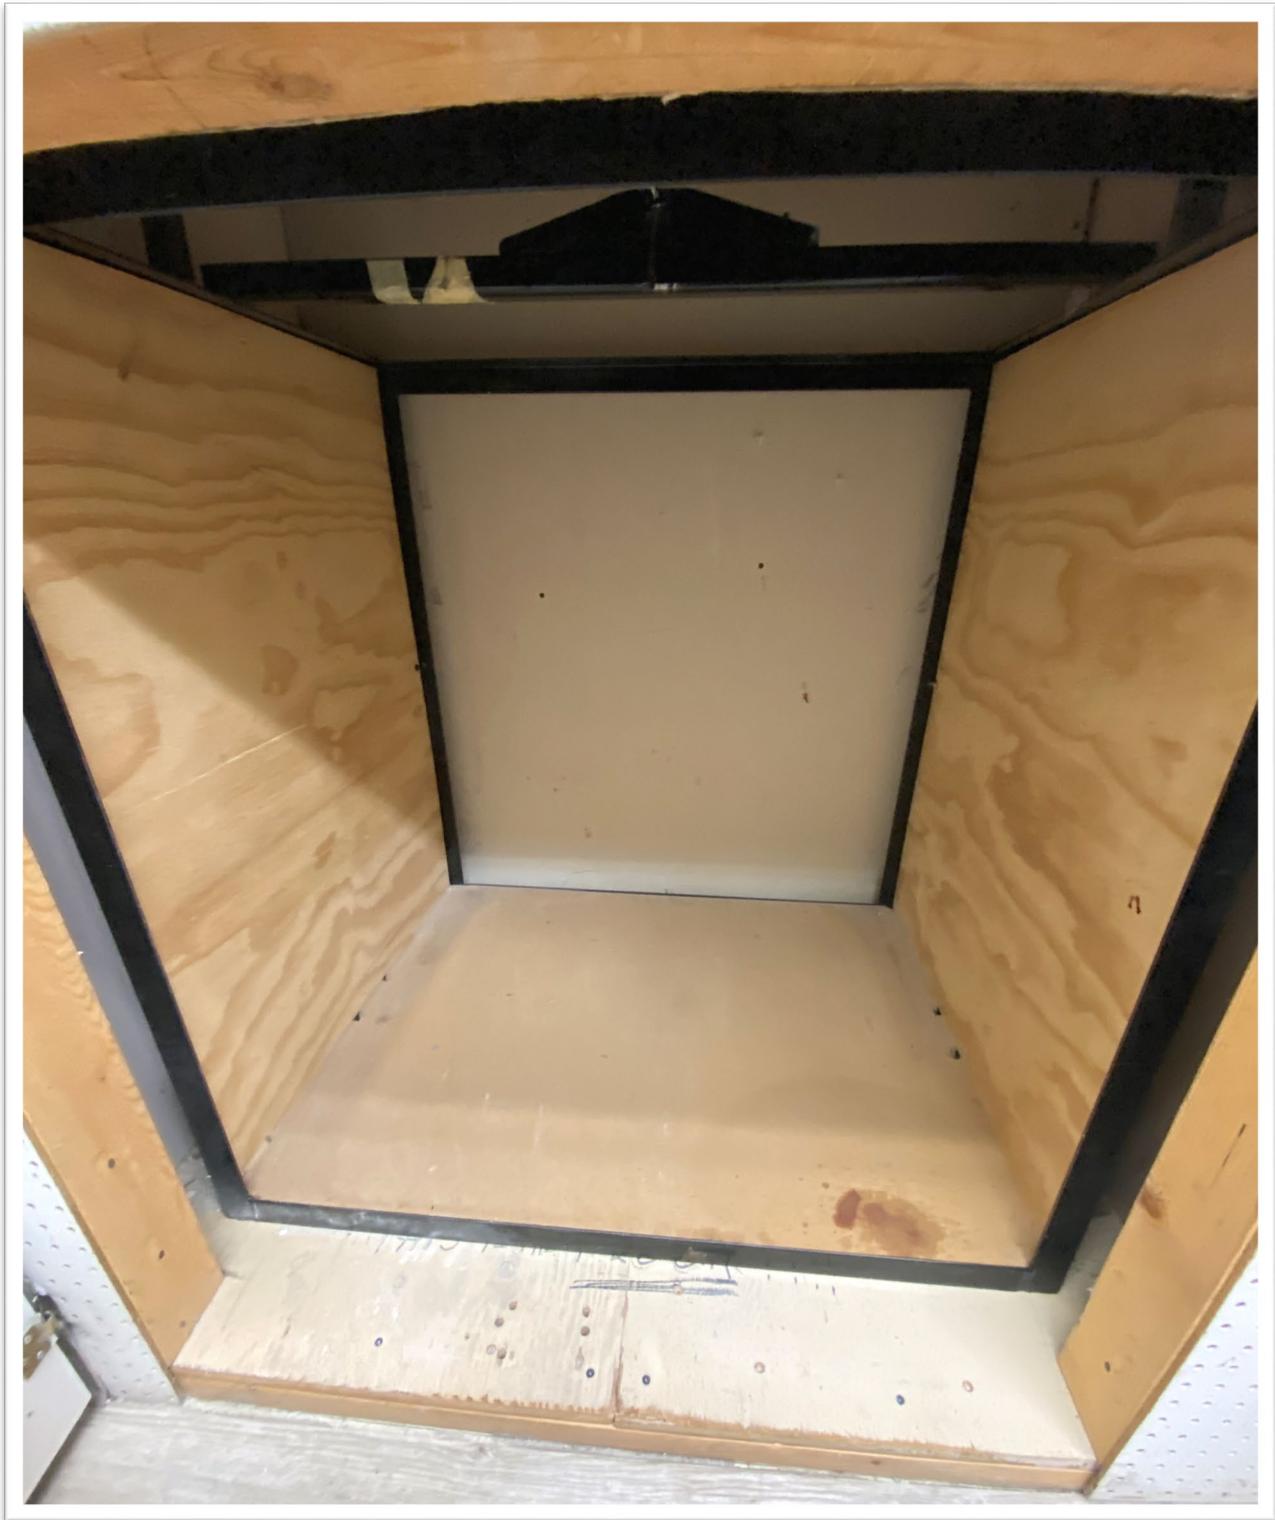
Photo 3 - First floor platform and hall door opened showing open platform design.

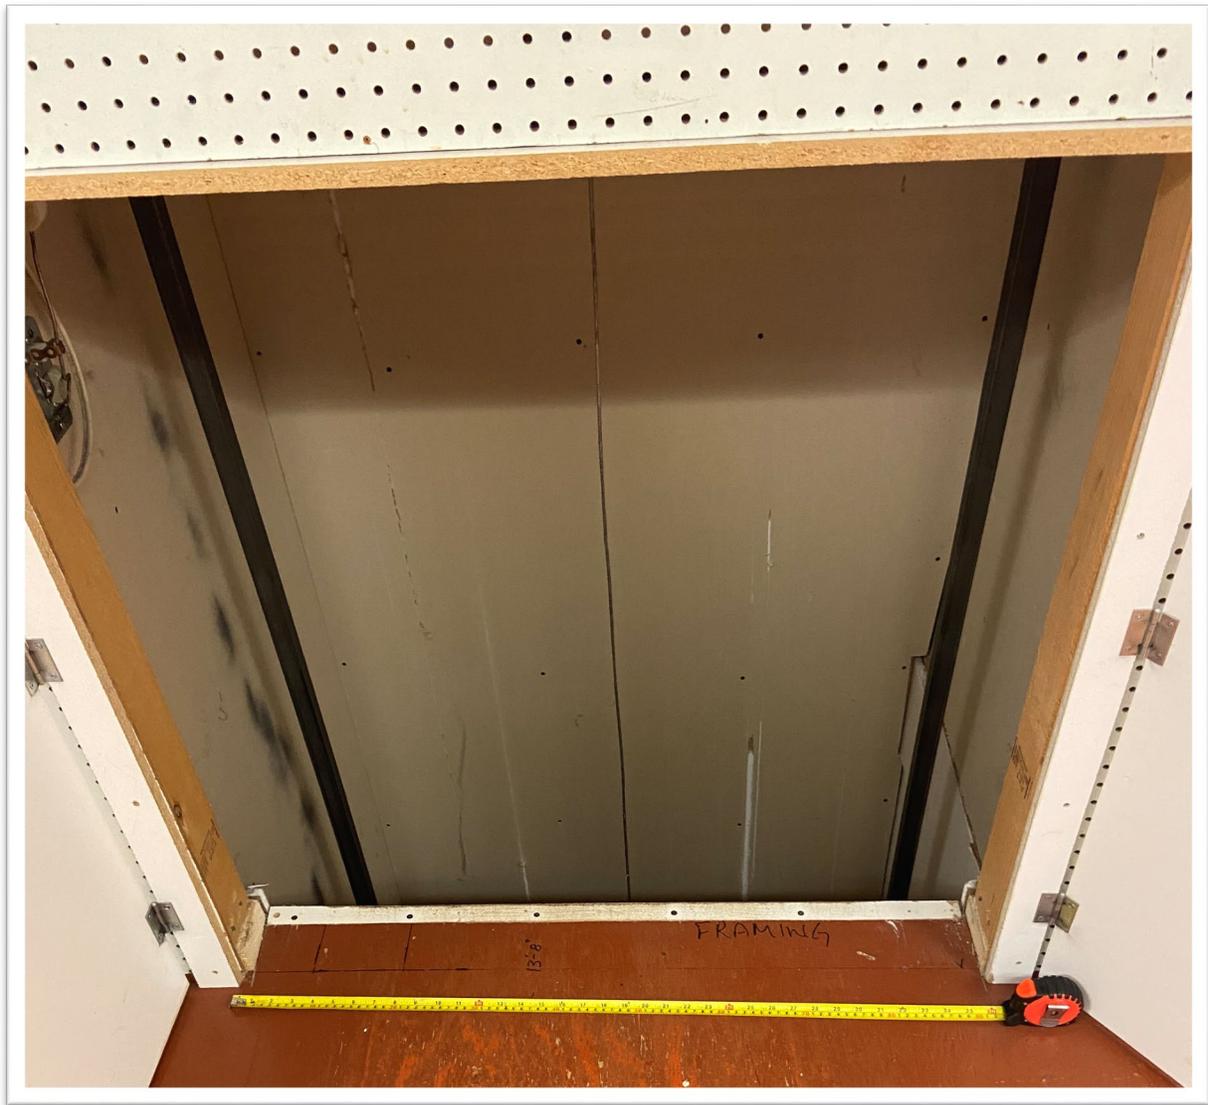
INVESTIGATION CONCLUSIONS	Site, system and components	<p>A dumbwaiter is a delivery system designed material lift. This device carries freight only and no passengers. It has a reduced capacity for loading and the platform area is limited to 1 meter square by code.</p> <p>The dumbwaiter carriage is lifted and lowered by a steel rope. The rope is connected to a winding drum located at the top of the hoistway that is powered by an electric motor connected to the winding drum through a gearbox. <a href="#">(Photo 5)</a>.</p> <p>Hoistway entrances are swing type doors with no automatic locking means. Where the bottom of a hoistway entrance is located within 600mm of the adjacent floor, the hoistway entrance requires an interlock that will prevent the door from being opened when the dumbwaiter is not located at the landing.</p>	
	Failure scenario(s)	<ol style="list-style-type: none"> <li>1) The open platform design of this system allows for any materials being transported to hang over the edges and get caught on the equipment in the hoistway while in travel <a href="#">(Photo 3)</a>.</li> <li>2) This system did not have the required door locking devices. The absence of door locking devices allow the users to open the doors at the top and bottom floors without the carriage being at that location.</li> <li>3) The top door is 3' by 3' and is located flush with the floor level <a href="#">(Photo 1 &amp; 2)</a>.</li> <li>4) To load at the top floor, the user needs to crouch, kneel, or bend over to insert materials into the carriage. It is therefore possible to have the platform at the bottom landing and open the top floor doors <a href="#">(Photo 4)</a>.</li> </ol>

Photo 4 – Second floor platform and hall door opened.

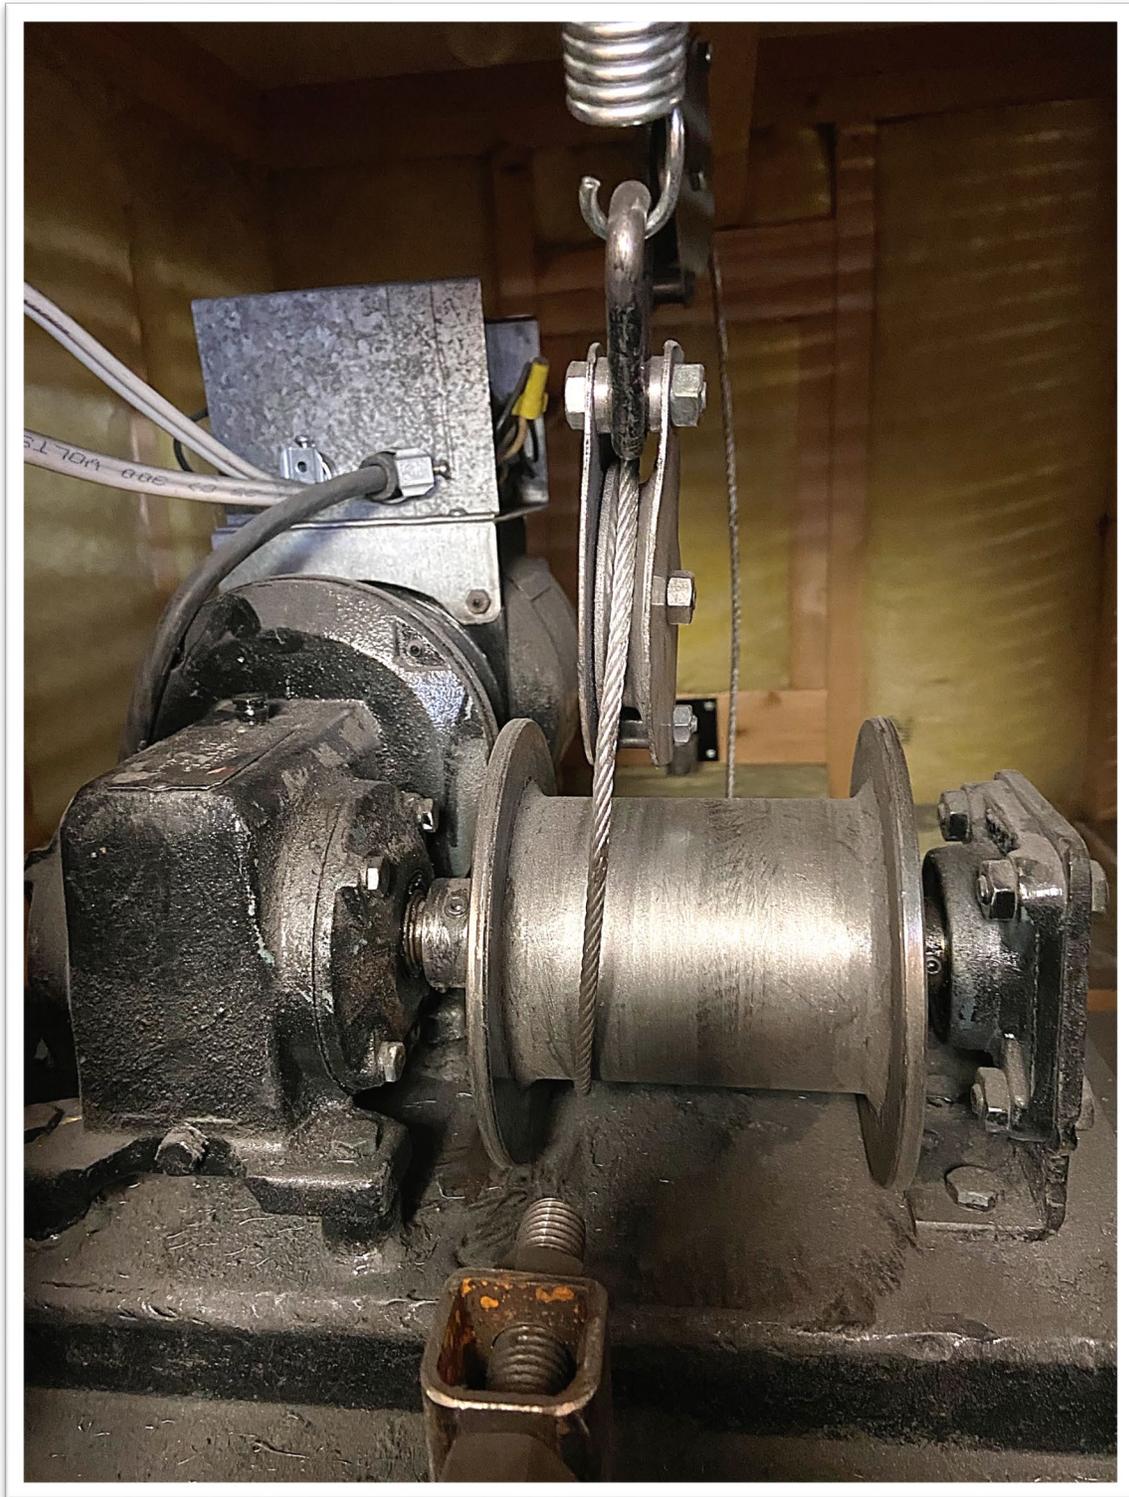
**Photo 5** – Capstan motor winch assembly for hoisting the platform, located at top of shaft.
