Inciden		December 10, 2019
	Location		Vancouver
z	Regulated industry sector		Elevating devices - Elevator
ATIO		Qty injuries	0
SUPPORTING INFORMATION	st Injury	Injury description	No injuries
INF	Impact	Injury rating	None
RTING	Damage	Damage description	Damage to elevator sling, top of elevator components and an overhead hitch beam. Elevator floor tiles damaged from impact.
Odd	Dan	Damage rating	Moderate
SL	Incident rating		Moderate
	Incident overview		During an annual emergency brake test procedure known as "unintended motion" the emergency brakes failed to deploy. The car continued to ascend until it's counterweight collided with the buffer and the car struck the overhead beam.
Nd INVESTIGATION CONCLUSIONS	Incident overview		 An electric elevator of the roped traction type. This unit uses steel ropes, electric motor and a counterweight to raise and lower the car. Motor has a brake assembly consisting of 2 electromagnetic brakes (automatically activated by a solenoid). 2 brake compression springs to adjust holding force. The electric motor, drive sheave and brakes are one unit mounted in the overhead of the hoistway. A controller in a remote room, located in an underground parkade.

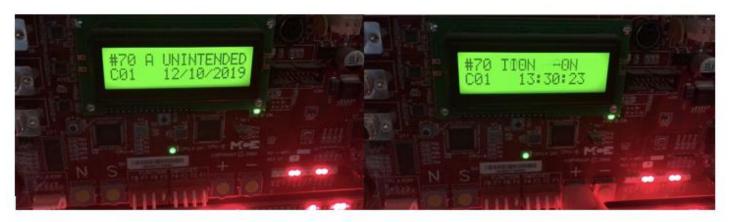
During the 125% load test, the car travels in the down direction due to the combined weight of the car and test weights exceeding the counterweight. During the no load test, the car travels in the up direction due to the counterweight weighing more than the car. During this test the mechanic would follow the manufacturers written procedures, located on-site.			
Failure scenario(s)	Testing of the emergency brake was being performed with no load in the car. Manufacturers test procedures were not followed correctly. The car was put into an unintended motion test in the up direction with the main brake being manually held open. The emergency brake failed to stop the car and the car travelled in the up direction until the counterweight struck the buffer located below it and the car struck the overhead hitch beam.			
	Photos of controller log			
Facts and evidence	 Photo of the "unintended motion fault" triggered during the test (See photos #2 and #3) Photos of mechanics initial steps captured by the fault log leading up to incident.

Photos #2 and #3 - Fault Log Registers an Unintended Motion Condition – Emergency Brakes Should Have Deployed and Stopped the Car.

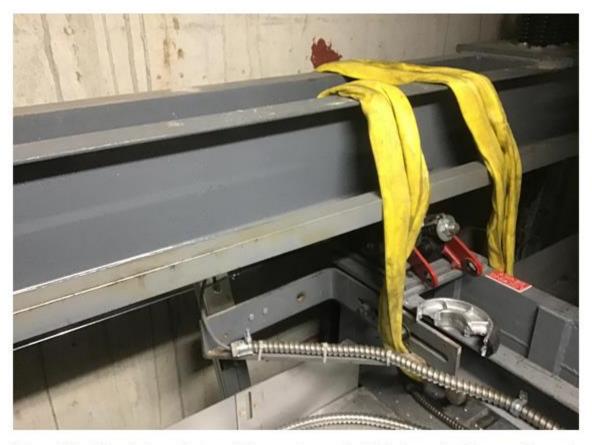
Photos from top of car and hoistway pit.
 Photo from top of car showing the overhead hitch beam the car collided with. (See photo #4.) Photo of car resting in the overhead and the counterweight on the pit buffer. (See photos #7,#8 and #9)
Written and signed statements of events leading up to the incident from both mechanics.
 Testing procedures from the manufacturer not followed- Lead mechanic states that after a second failed attempt he switches the brake wires to different terminals in an attempt to open the brakes. No visual guidance during testing - The manufacturers testing procedures fails to provide the user with instructions on how to use the LCD board to monitor movement and speed of the car. Mechanic unaware of the LCD board to monitor car movement and speed- The mechanic performing the test makes no mention of ever having a visual on the car during the test. Was unaware of such a feature when asked. No troubleshooting attempted - The lead mechanic does not recognize that there is a trim pot R67 marked on the manufacturers procedures for adjusting brake pick voltages. Brake down of two way radio communication – The mechanic in charge of providing feedback to the lead mechanic states that the repeated message to stop, did not go through until it was too late. Lack of training on equipment and interpretation of electrical prints- The mechanic was asked as part of the investigation if he checked the voltage to the brakes. The mechanic responded as not knowing how to check or how to troubleshoot the brake system using electrical drawings.

Photo #4 - This pic from the top of the car shows the hitch beam that it came into contact with. Rollers were damaged upon impact.

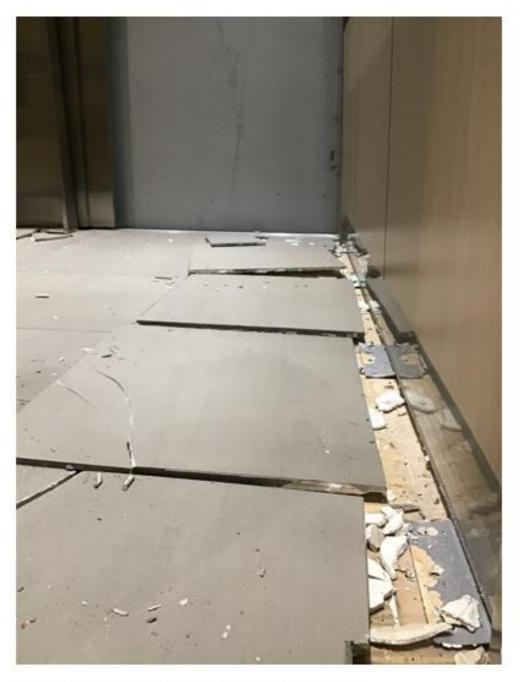
Photo #5 - Damaged floor tiles from impact

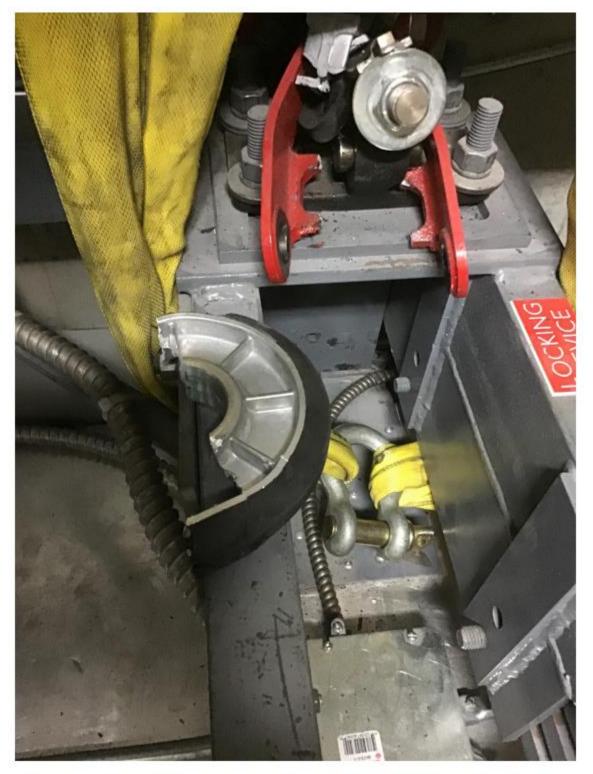
Photo #6 - Damaged roller guides on top of car

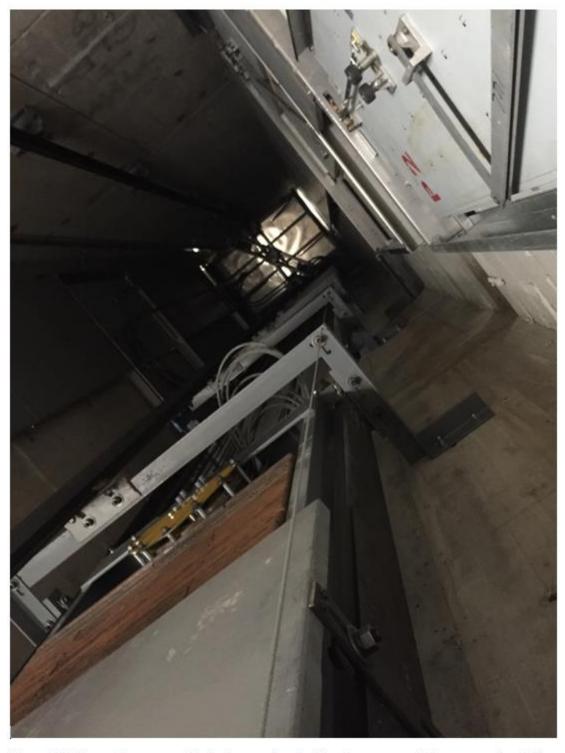
Lead Mechanic's written statement
 After servicing and adjusting the compression tensioning springs on the brakes, the mechanic tested the brakes by riding the elevator on top of car and ensuring the brakes held the weight. The Mechanic then proceeded to set up in the control room to perform the brake test. The second mechanic set up at lobby in front of the car door. Lead mechanic radioed to the mechanic at lobby to stand by for test. Lead mechanic pushed the brake test buttons. The brakes didn't open and the car didn't move. Lead mechanic tried again, pushed the buttons but brakes failed to open. The lead mechanic then transferred a set of brake wires to a different set of terminals in an attempt to open the brakes. Terminals BT1 and BT2. Mechanic tried to open the brakes up again to drift the car but brakes failed to open. The lead mechanic then transferred the brake wires back to their original terminals. Put the brake board on manual mode again and pushed the buttons to open the brakes. Brakes opened up on the third attempt but the mechanic did not know. The emergency brake failed to stop the car drifting upwards. The counterweight gained momentum as it came down and the car shot upwards. Car crashed into the overhead and counterweight struck the buffer(See photo #7). Car came to a rest after colliding with the overhead hitch beam.

Photo #7- Photo show car resting in the overhead while the counterweight rests on the buffer.

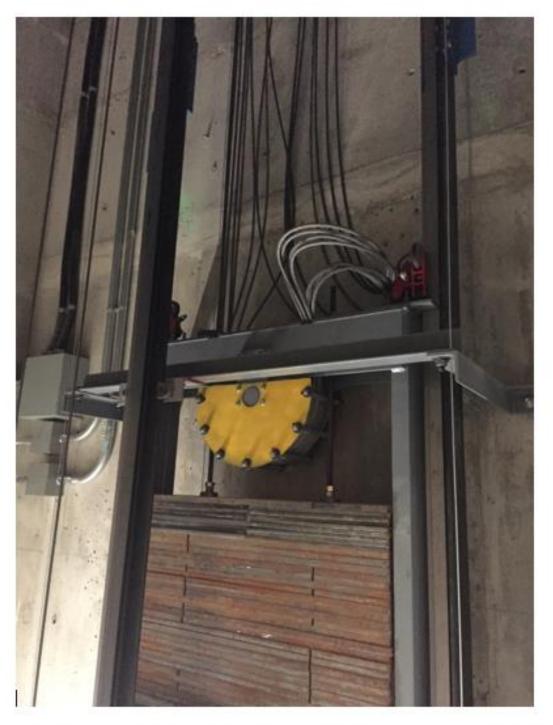
Photo #8 - Picture of counterweight resting on buffers with slacked cables.

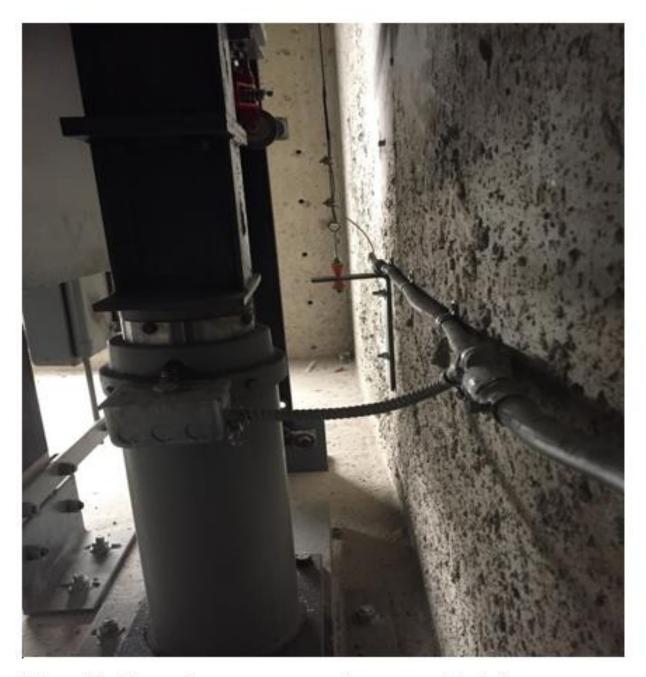
Photo #9 - Picture shows a compressed counterweight buffer.
