**KICKING HORSE MOUNTAIN SKI RESORT  
GOLDEN EAGLE EXPRESS  
LEITNER-POMA OF AMERICA GONDOLA**

**HANGER ARM FAILURE**

TECHNICAL SAFETY B.C.  
2889 East 12 Avenue  
Vancouver, B.C.  
V5M 4T5

File Number: 605-J215610  
EGBC Permit Number: 1001973  
Date: January 28, 2026

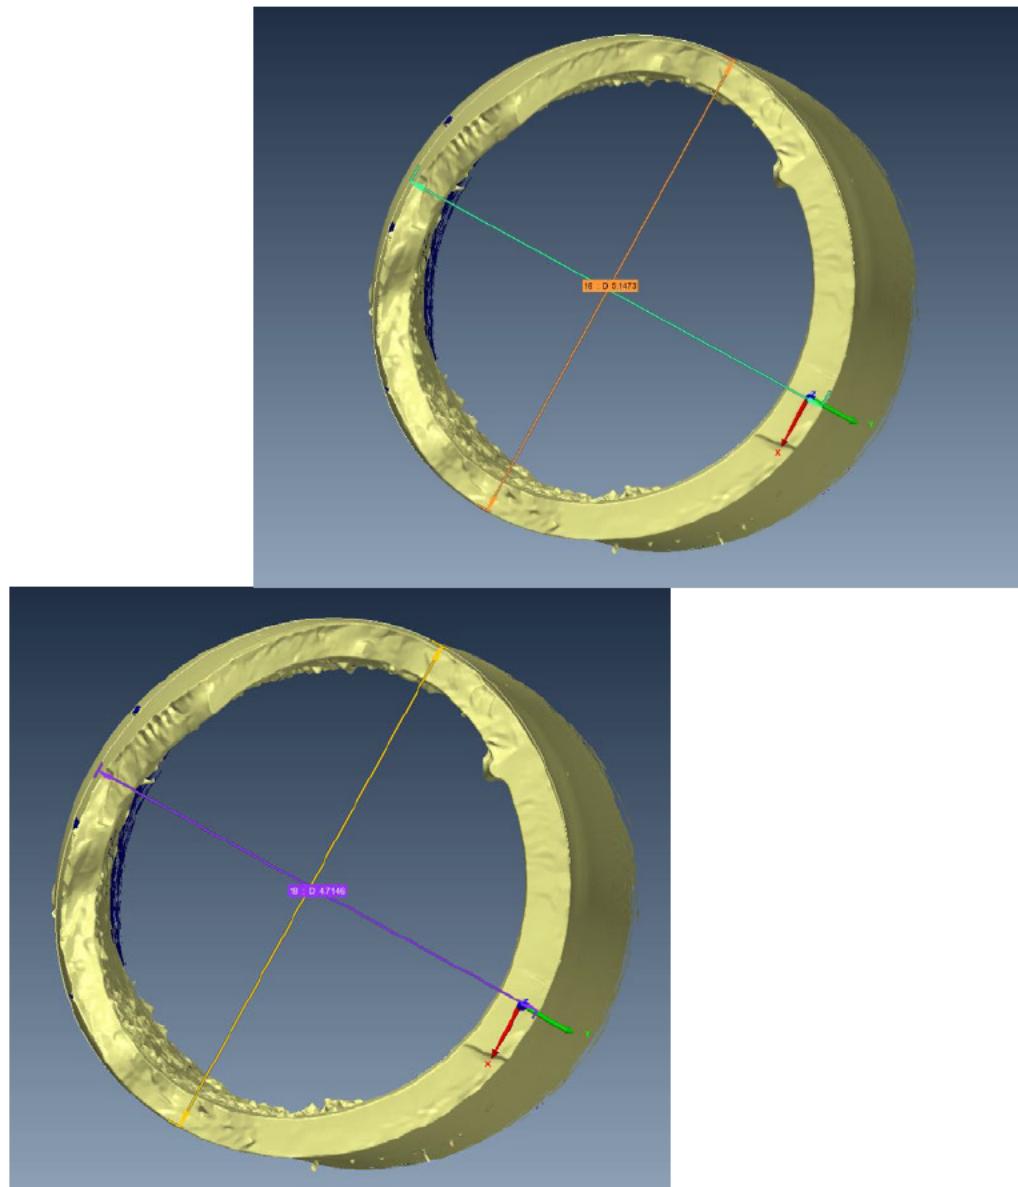
Pipe Ovality at Fracture Surface

A further scan at the fracture location shows the degree of permanent ovality caused by the cold bending operation. The fracture origin thumbnail is near the point where the pipe ovality is most pronounced. (highest amount of cold work).

The observed ovality is caused by the cold bending method used to form the hanger. There was no apparent attempt to reduce or eliminate pipe deformation during the cold forming operation. A roughly 1 cm difference in ID exists between the two planes of the bend.

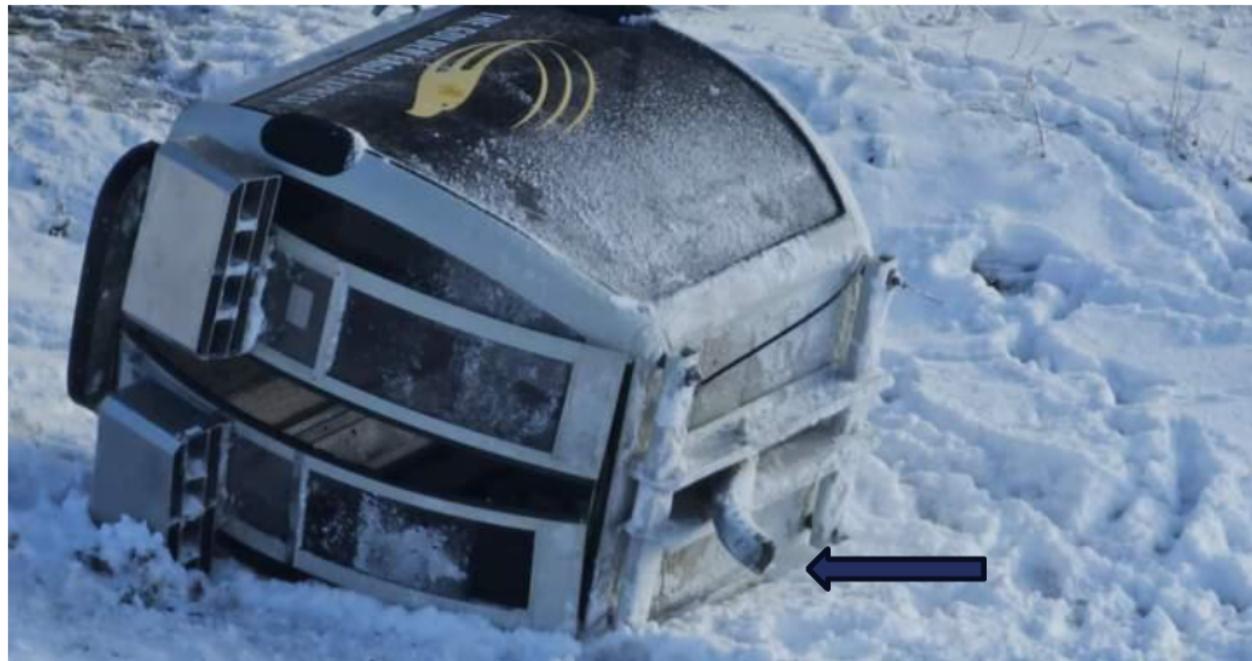
**Figure 1** Overall view of gondola attachment arm failure as shown in Global news photo. Fracture occurred at the top of the bend outside of the “H frame” attachment point (arrow).

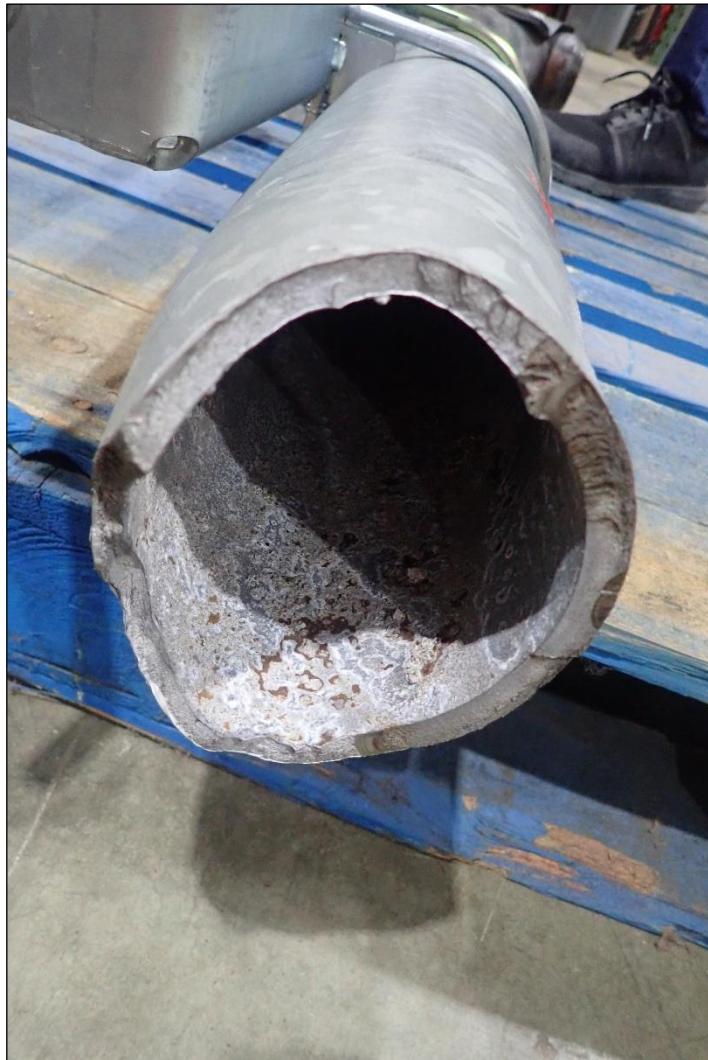
**Figure 2** Overall view of straight section of hanger arm containing fracture as received at the Acuren Facility.

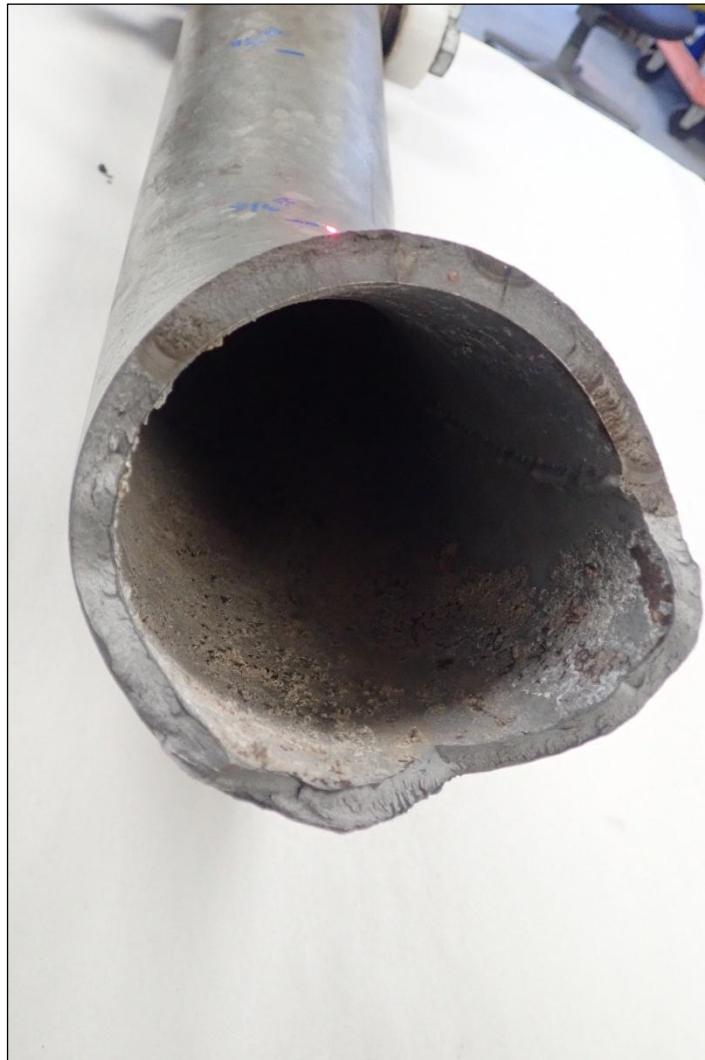
**Figure 3** Overall view of the opposite side of the fracture (short 60° bend section) as it exists the gondola cover.

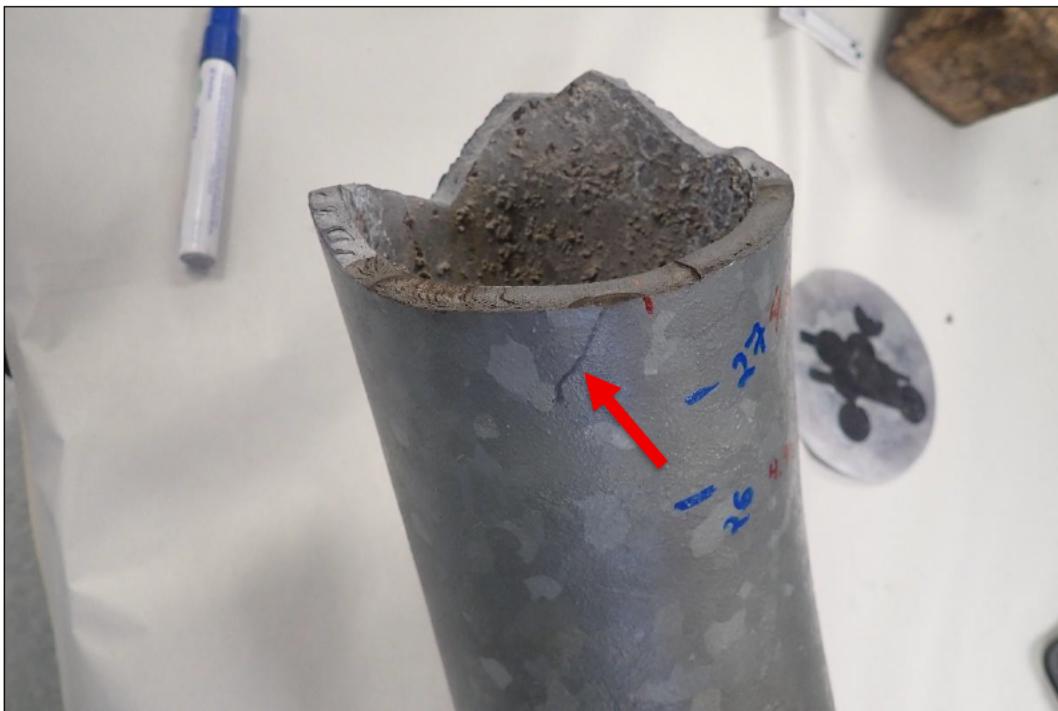
before the incident. It is possible that an inspector noticed something resembling a crack and picked at it with a sharp tool. The scratch is precisely at the center of the thumbnail (Figure 12).

**Figure 5** Scratch on intrados of the bend aligning with center of thumbnail.

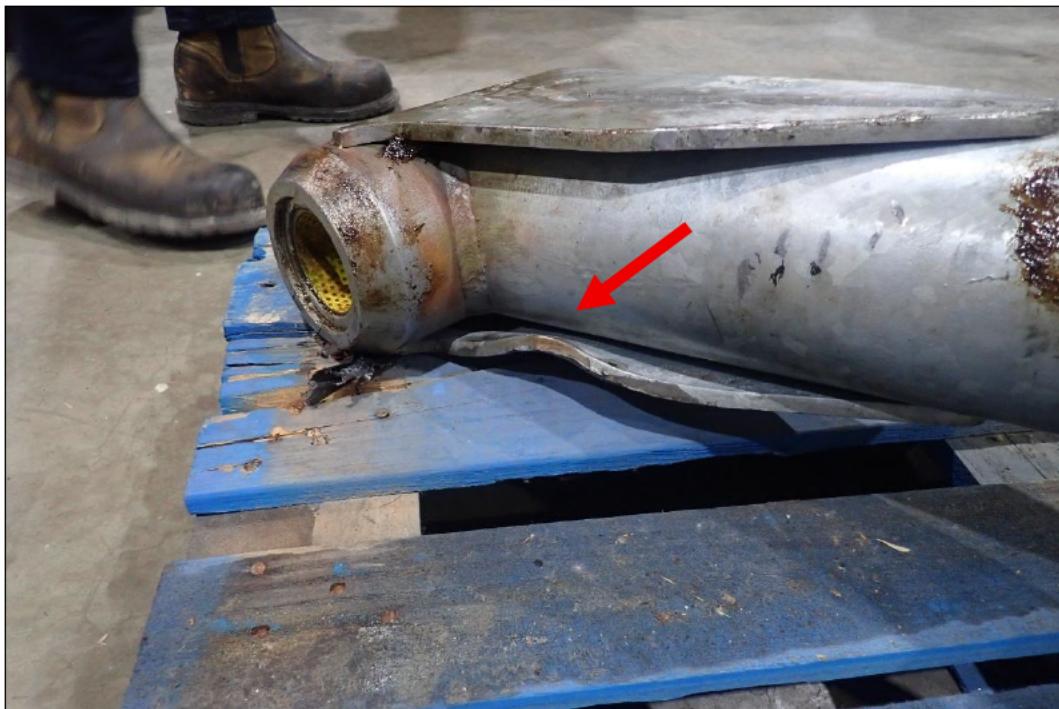
The gondola arm that failed had suffered a severe impact on the upper arm guideway bracket that resulted in permanent bending of the bracket. This damage is remote from the arm failure location. Evidence of smaller impacts on this and other arm brackets was reported.

**Figure 6** Deformation on upper reinforcing bracket cause by impact with lateral rail at drive station.

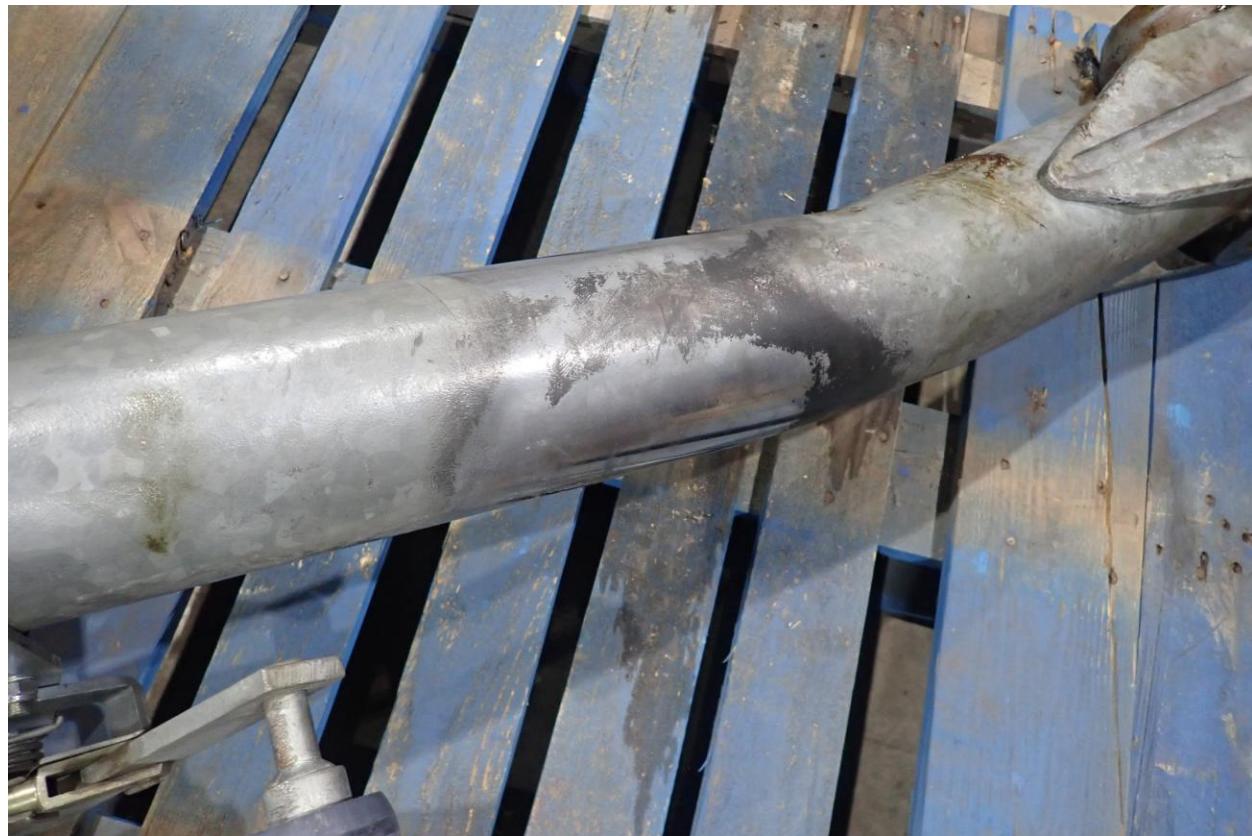
**Figure 7** Shiny area on hanger arm galvanized surface indicating light contact during normal operation.

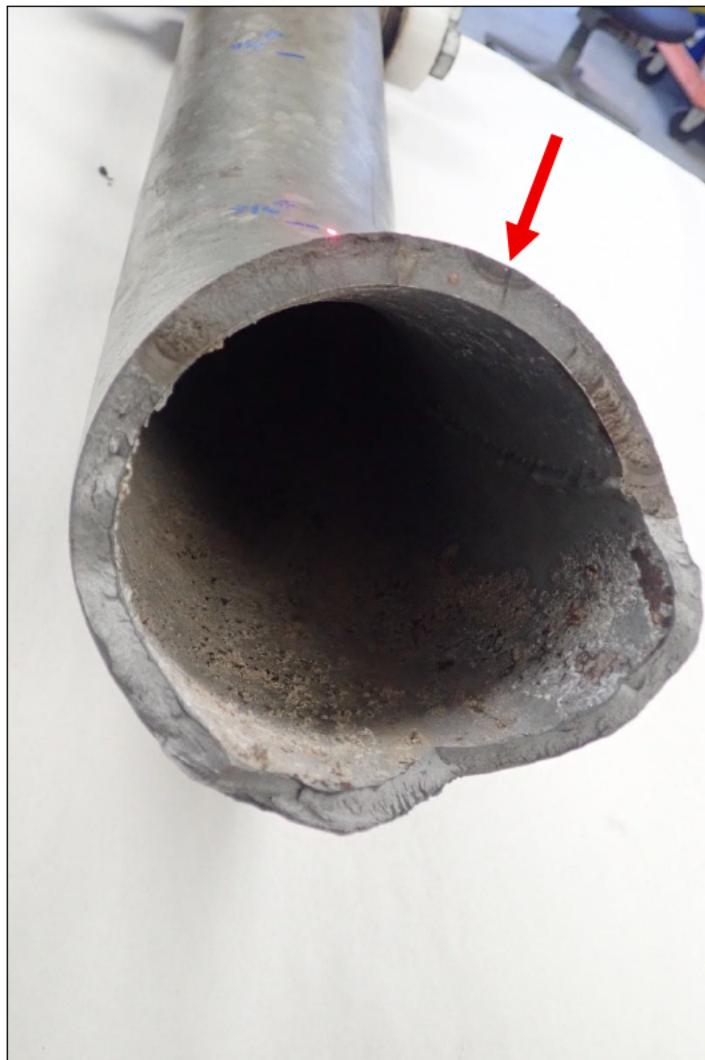
**Figure 8**      Thumbnail shaped fracture origin at roughly the 7 o'clock position from the intrados of the bend (intrados centerline at 6 0'clock position)

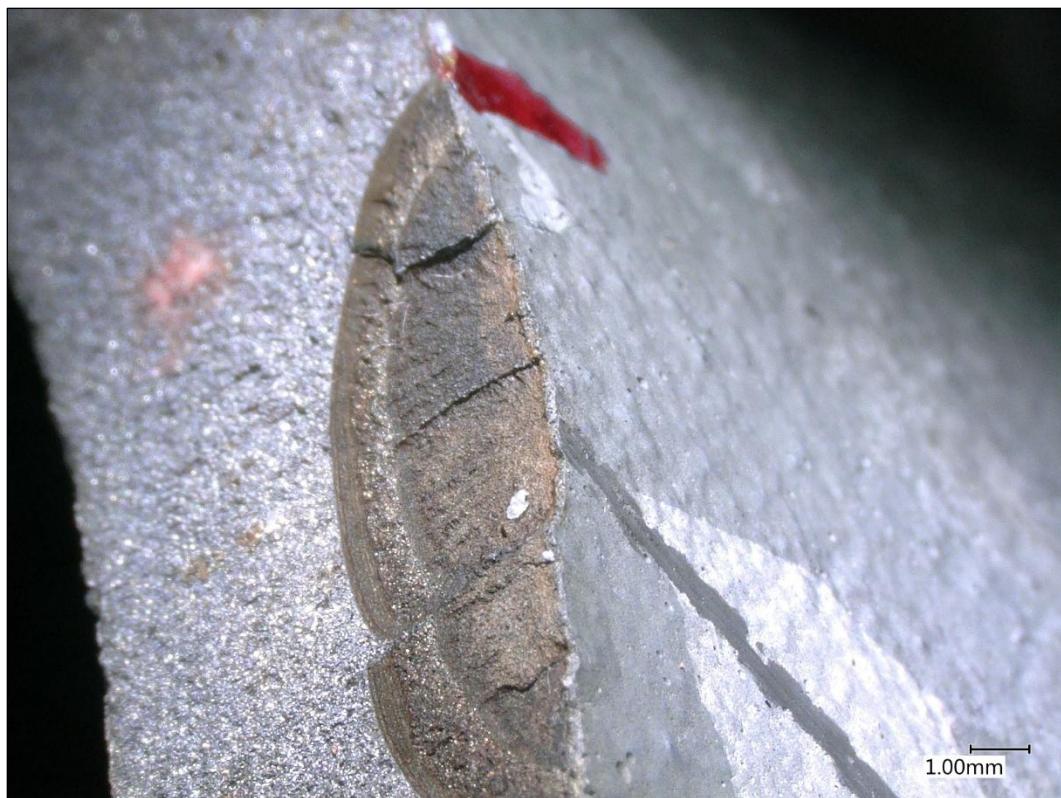
**Figure 9** Close-up view of thumbnail area showing brittle fracture lines leading back to the thumbnail origin. The red mark is at the centerline of the intrados of the bend. The grey line is a scratch coming from the middle of the thumbnail (unknown origin).

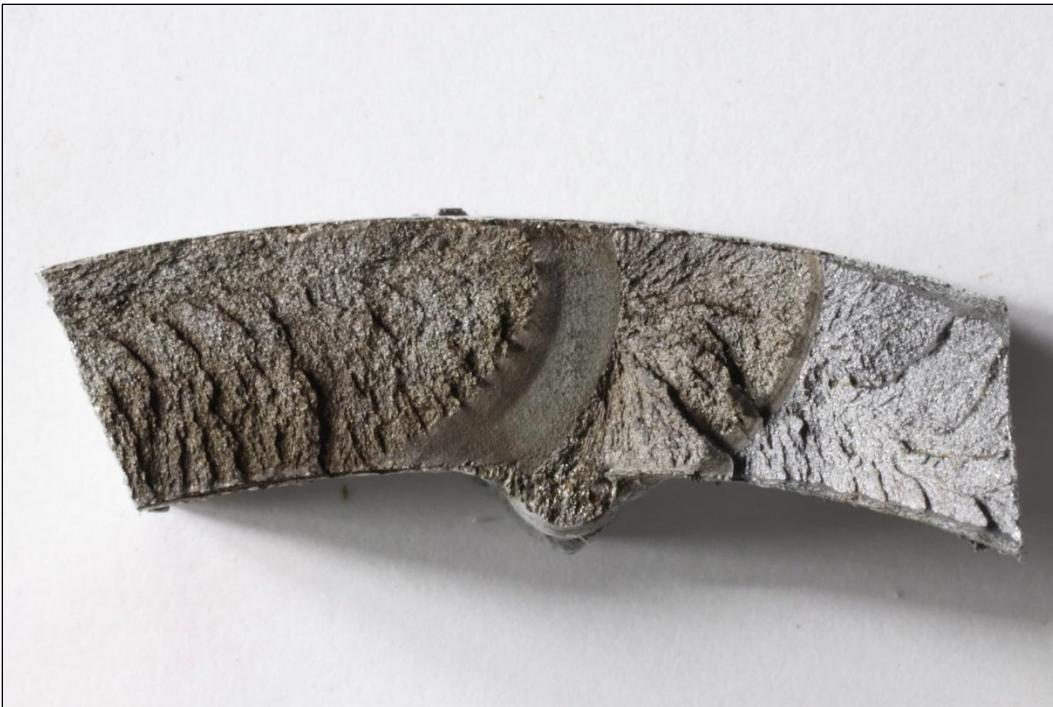
This larger brittle fracture arrested when it reached the heat affected zone of the pipe weld seam. The crack then begins to grow by fatigue in the tougher HAZ and weld metal in the weld zone. The crack also arrests on the opposite side of the pipe fracture plane where cold work from the pipe bending operation is less severe. Fatigue cracking also restarted at the location opposite the weld metal and travelled for a distance of approximately 5 – 6 mm .

**Figure 10** Crack arrest at the pipe seam weld. Fatigue crack grew until reaching a critical size and brittle cleavage proceeded. Microstructure change at weld arrested brittle fracture

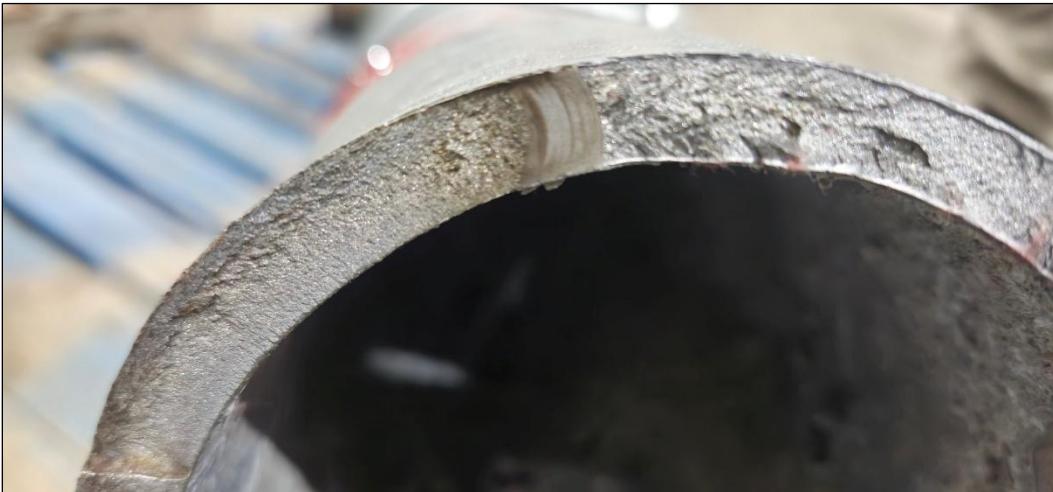
**Figure 11** Fatigue crack initiation and growth on opposite side of thumbnail at the same relative location as the pipe weld fatigue crack. .

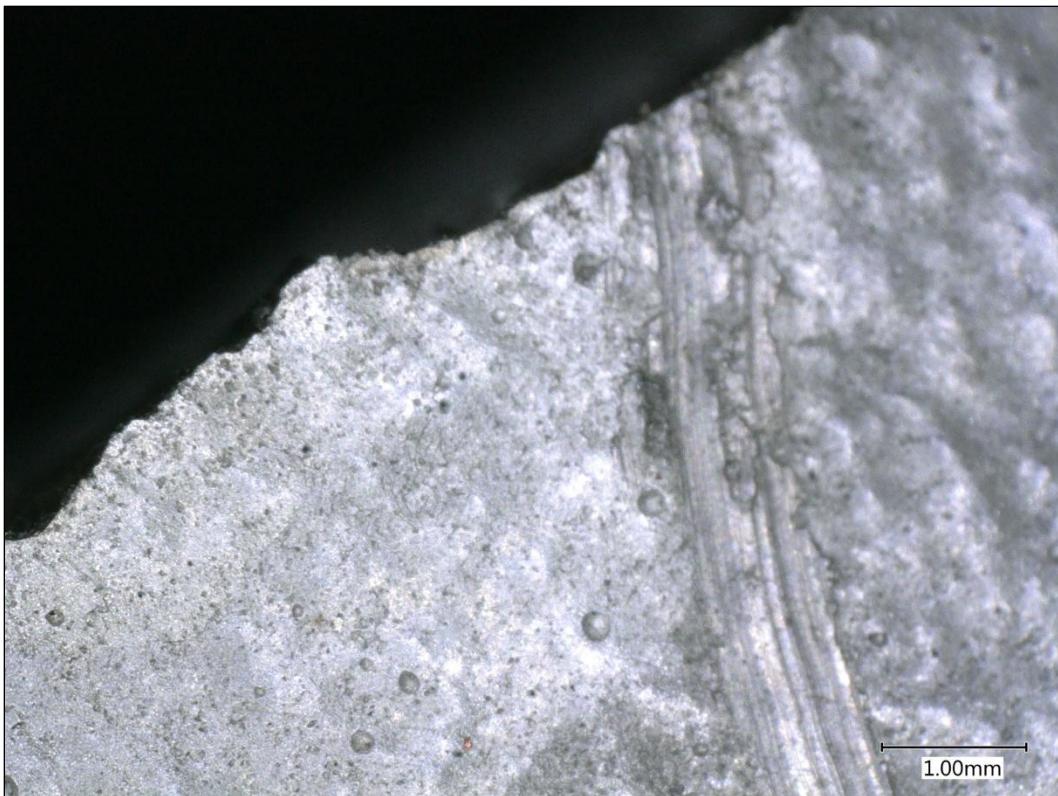
**Figure 12** Close-up view of scratch in galvanizing shown at low magnification in Figure 5.

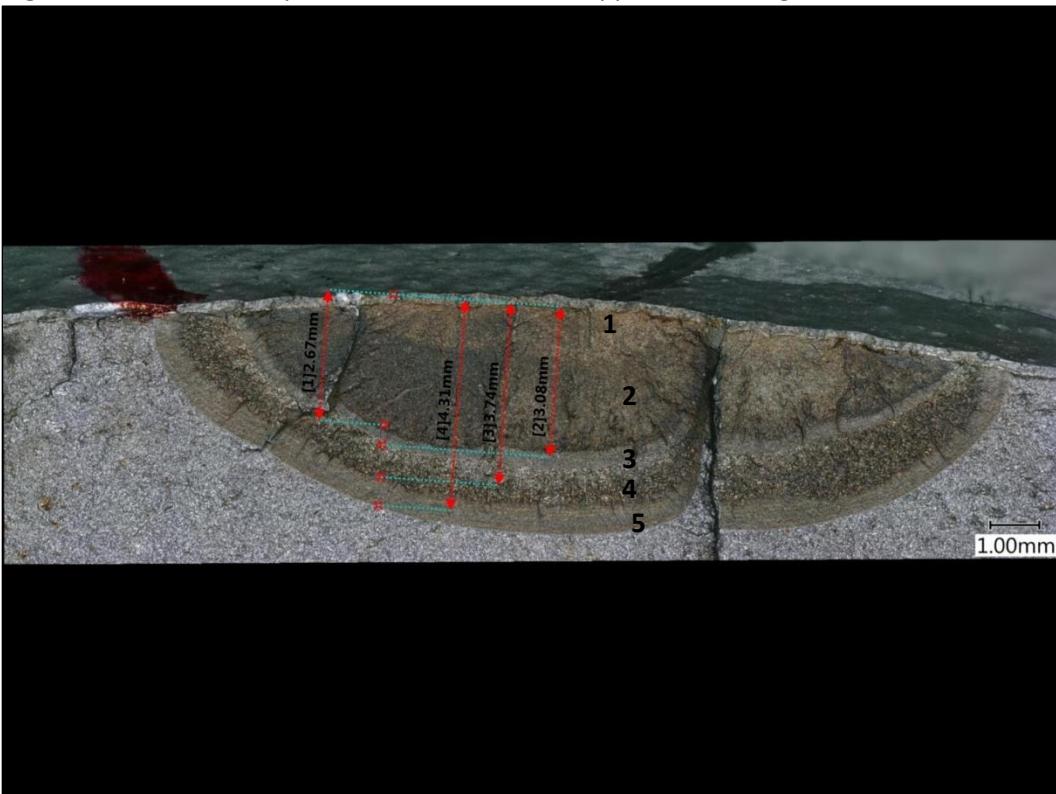
The fracture origin area near the intrados of the bend is shown in Figure 15. The thumbnail shaped origin initially started as three small thumbnails which eventually joined together to form a single crack front. The larger thumbnail contains 5 distinct zones beneath the fractured outer galvanized layer as numbered on Figure 15. Each zone was examined using a scanning electron microscope to confirm the fracture mode in each zone (Section 4.3).

**Figure 15** Close-up view of thumbnail origin showing multiple steps before final overload occurred. Progressive zones are arbitrarily labelled 1 – 5 for reference.

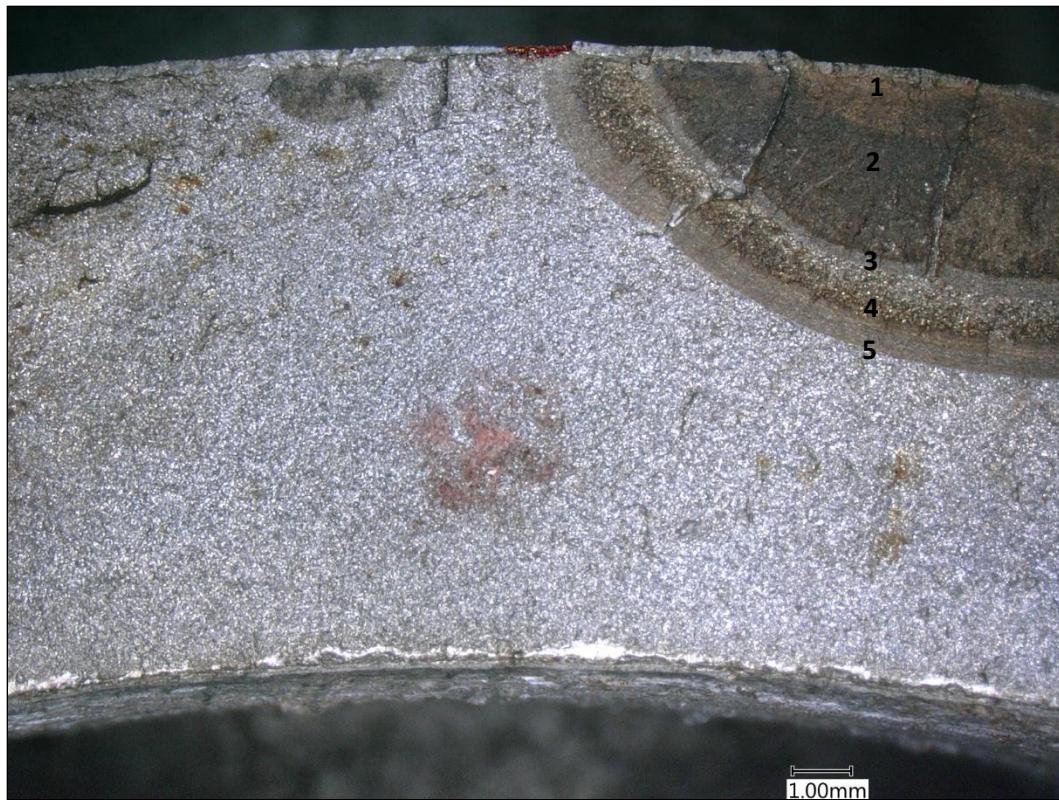
**Figure 16** Keyence microscope view of fracture at the 6:00 position (black vertical mark) on the external surface of the intrados of the bend. Zones are arbitrarily labelled 1 – 5.

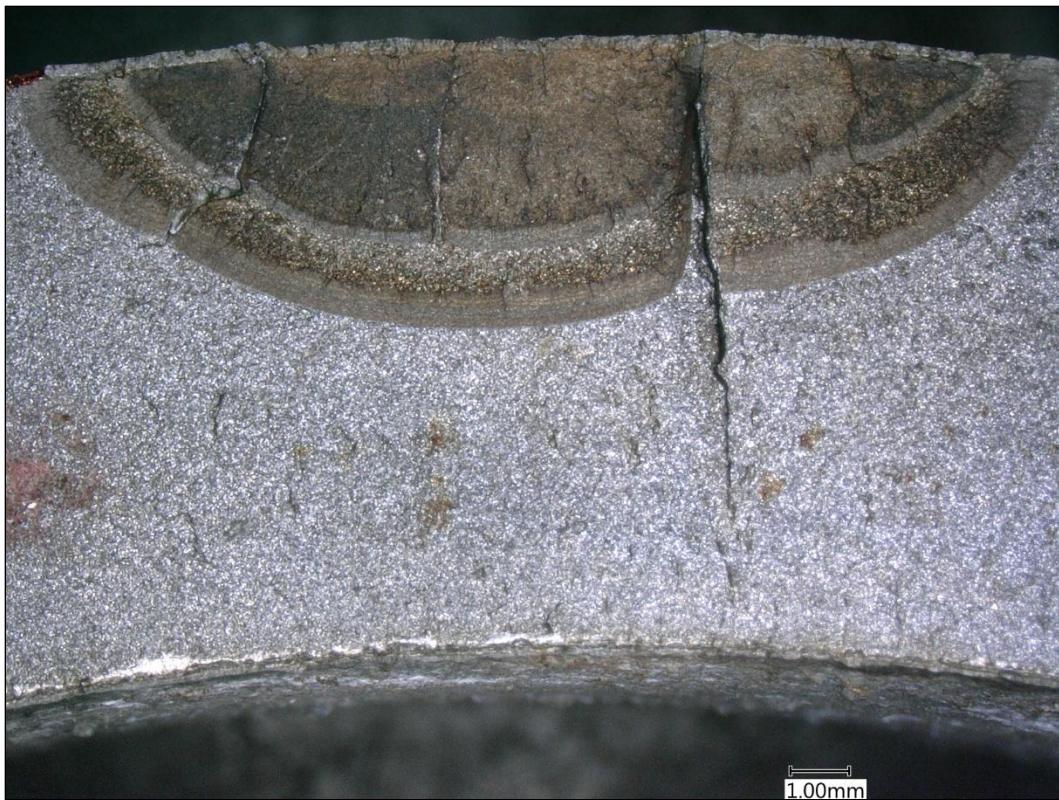
**Figure 17** Reference 1 at roughly the 7:00 position.

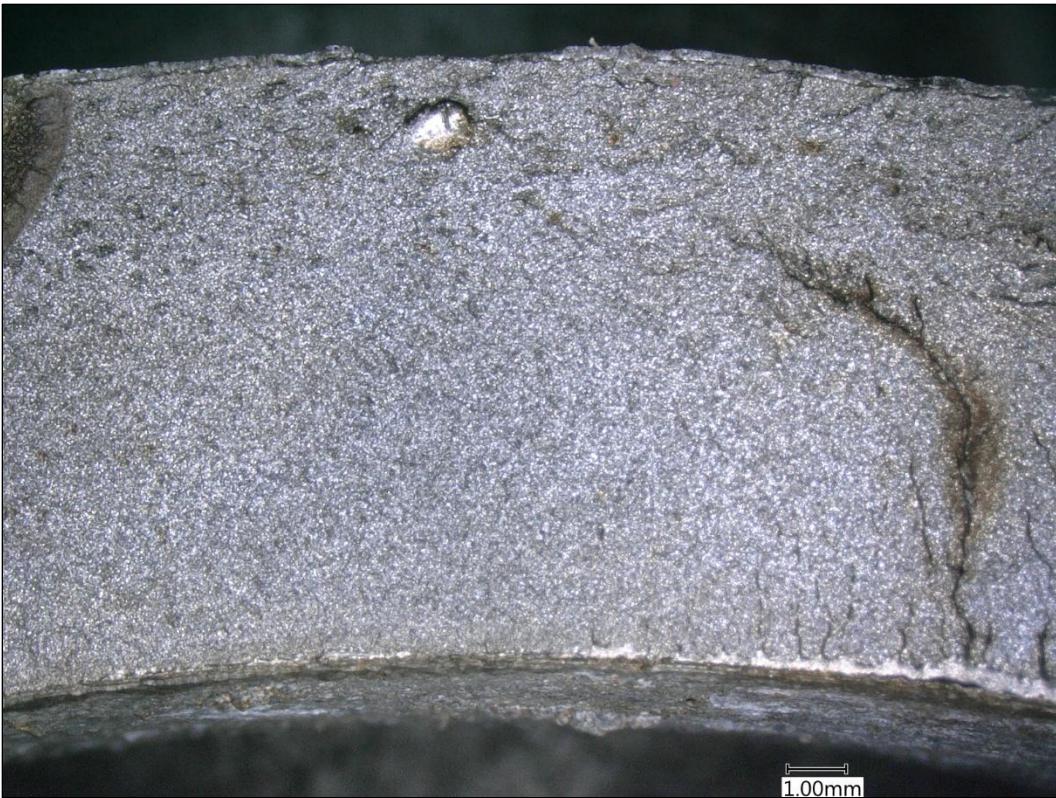
**Figure 18** Reference 2 moving toward the seam weld (100% brittle)

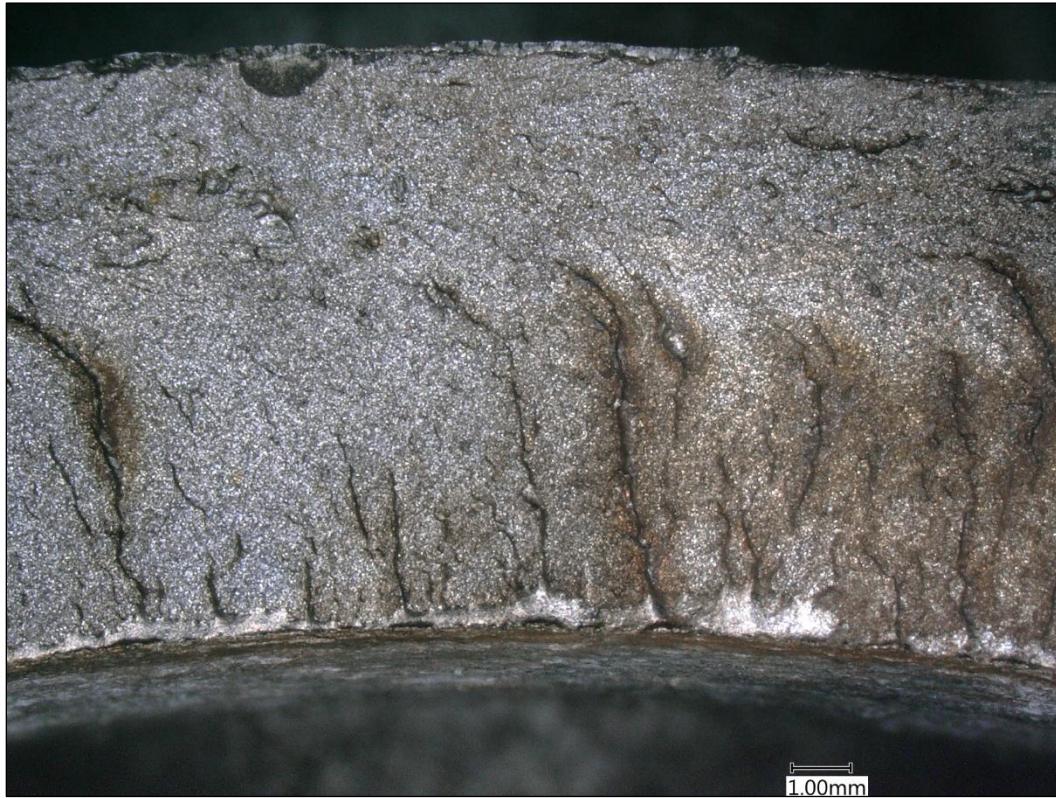
**Figure 19** Reference 3 moving toward the seam weld (100% brittle)

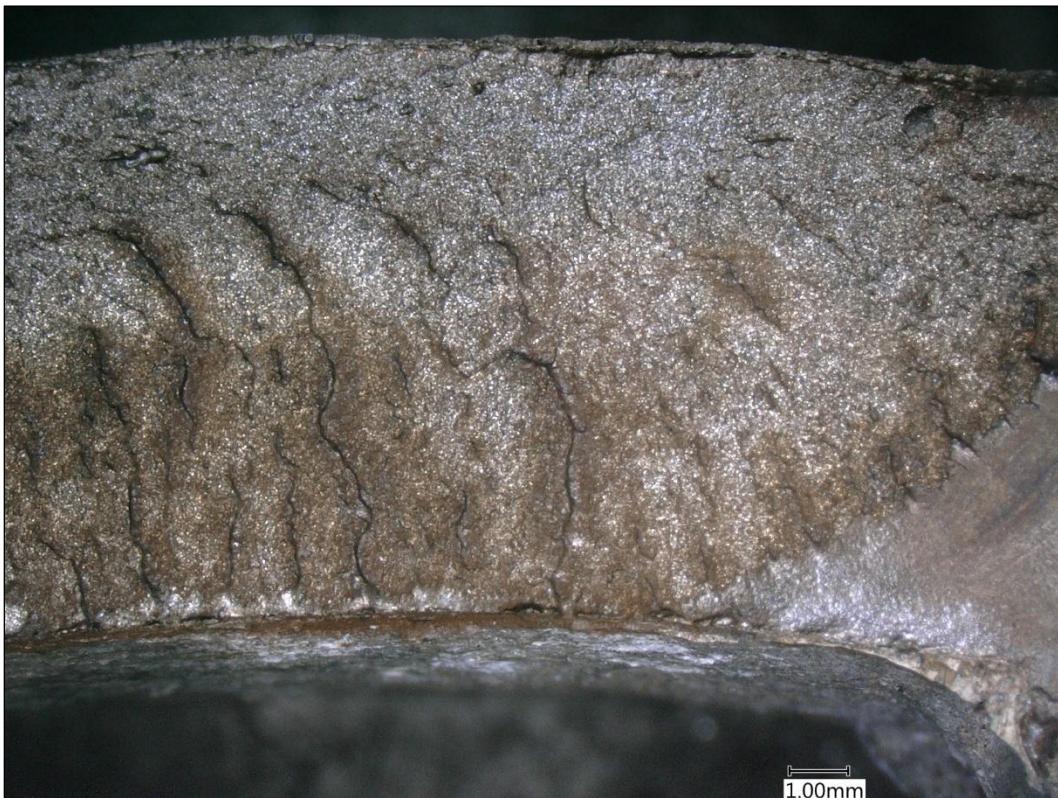
**Figure 20** Reference 4 brittle fracture arrested at seam weld HAZ.

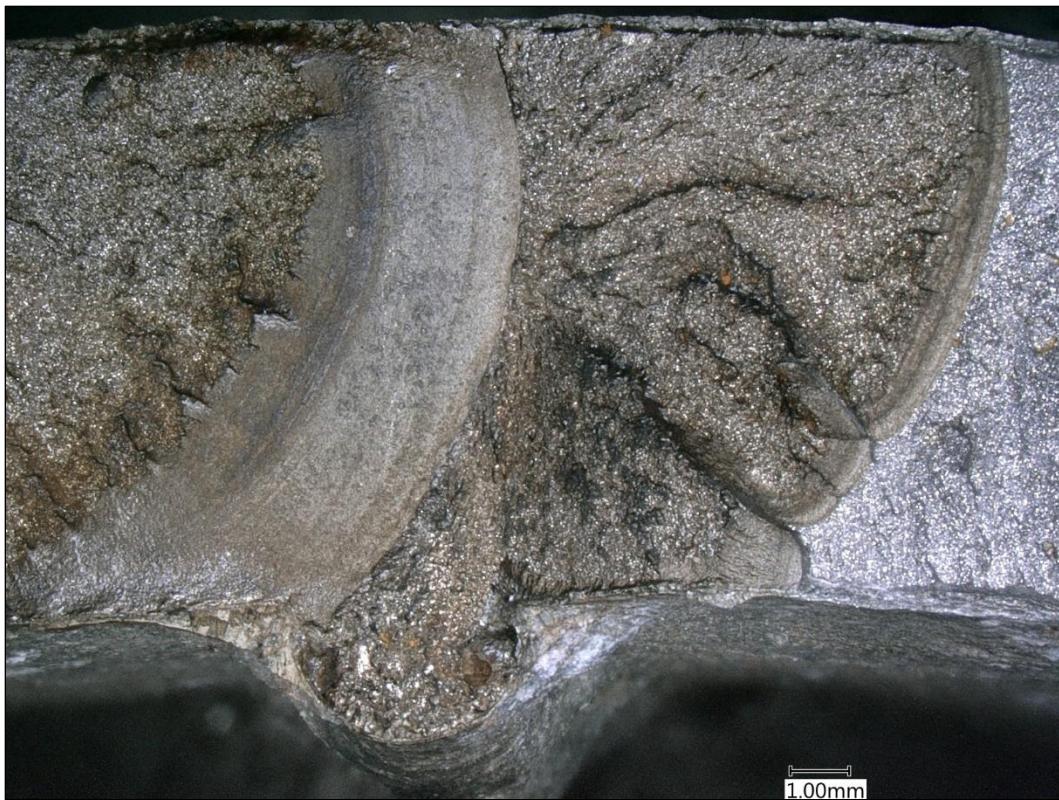
**Figure 21** Reference 5 brittle fracture on either side of fatigue cracking through seam weld HAZ

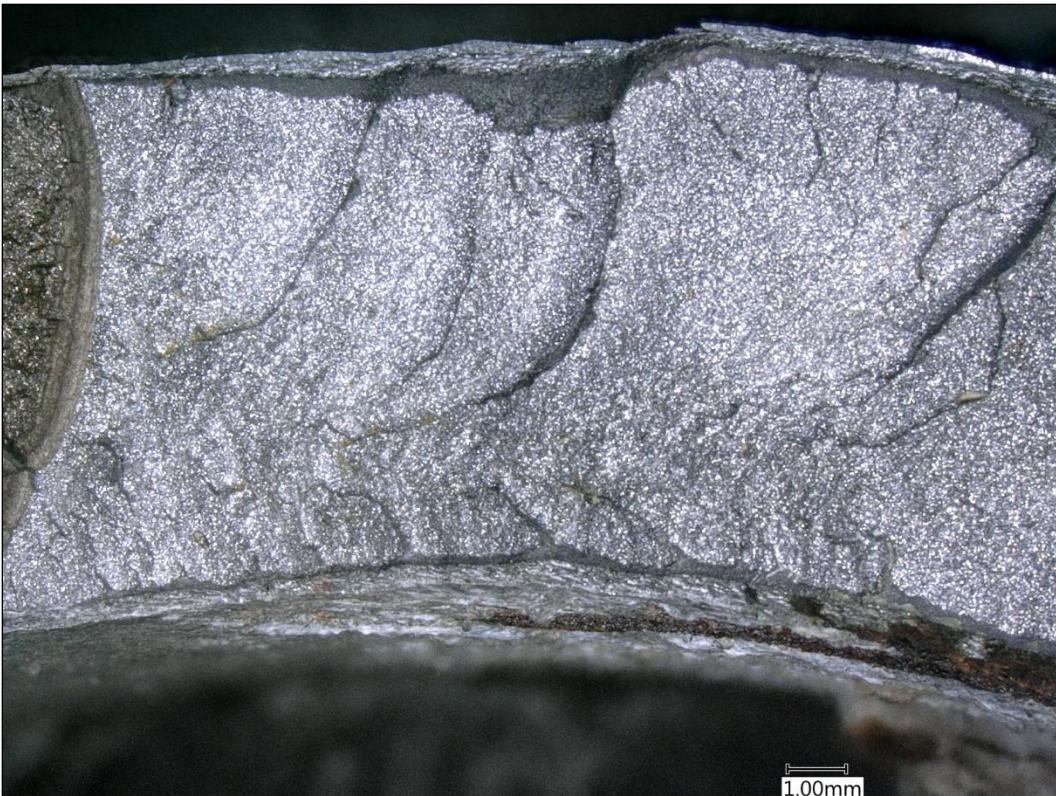
**Figure 22** Reference 6 brittle fracture starting at tip of HAZ fatigue zone.
