**KICKING HORSE MOUNTAIN SKI RESORT  
GOLDEN EAGLE EXPRESS  
LEITNER-POMA OF AMERICA GONDOLA**

**HANGER ARM FAILURE**

TECHNICAL SAFETY B.C.  
2889 East 12 Avenue  
Vancouver, B.C.  
V5M 4T5

File Number: 605-J215610  
EGBC Permit Number: 1001973  
Date: January 28, 2026

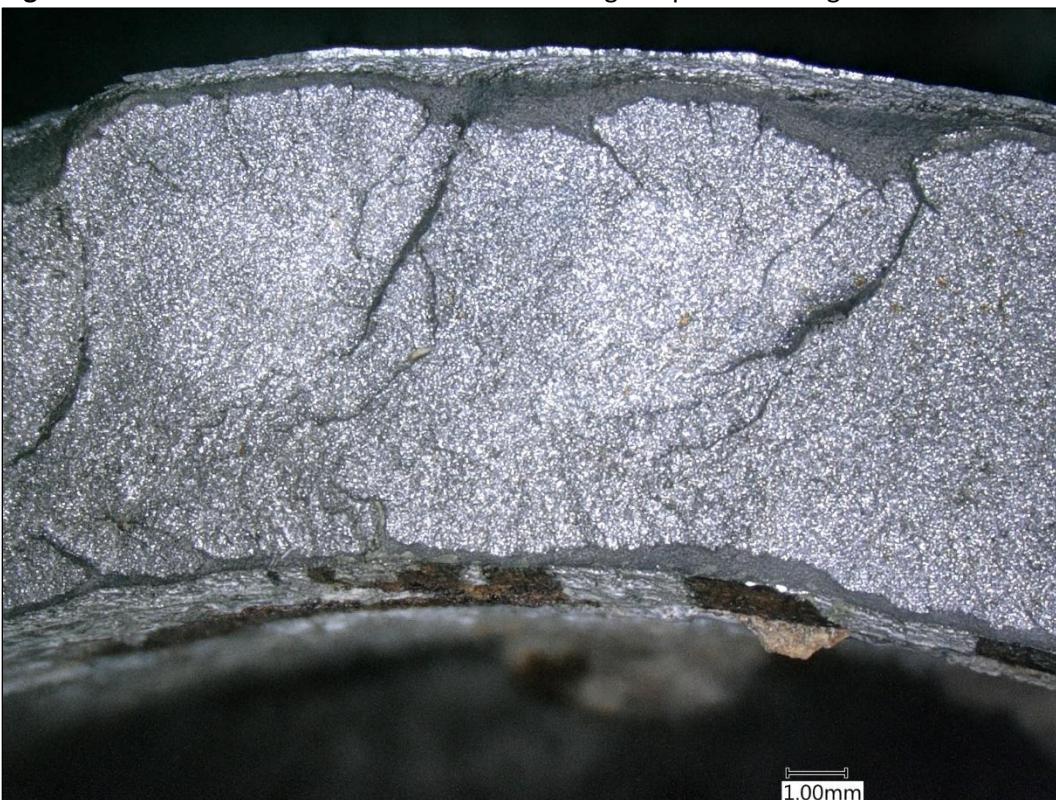
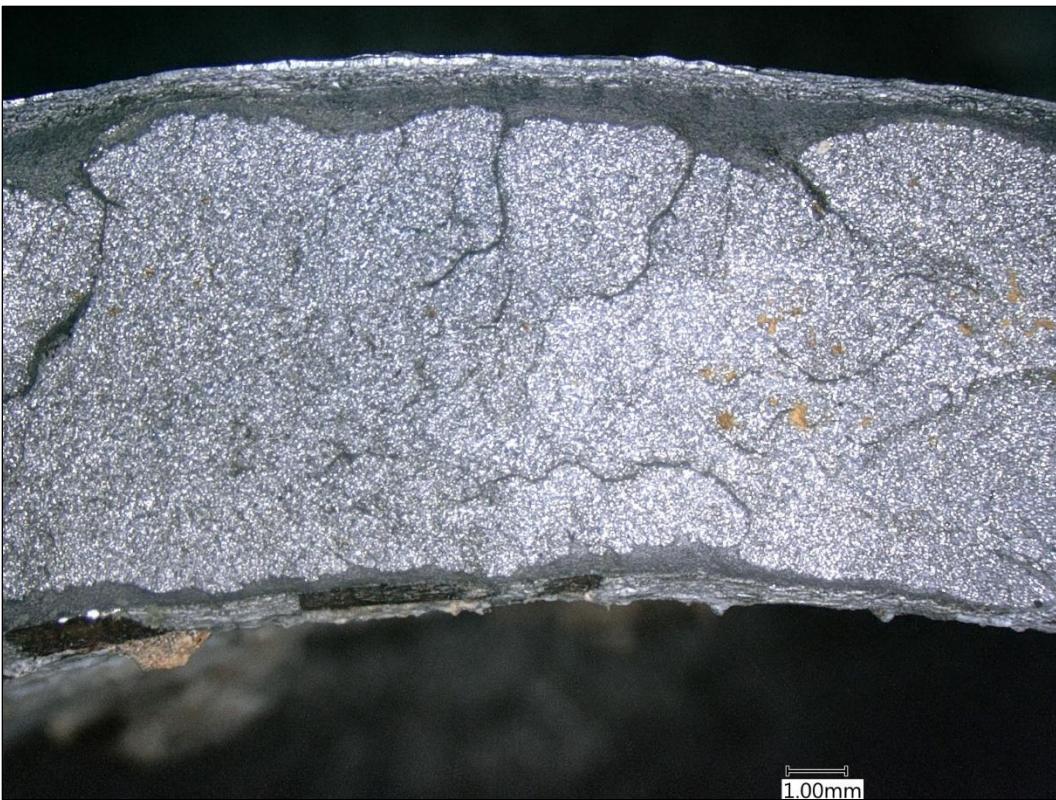
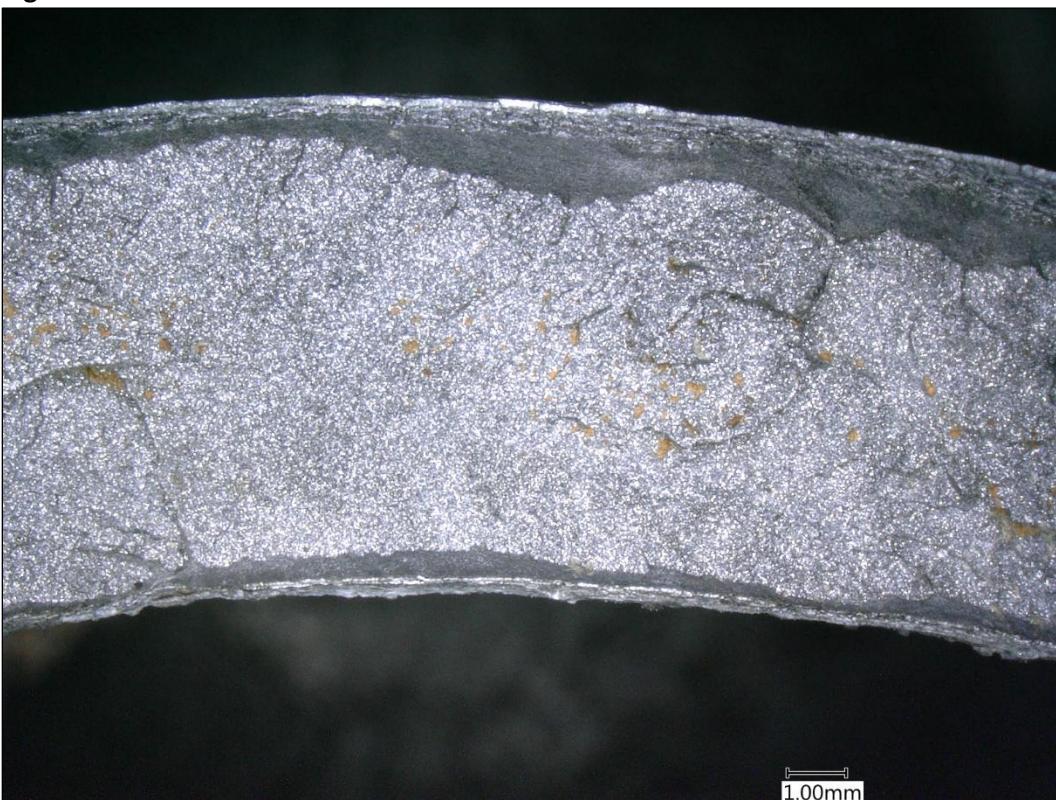
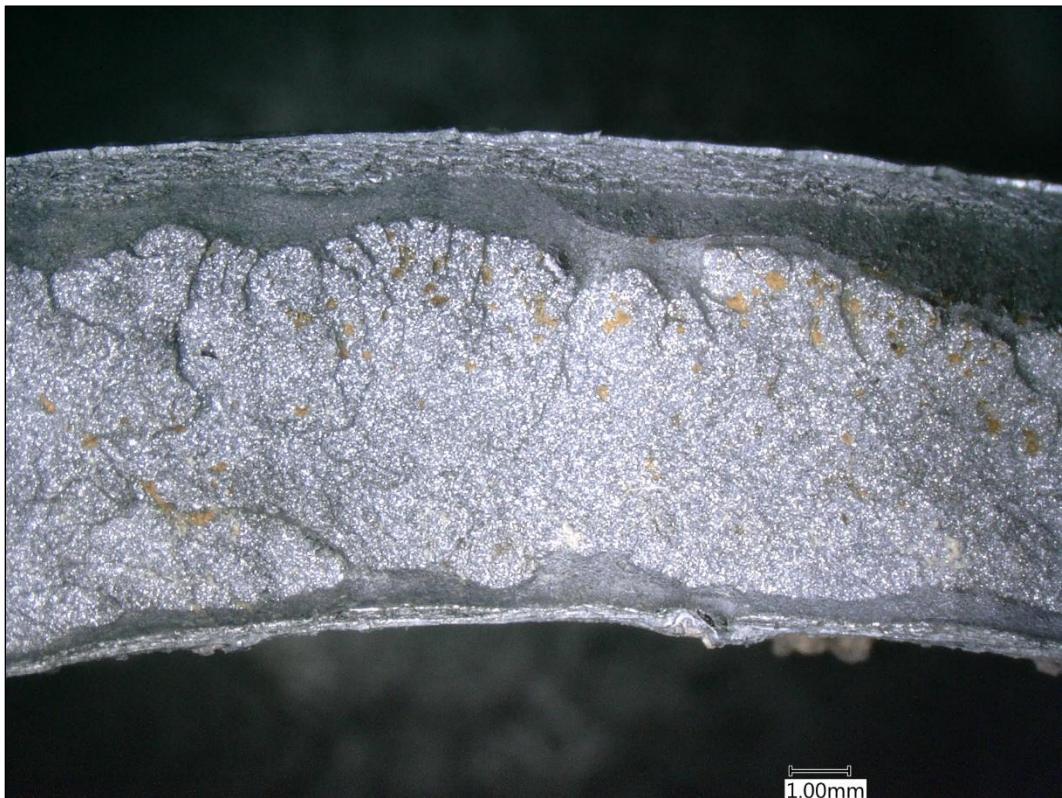
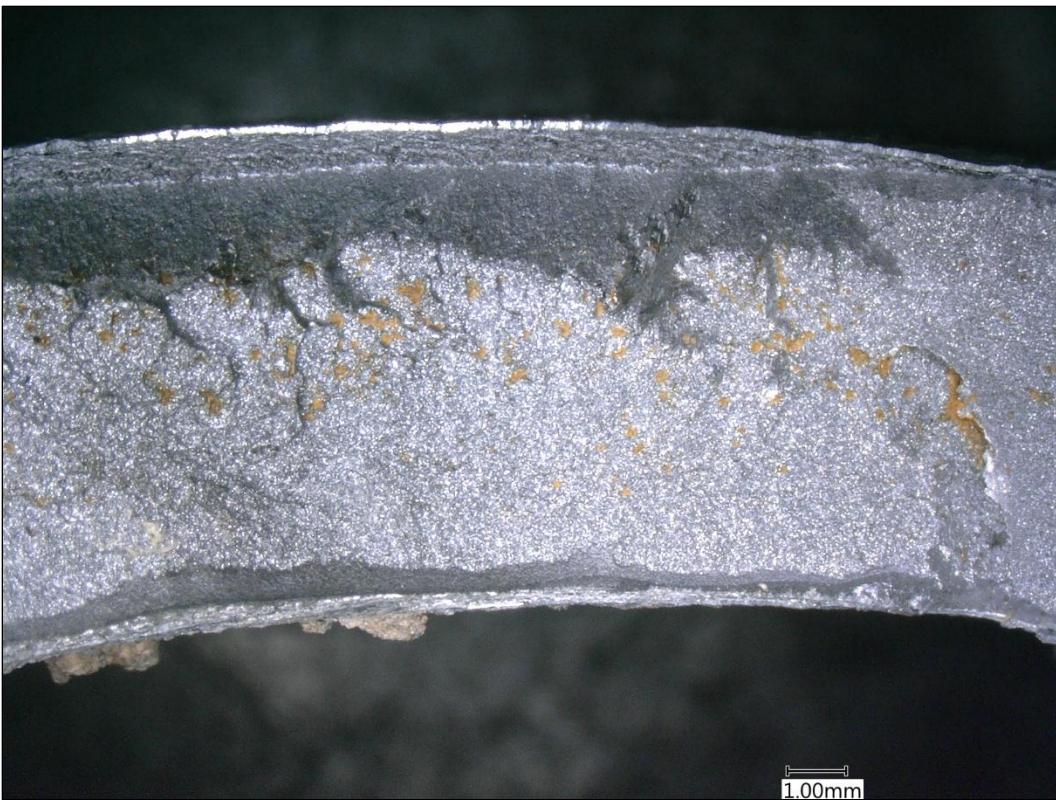
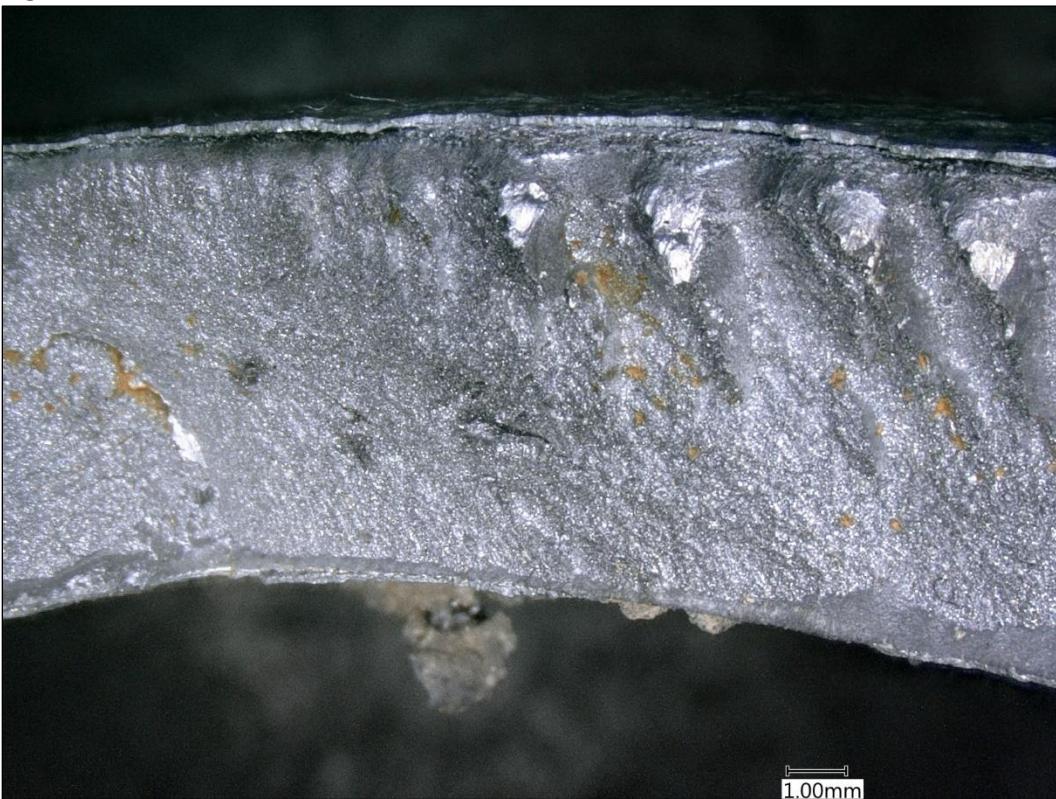
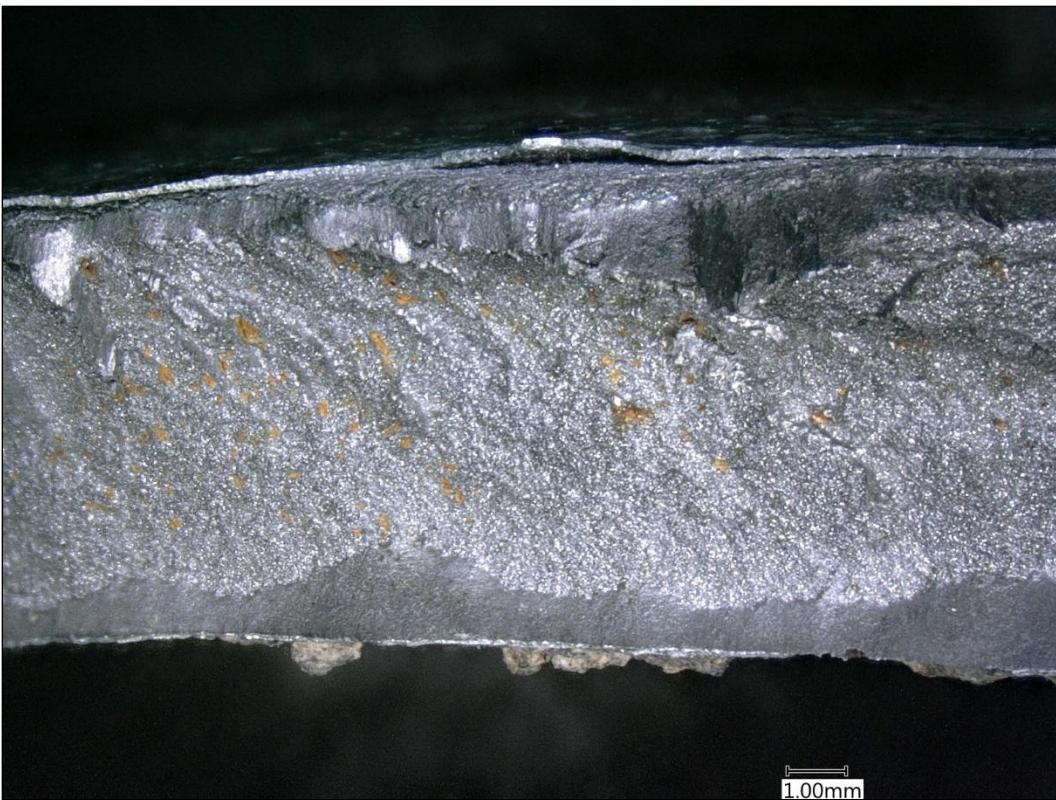
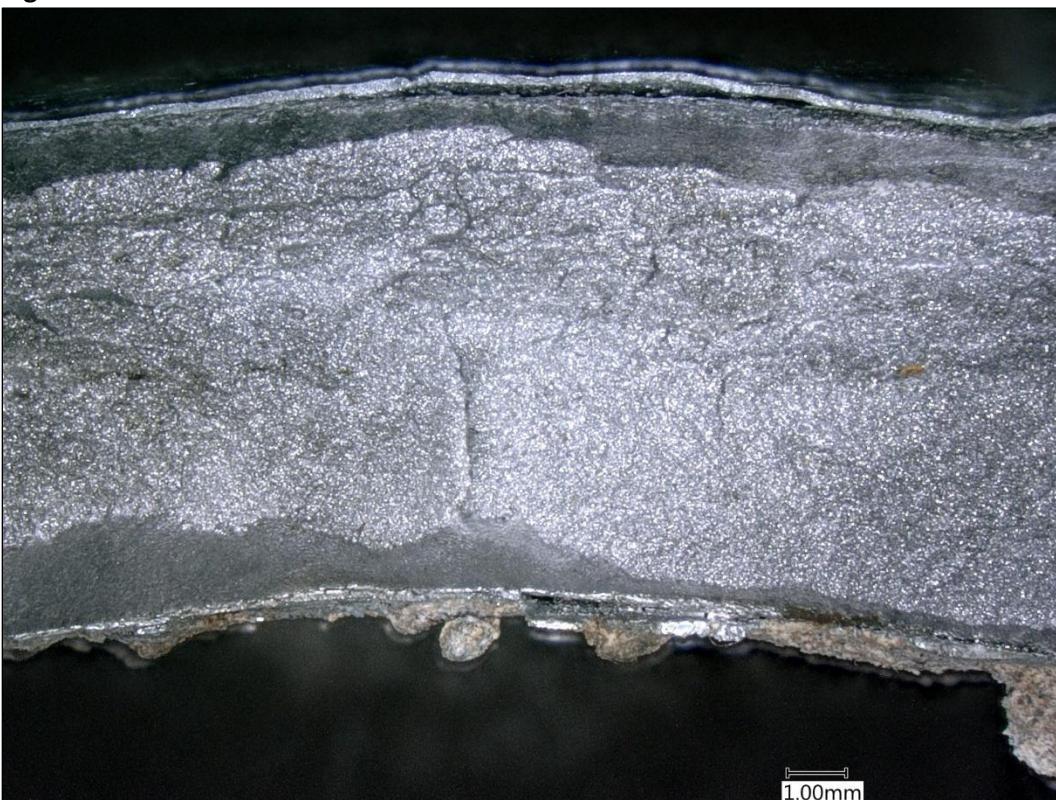
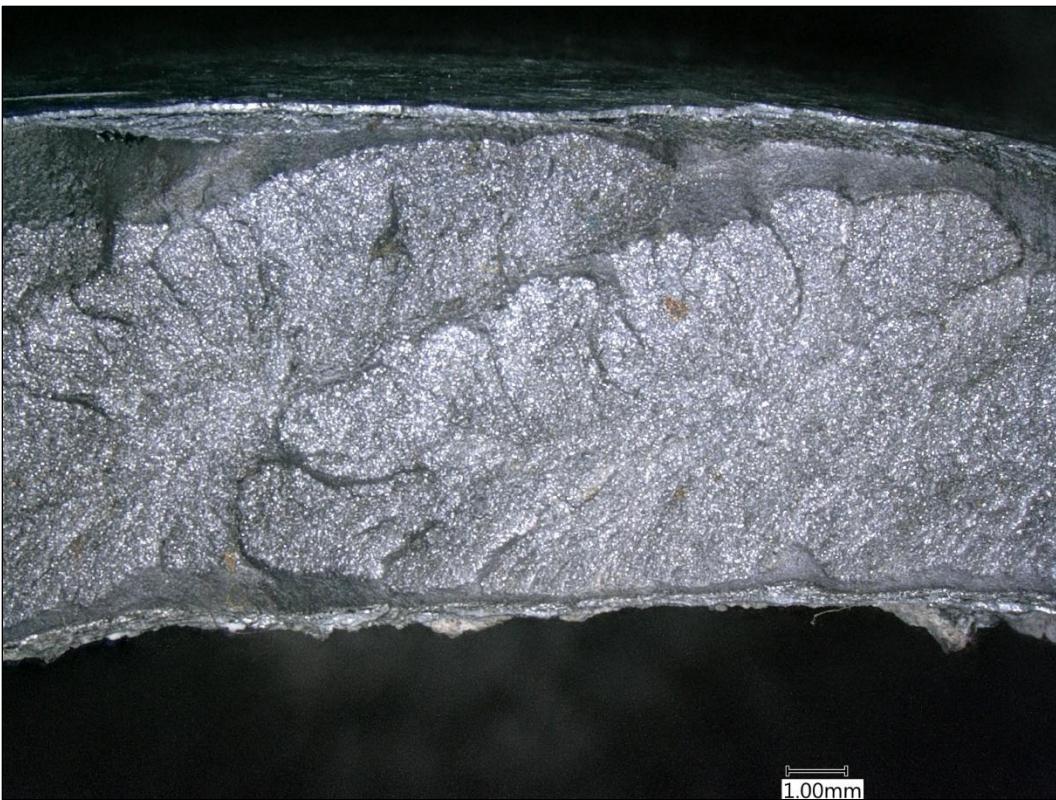
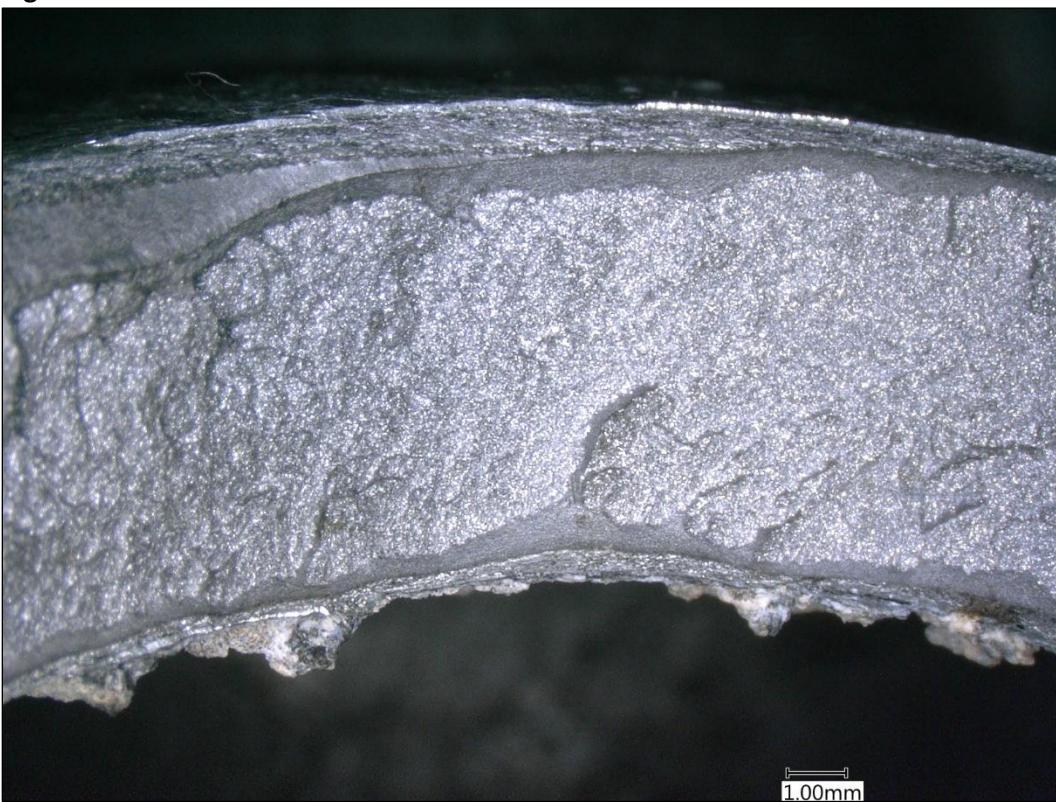
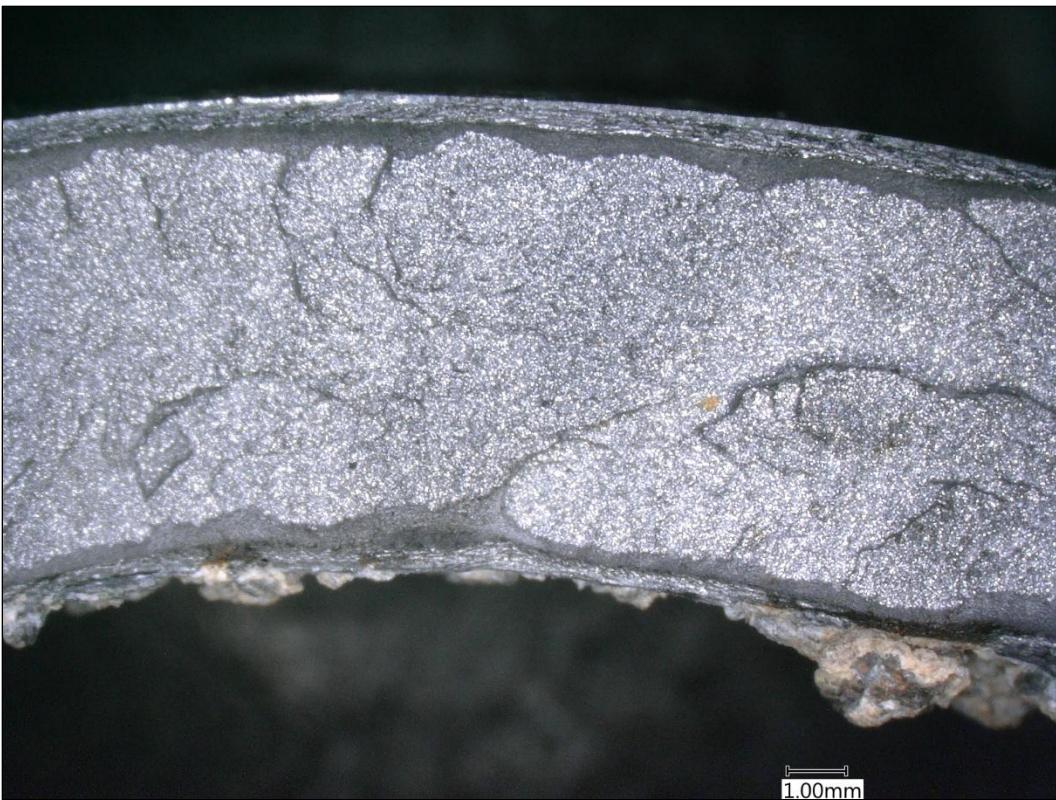
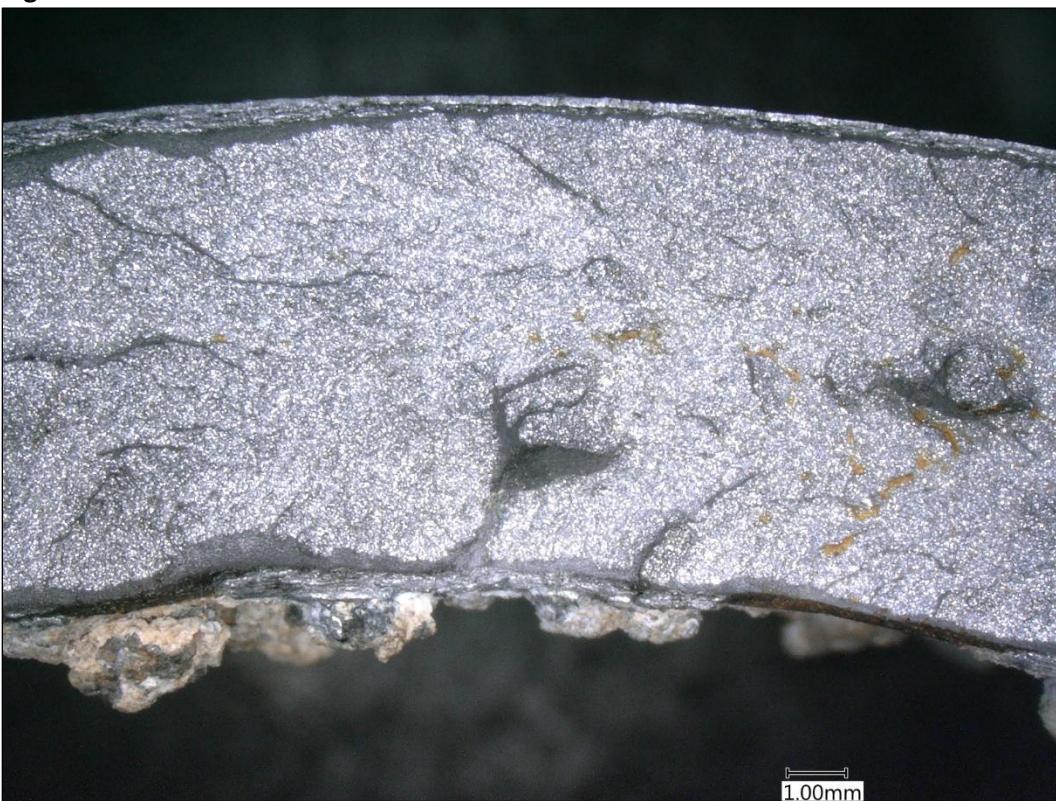
**Figure 23** Reference 7 brittle fracture in overload zone.

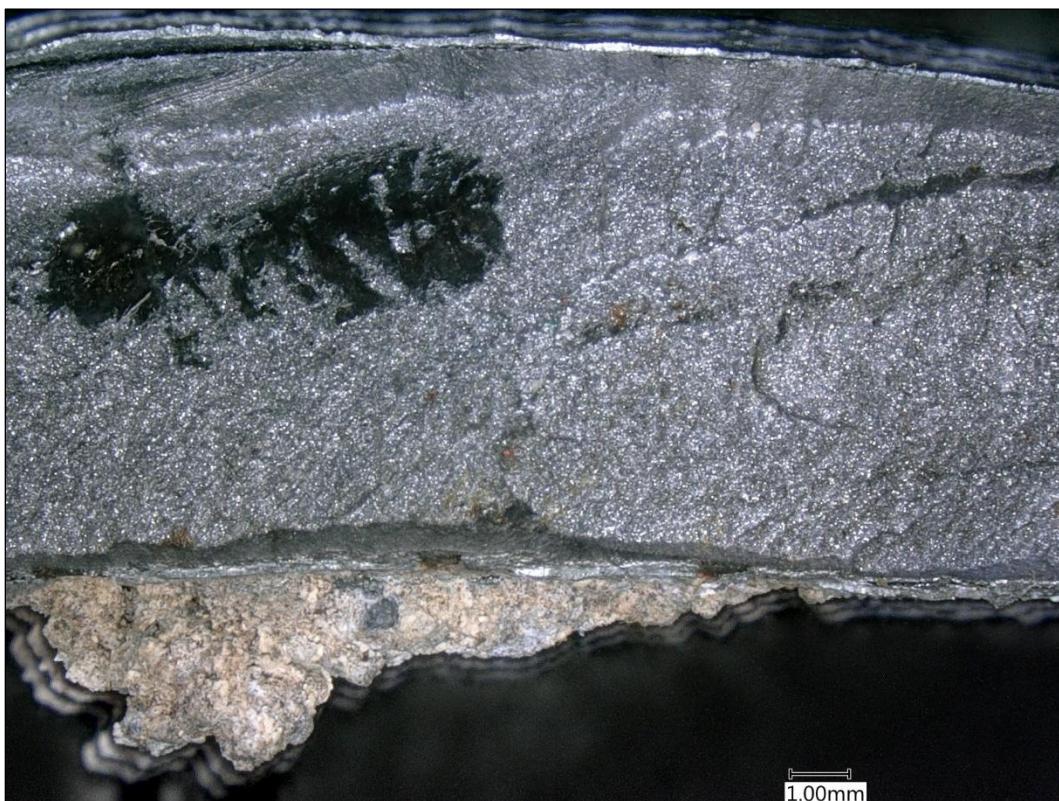
**Figure 31** Reference 15 brittle fracture in overload zone. Note dross on inside of pipe

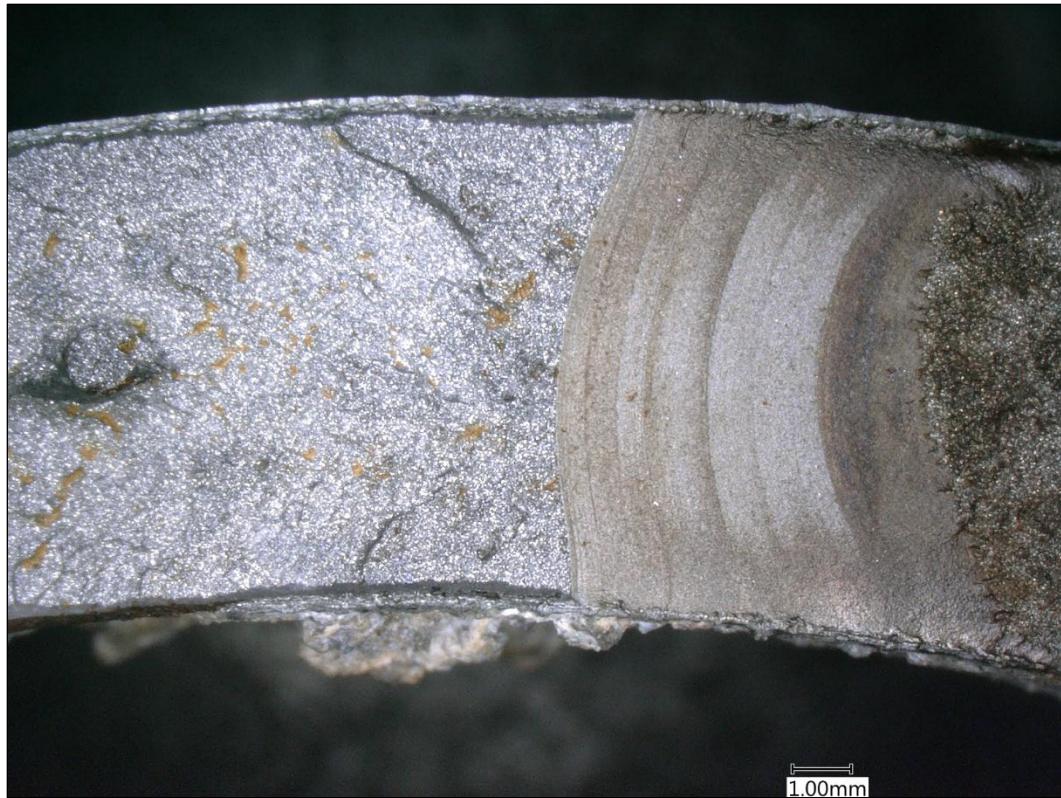
**Figure 36** Reference 20 brittle fracture arrested . Beginning of fatigue crack at toe of brittle fracture zone. Position of fatigue zone roughly corresponds to position of HAZ fatigue zone on opposite side of thumbnail.

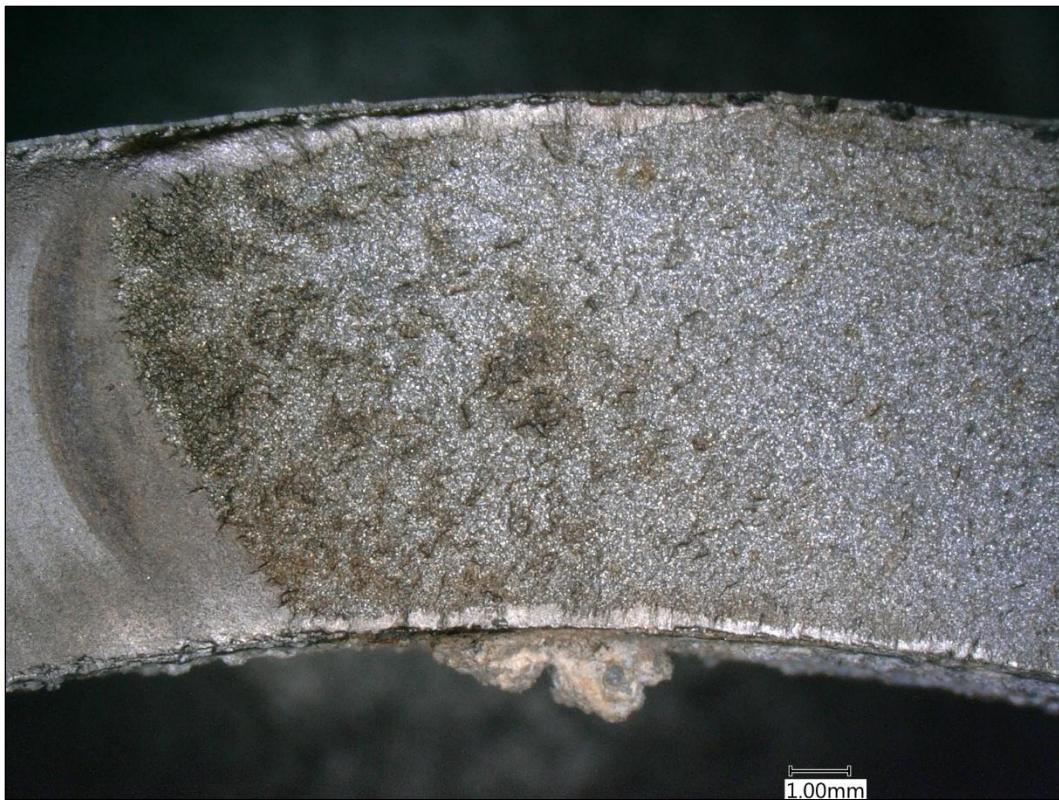
**Figure 37** Reference 21 end of fatigue and start of brittle fracture heading away from thumbnail.

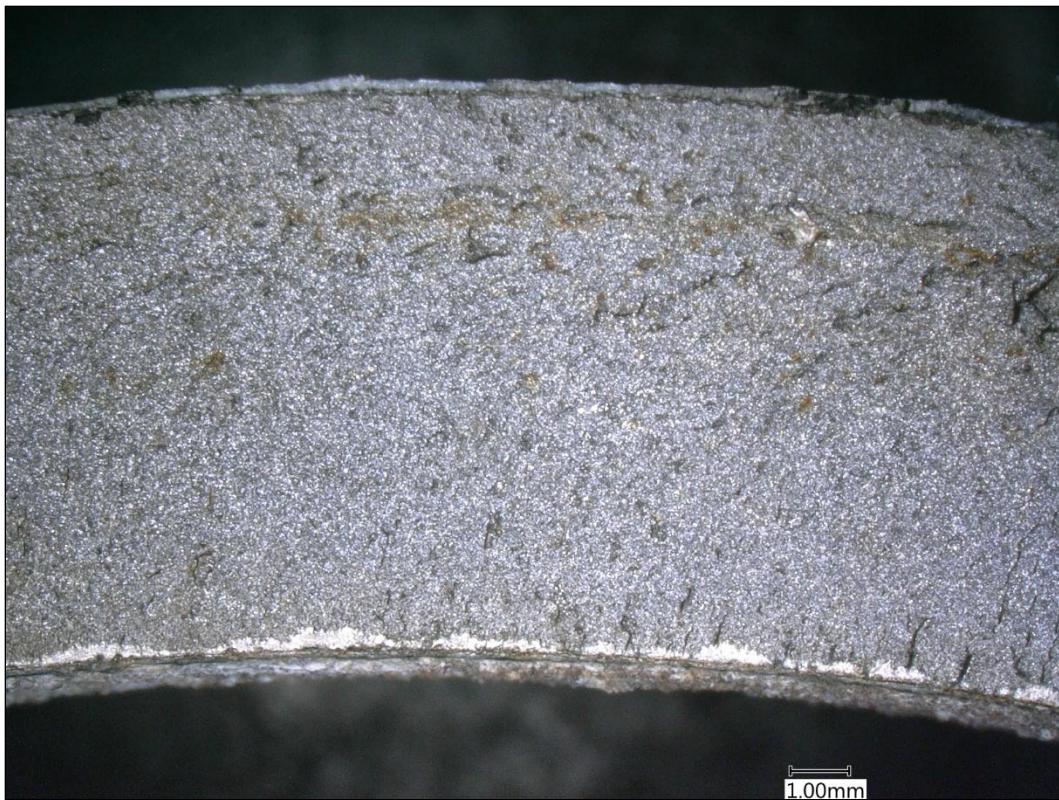
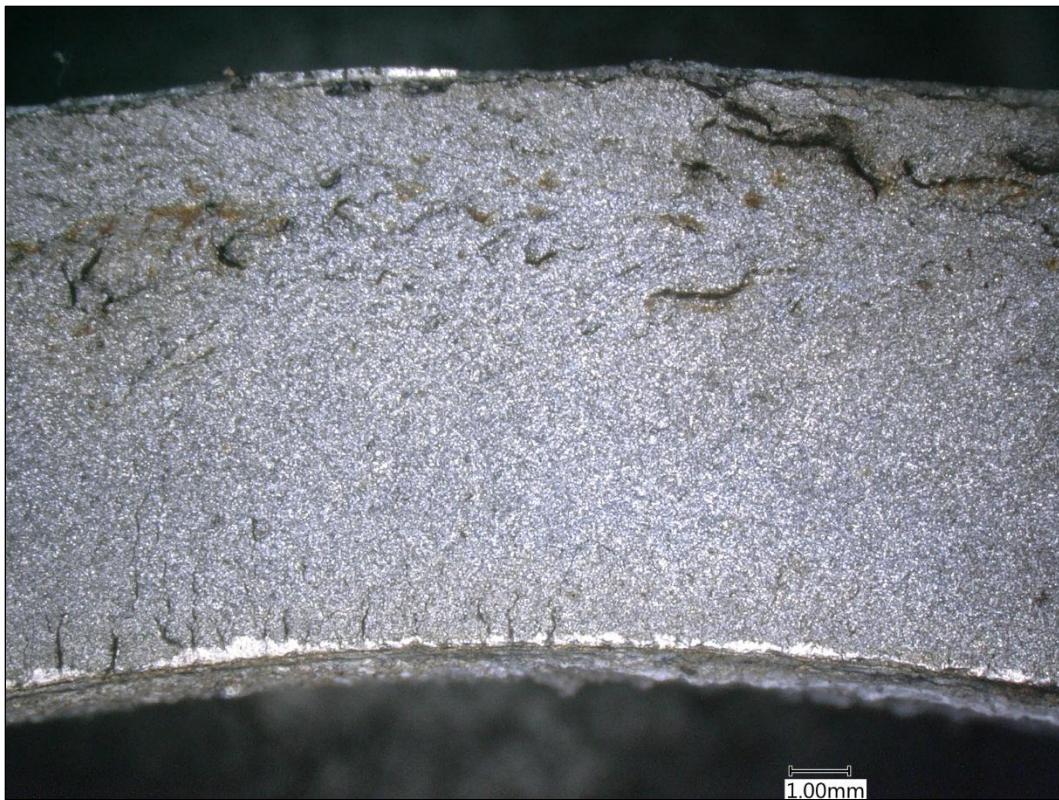
**Figure 38** Reference 22 brittle fracture heading toward fatigue zone.

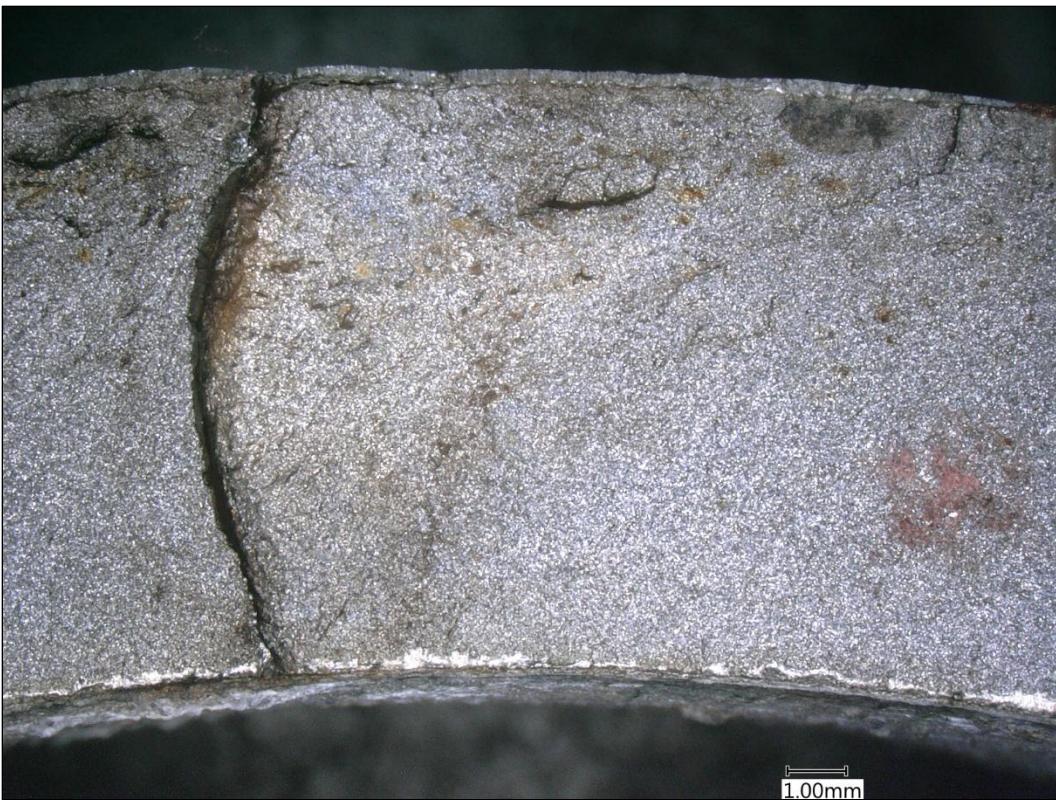
**Figure 40**      Brittle fracture near large thumbnail containing small thumbnail.

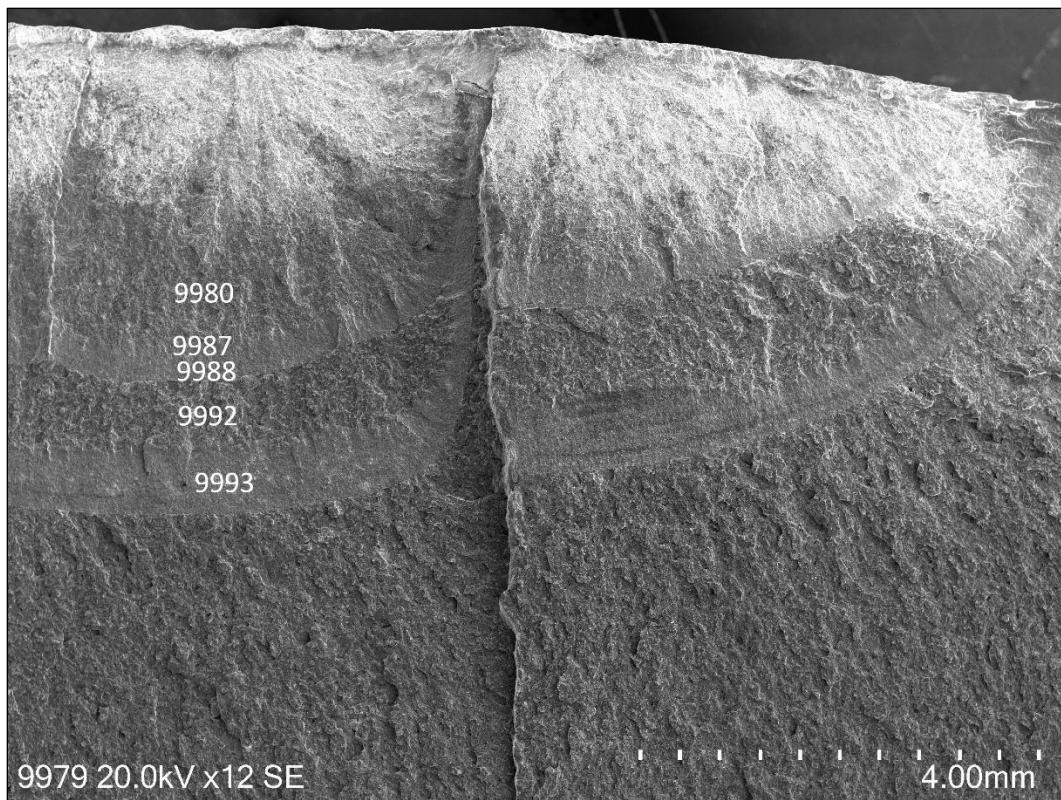
**Figure 42** SEM view of uncleaned thumbnail. White haze is zinc oxide washed onto surface after initial cracking took place.

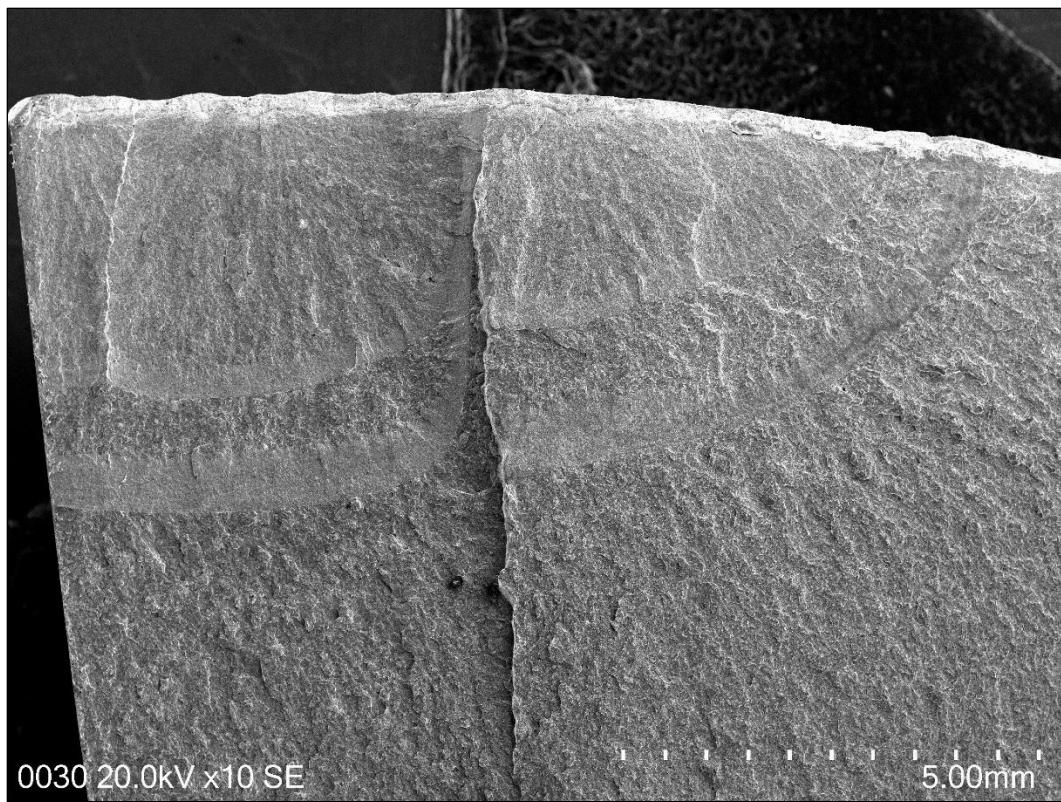
**Figure 43**      Thumbnail after cleaning with detergent in ultrasonic bath . Zones are labelled 1 – 5

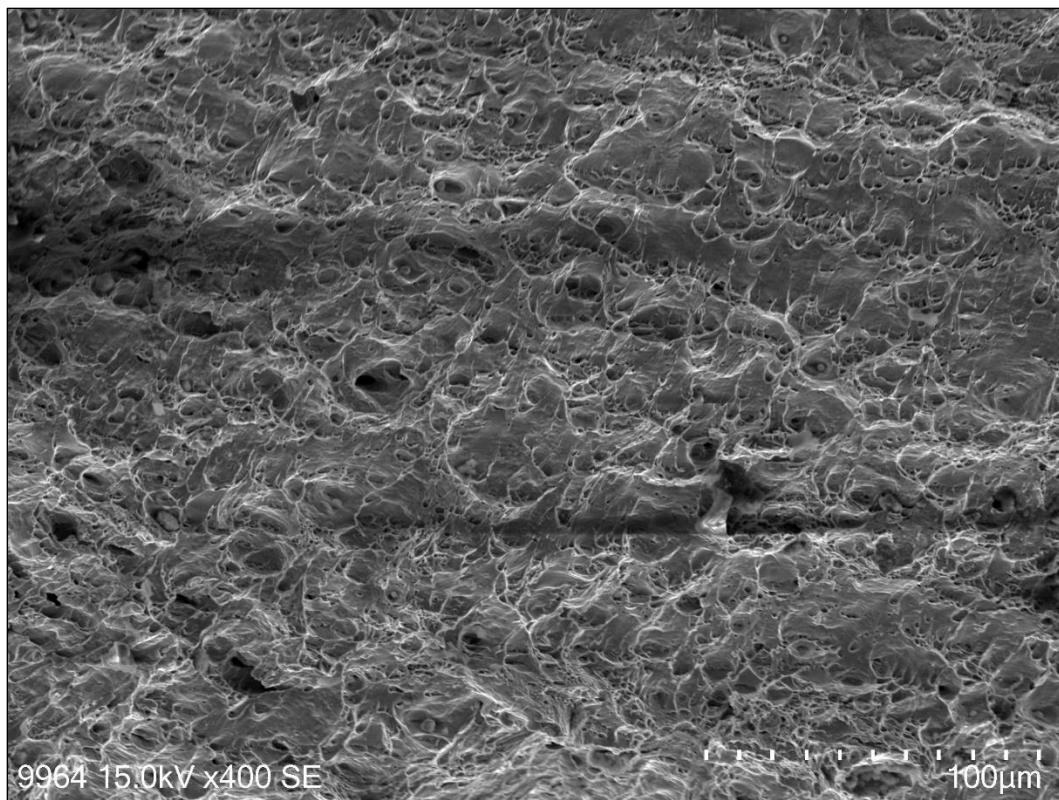
**Figure 44** Features in origin area right at the surface. Features are a mixture of ductile and brittle cleavage.

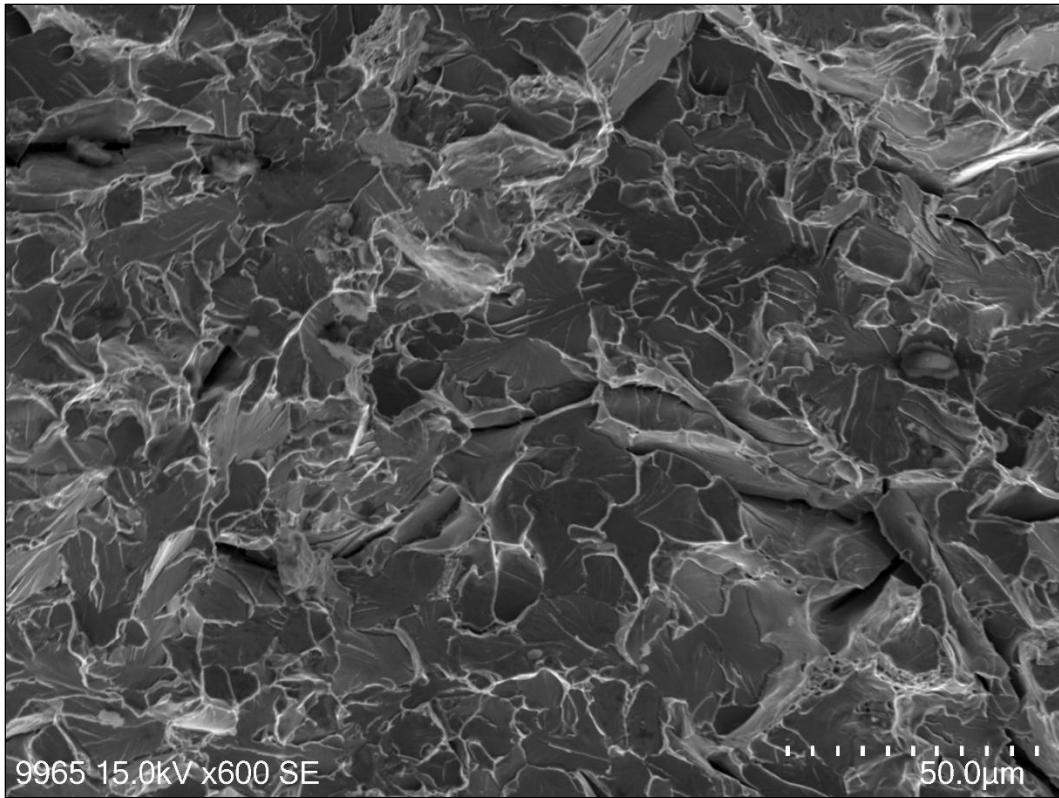
**Figure 45** Features in Zone 1 containing 100% brittle cleavage.

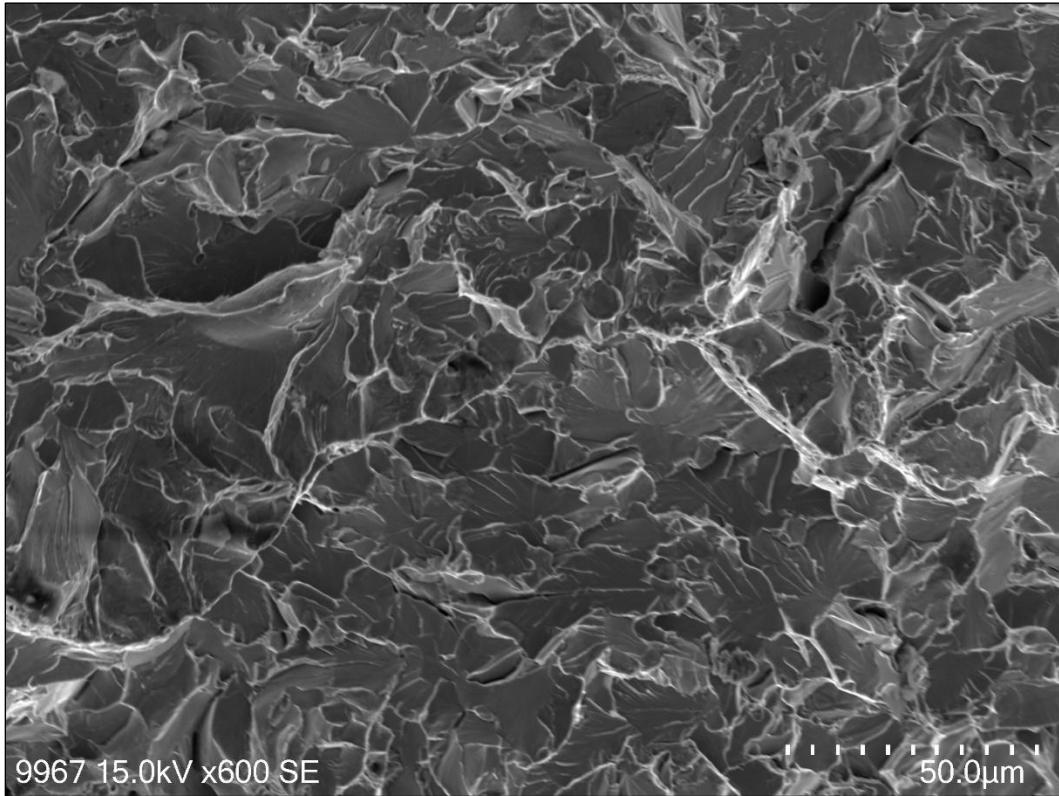
**Figure 46** Features in Zone 2 containing 100% brittle cleavage.

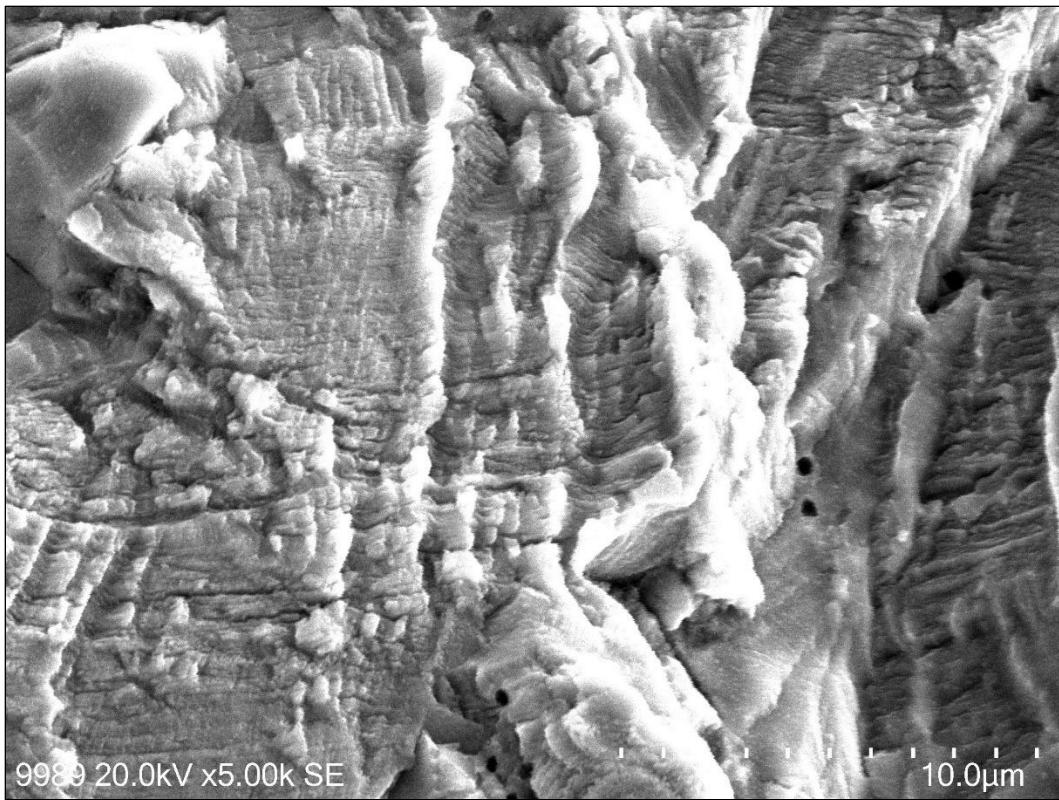
**Figure 47** Features in Zone 3 containing fine fatigue striations. Striation spacing is approximately 0.3 microns

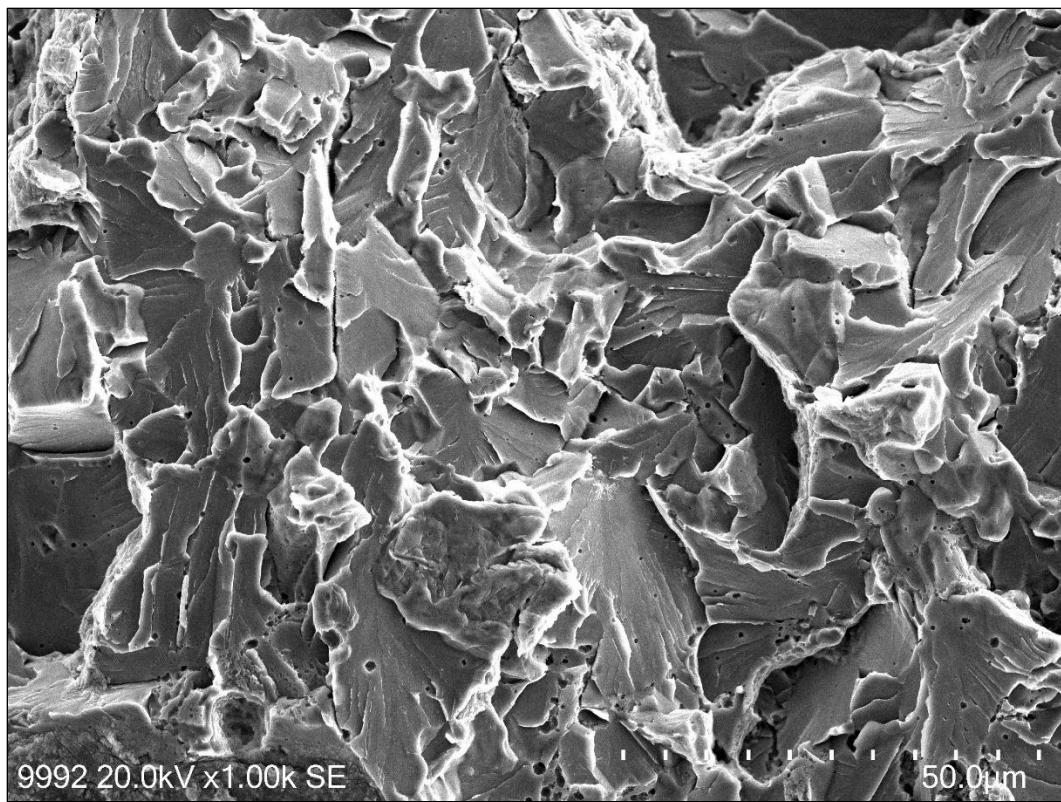
**Figure 48** Features in Zone 4 containing 100% brittle cleavage.

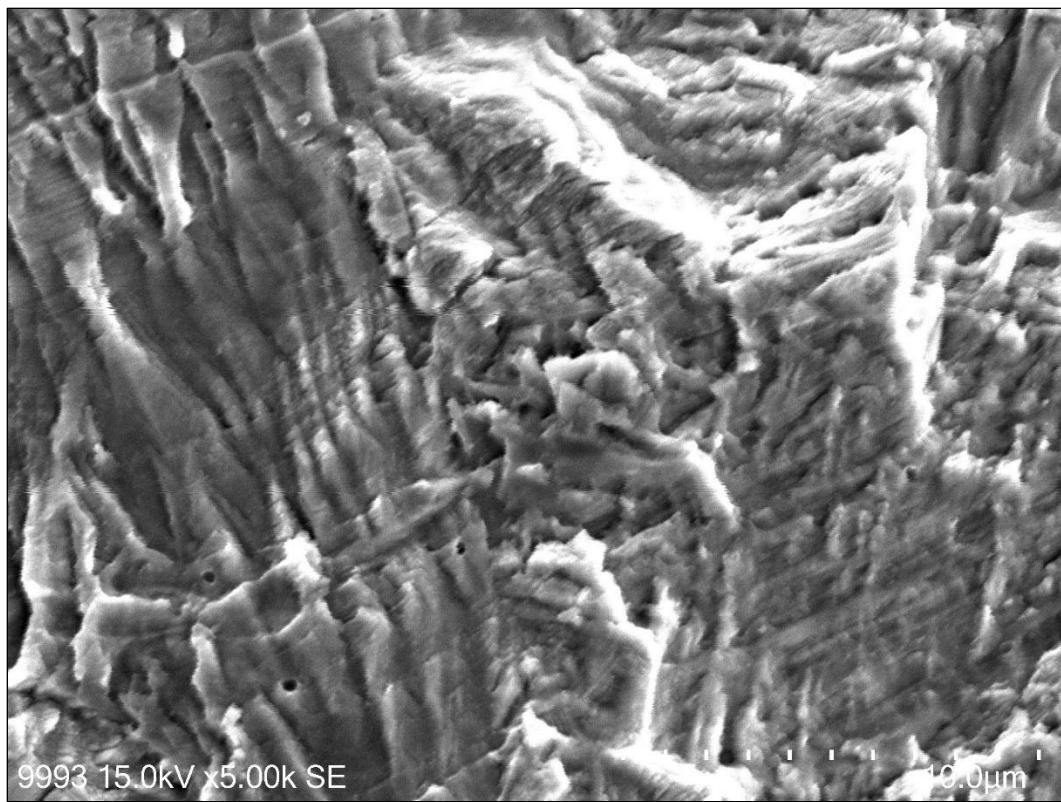
**Figure 49** Features in Zone 5 containing fatigue striations. Striation spacing is approximately 0.3 microns.

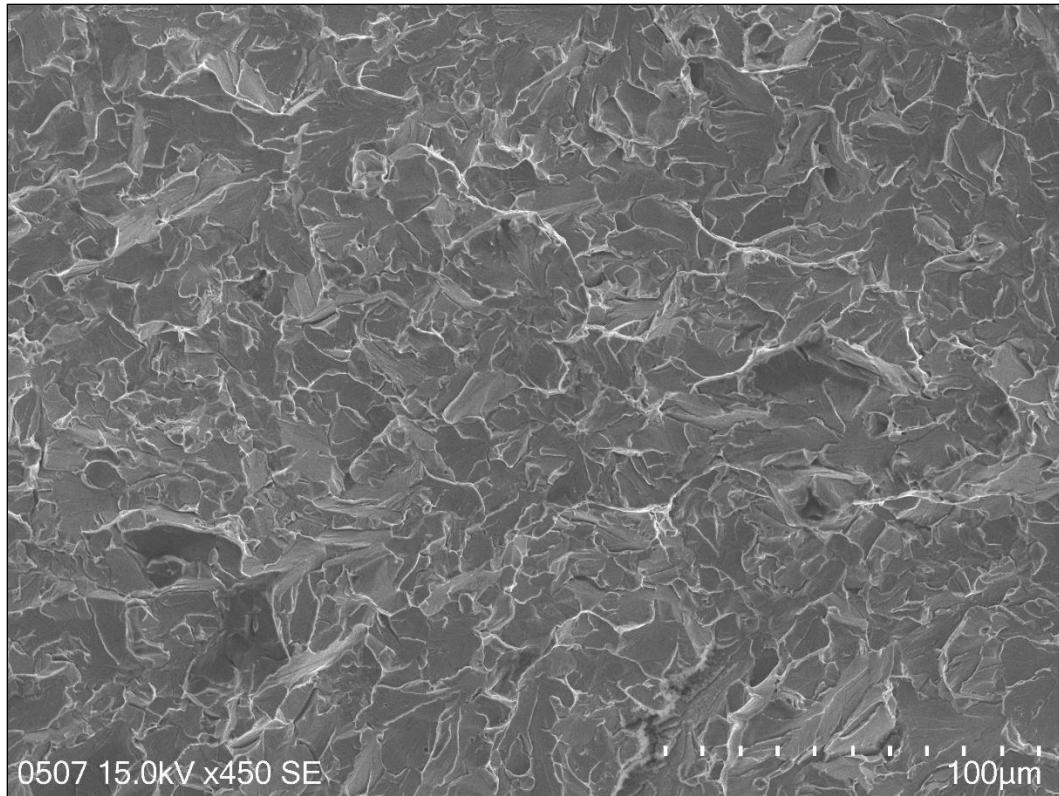
**Figure 50** 100% brittle cleavage below thumbnail.
