**KICKING HORSE MOUNTAIN SKI RESORT  
GOLDEN EAGLE EXPRESS  
LEITNER-POMA OF AMERICA GONDOLA**

**HANGER ARM FAILURE**

TECHNICAL SAFETY B.C.  
2889 East 12 Avenue  
Vancouver, B.C.  
V5M 4T5

File Number: 605-J215610  
EGBC Permit Number: 1001973  
Date: January 28, 2026

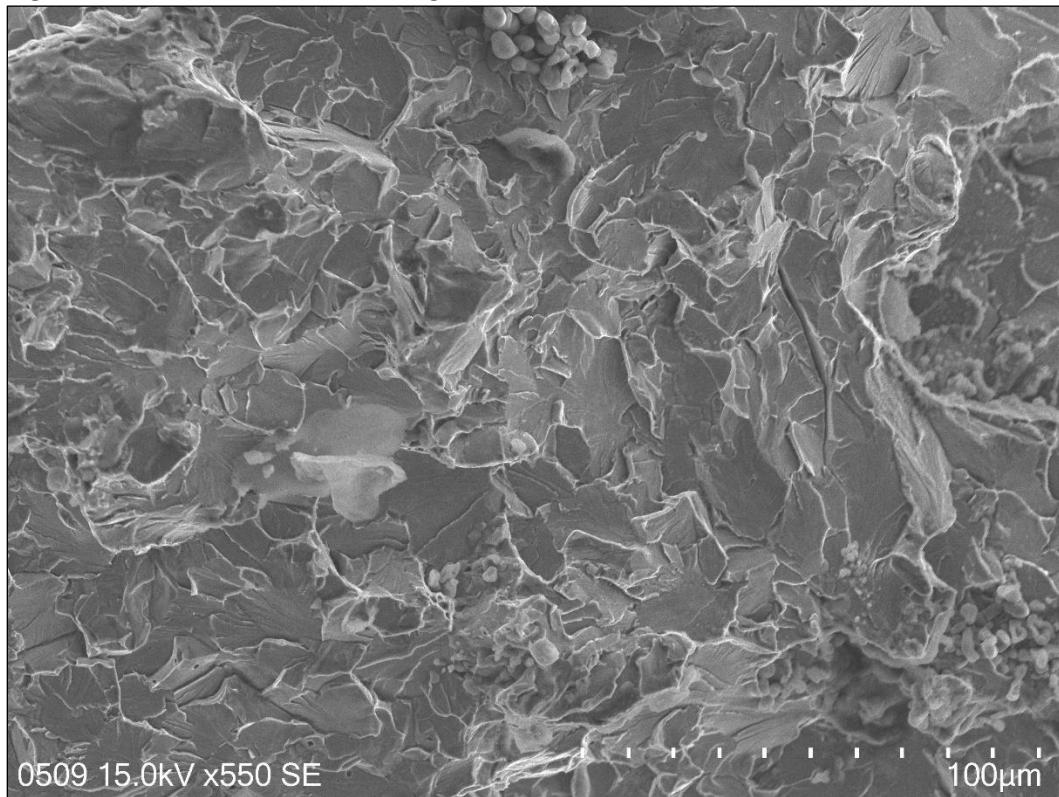
**Figure 51** 100% brittle cleavage between thumbnail and ID of pipe

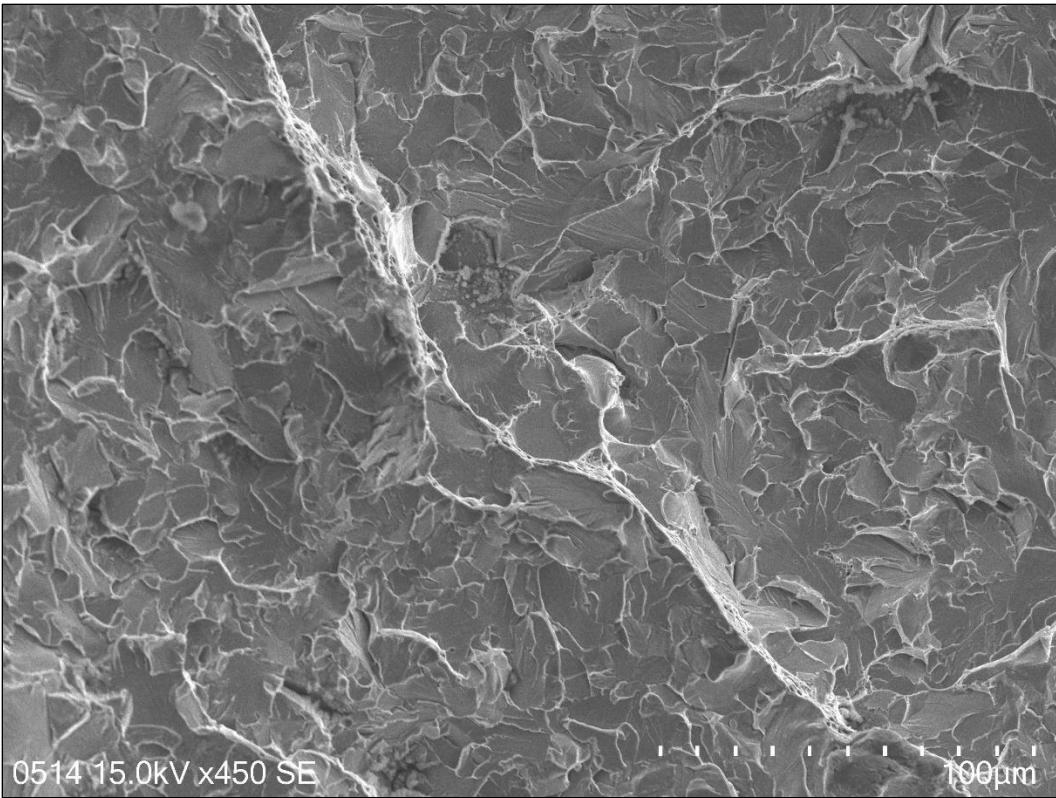
**Figure 52** 100% brittle cleavage between thumbnail and weld zone.

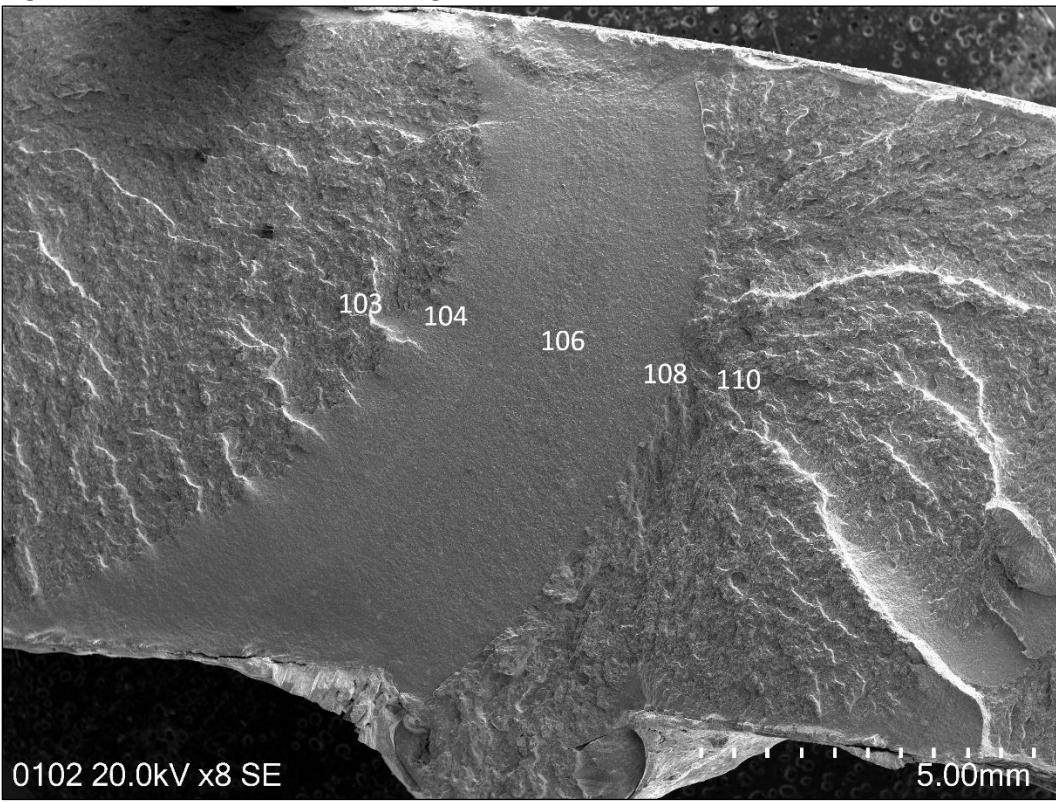
**Figure 53** Fatigue zone starting at brittle fracture arrest in weld metal HAZ

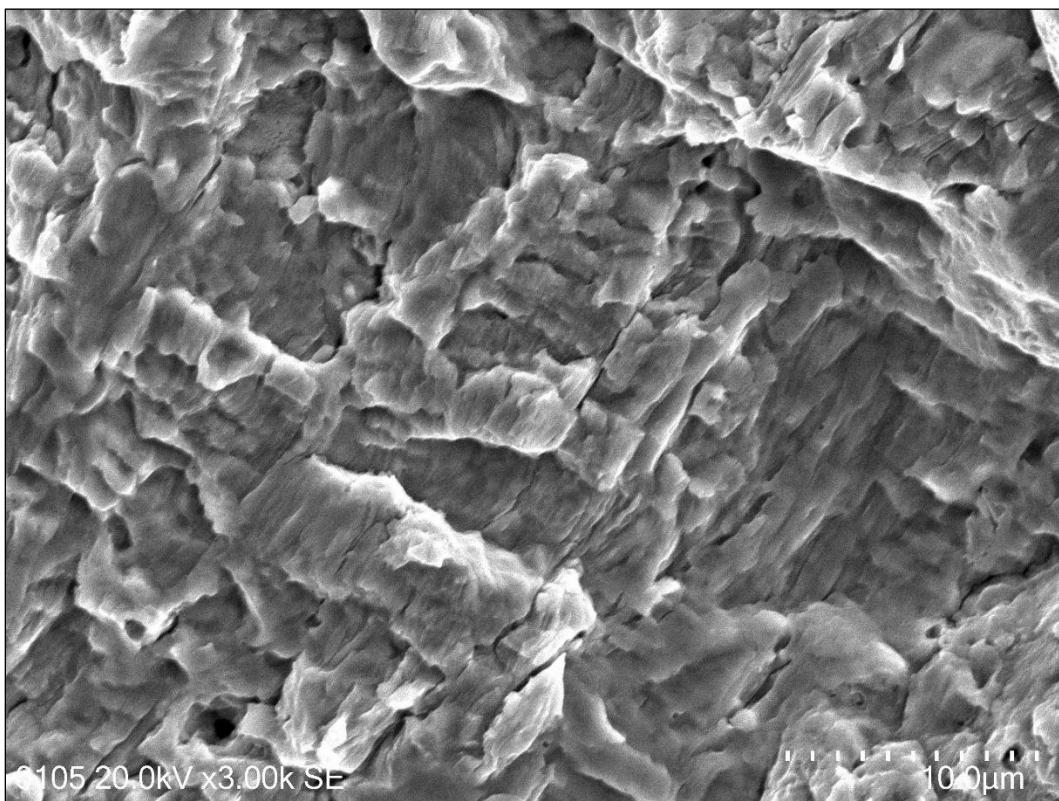
**Figure 54** Fine fatigue striations in weld metal fatigue zone

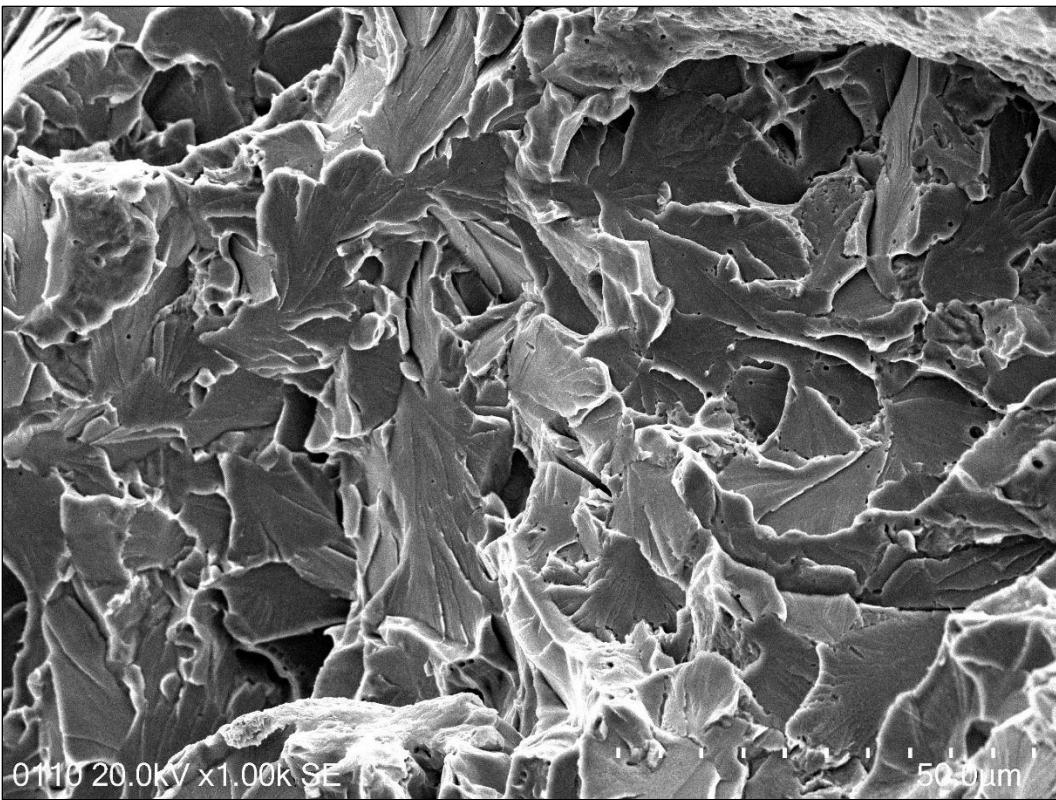
**Figure 55** 100% brittle cleavage in overload zone

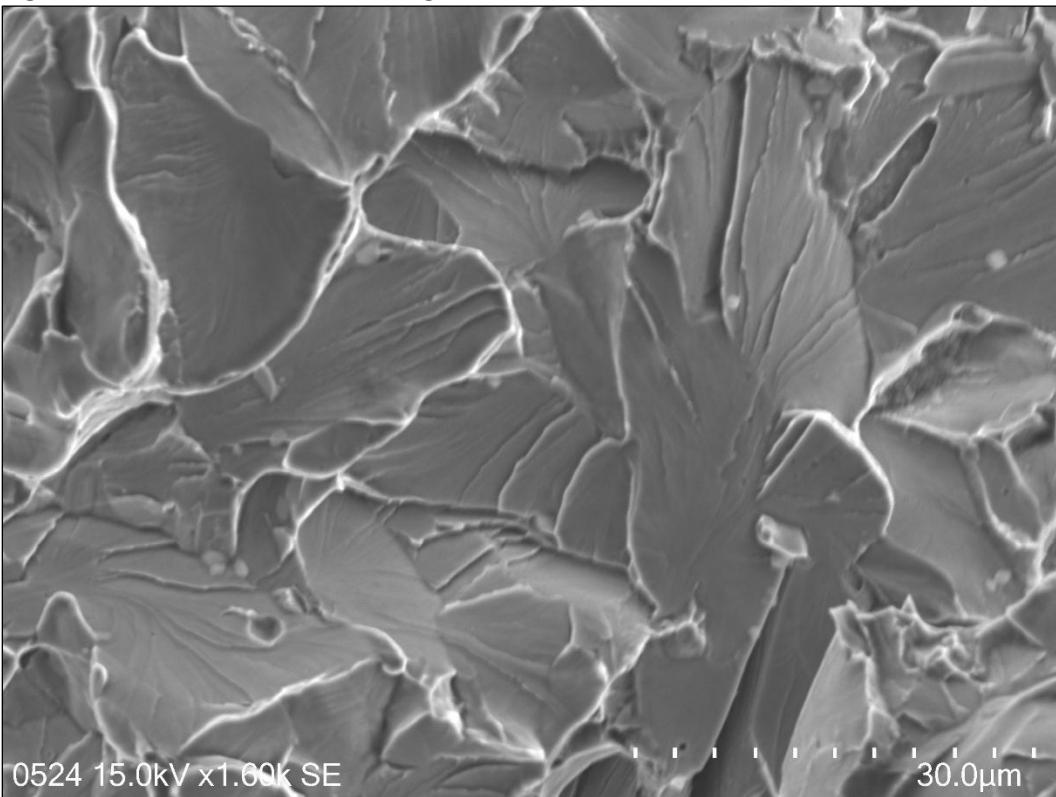
**Figure 56** 100% brittle cleavage in last area to separate.

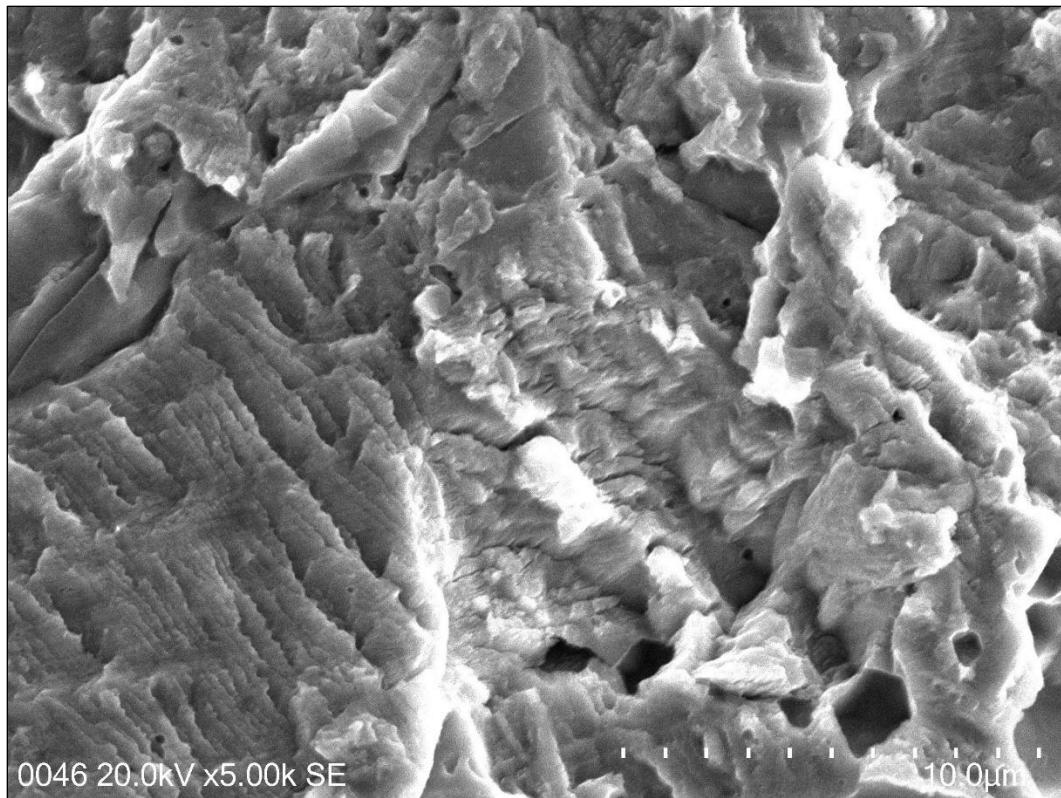
**Figure 57** Fine fatigue striations in fatigue zone on opposite side. Striation spacing is 0.2 - 0.3 microns

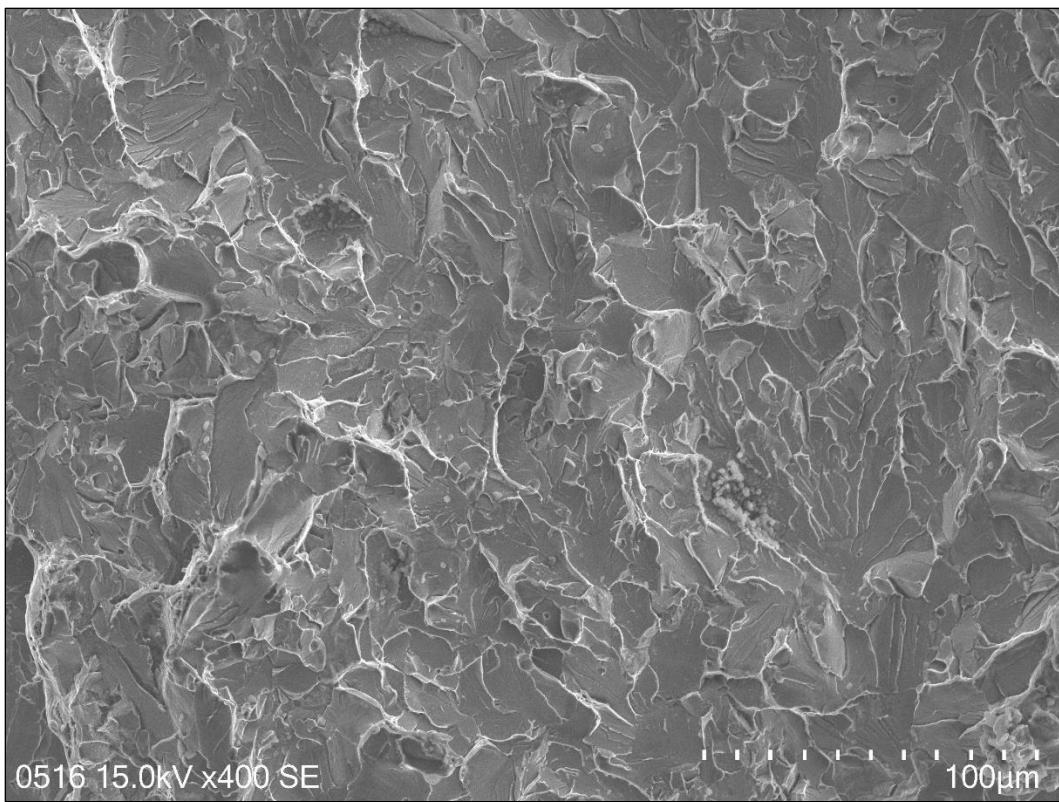
**Figure 58** 100% brittle fracture toward thumbnail

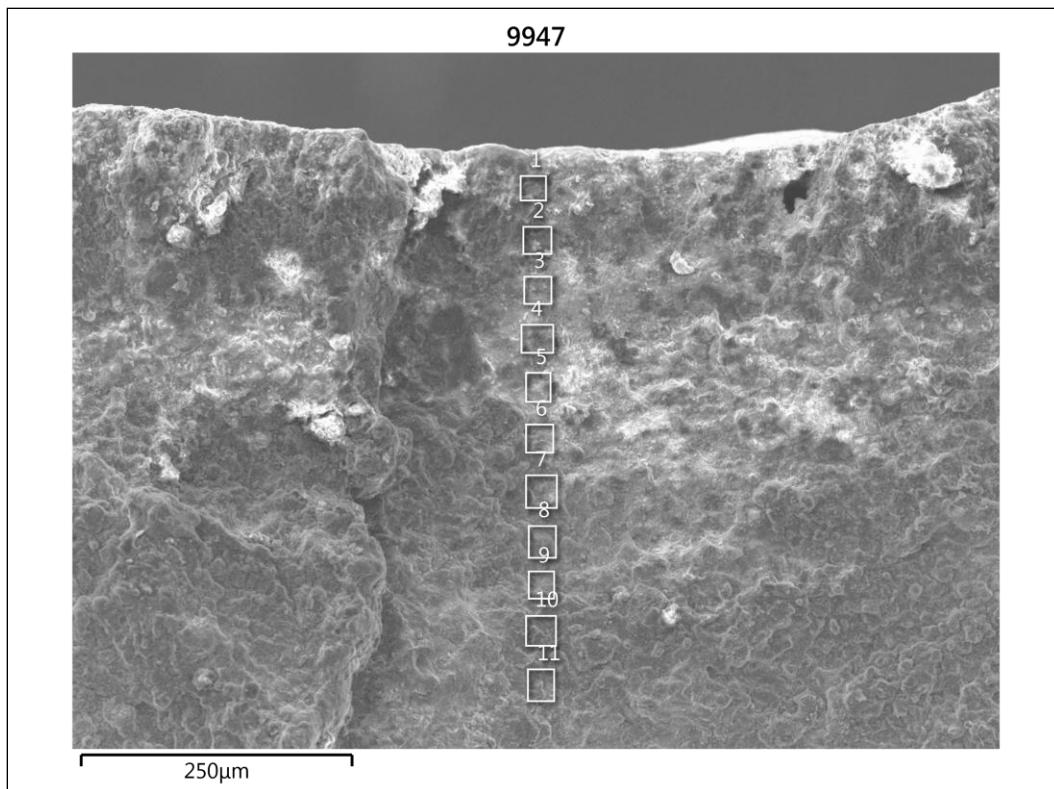
The white haze found on the thumbnail before cleaning was checked using EDXA and found to be zinc oxide (Figure 59). The zinc oxide likely washed onto the upper fracture surface during wet weather.

**Figure 59** EDXA of haze showing decreasing zinc content toward the bottom of the thumbnail

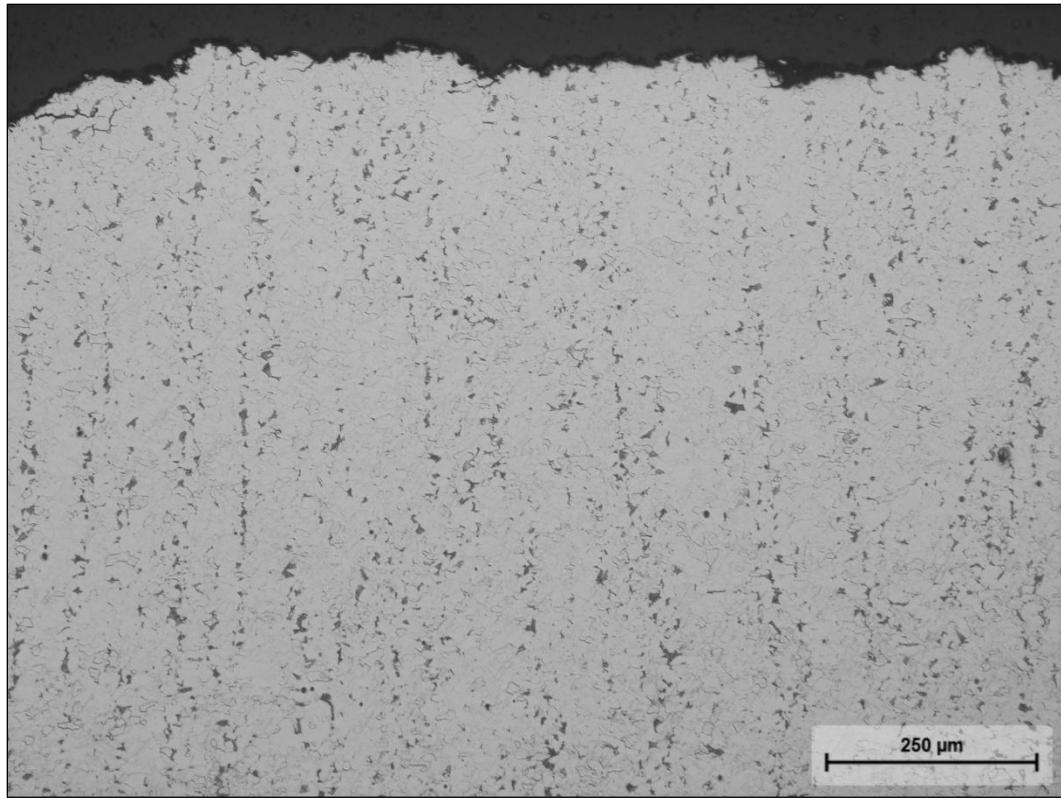
An overall view of the pipe microstructure away from the fracture is shown in Figure 60. The microstructure consists of fine grained pearlite and ferrite. The longitudinal plate rolling direction is indicated by the elongated grain structure visible in the micrograph.

**Figure 60** Hanger microstructure through fracture. Steel is relatively low carbon ferrite – pearlite microstructure.

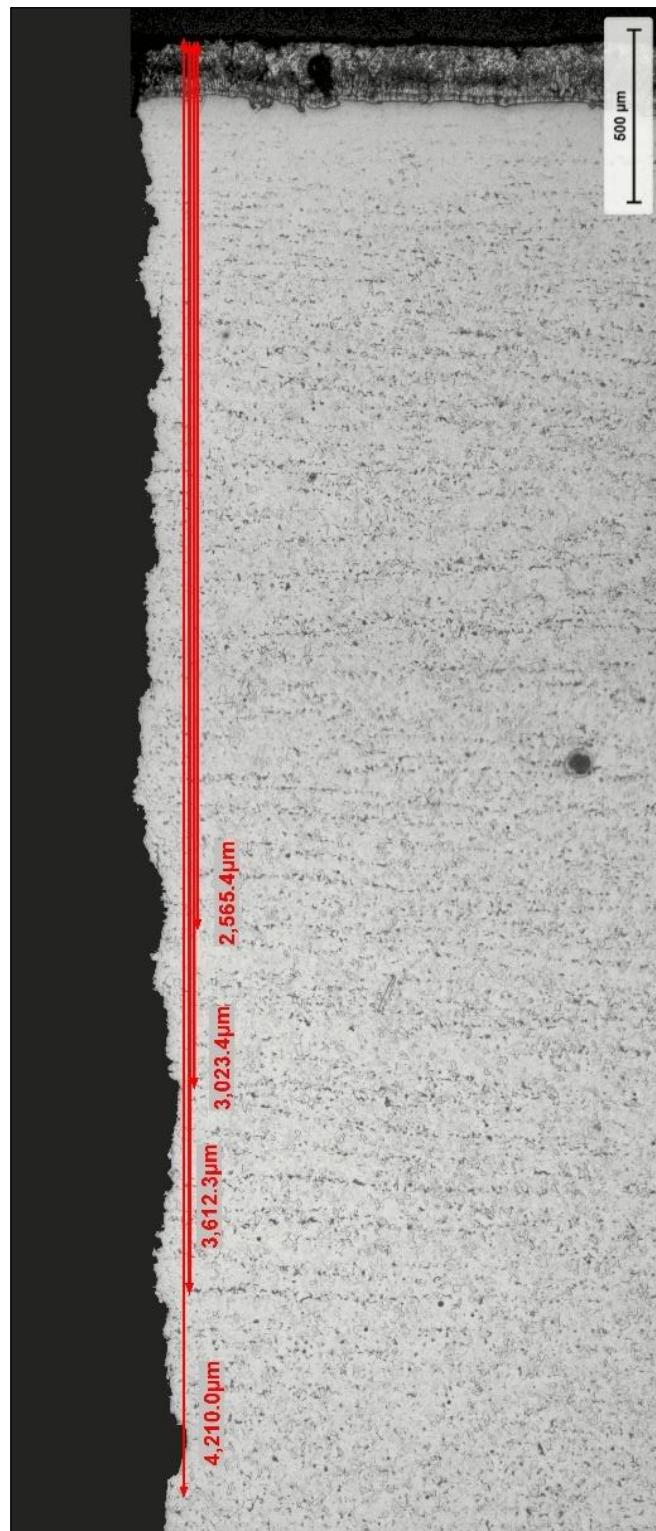
Figure 61

The fracture origin area through the thumbnail is shown at low magnification in Figure 61. Cold work is visible in the direction of the pipe forming operation (transverse). The distances shown on the micrograph match the distances shown in Figure 15 on the thumbnail fracture surface.

Locations of zones 1 – 5 through large thumbnail. Distances correspond to Figure 15 fracture surface measurements

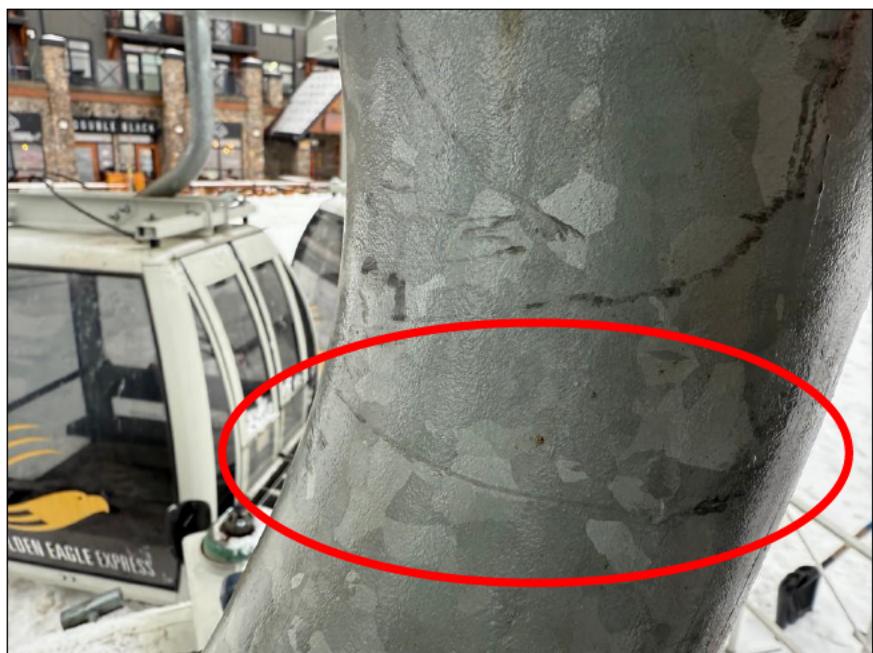
Length approximately 4"

Found on the inside section,  
approximately 2" below start of  
bottom bend

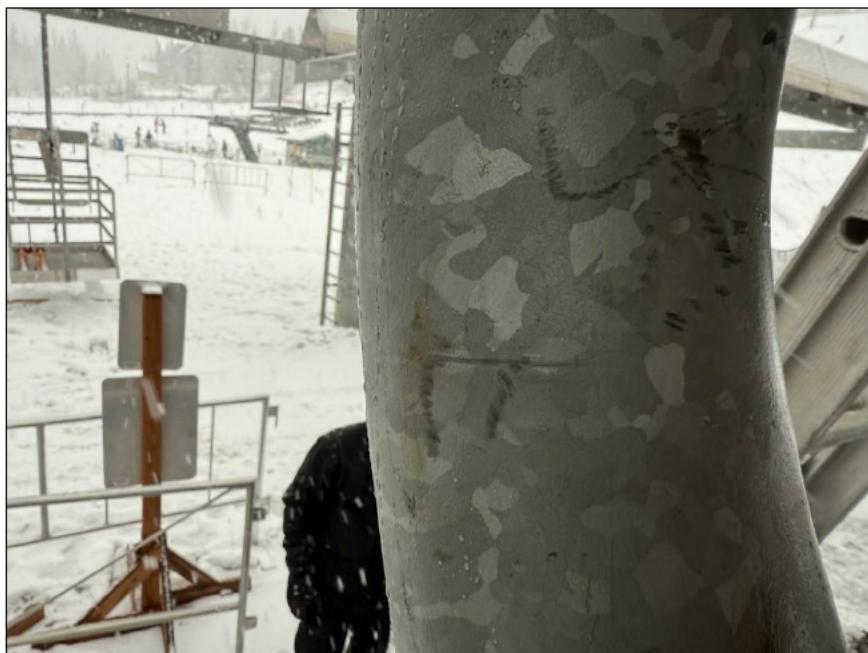
Length approximately 2".

Found on the inside section, approximately 4" below start of bottom bend.

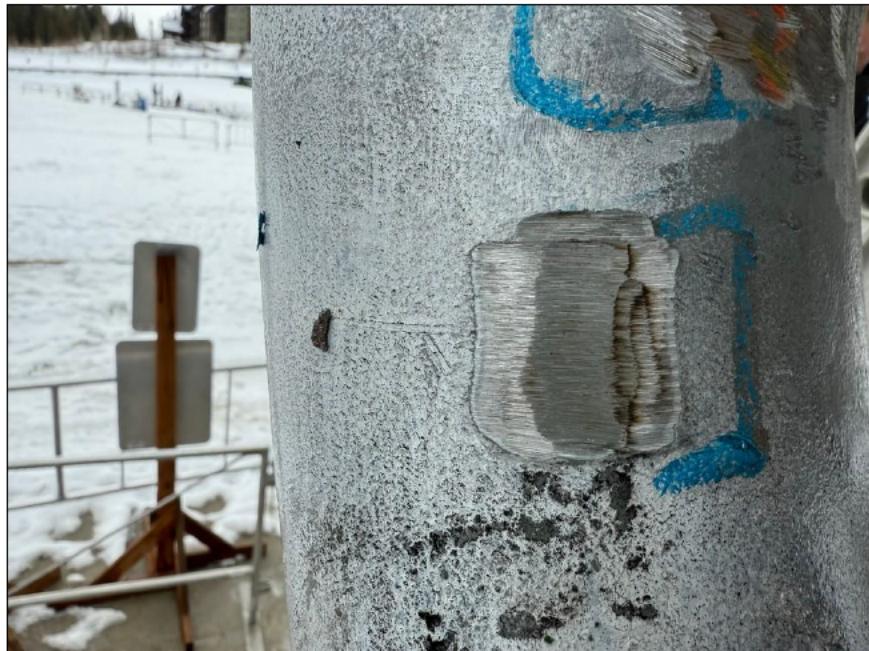
Found on the inside section, approximately 4" below start of bottom bend.

Indication was removed by grinding stone.
