## Incident Summary #II-1674372-2024 (#44359) (FINAL)

SUPPORTING INFORMATION	Incident Date	February 15, 2024	
	Location	Penticton, BC	
	Regulated industry sector	Gas - Propane system	
	Impact	Qty injuries	1
		Injury description	Burns to hands and face.
		Injury rating	Major
	Damage	Damage description	Trailer subjected to explosion and is a total loss.
		Damage rating	Severe
	Incident rating	Severe	
Incident overview	A recreational vehicle (RV) trailer exploded with a single occupant inside after a new propane cylinder was attached to it. The RV trailer was located at an RV park and was being lived in full time.		
INVESTIGATION CONCLUSIONS	Site, system and components	<p>Propane gas is stored in liquid state in cylinders on the front of a trailer. It is piped to appliances via a propane piping system. This system can be composed of black malleable iron fitting or soft copper tubing. If the ends are left open or if there are leaks, propane can find a source of ignition and ignite. If the propane is in the correct concentration when it finds a source of ignition it may explode.</p> <p>The alteration of gas systems and piping in BC, including adding, replacement or removal, is regulate

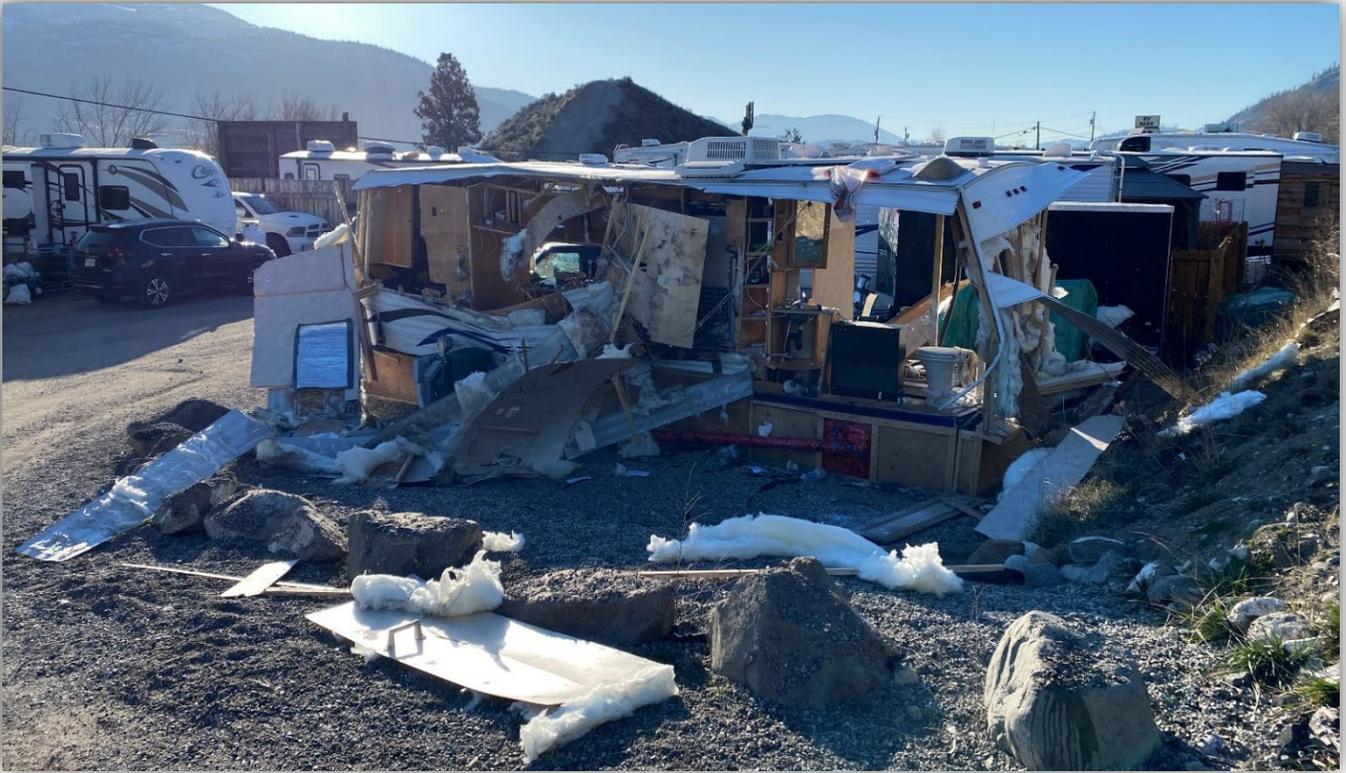
Image 1 - Incident scene at time of investigation.

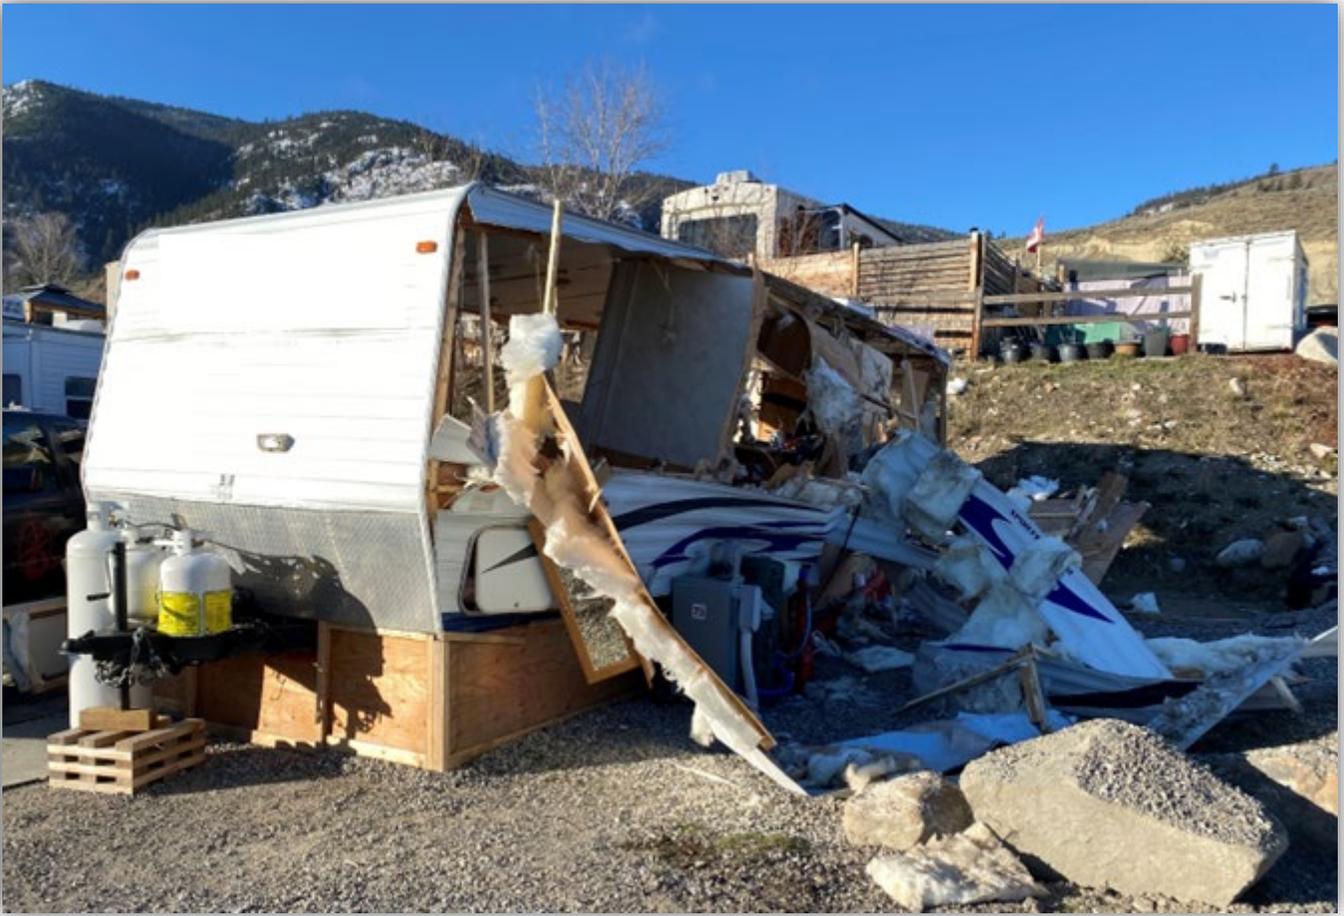
Image 2 - Alternate angle of incident scene.

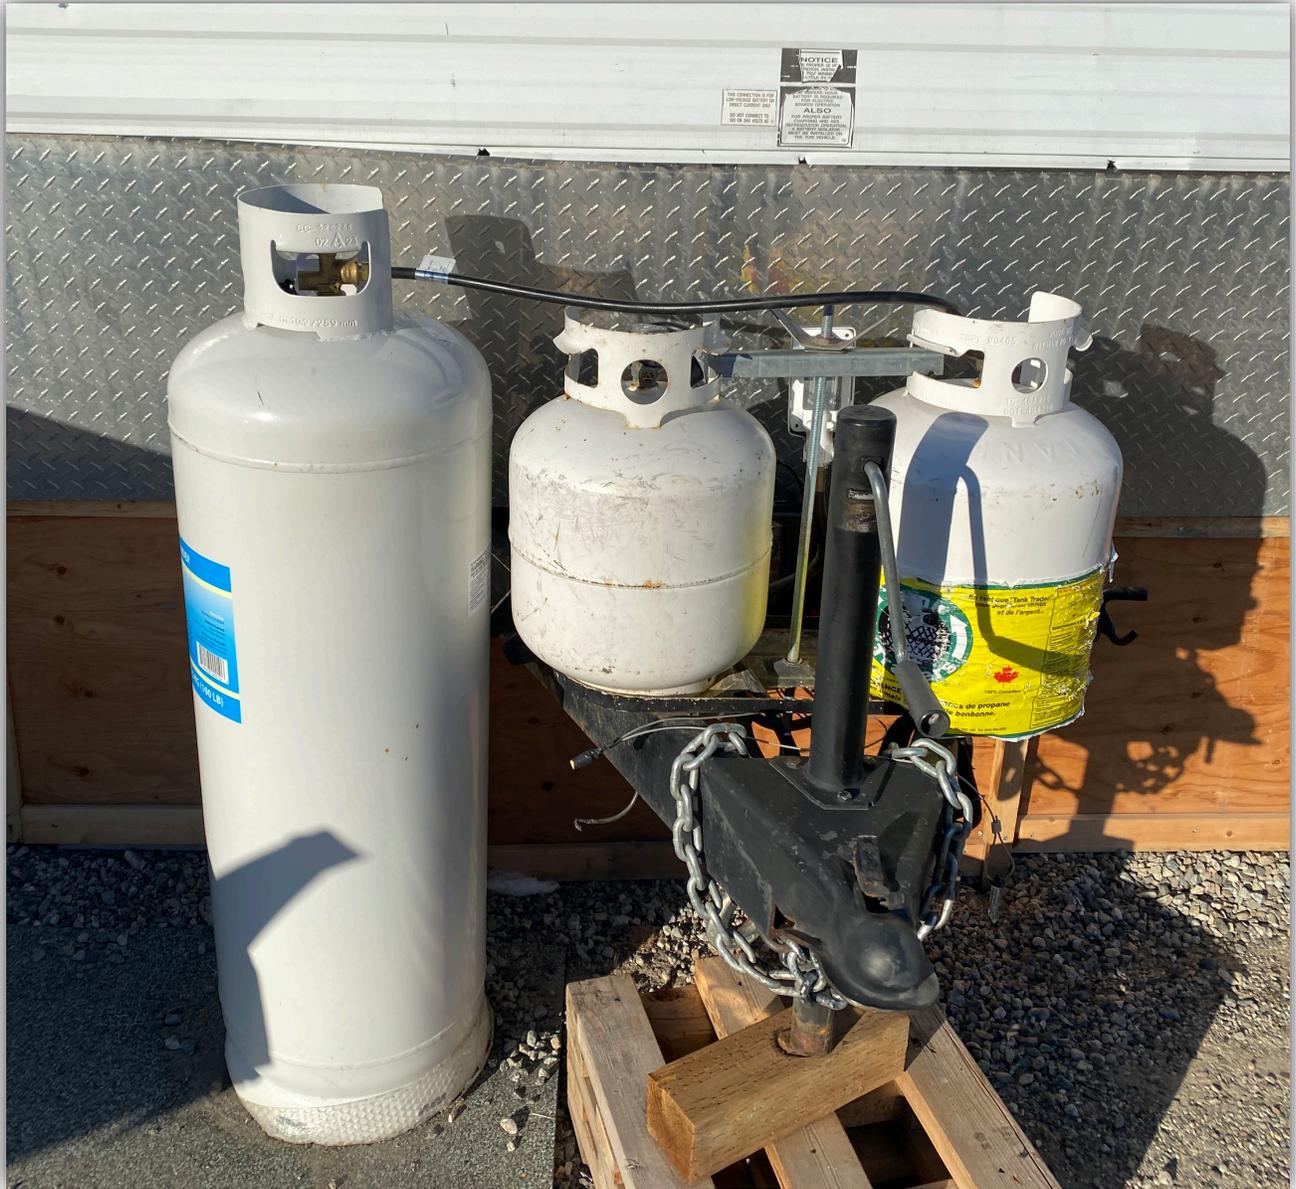
Image 3 - Propane cylinders mounted on front of trailer, including new 100lb propane cylinder and modified supply hose.

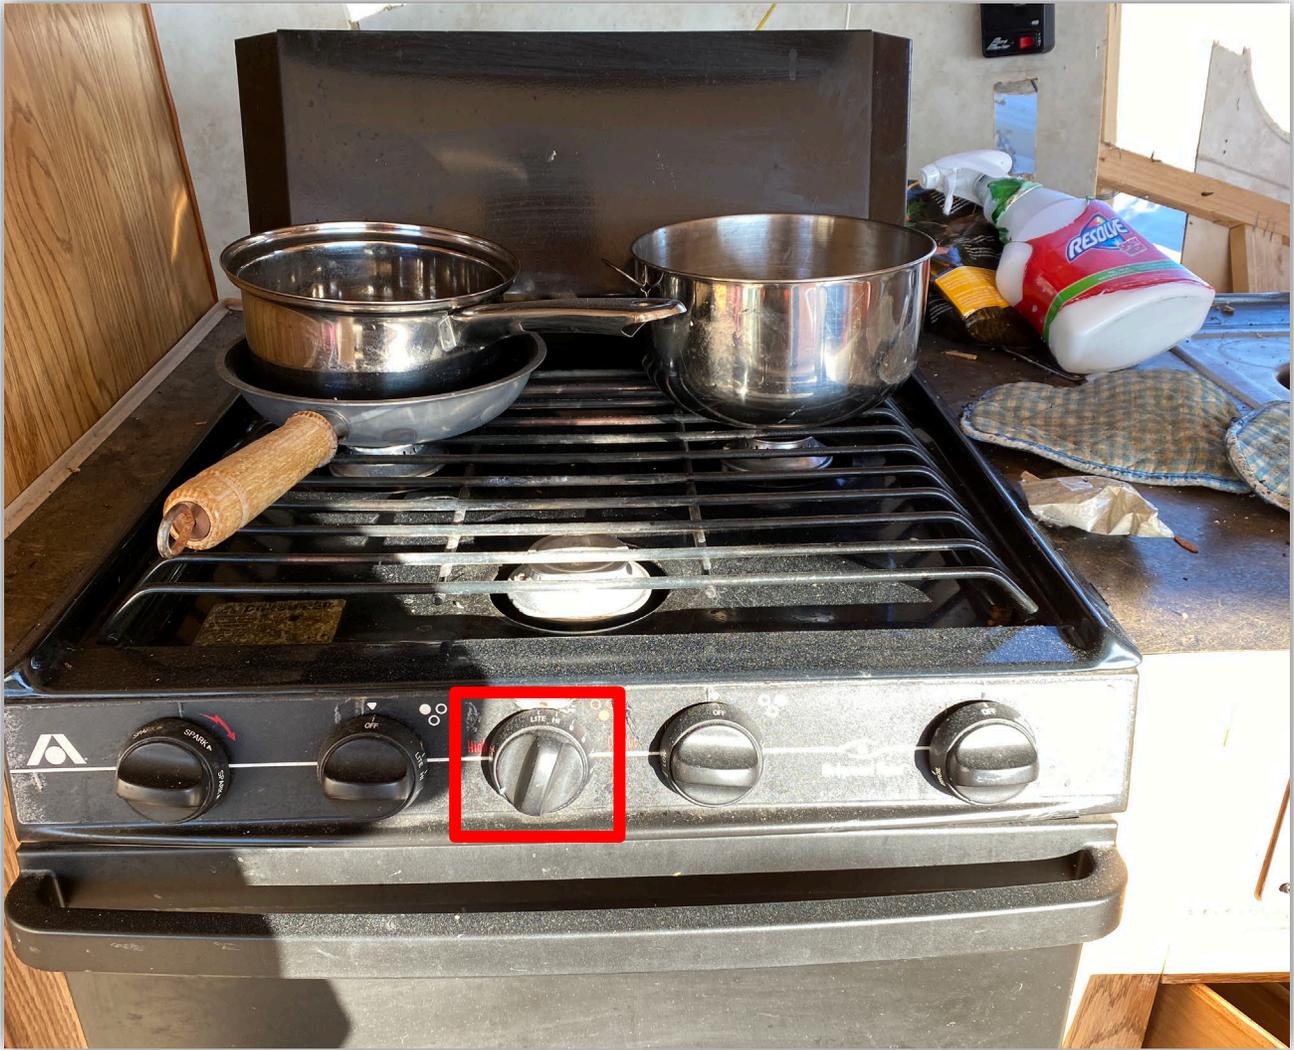
Image 4 - Stove at time of investigation with red box showing center knob in "Lite" position.

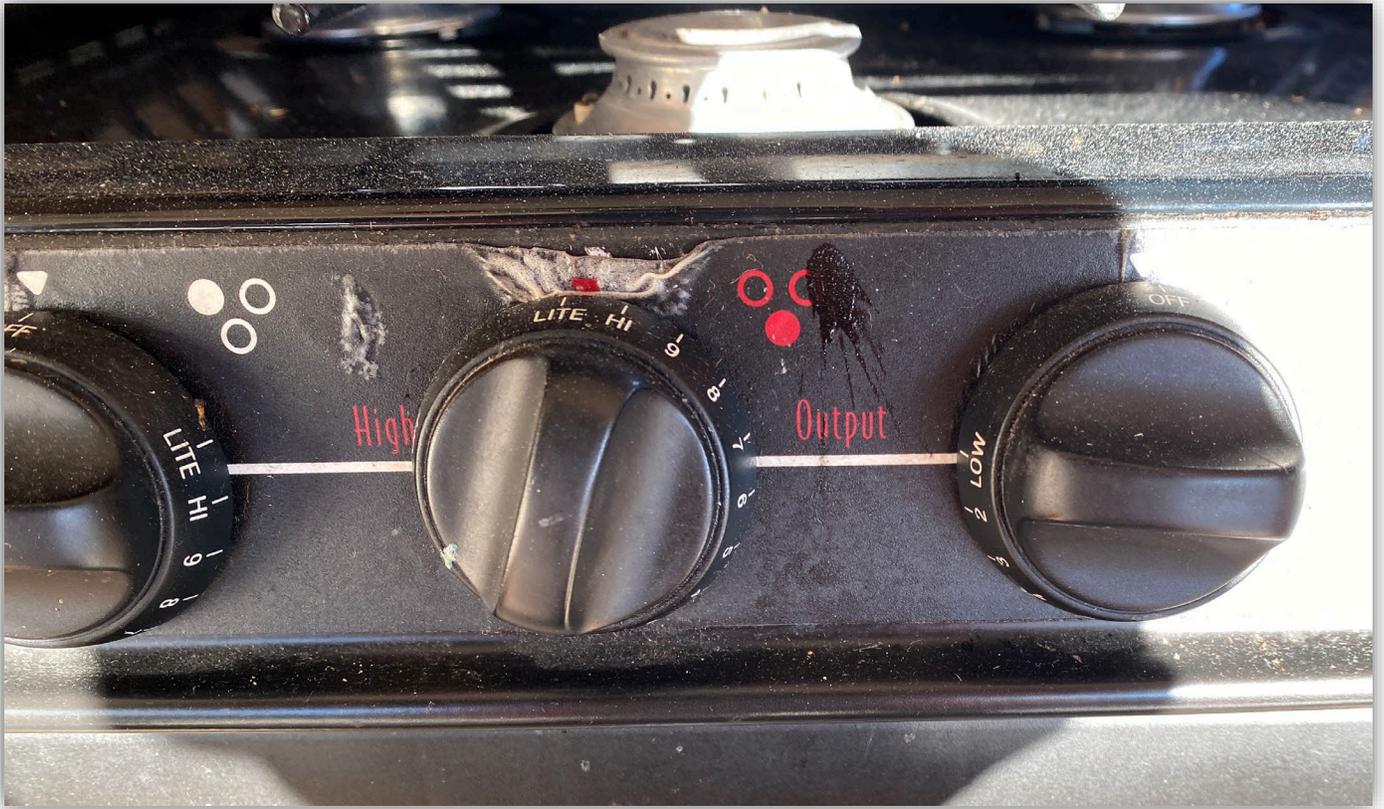
Image 5 - Close up stove knob in "Lite" position.

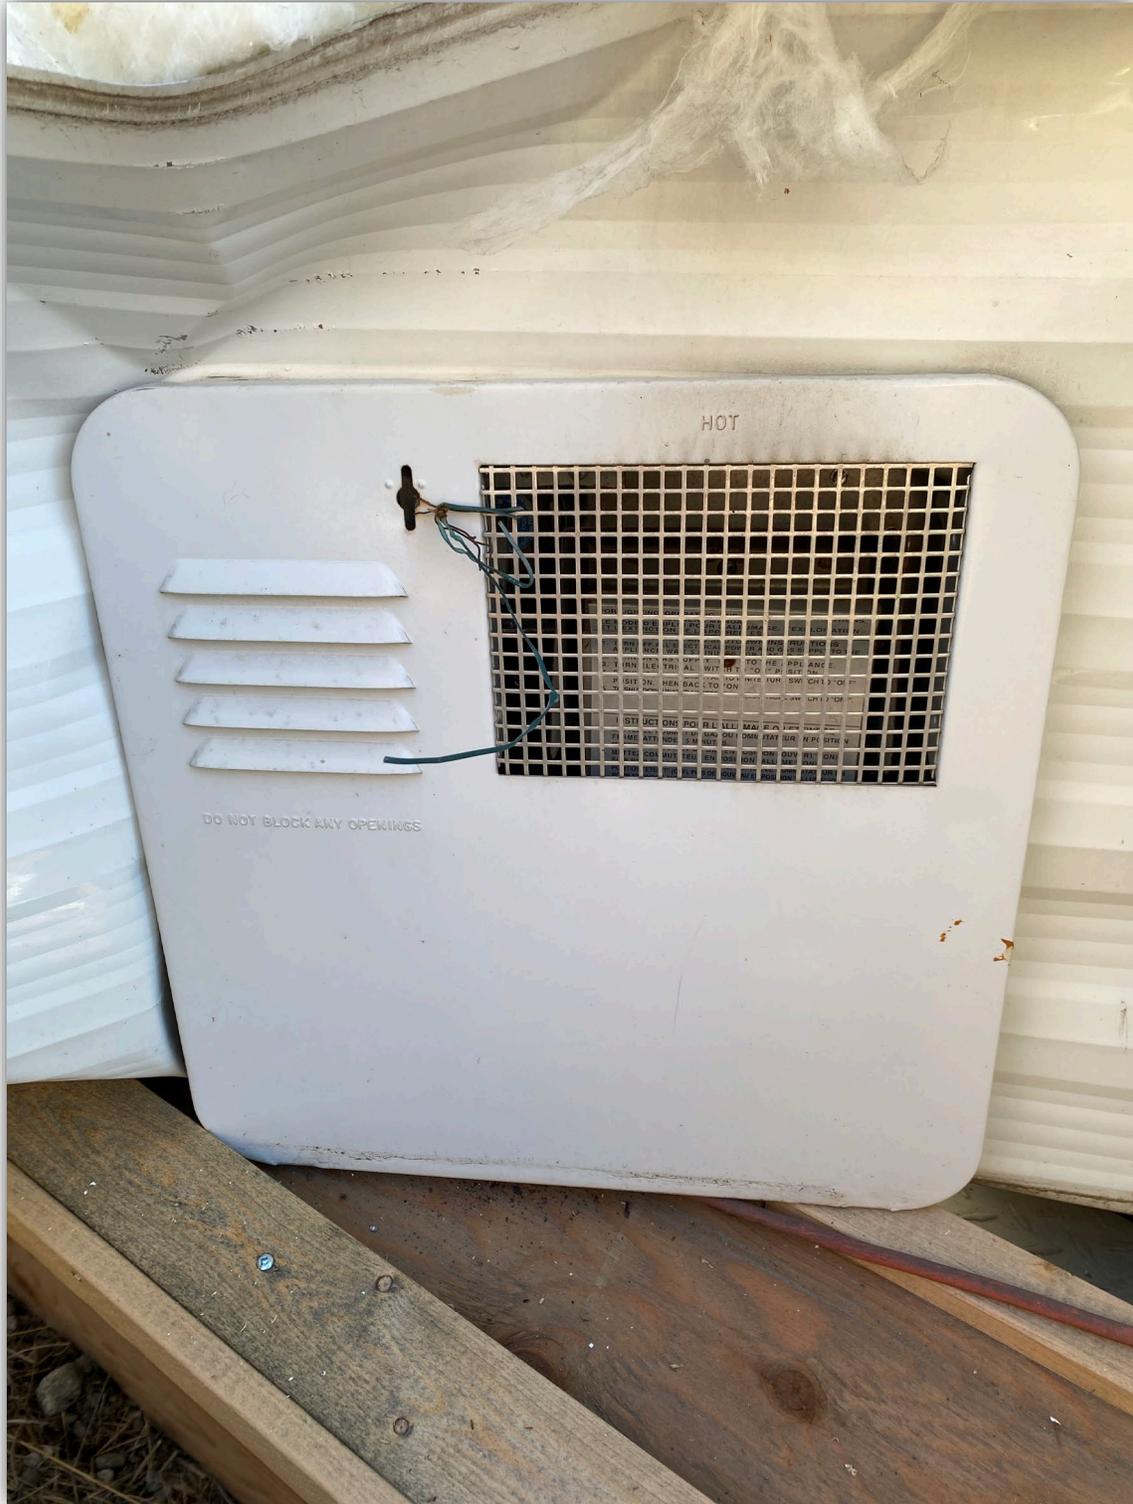
Image 6 - Trailer water heater at rear of unit.

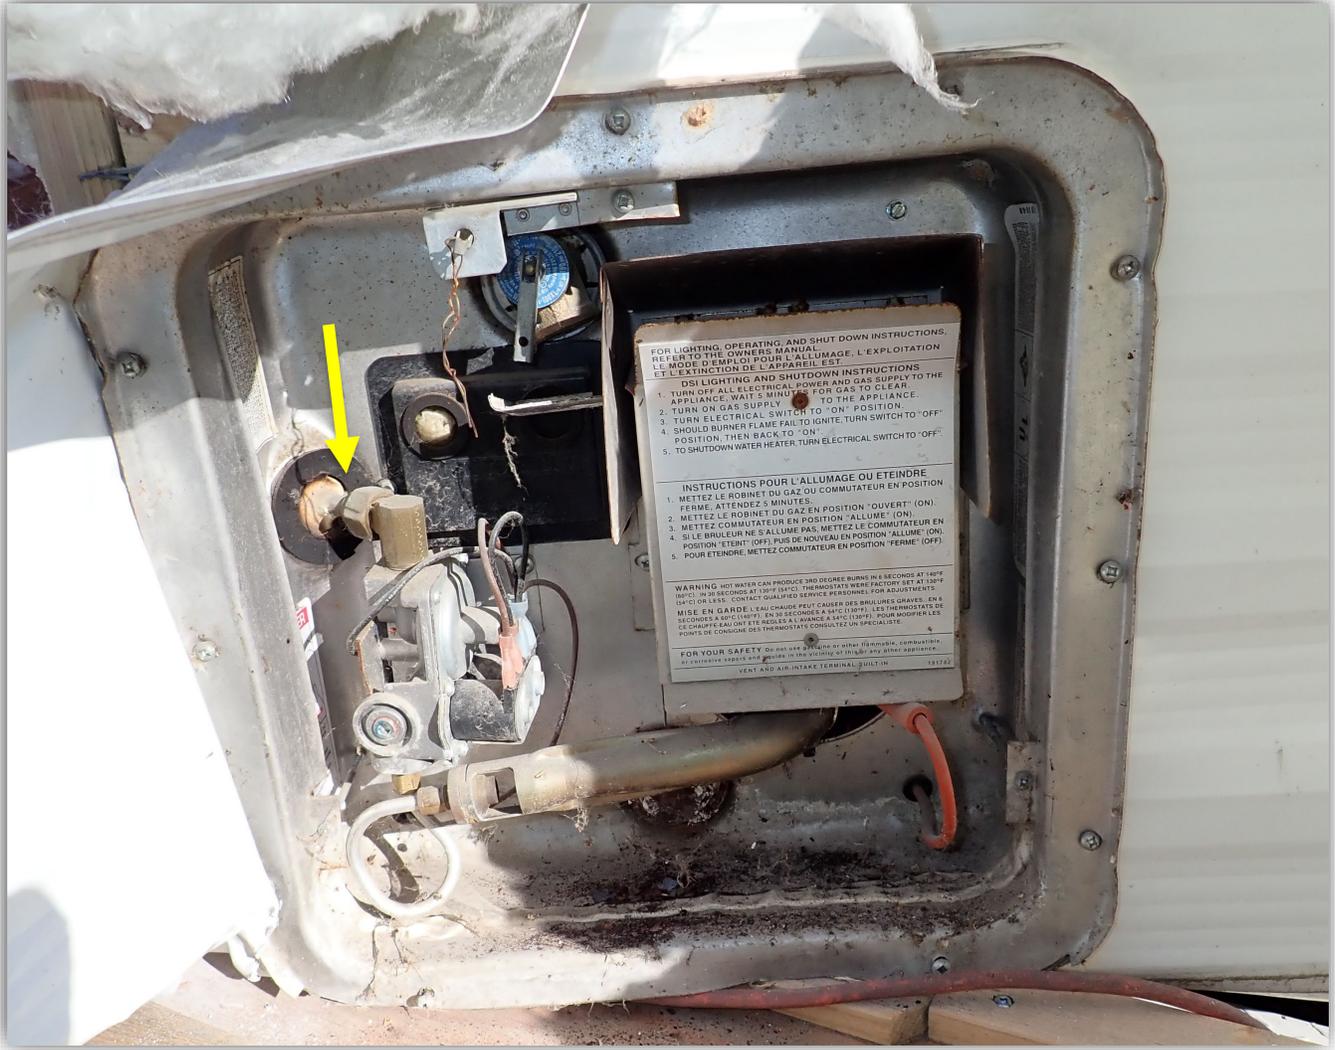
Image 7 - Interior of trailer water heater showing piping configuration. Arrow indicates propane supply piping.

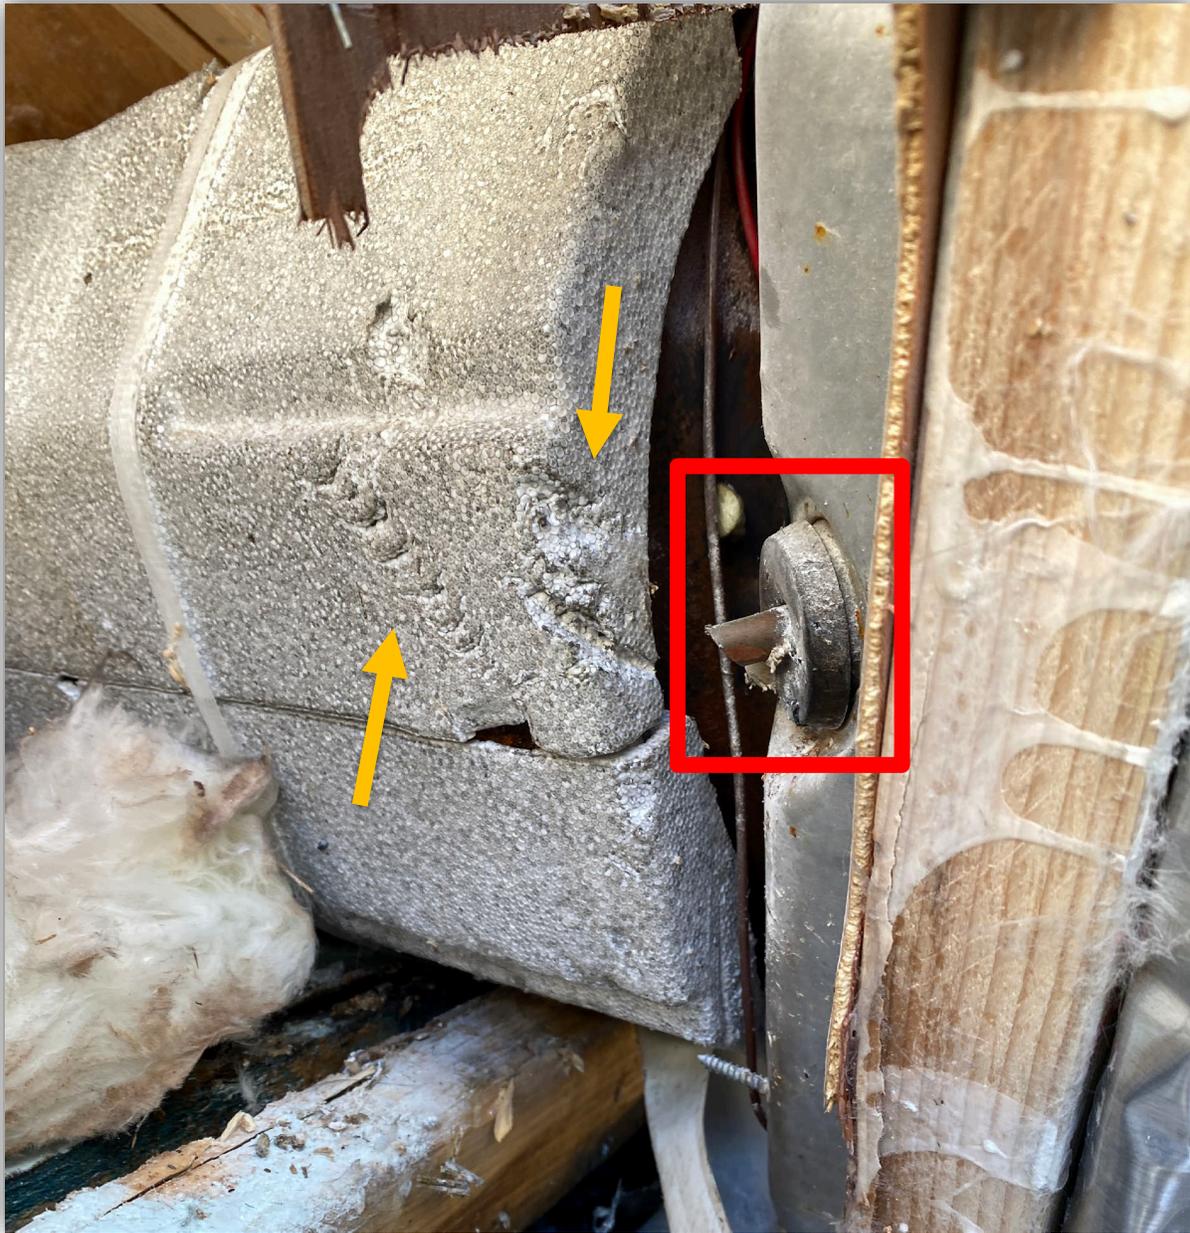
Image 8 - Side view of water heater showing copper propane tubing. Arrow indicates cut marks found in water heater insulation.

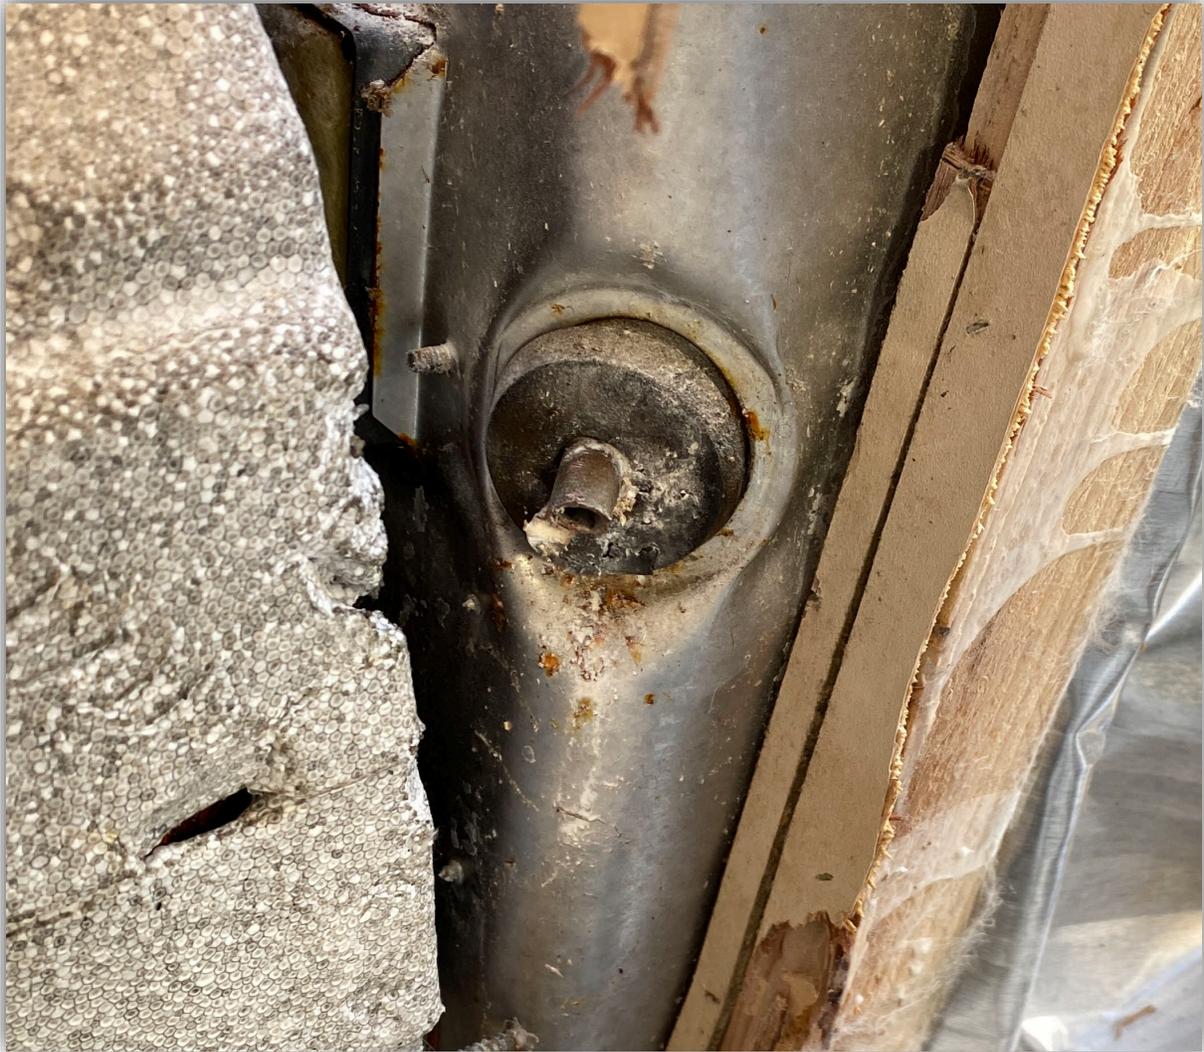
Image 9 - Alternate view of propane tubing connection to water heater.

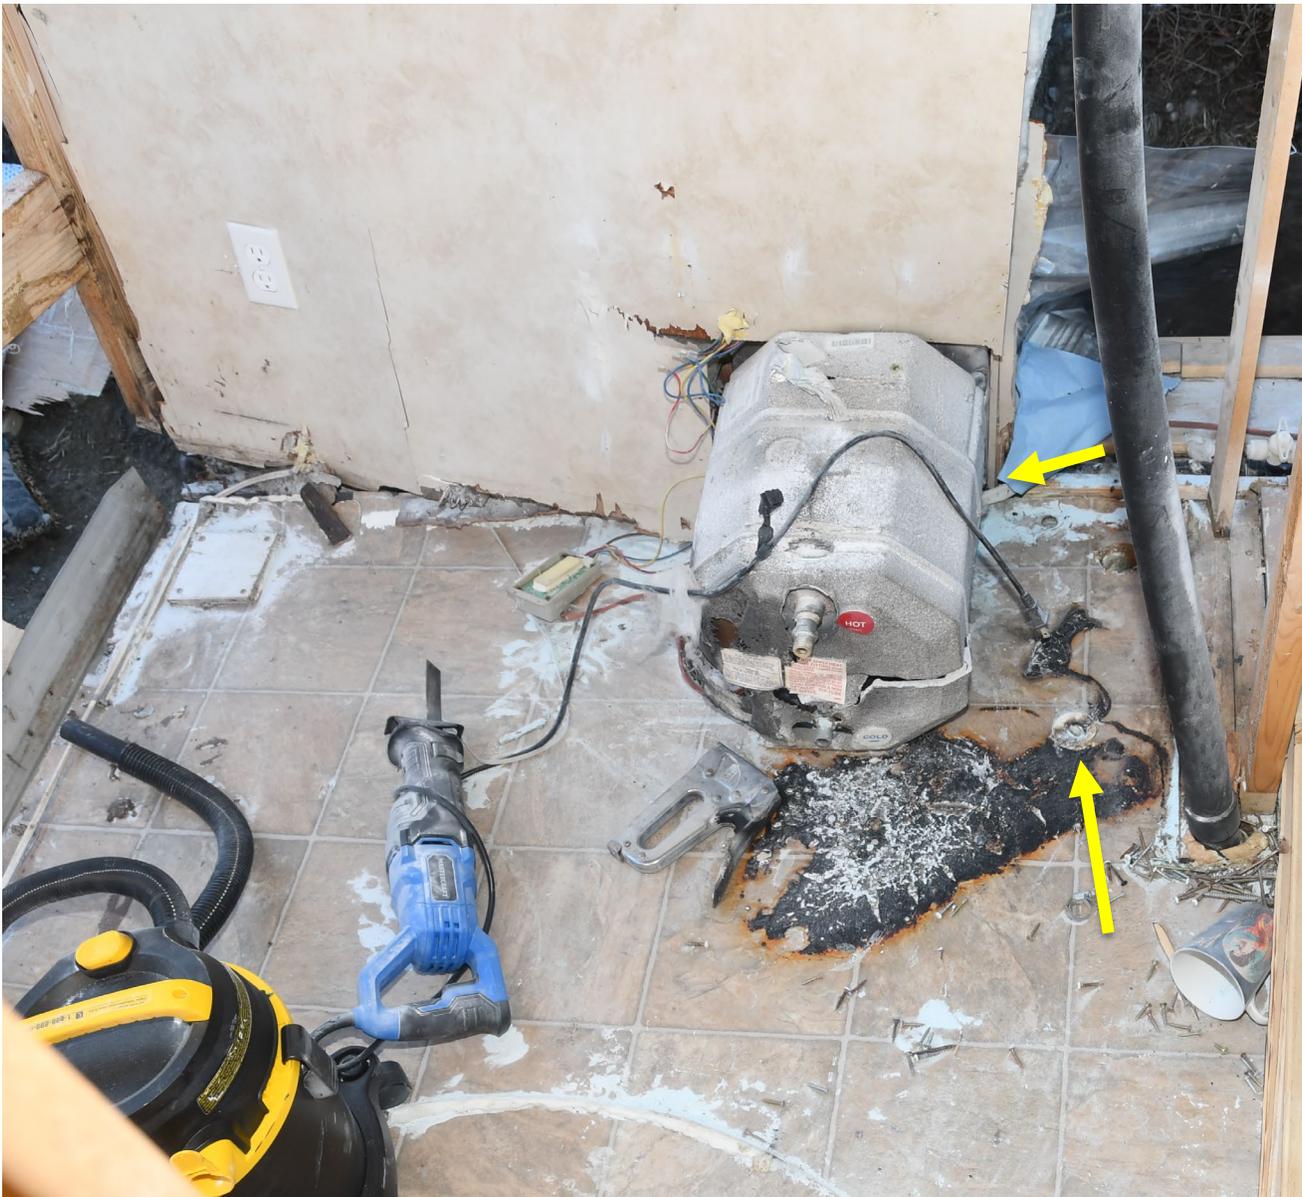
Image 10 - View of bathroom at time of investigation. Arrows indicate area where copper propane tubing left floor and connected to water heater. Note burn marks around where propane tubing left floor.

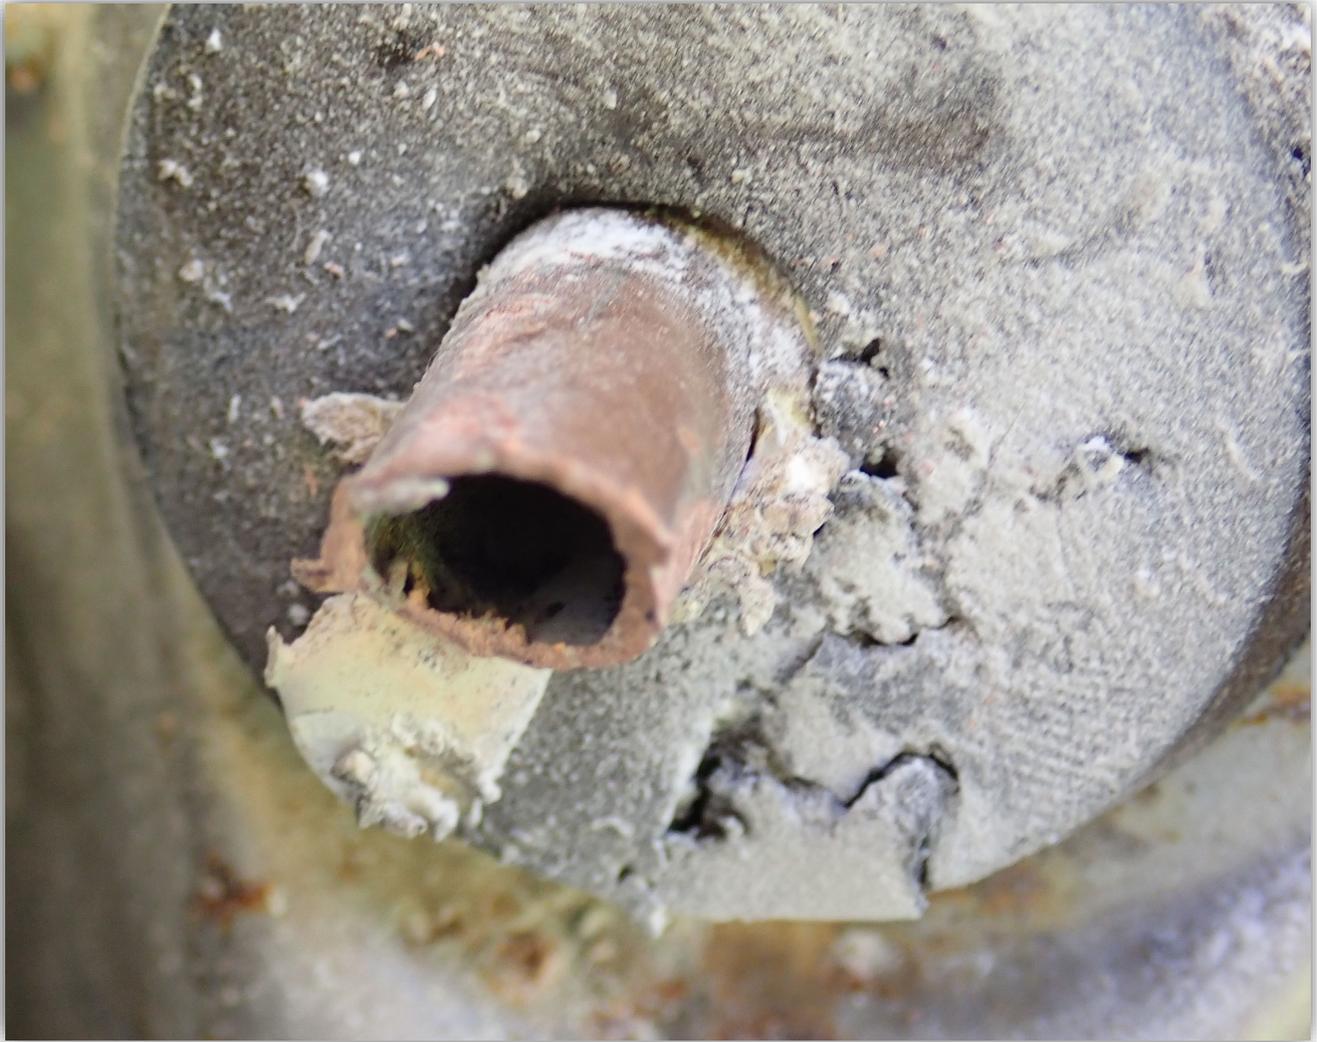
Causes and contributing factors	<p>It is very likely that propane found its way out of the open gas line and accumulated to an explosive accumulation before it found a source of ignition leading to the explosion. The regulated work of altering the propane gas line in the trailer, being performed by an unqualified, unlicensed individual likely contributed to this incident.</p>

Image 11 - Close up of cut copper propane tubing.

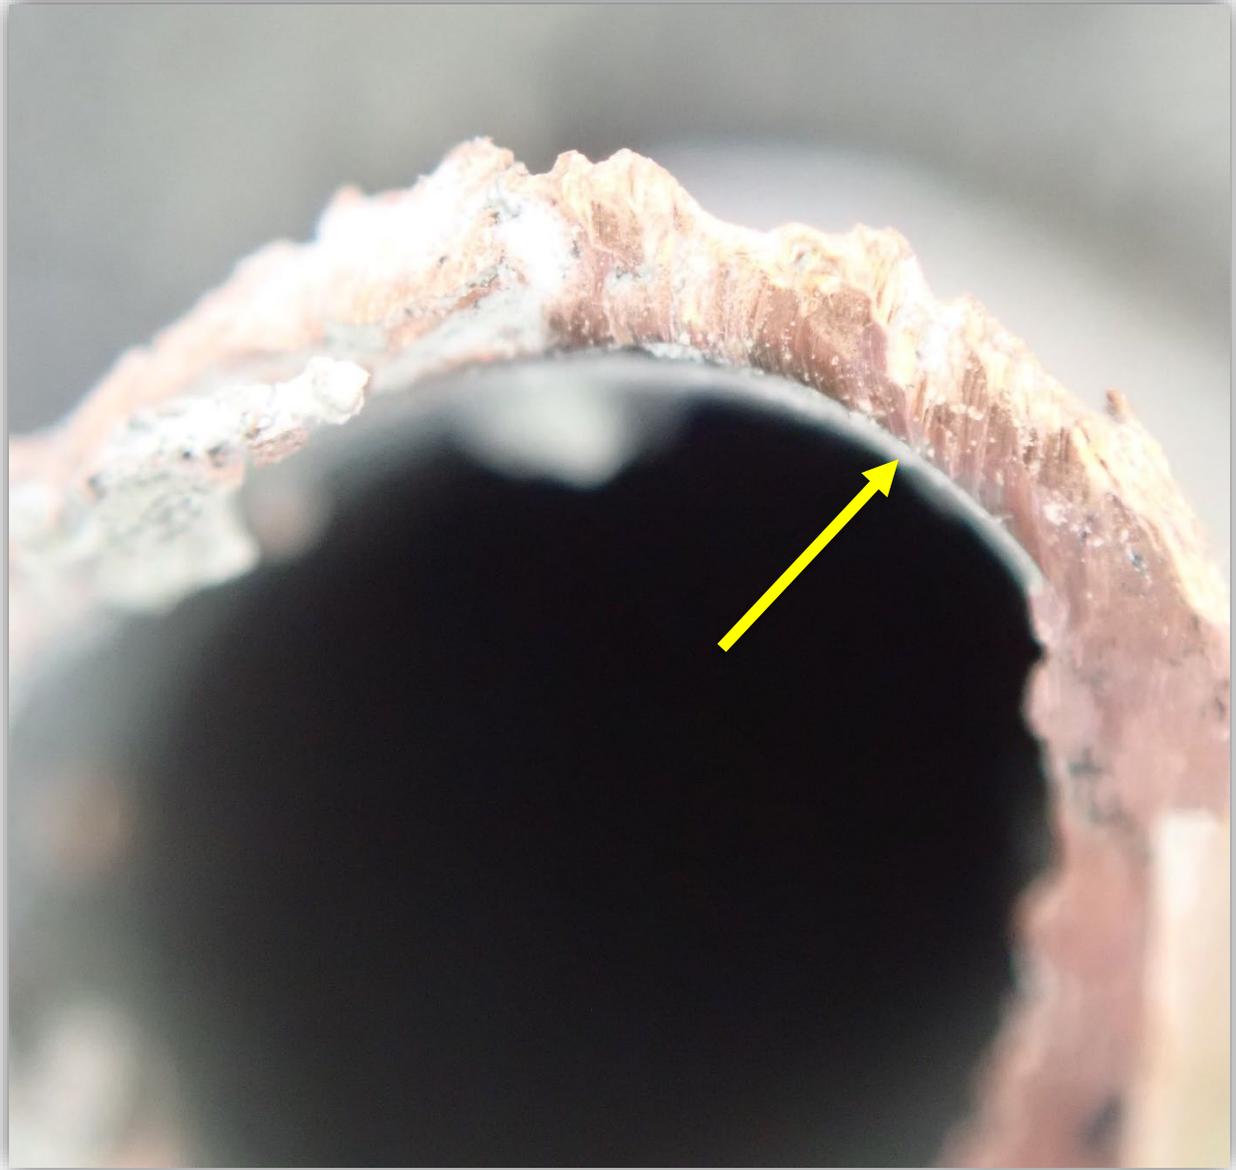
Image 12 - Close up of cut copper propane tubing, arrow indicates cut marks in soft metal.

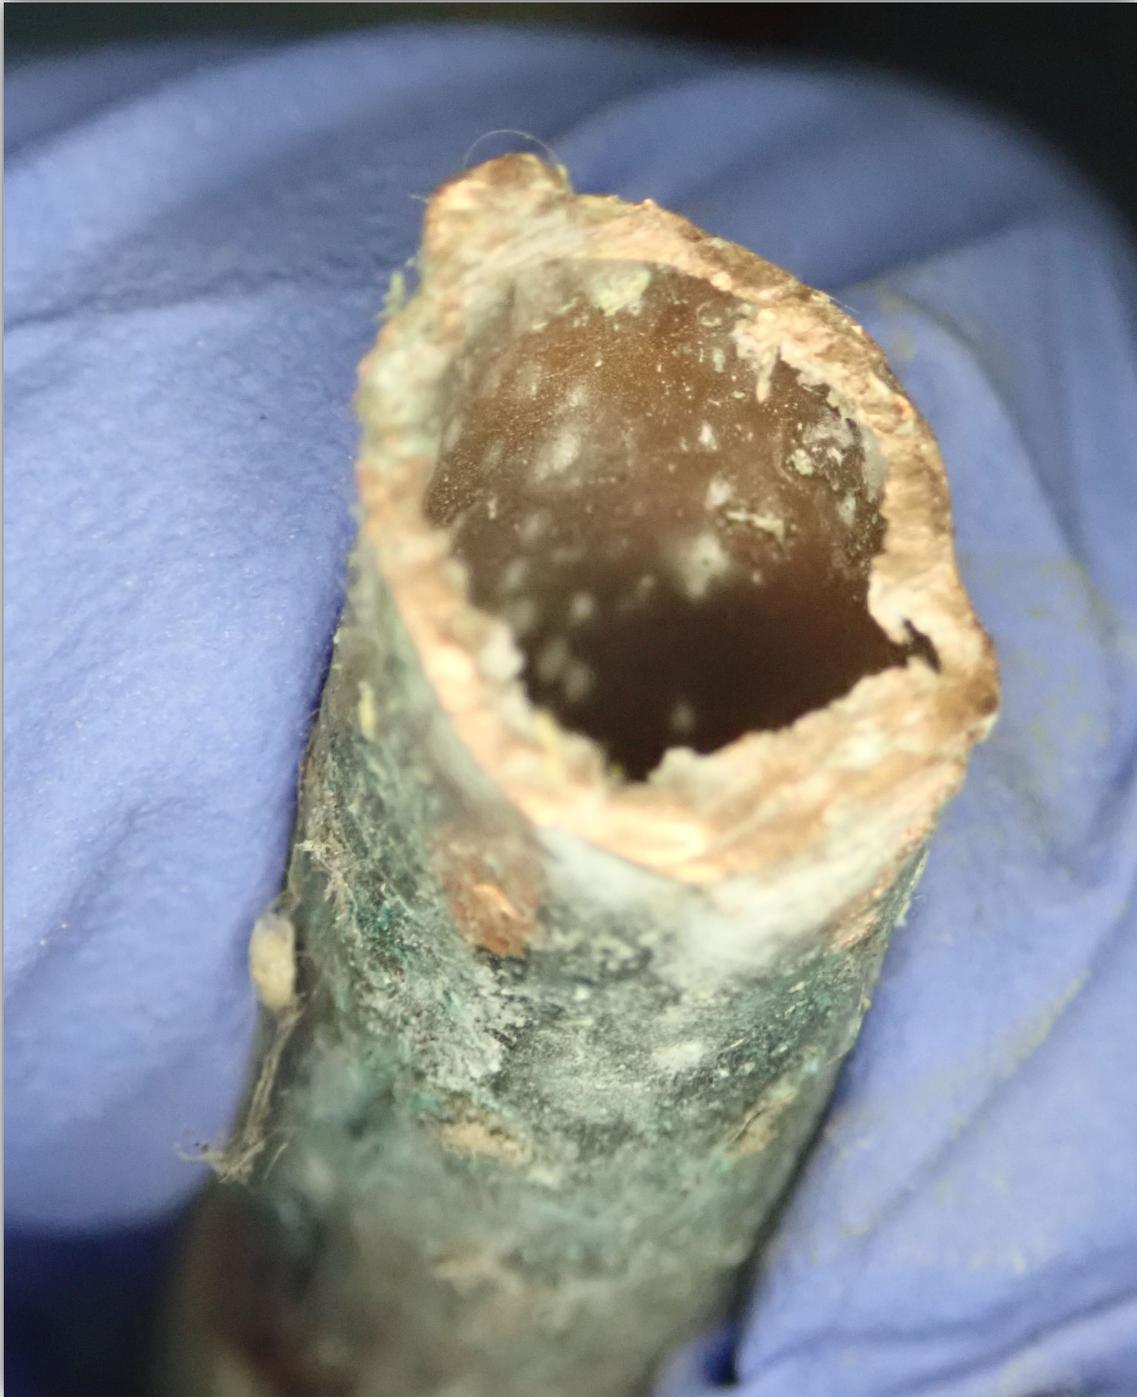
Image 13 - Supply side of cut propane tubing.

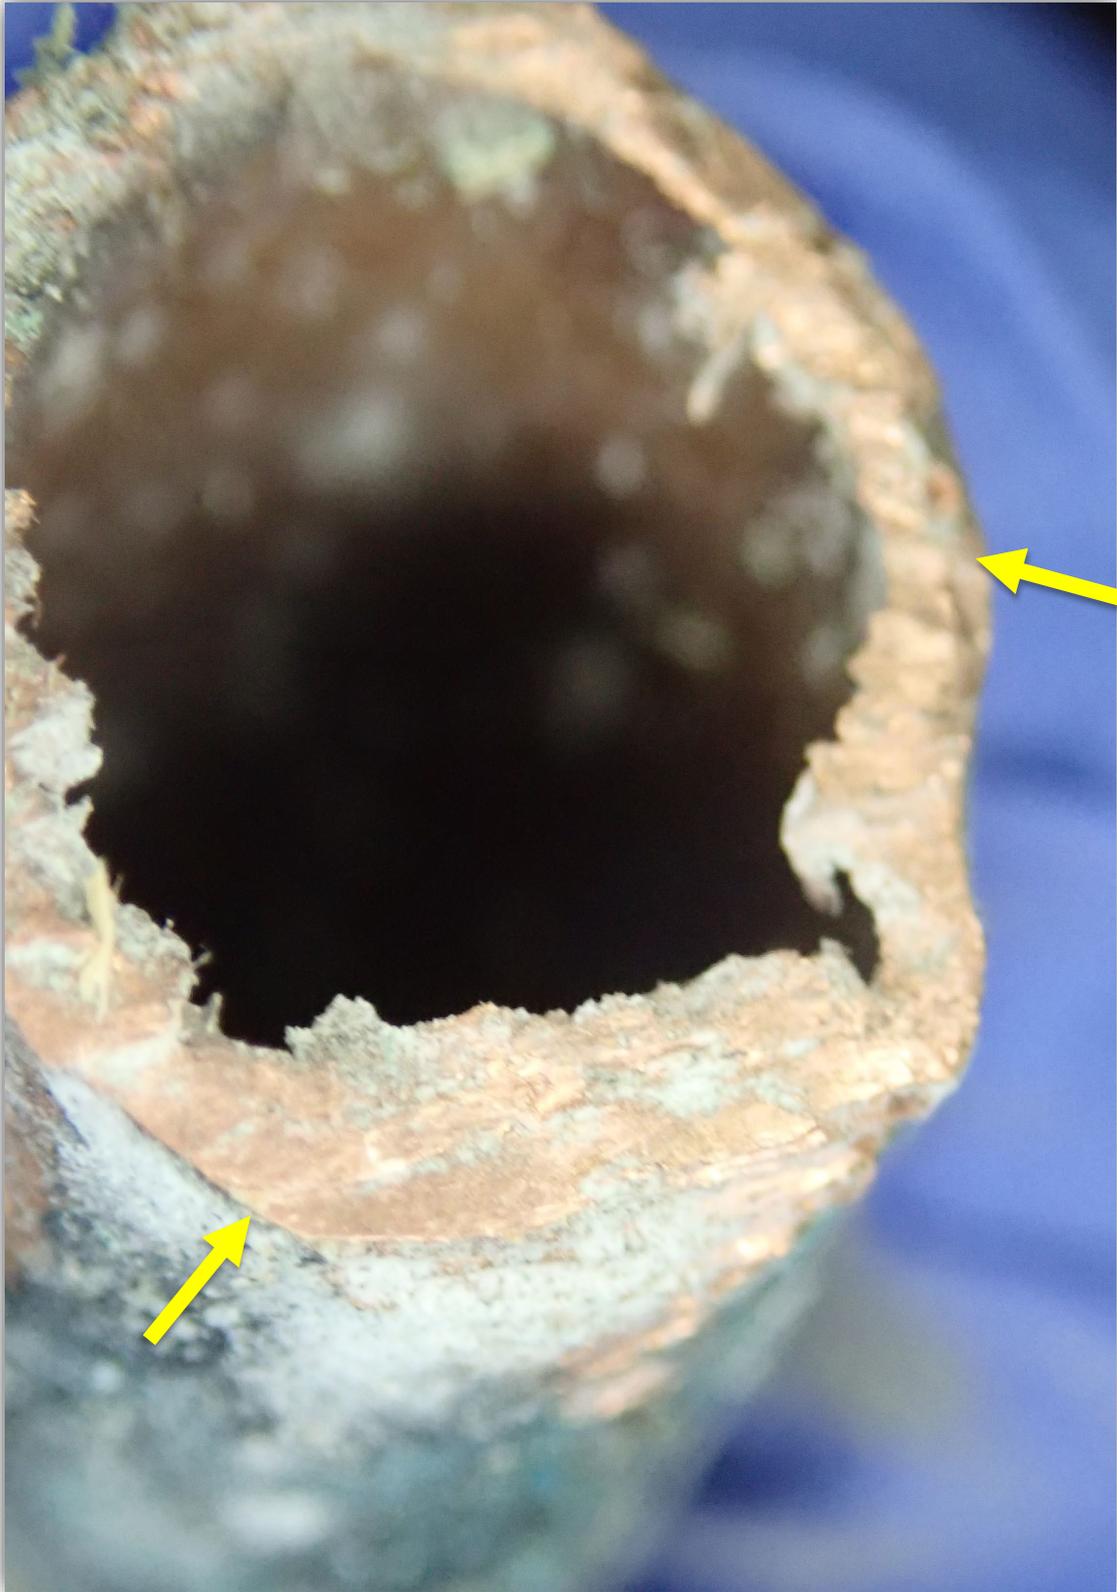
Image 14 - Close up of cut propane tubing arrow indicates cut marks in soft metal.
