Incident Summary #II-1812919-2024 (#55410) (FINAL)

SUPPORTING INFORMATION	Incident Date	December 22, 2024
	Location	Langford
	Regulated industry sector	Electrical - High voltage electrical system (greater than 1000V)
	Qty injuries	0
	Injury description	N/A
	Injury rating	None
	Impact	A fire was mainly contained to the components of a light-emitting diode (LED) illuminated sign area in a ceiling and wall around the front of a restaurant.
	Damage	Fire crews had to cut several holes into the exterior wall of the building during fire suppression efforts and had to tear down some drop ceiling tiles.
	Damage rating	Moderate
	Incident rating	Moderate
INVESTIGATION CONCLUSIONS	Incident overview	A few years after the upgrading of a neon sign to a more energy efficient LED sign on the exterior of a business, an electrical fire occurred in the interior wall above the entrance/exit. This took place during dinner hour at a restaurant and included a disruption to dinner service operations when they had to evacuate the patrons from the restaurant and close the business.

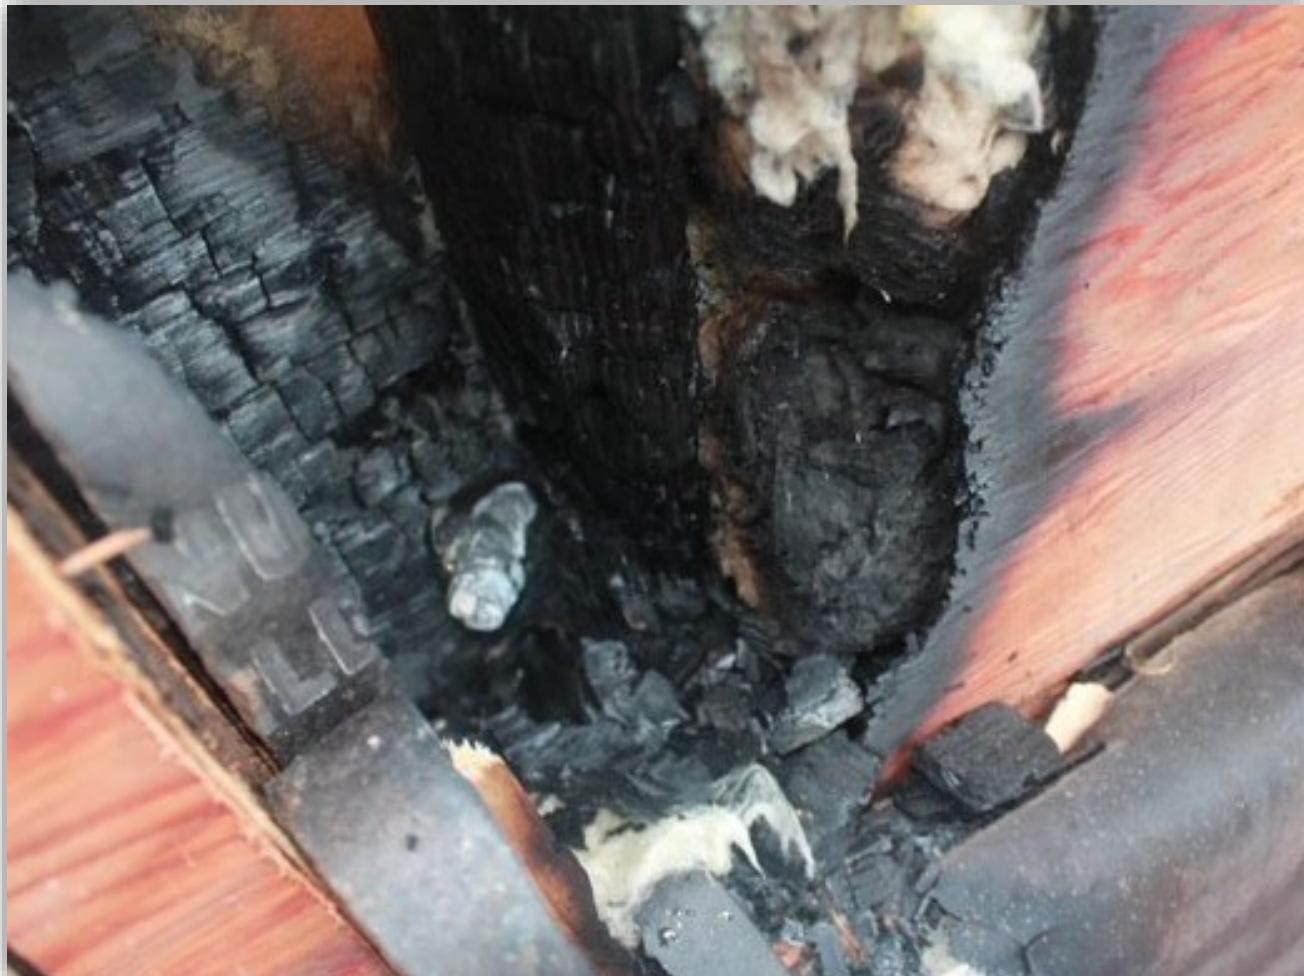
Image 1 – Burn damage from outside.

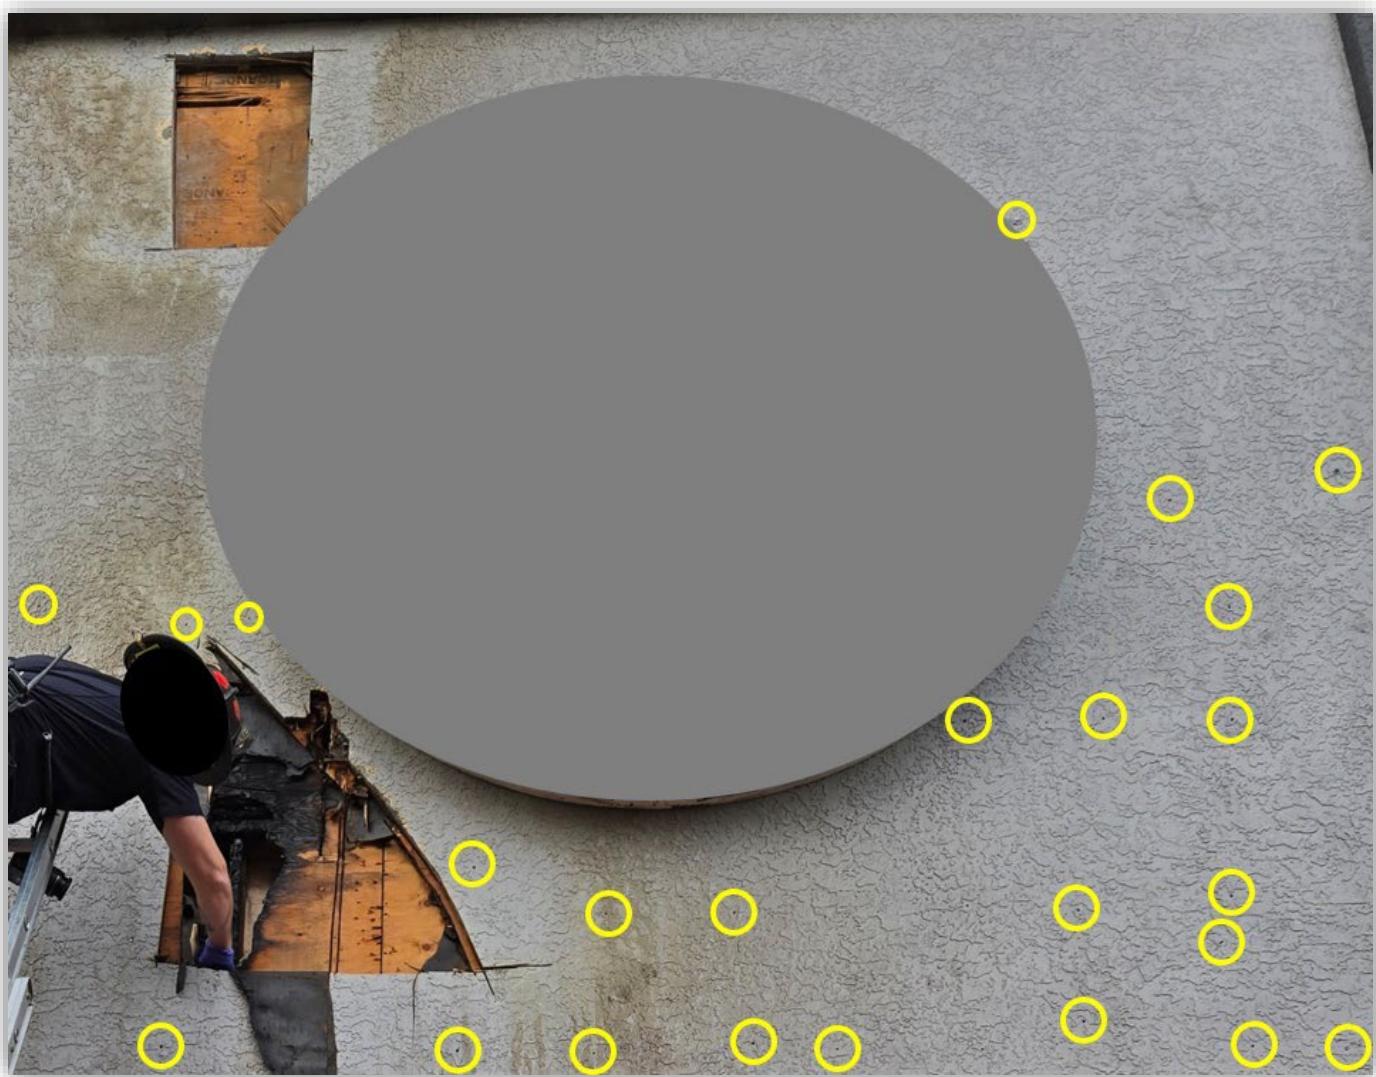
Site, system and components	<p>The restaurant location is franchise-owned but operates under contractual obligations from the franchisor to maintain a consistent brand aesthetic and implement required updates and upgrades as directed.</p> <ul style="list-style-type: none"> Traditional Neon Signage: These signs require a very high voltage lighting system over 1000-volts (typically 4,000 to 15,000 volts) to ionize the gas inside glass tubes and make them glow. This high voltage is achieved using a "step-up" transformer which increases the standard line voltage (120V-240V) to the necessary high voltage. Light Emitting Diode Technology, (LED) signs operate on much lower voltages, typically 12- or 24-volts DC. They use a "step-down" power supply (or driver) to convert the standard line voltage down to this safer, lower energy efficient voltage. LED lighting technology is longer-lasting, durable, which are some reasons why it is a common upgrade for many businesses. <p>Armoured cable is wiring covered in a metallic protective layer commonly used for protecting wiring in more extreme applications where mechanical damage, weather, and other factors are a concern.</p> <p>Externally, when neon signage is removed from a building it leaves penetrations in the building envelope that need to be sealed using equivalent means to prevent the ingress of moisture (Image 2).</p>

Image 2 – The circled items throughout the image shows some of the screw holes that were left in the envelope from several years prior when neon sign was removed.

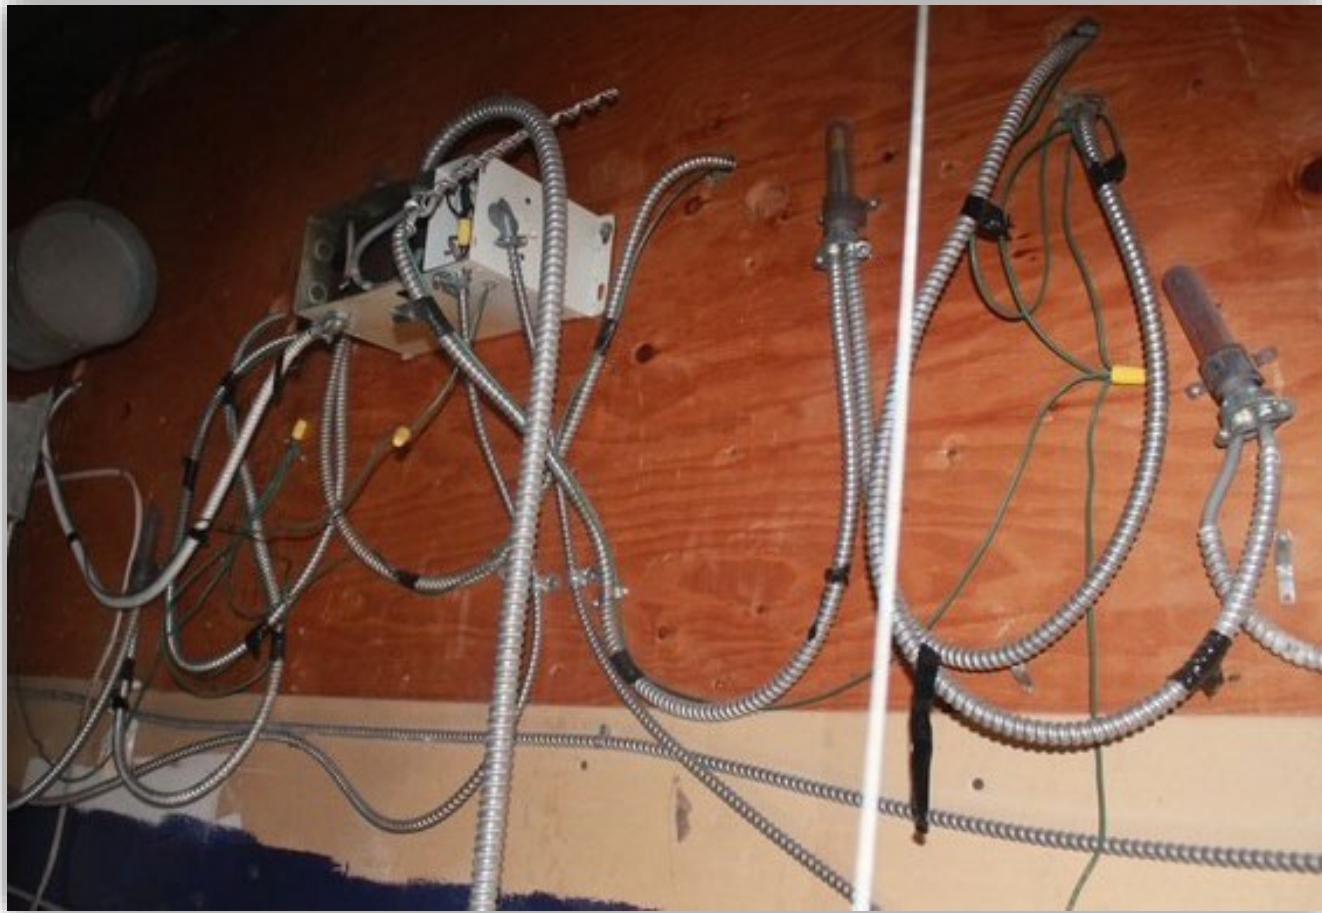
<p>During suppression, firefighters removed ceiling tiles and were able to document the existing cables and transformer as well as the original armoured cable which was severely burned (Image 3A and Image 3B). Fire in the surrounding area was contained in the effort due to the speed of the response. Portions of the outside of the building had to be removed for firefighting efforts as well (Image 1).</p>
Facts and evidence	<p>Permits and Licencing No permits were issued for any electrical work by the installation contractor. The installation contractor was not licensed in British Columbia to perform electrical work.</p> <p>Understanding Franchisee Operations A long-standing restaurant chain established in the 1960's has many policies and procedures in place for most foreseen upgrades and maintenance.</p> <p>Responsibilities are divided between the franchisor, where decisions are made on many aspects of the businesses aesthetic and layout, new construction and operational policy and procedures and the franchise owners who handle maintenance, human resources and other responsibilities.</p> <p>Restaurant (Contractual Liability Policy) Franchisor <i>Re: Contractual Enforcement:</i></p> <ol style="list-style-type: none"> 1. Despite the strict wording of the franchise agreement, franchisor does not enforce these requirements where the proposed work is not extensive in nature (e.g. only electric work, as versus a full renovation). While the franchisor is involved in larger projects such as the initial construction of a new restaurant or a full renovation of an existing restaurant, the general contractor for those projects controls the subtrades and manages local permitting requirements. <p>Day-to-day building maintenance is generally left in the hands of the franchisees.</p> <p>Additionally, during COVID-19, the franchisor provided greater flexibility to franchisees regarding work being performed at franchised restaurants due to the extreme adverse economic consequences suffered by franchisees, the franchisor expects franchisees to retain contractors with proper permits, qualifications and certifications, franchisees are permitted discretion in engaging the specific contractors they wish to retain.</p> <ol style="list-style-type: none"> 2. Franchisees must provide relevant documentation to the franchisor upon request, but this requirement is generally not enforced where the proposed work is not extensive in nature. <p><i>Insurance investigation following the Incident indicated that the Incident was not caused by a particular issue in the signage tower or the signage itself, rather, the likely cause was water ingress in the building or another issue in the backend electrics. - Provided information from Franchisor.</i></p>

The existing high voltage cabling was connected to the neon sign transformer and is cut and left energized inside wall space with no protection on ends of conductors. Energized conductors made contact with flammable materials inside wall and started a fire. There were no permits found.

Image 3A – Conductive wiring not terminated.

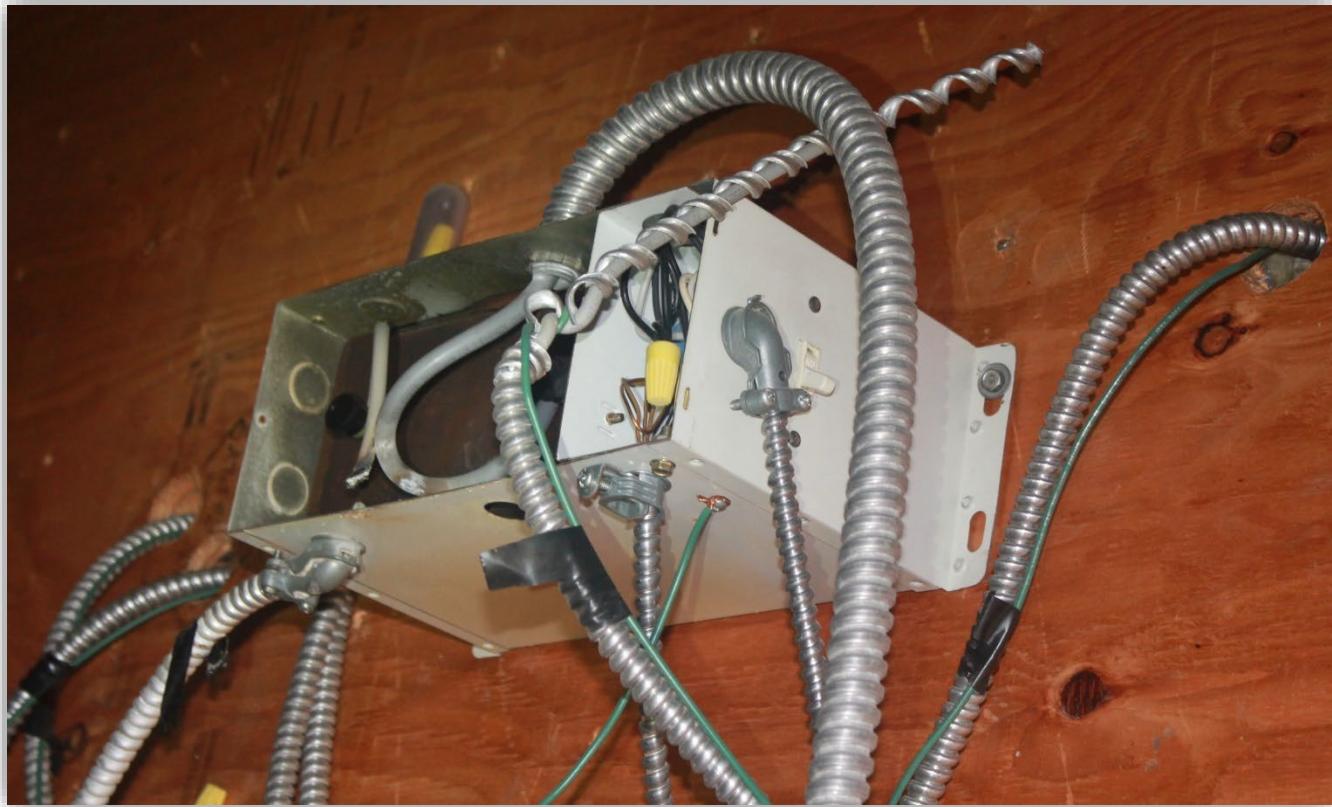
Image 3B – Conductive wiring not terminated.

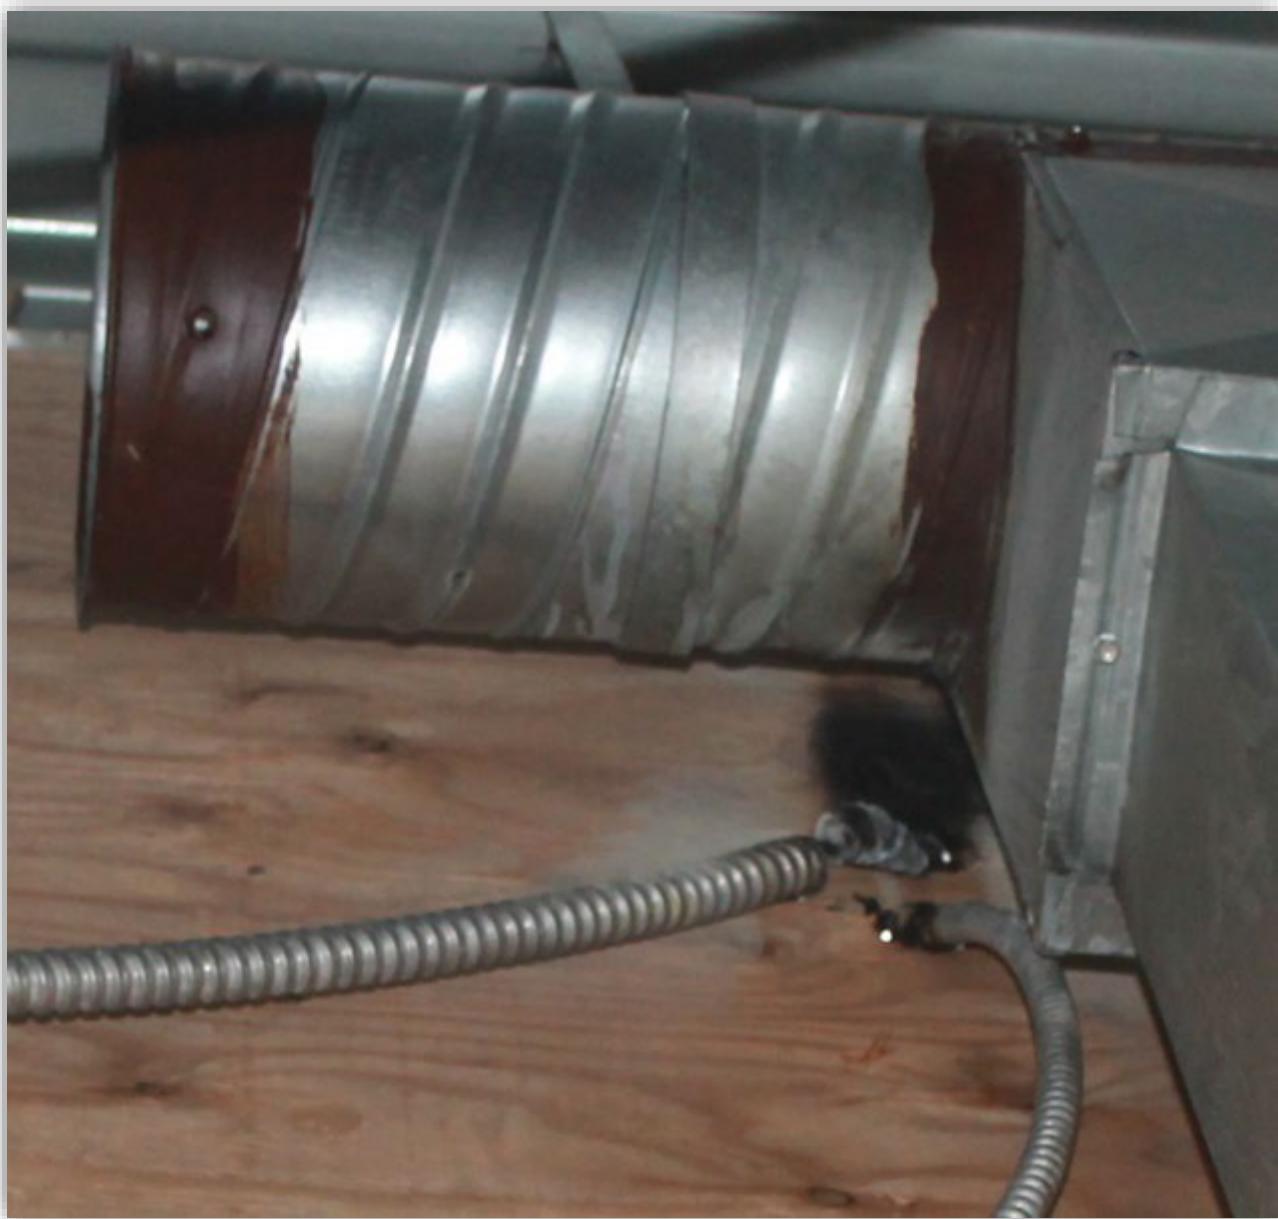
Image 4 – Fire area from inside wall of restaurant.

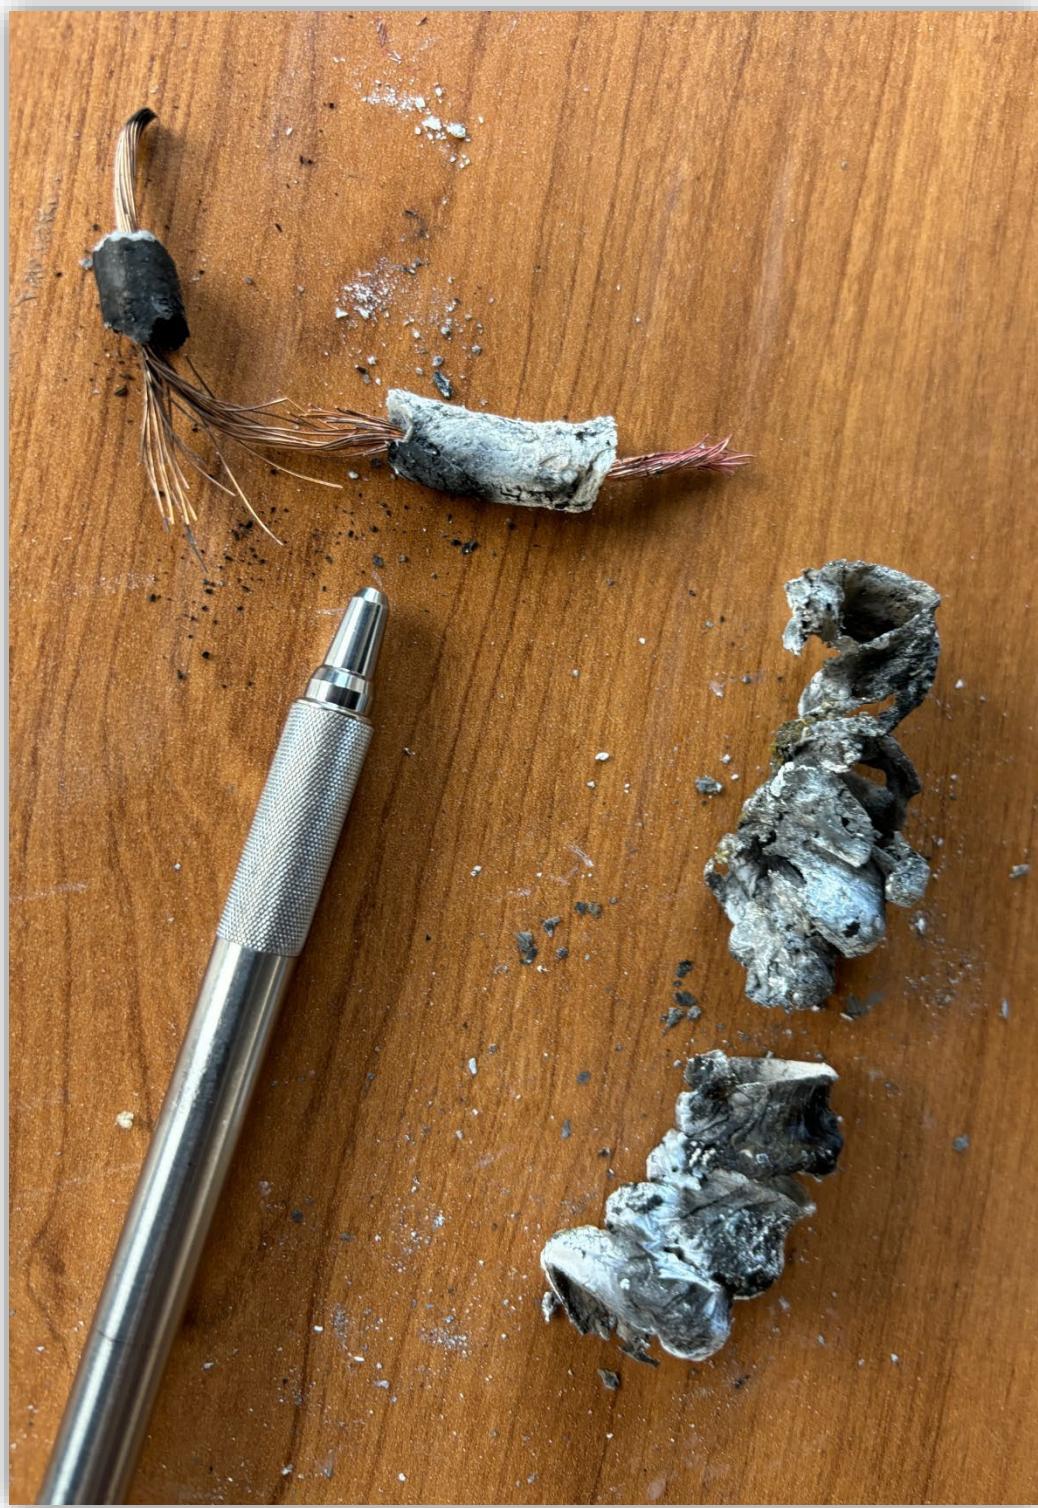
Image 5 - Burnt wiring.
