## Incident Summary #II-2108298-2026 (#66420) (FINAL)

| | Regulated industry sector | | Gas - Natural gas system | |
| Incident overview | | CO was released into a multi-unit residential building when the venting system for one of the heating boilers became detached, and the boiler continued to operate. The CO migrated into multiple occupied suites in the 25-unit, three-storey residential apartment building. There were no operating CO detectors or alarms in the building, and the leak was only identified after multiple people reported experiencing illness symptoms aligned with CO exposure. Emergency first responders arrived, identified high levels of CO indoors, evacuated the building, and shut off operation of the gas-fired heating boilers. | | |

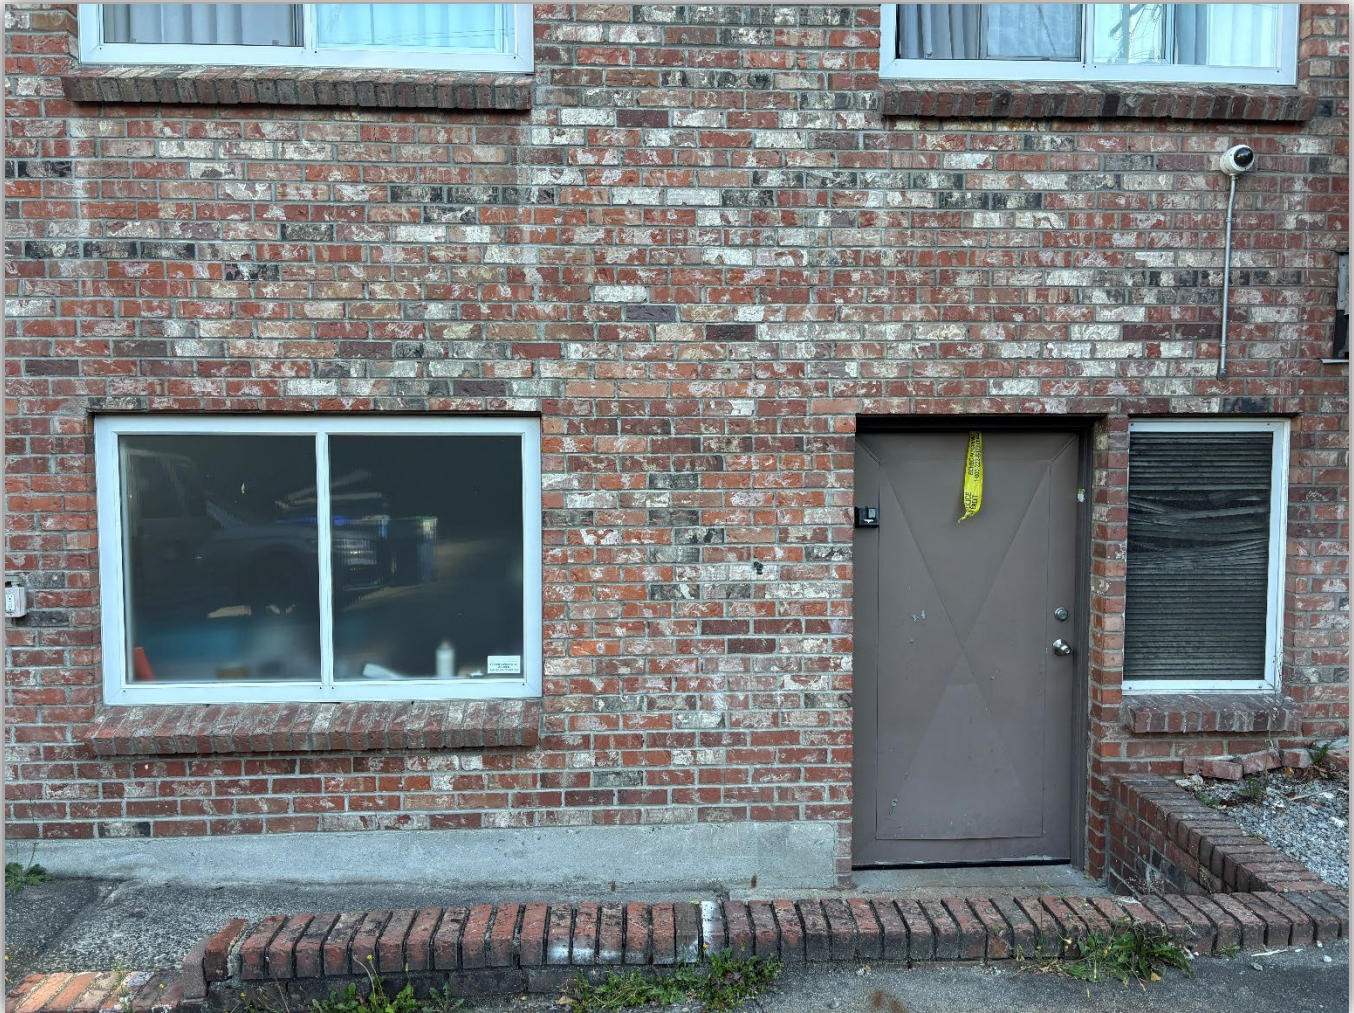
- Both IBC boilers and both domestic hot water boilers drew their combustion air from the mechanical room.
- A screened and louvered opening communicated directly with the outdoors and had ducting that separated combustion air directed to the floor from ventilation air near the ceiling of the room.

Image 2 – Mechanical room door with passive air intake opening, screen, and louvers on the right side.

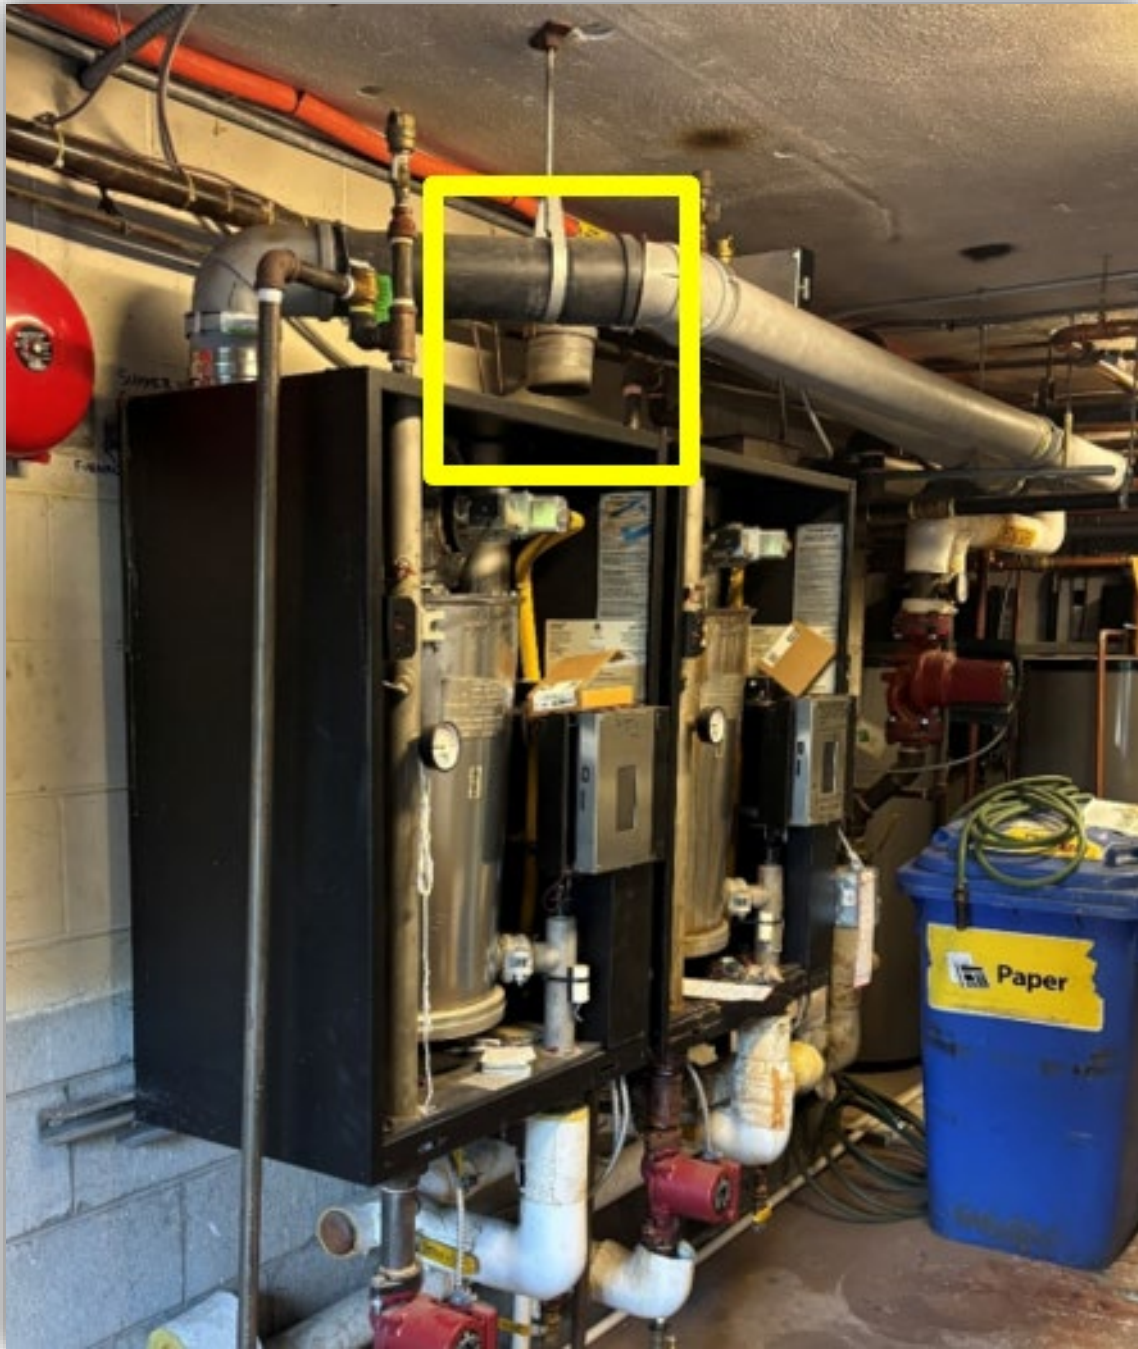
- The vent for Boiler #2 was observed dislocated from the appliance vent connection and wedged beside the external low-water cutoff switch installed above the boiler.

Image 3 – Two heating boilers in the mechanical room, with the disconnected vent on Boiler #2 shown at right.

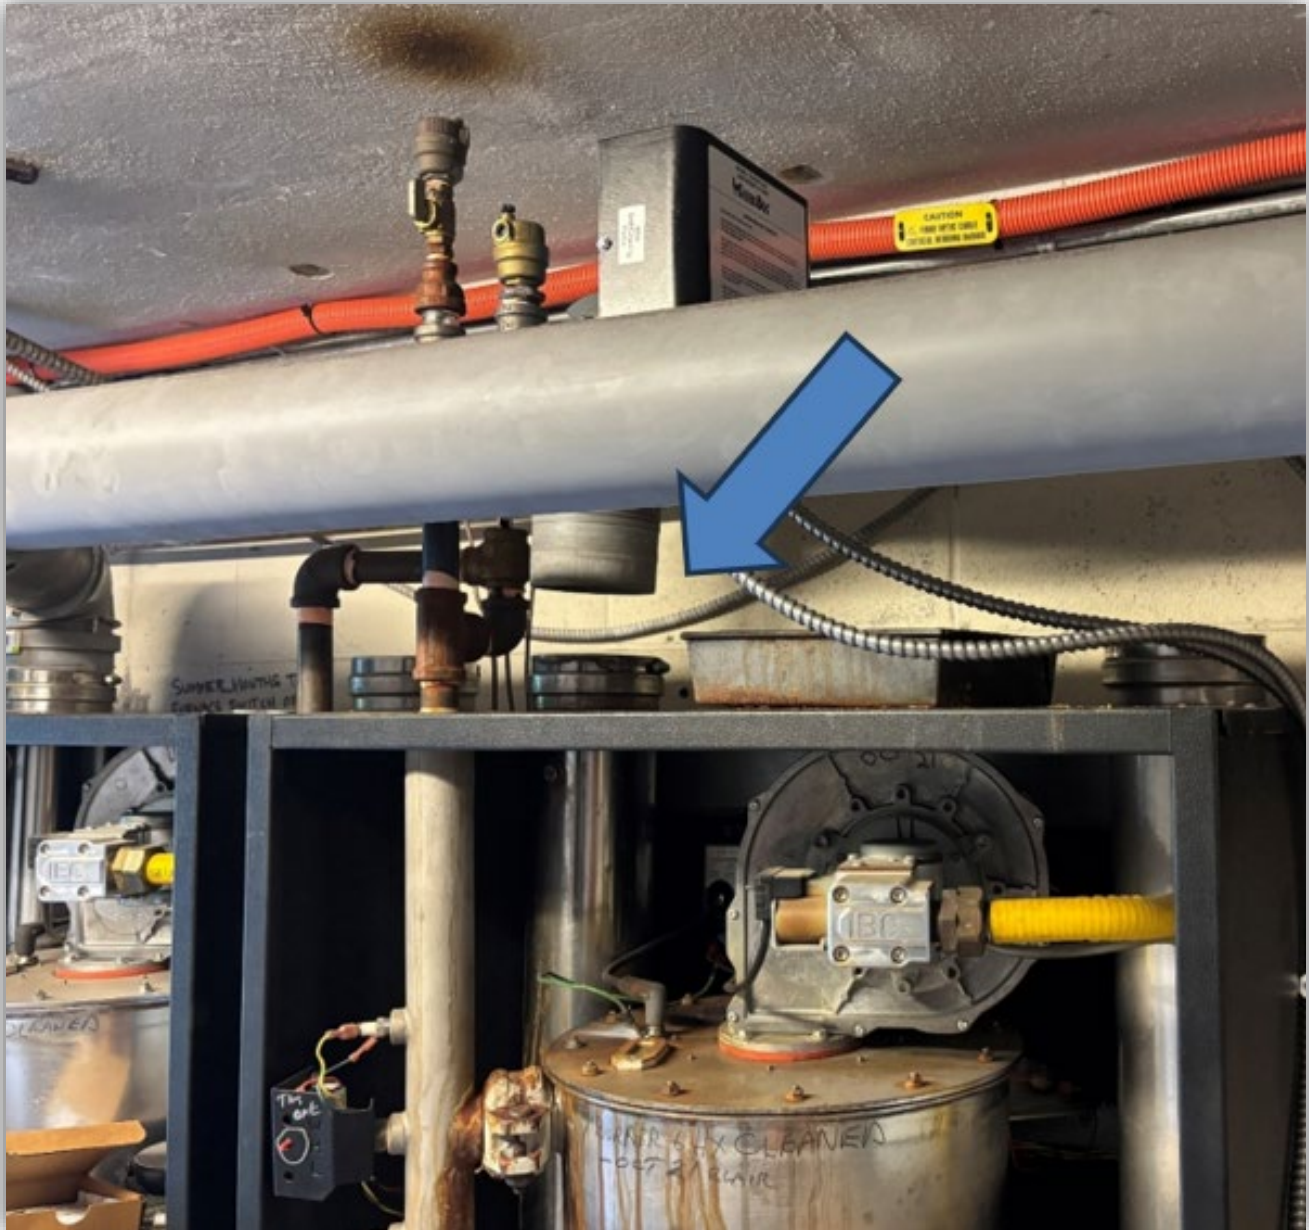
The incident was caused by the boiler vent dislocating during a delayed ignition while the boiler continued to operate.

- The boiler vent connection did not sufficiently secure the vent when the clamp was tightened, allowing the vent to disconnect during delayed ignition.

Image 4 – Vent disconnected from the flue outlet on Boiler #2.

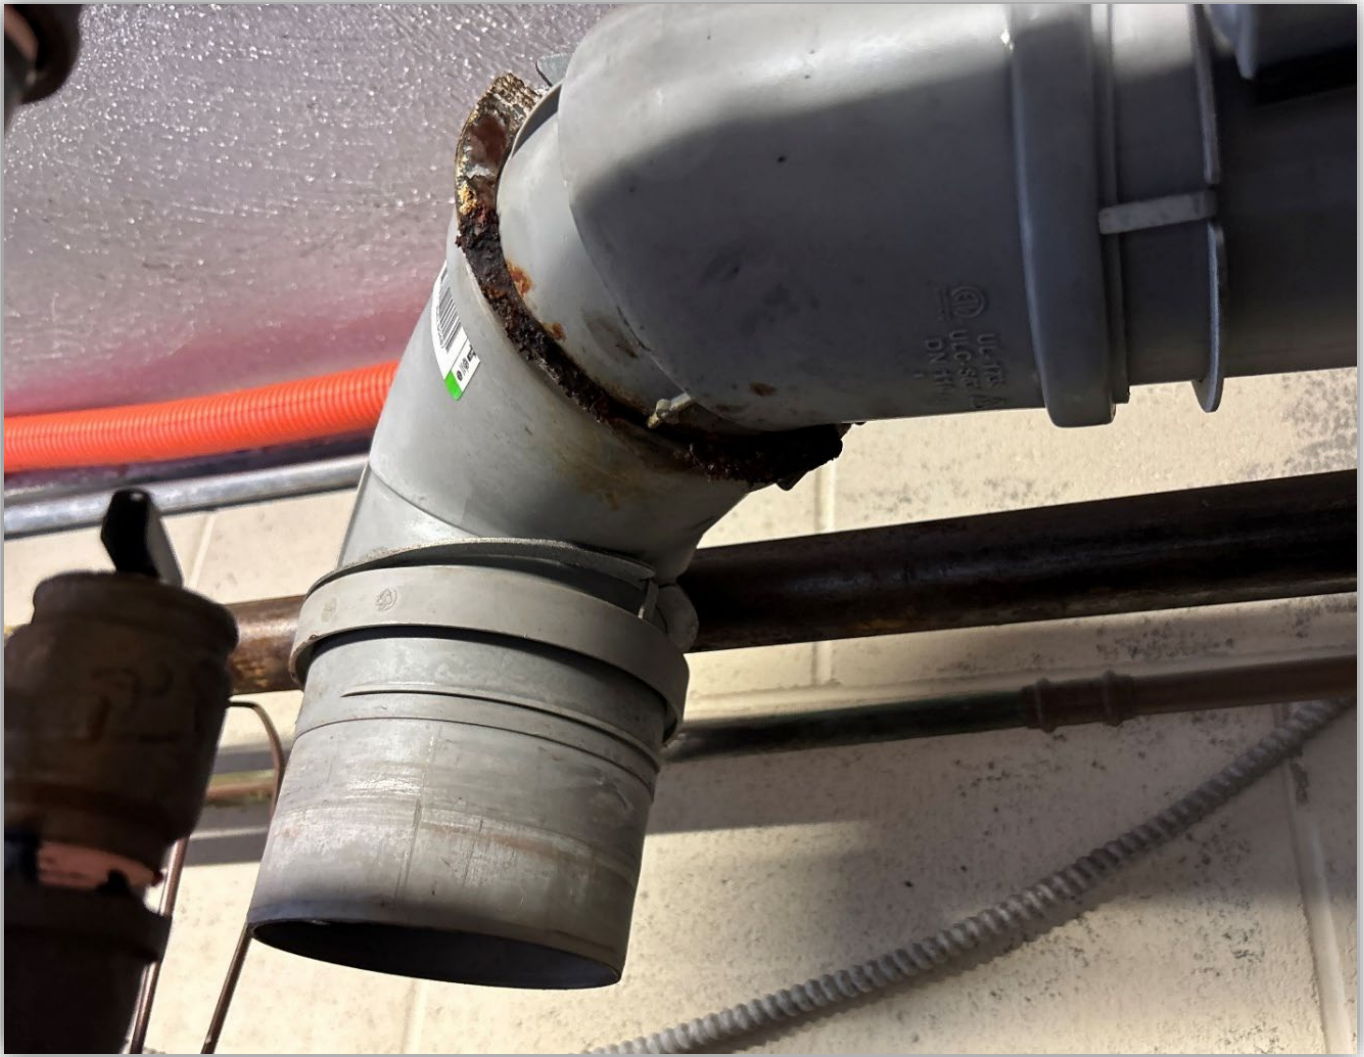
- Staining on Boiler #2 suggested long-term leaking condensate from the horizontal vent connection above the appliance.
- The retaining ring at the first horizontal connection after the elbow on top of the appliance had corroded completely through and was no longer effectively retaining the connection.

Image 5 – Close-up of disconnected vent and corroded retaining ring.

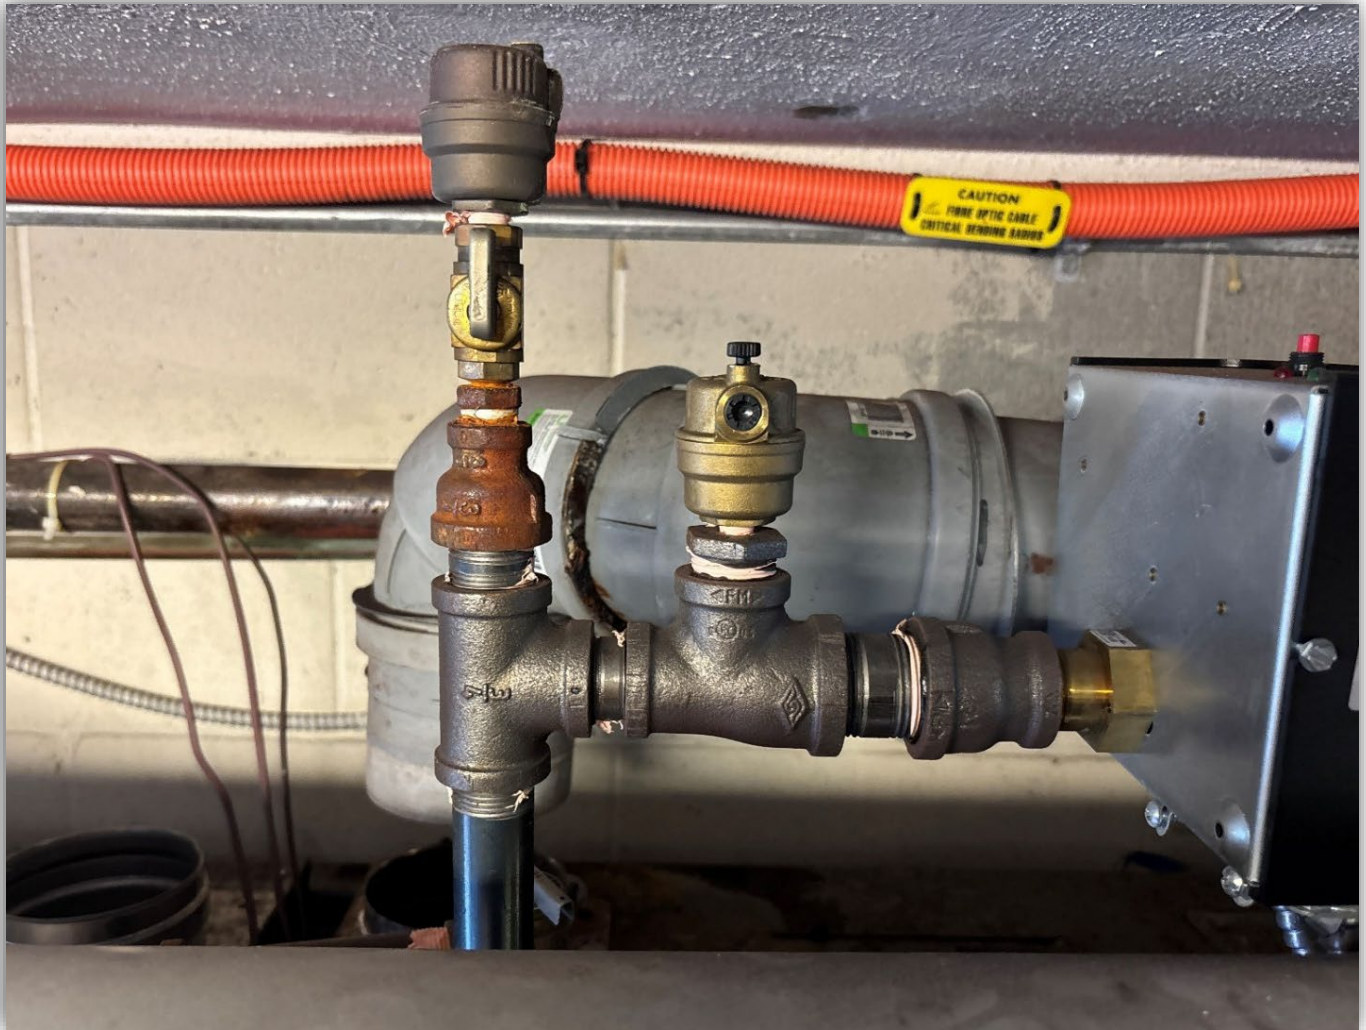
Image 6 – Piping for external low-water cutoff valve.

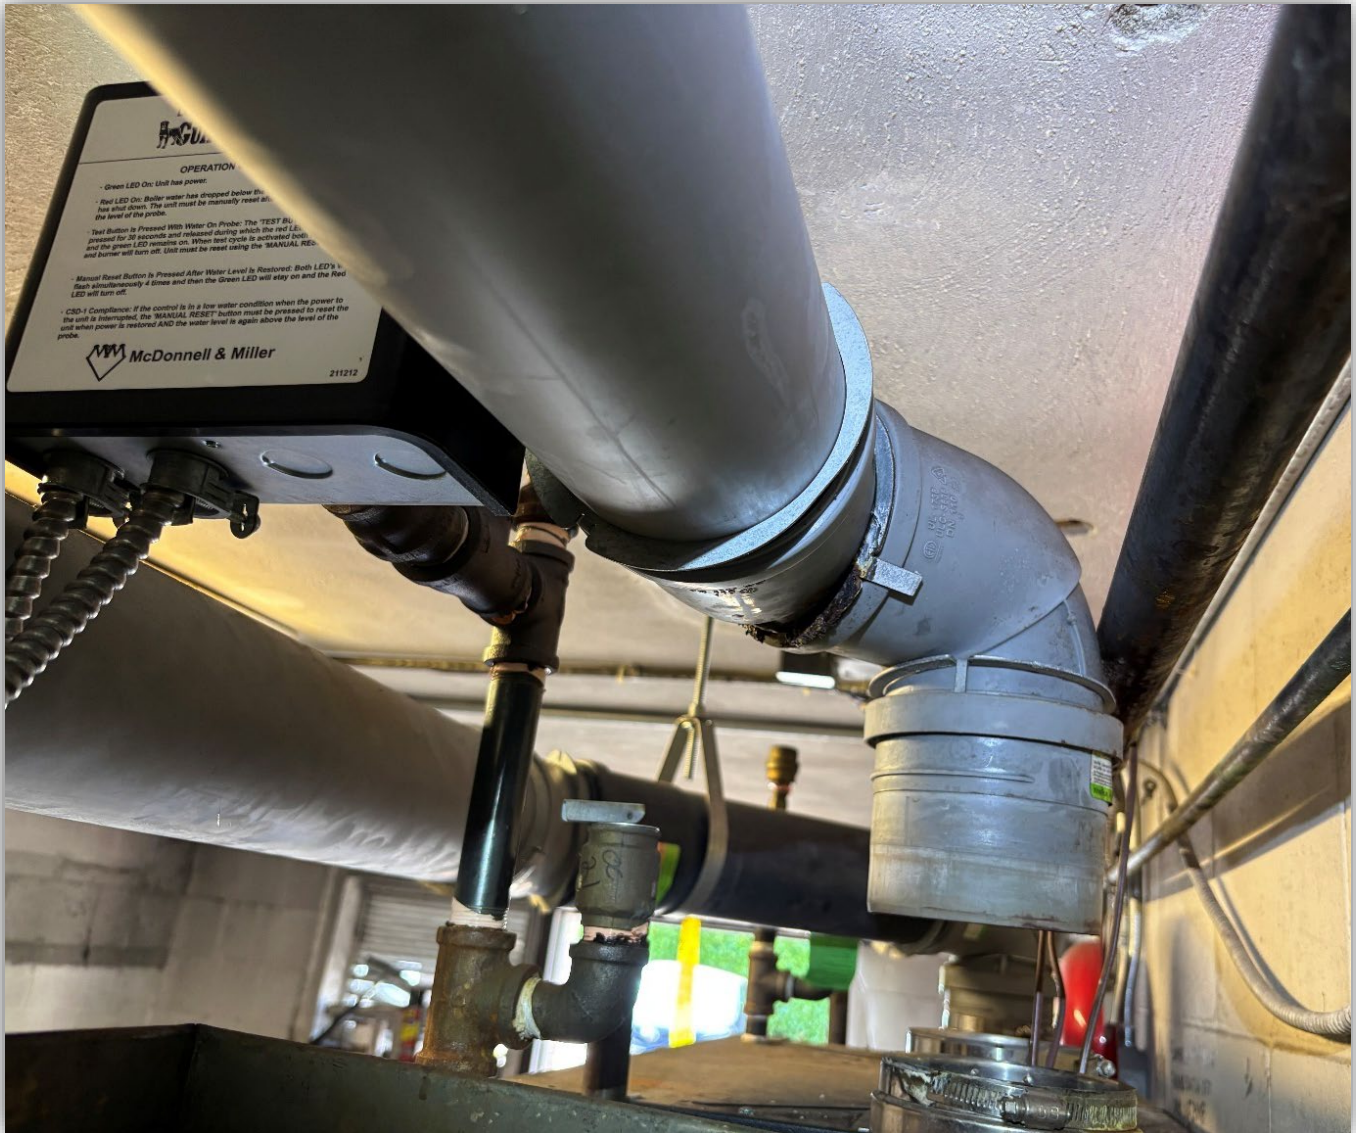
- The external low-water cutoff installed on top of the boiler allowed the vent to wedge against it after a delayed ignition displaced the vent from the connector.

Image 7 – Disconnected vent pipe wedged against external low-water cutoff valve holding it in place.

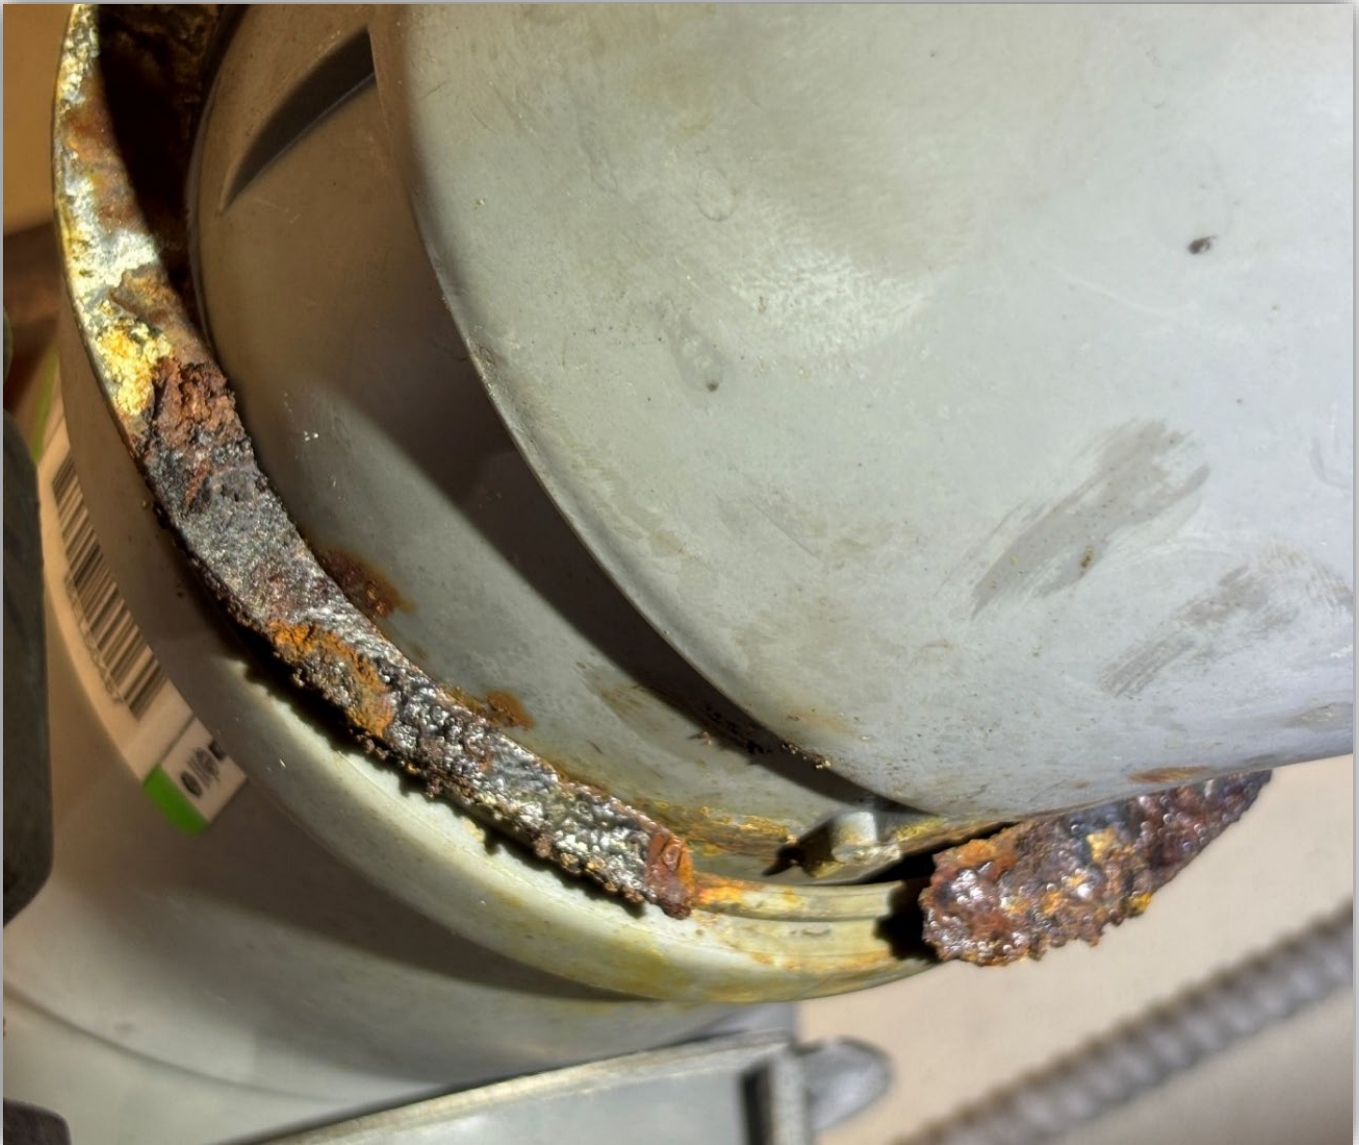
Image 8 – Close-up of corroded retaining ring on Boiler #2 vent elbow.

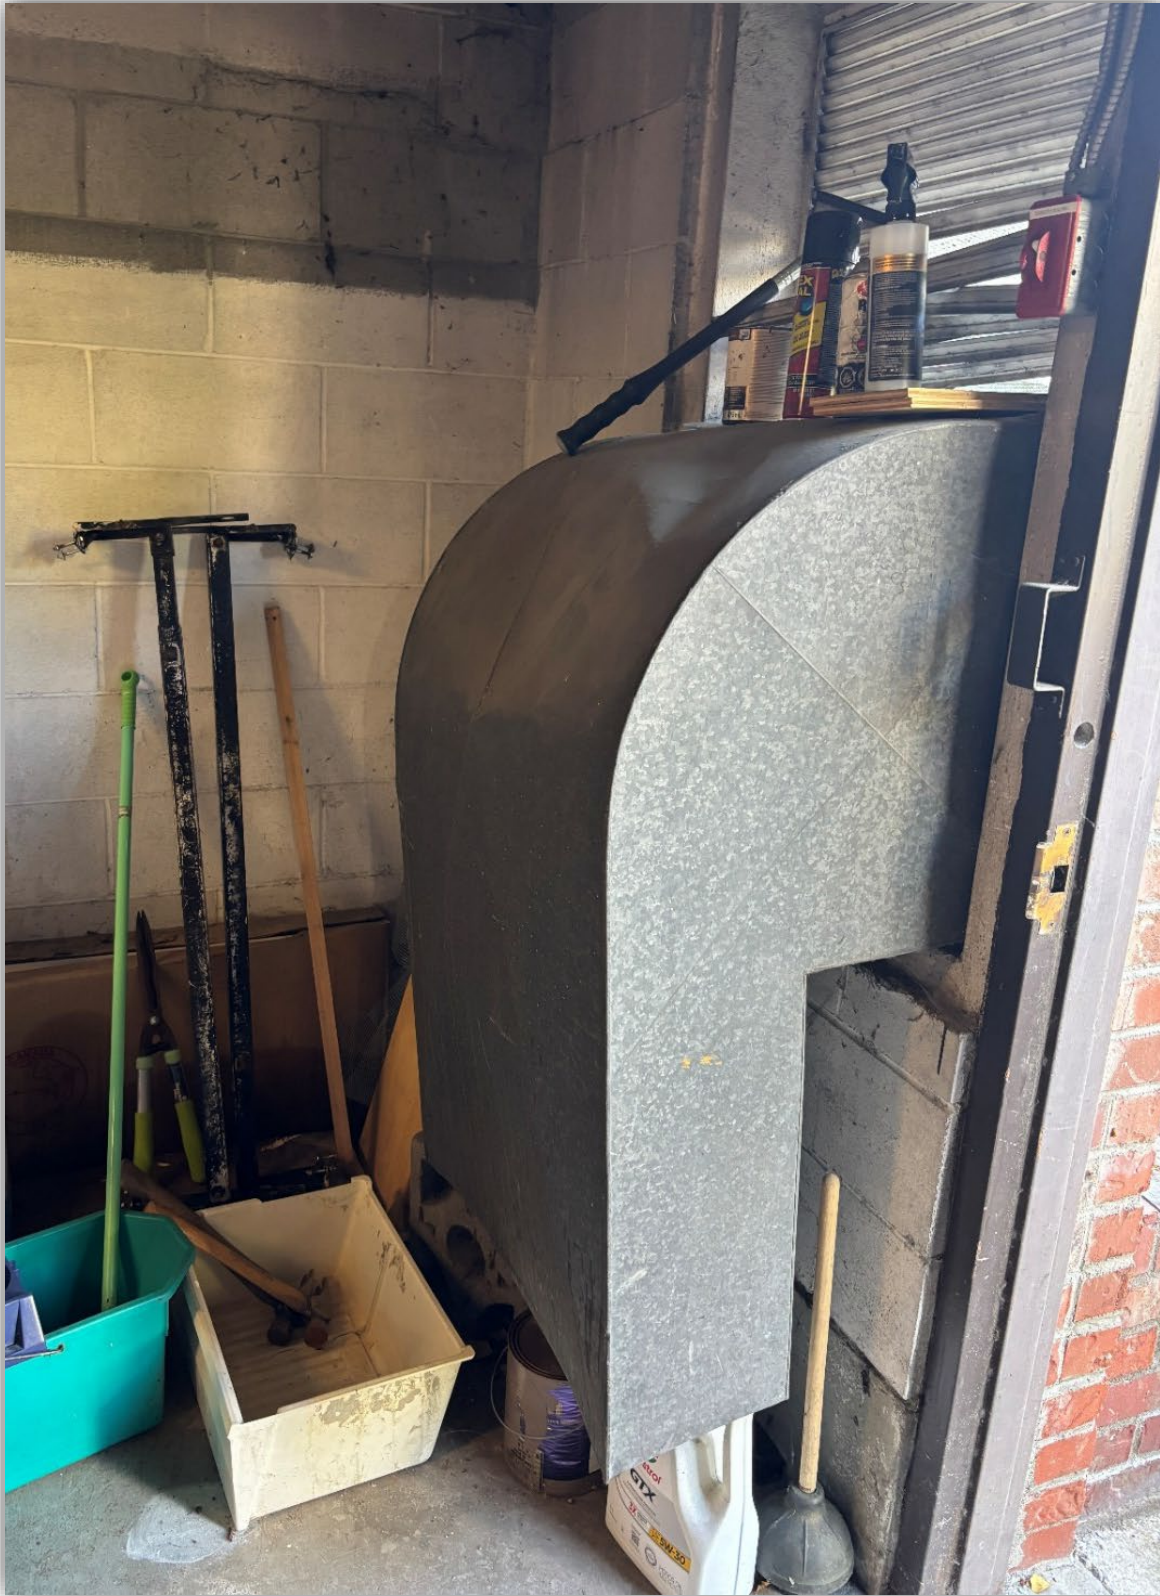
- The combustion air ducting was measured at 28.5" × 10", which provided 285 square inches of opening and exceeded the minimum requirement for the appliances in the room.
- Boiler #2 was energized after the incident while the gas remained shut off. The boiler initialized and then attempted to ignite the burner.
- The gas was turned on, the boiler ignited smoothly, and combustion analysis showed CO levels within the expected range for a properly operating appliance.

Image 9 – Combustion and ventilation air openings for mechanical room.

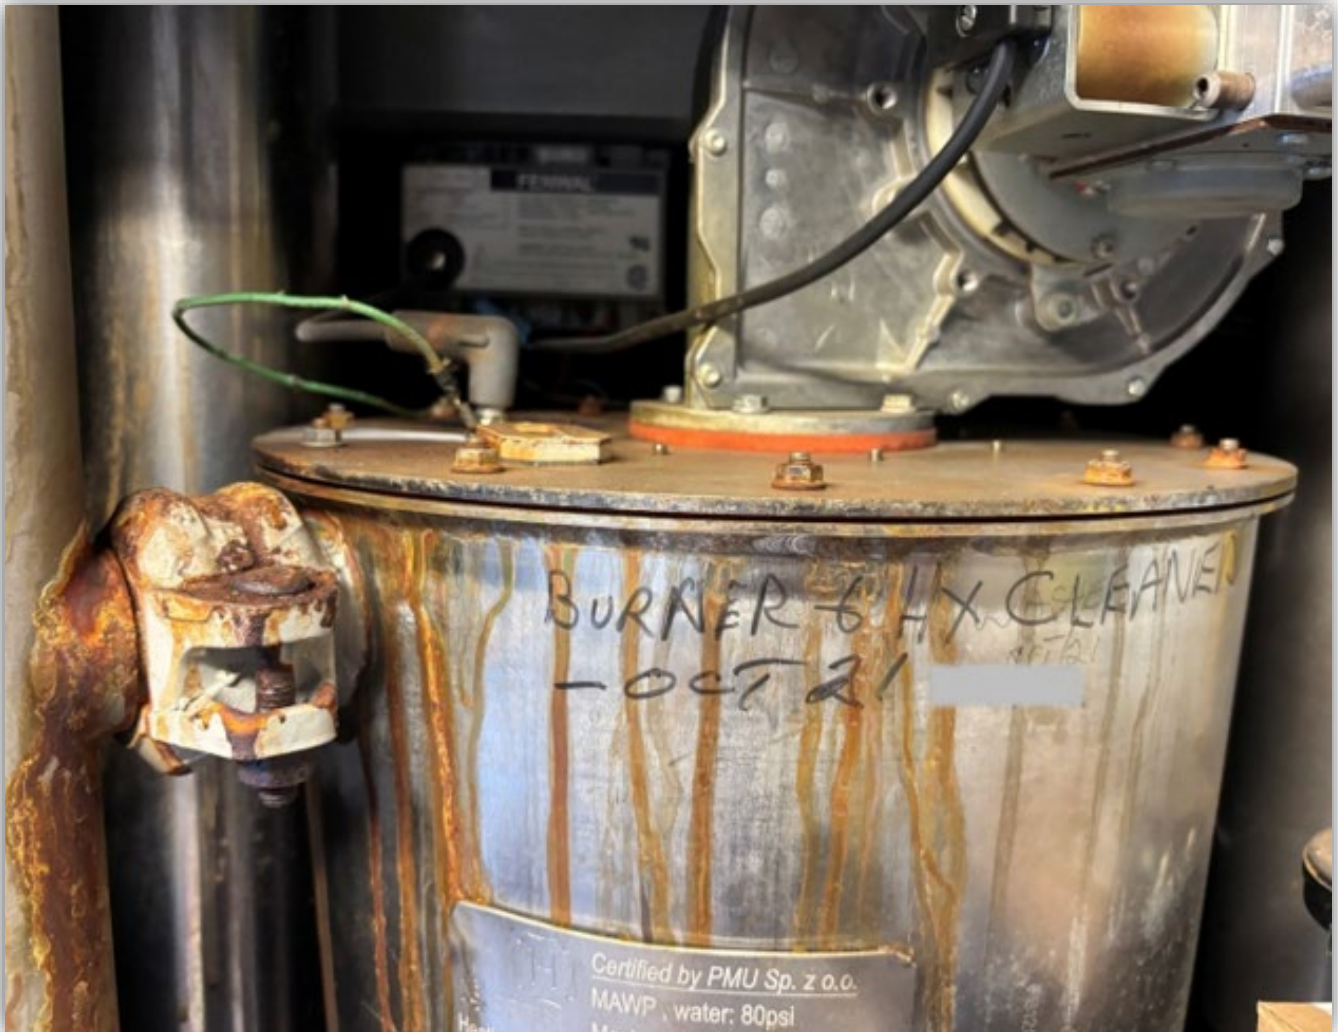
Image 10 – Staining and corrosion on combustion chamber from leaking condensate from flue vent on Boiler #2.

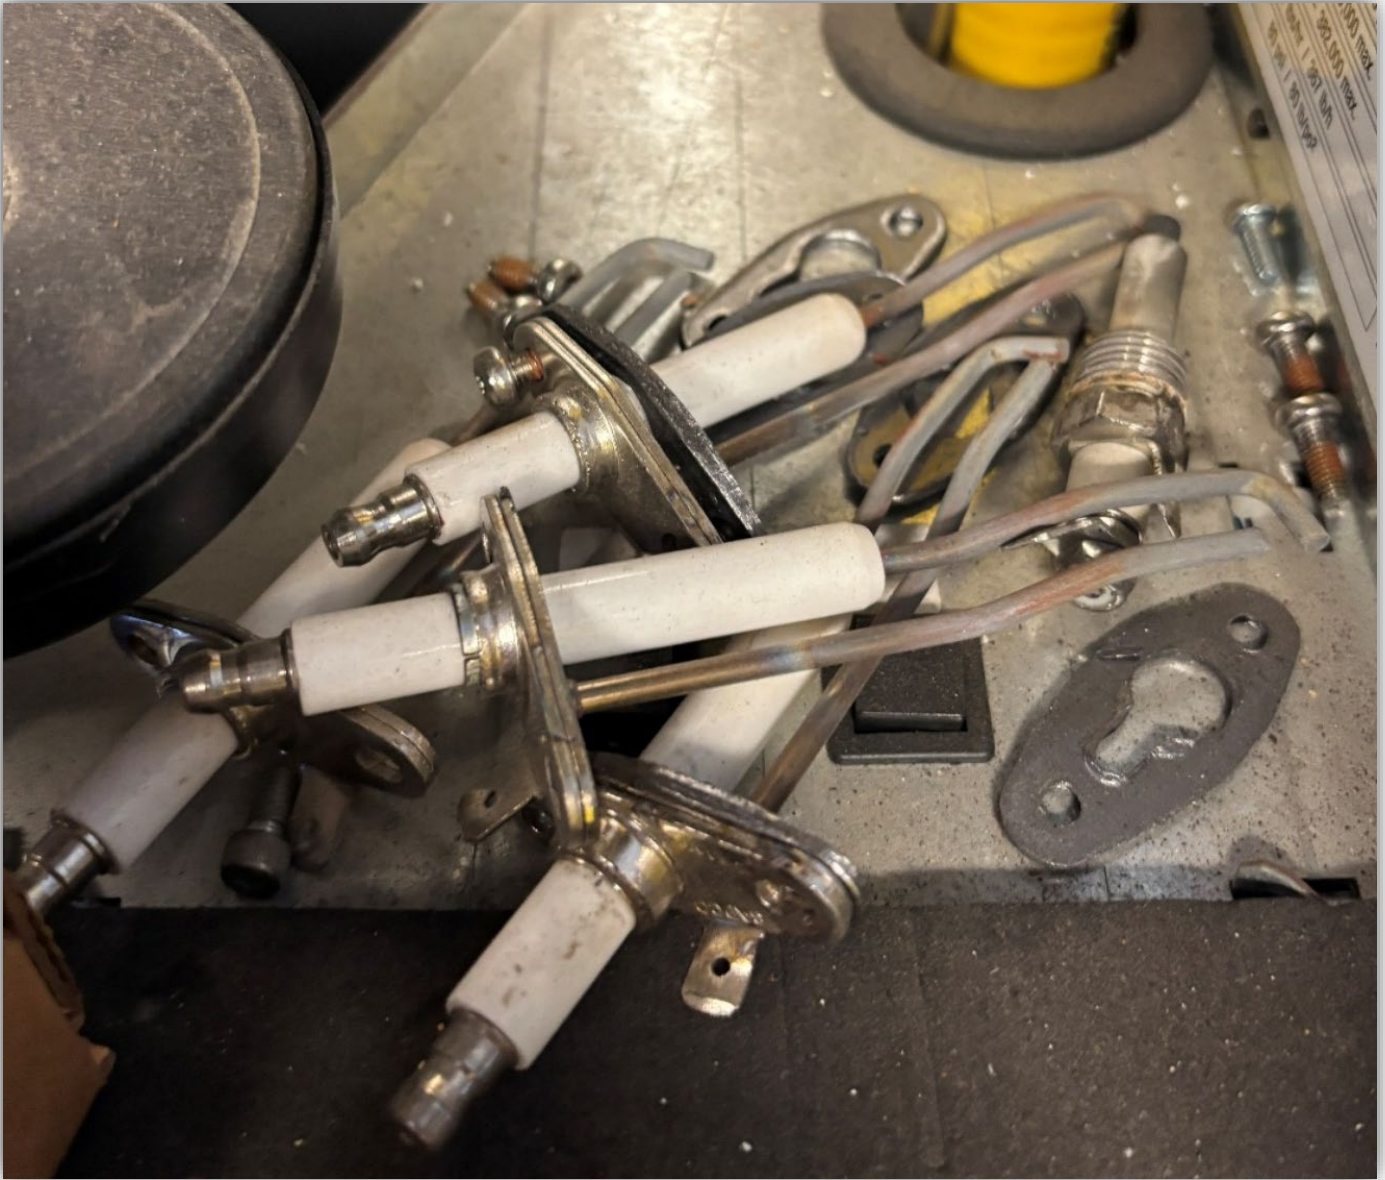
- Both boilers had several old used ignitors stored inside them.
- There were multiple unsealed passages through the mechanical room's block walls and one large hole in the ceiling communicating directly with the floor joists of the suites above.

Image 11 – Multiple used ignitors from boiler repairs of ignition issues.

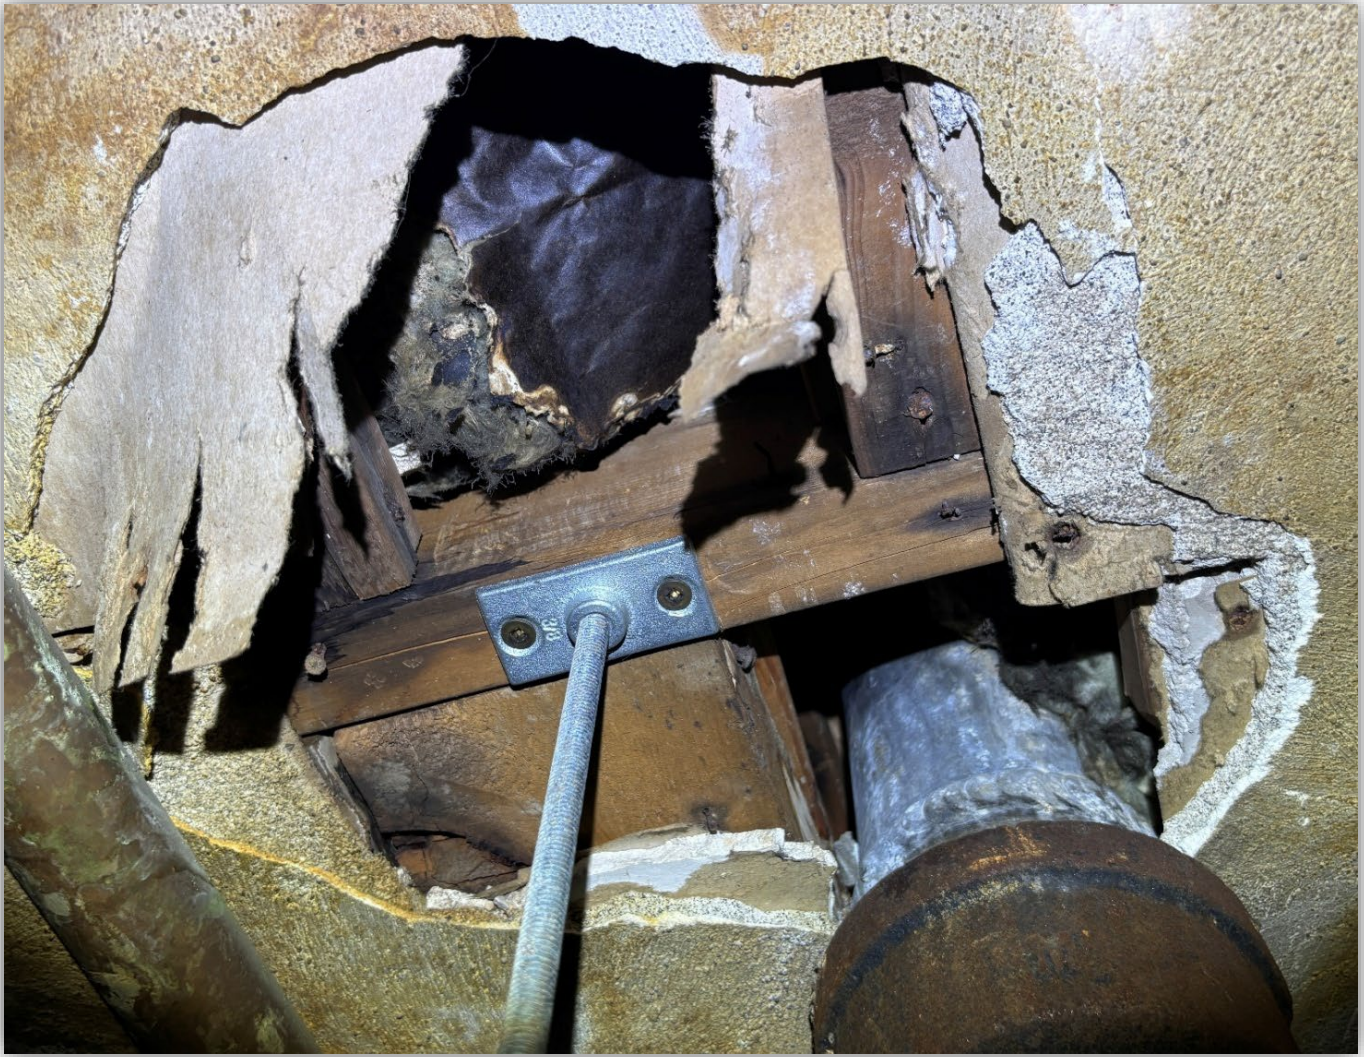
- Unsealed passages in the mechanical room walls and a ceiling opening allowed CO to migrate into occupied indoor spaces.
- The absence of installed CO detectors allowed CO exposure to continue for a prolonged period and increase in severity before being identified through occupant illness symptoms.

Image 12 – Hole in mechanical room ceiling providing a migration path for CO into the building with vent support bracket installed on exposed floor joist.

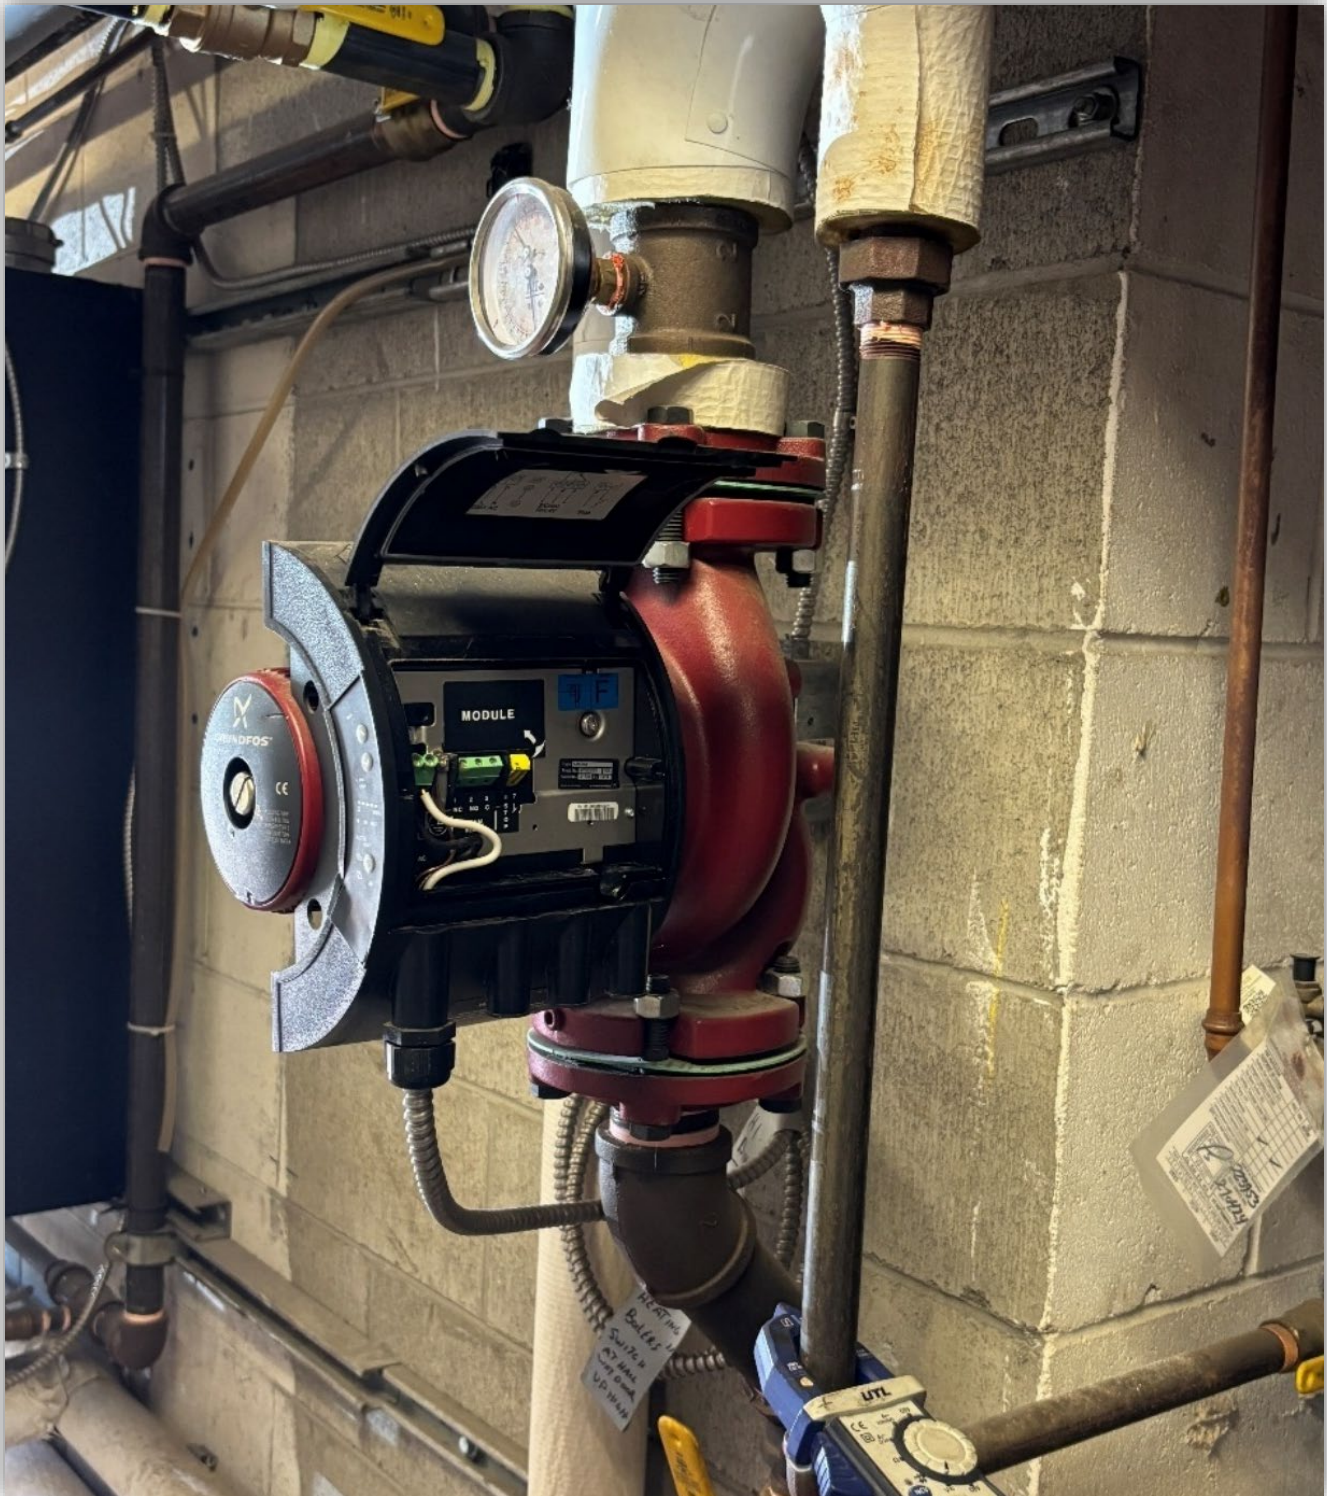
- The water temperature rose quickly, and the boiler shut down, indicating that the external circulating pump was not operating.
- The pump was tested and confirmed not to be operating because the outdoor temperature was above the summer setpoint and the pump was being controlled only by Boiler #1.

Image 13 – Main circulating pump for building's hydronic heating system.

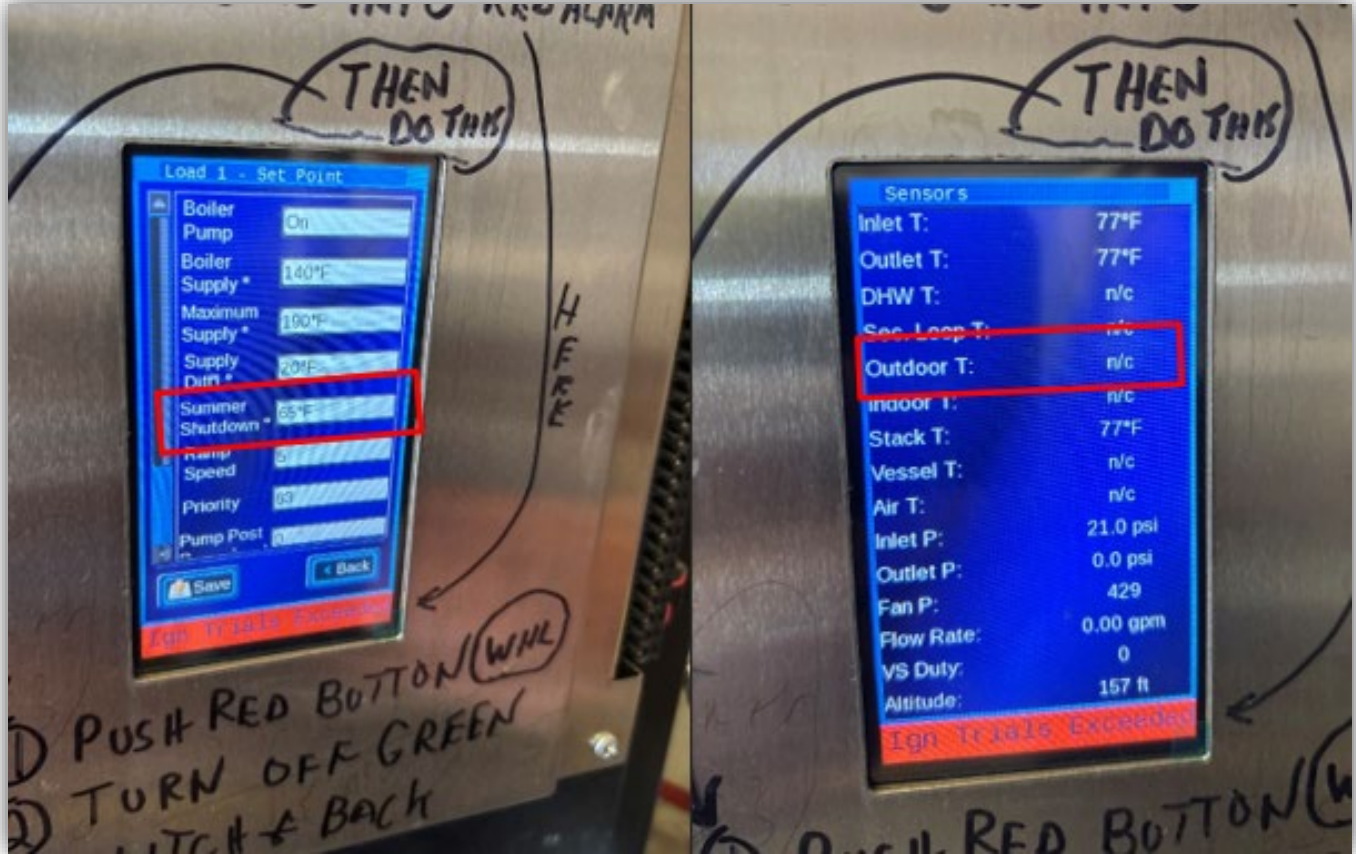
- The incorrect summer shutdown setpoint setup allowed Boiler #2 to operate without the main circulating pump. This caused short cycling and increased the number of ignition attempts, likely increasing the frequency and severity of delayed ignitions.

Image 14 – Boiler #2 display showing summer shutdown temperature setting (left) and no reading of the outdoor temperature (right).
