## Incident Summary (II-696340-2018)

SUPPORTING INFORMATION	Incident Date		June 02, 2018	
	Location		Prince George	
	Regulated industry sector		Boiler and Pressure Vessel system.	
	Impact	Injury	Qty injuries	None
			Injury description	None
			Injury rating	None
	Damage		Damage description	Leak in Furnace wall tube.
			Damage rating	Moderate
	Incident rating		Moderate	
Incident overview		The emergency shutdown procedure was initiated when a tube leak was identified in the Recovery Boiler furnace.

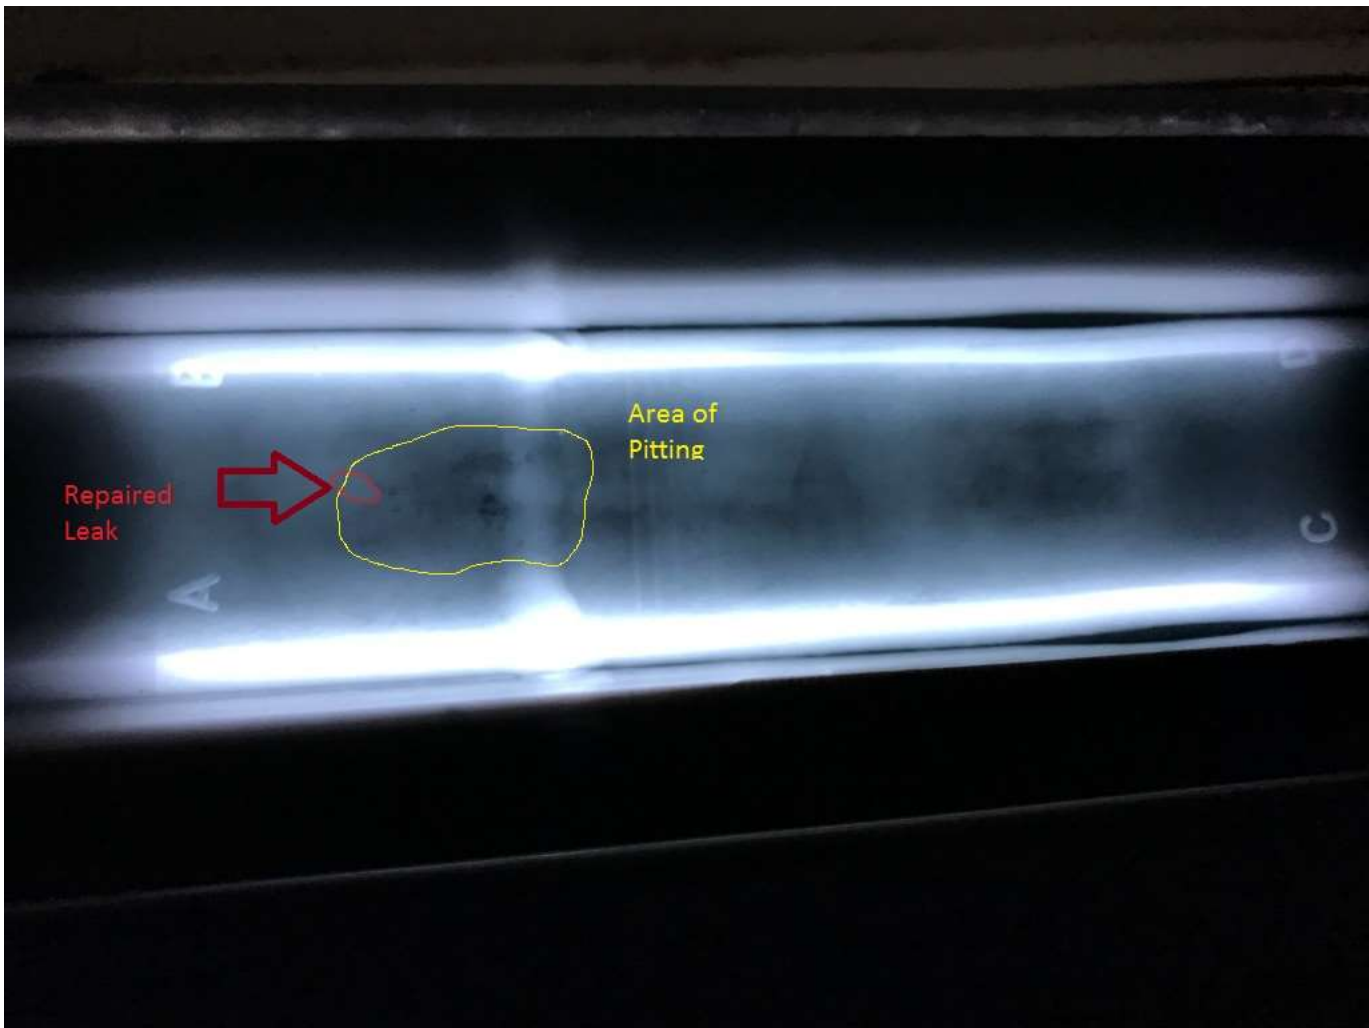
INVESTIGATION CONCLUSIONS	Site, system and components	<p>In a Pulp Mill Recovery Boiler, the carbon steel boiler tubes contain the water which is heated by the combustion of black liquor within the furnace. During the combustion process smelt is formed within the furnace and when exposed to water may cause an explosion.</p> <p>Black liquor is the waste product from the kraft process when digesting pulpwood into paper pulp removing lignin, hemicelluloses and other extractives from the wood to free the cellulose fibers. The smelt (green liquor) results after the combustion of the black liquor.</p>
	Failure scenario(s)	A pin hole sized leak occurred in the boiler water wall tube allowing water to escape into the furnace.
	Facts and evidence	At the location of the leak, which occurred on the left wall on Tube 103 at approximately 6 feet above the floor, external localized thinning was present and corrosion resistant metal spray coating had not been applied as with the adjacent tubes. Non-Destructive examination determined that internal pitting was also present at the leak location.

Causes and contributing factors	It is highly probable that the lack of corrosion resistant metal spray coating on this tube allowed external corrosion to occur and combined with the internal pitting resulted in the tube wall thinning to the point of a leak occurring.
