## **Incident Summary (Reference #5618019) (Final)**

| | Inci | dent | Date | July 5, 2017 |
|--|---|---|---|--|
| INVESTIGATION CONCLUSIONS SUPPORTING INFORMATION | Loc | ation | | Penticton |
| | | Incident overview | | There were no injuries or property damage due to the Ammonia release from the pinhole in the 1" piping to the Hydro Cooler Surge Drum. The Ammonia vapor set the leak detector on at 50ppm which activated the alarms. The Vapor was drawn in from the outside of the building where the leak occurred. The Ammonia vapor was pulled in by the inlet air louvers by the continuous vent fan. The affected area of the 1" piping to the Surge Drum was isolated by a valve and the Refrigeration Compressor Shutdown. The area of piping was covered by insulation and stripped back to expose the pinhole in the pipe. The local BSO was contacted for inspection with approval to replace piping by pressure welding the joints. |

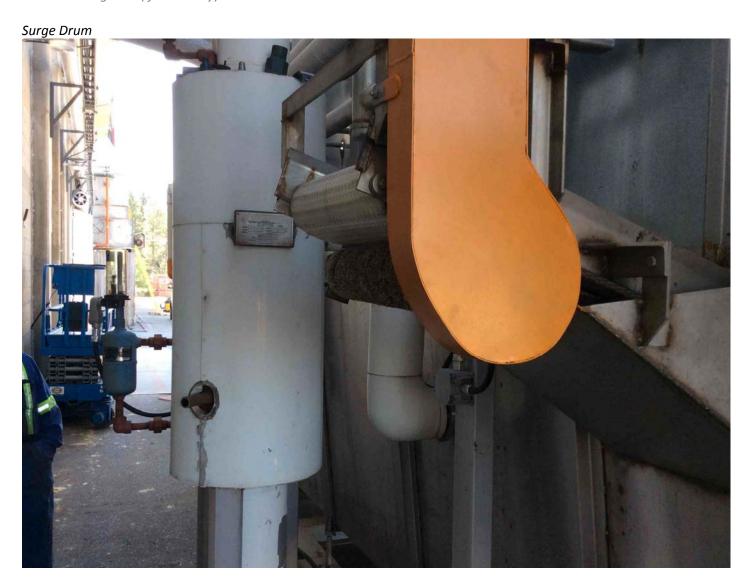
| | Inci | dent | Date | July 5, 2017 |
|--|---|---|---|--|
| | Fail | Failure scenario(s) | | -The conditions of the temperature changes and insulated piping allowed for external corrosion in the piping. Then a pinhole in the pipe occurred and an Ammonia leak resulted. |
| | | ts and | d evidence | -The daily packing of the cherry cooler equipment was in full process with normal conditions. - Ammonia leaked from a pin hole in the 1" NPS supply line at the hydro-cooler Surge Drum with an operating pressure of 140 psi. and 50 lbs of Ammonia was released into the atmosphere. The ammonia vapor set off the Ammonia Leak detector at 50 ppm in the machine room, probably drawn through the inlet air louvers by the continuous vent fan. -The area of piping is a liquid Ammonia supply line that runs along the outside of the Building and creates condensation because of the cold temperature of the Ammonia. - There was insulation covering the 1" piping that created corrosion from the outside of the pipe to the inside, this created the pinhole in the piping for a leak to occur. - The area of piping was insulated from the original piping Installation and the cause of (CUI) corrosion under insulation. |

The cold temperatures of the Ammonia liquid supply line that was insulated created condensation between the 1" piping and the insulation. The wet insulation soaked with moisture had no place for drainage and could not dry. In most cases the Ammonia supply liquid line is exposed and no insulation is required. Most piping is painted to prevent corrosion and maintained over the operating years of the refrigeration plant.
