## Incident Summary #II-1291094-2021 (#25150) (FINAL)

| Incident overview | | A motion switch overheated and caught fire internally. This switch automatically controls all the overhead fluorescent lighting in the building. As a result, the lighting could not be turned on. | | |

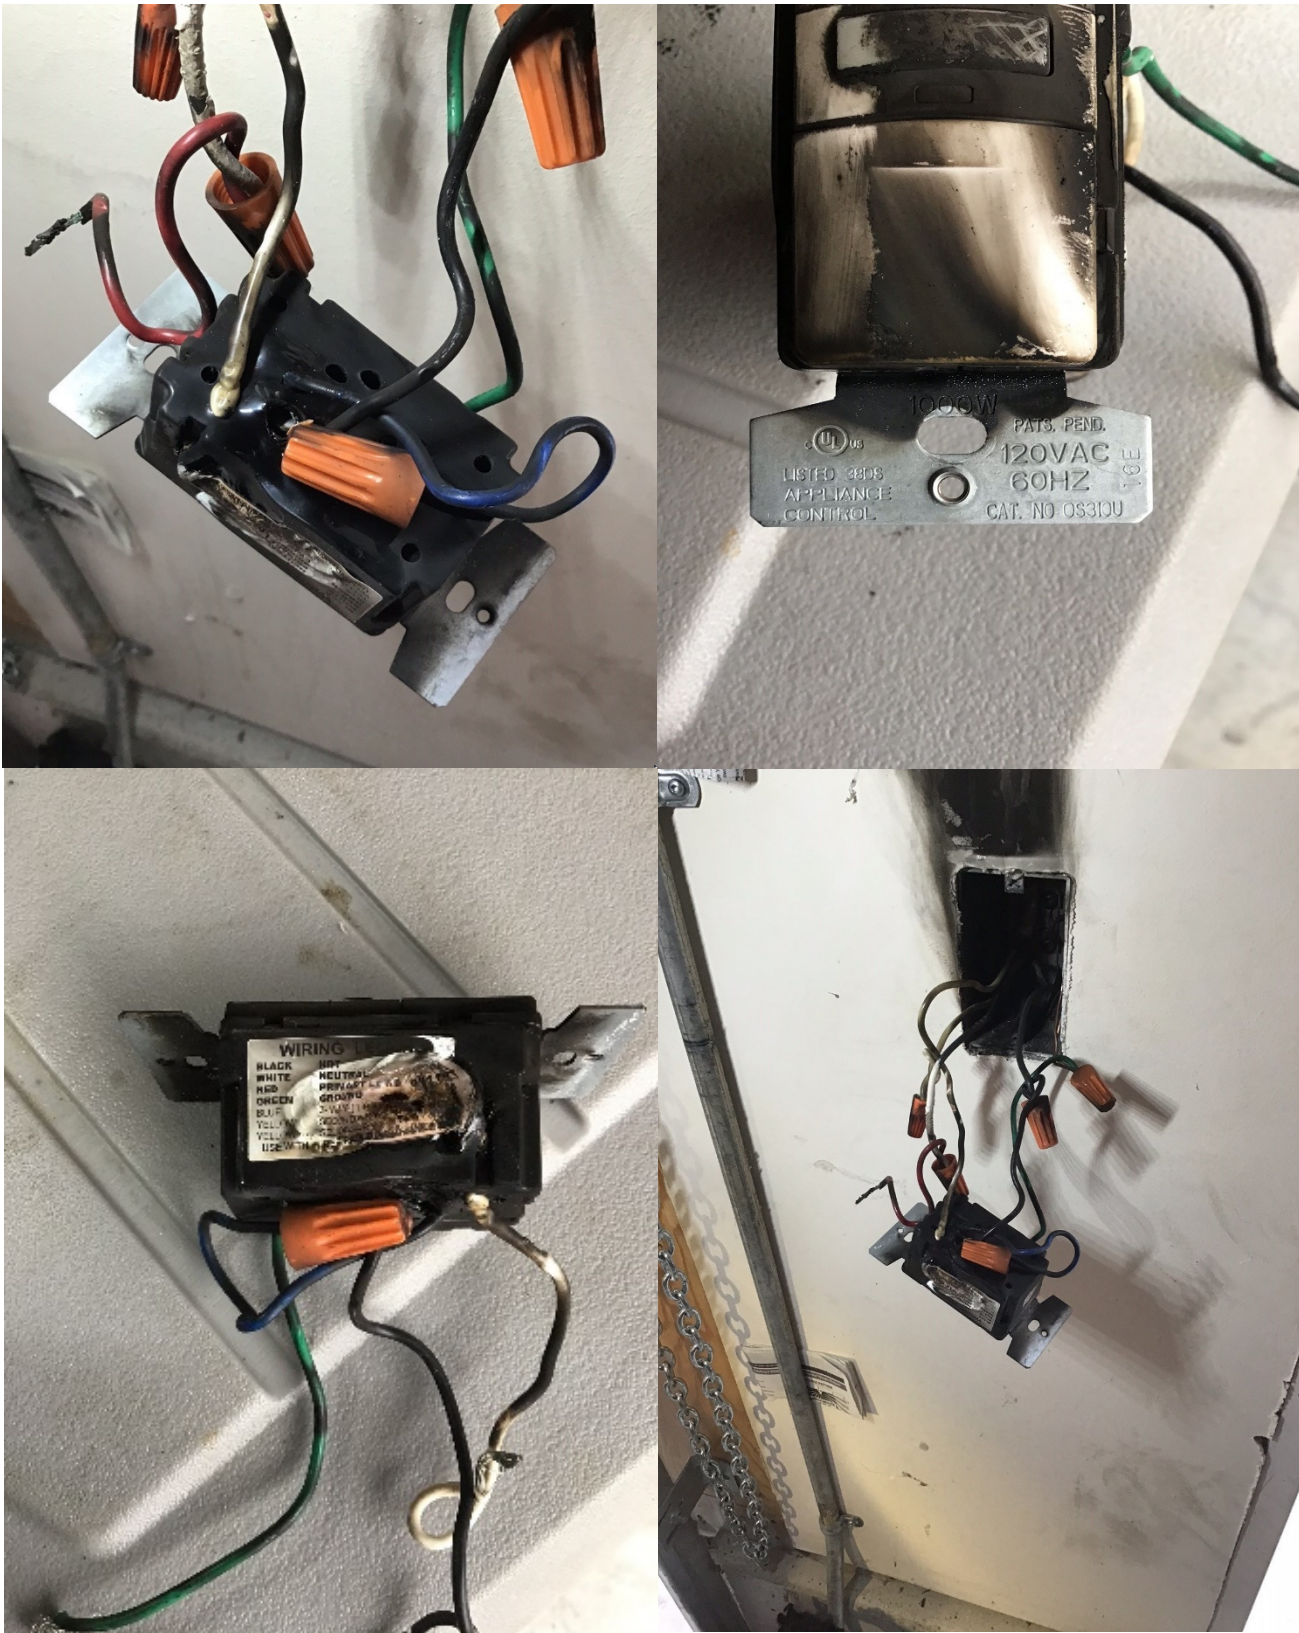
| | Damage | Damage | Damage description | Motion switch failed internally, overheating and melting, creating black smoke around the device. No damage to the building wiring or device box. |

Image 1 - Motion switch

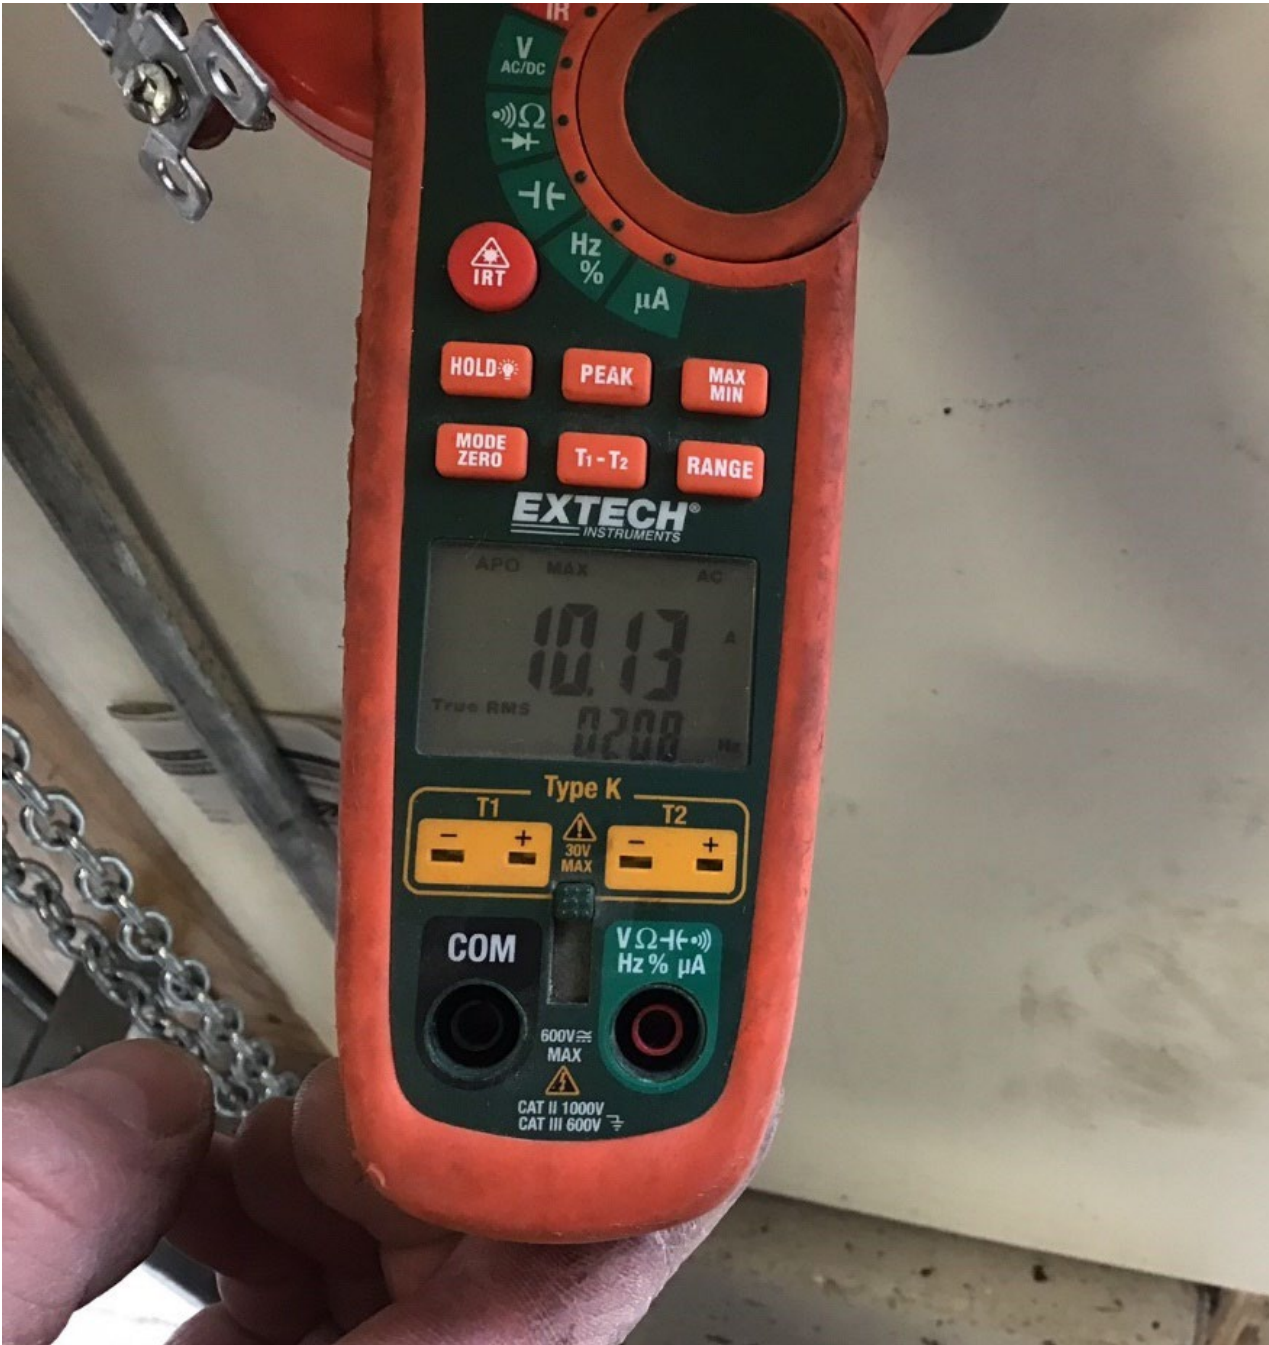
Image 3 - Load test: 10.13-amps

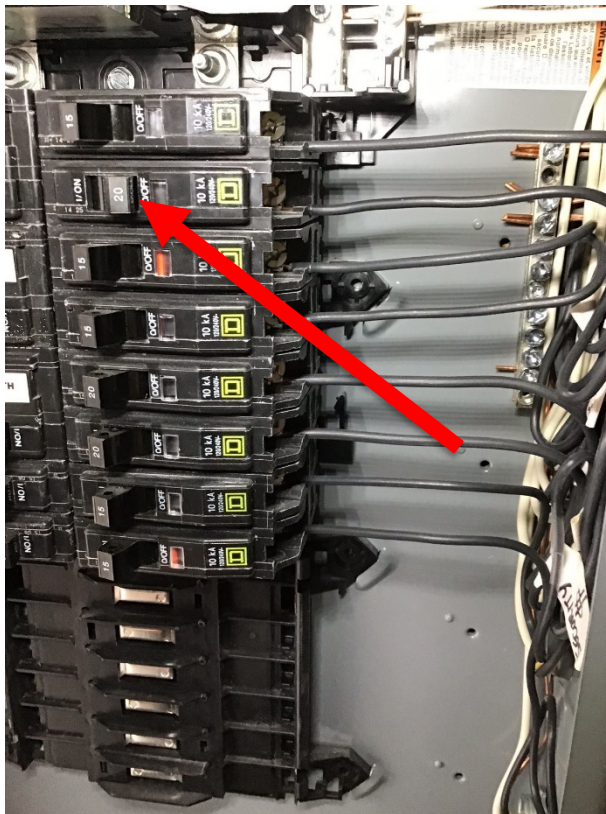
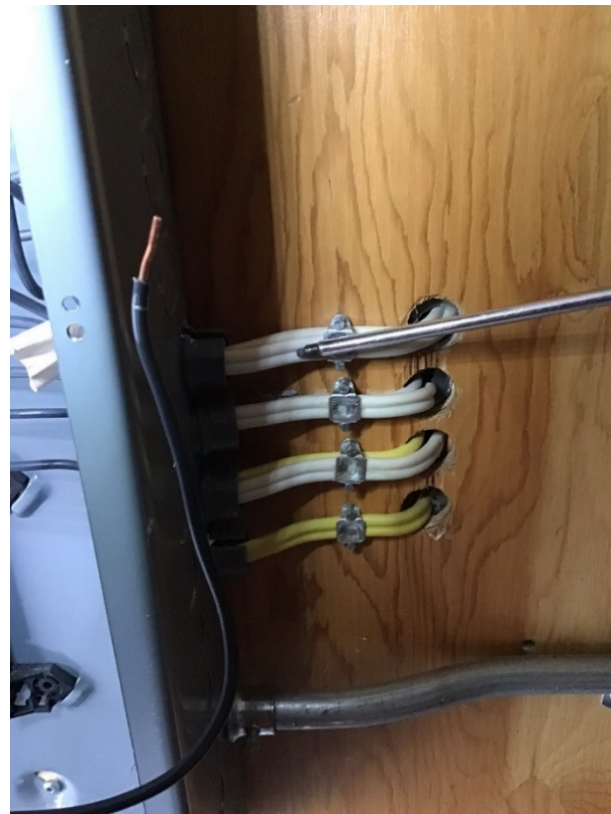
| | <p><b>Site installation conditions:</b></p> <p>The lighting branch circuit is protected by a 20-amp breaker to match the lighting load, but the wiring used is 14/2 NMD90 (standard non-metallic building wire), which is rated at a maximum of 15 amps for normal use.</p> <p>The motion switch is rated at a maximum use of 1000 watts, 120 volts and 8.3 amps.</p> <p>The lighting present and controlled by the motion switch consists of 5 – 6 lamp high output fluorescent fixtures rated at 358 watts, 120 volts and 2.98 amps each, and 2 – 2 lamp high output fluorescent fixtures rated at 120 volts and 1 amp each. The overall calculated load is 16.9 amps at 120 volts.</p> <p>In this case the motion switch was not rated to handle the existing lighting load and the installer may not have checked or been aware of this issue.</p> <p><b>Electrical contractor testing:</b></p> <p>A measurement of actual lighting power usage under load was taken at the motion switch by the qualified electrician present, and the maximum value found during the testing was 10.13 amps.</p> |

Image 5 - 14/2 NMD90 branch circuit wire (right photo) from the lighting circuit connected to a single pole 20-amp breaker (Red arrow)
