Incident Summary #II-818656-2019 (#10666) (FINAL)

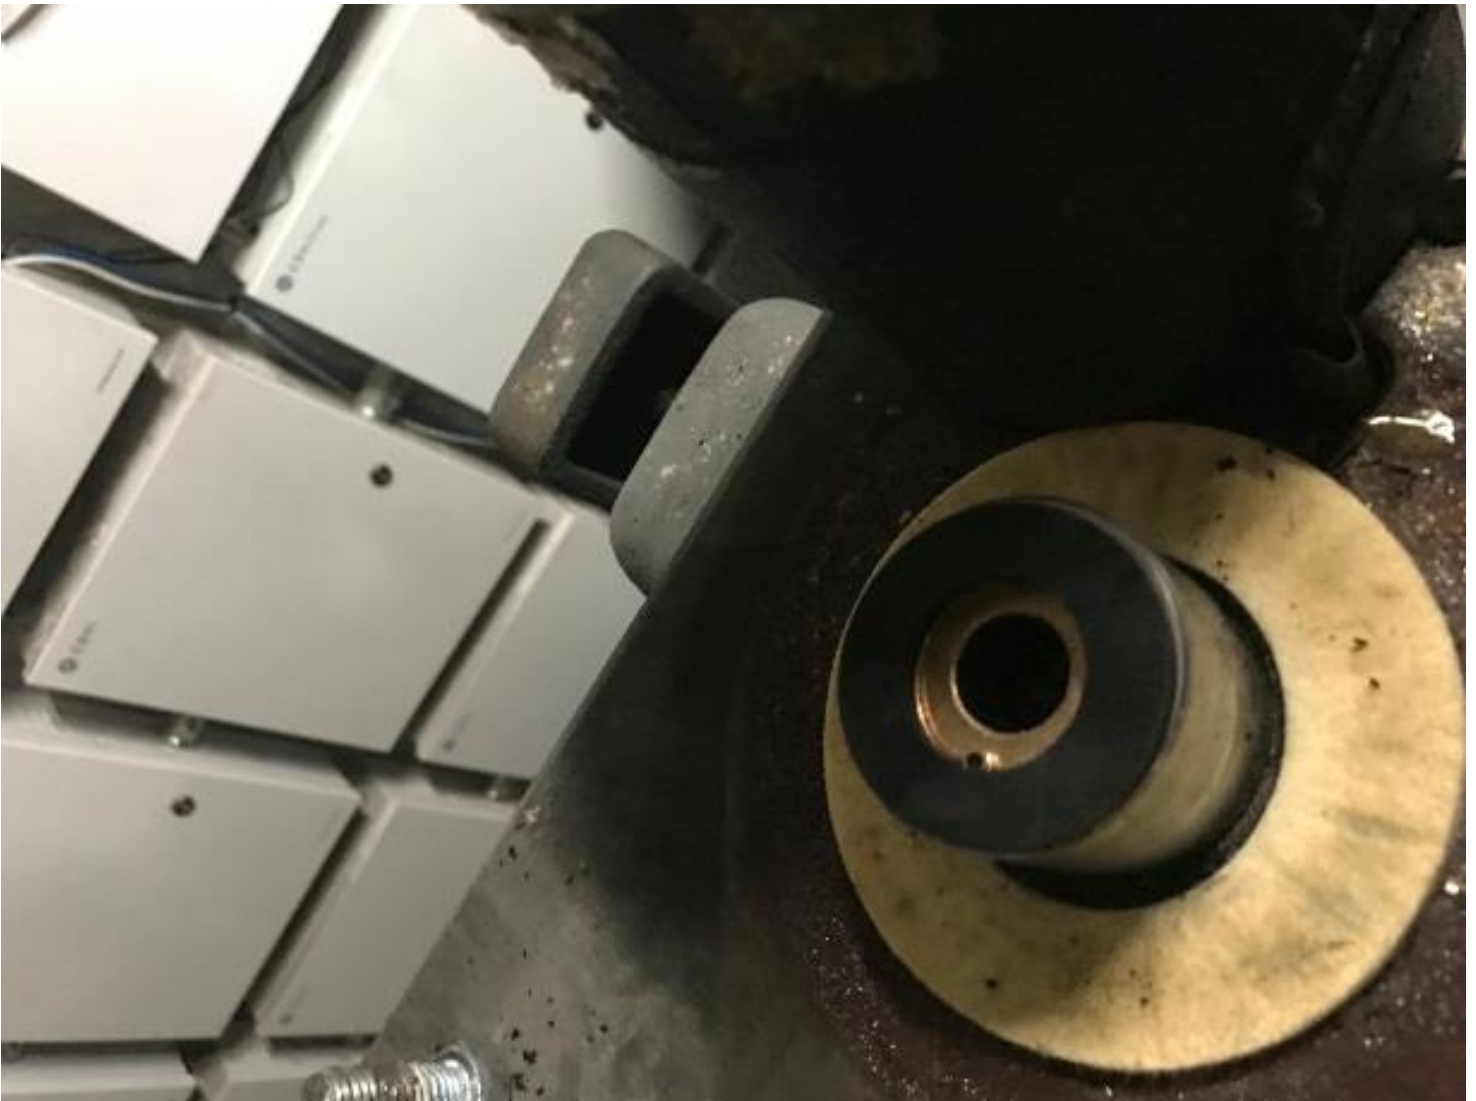
Photo 2 Machine brake assembly with a new rubber washer

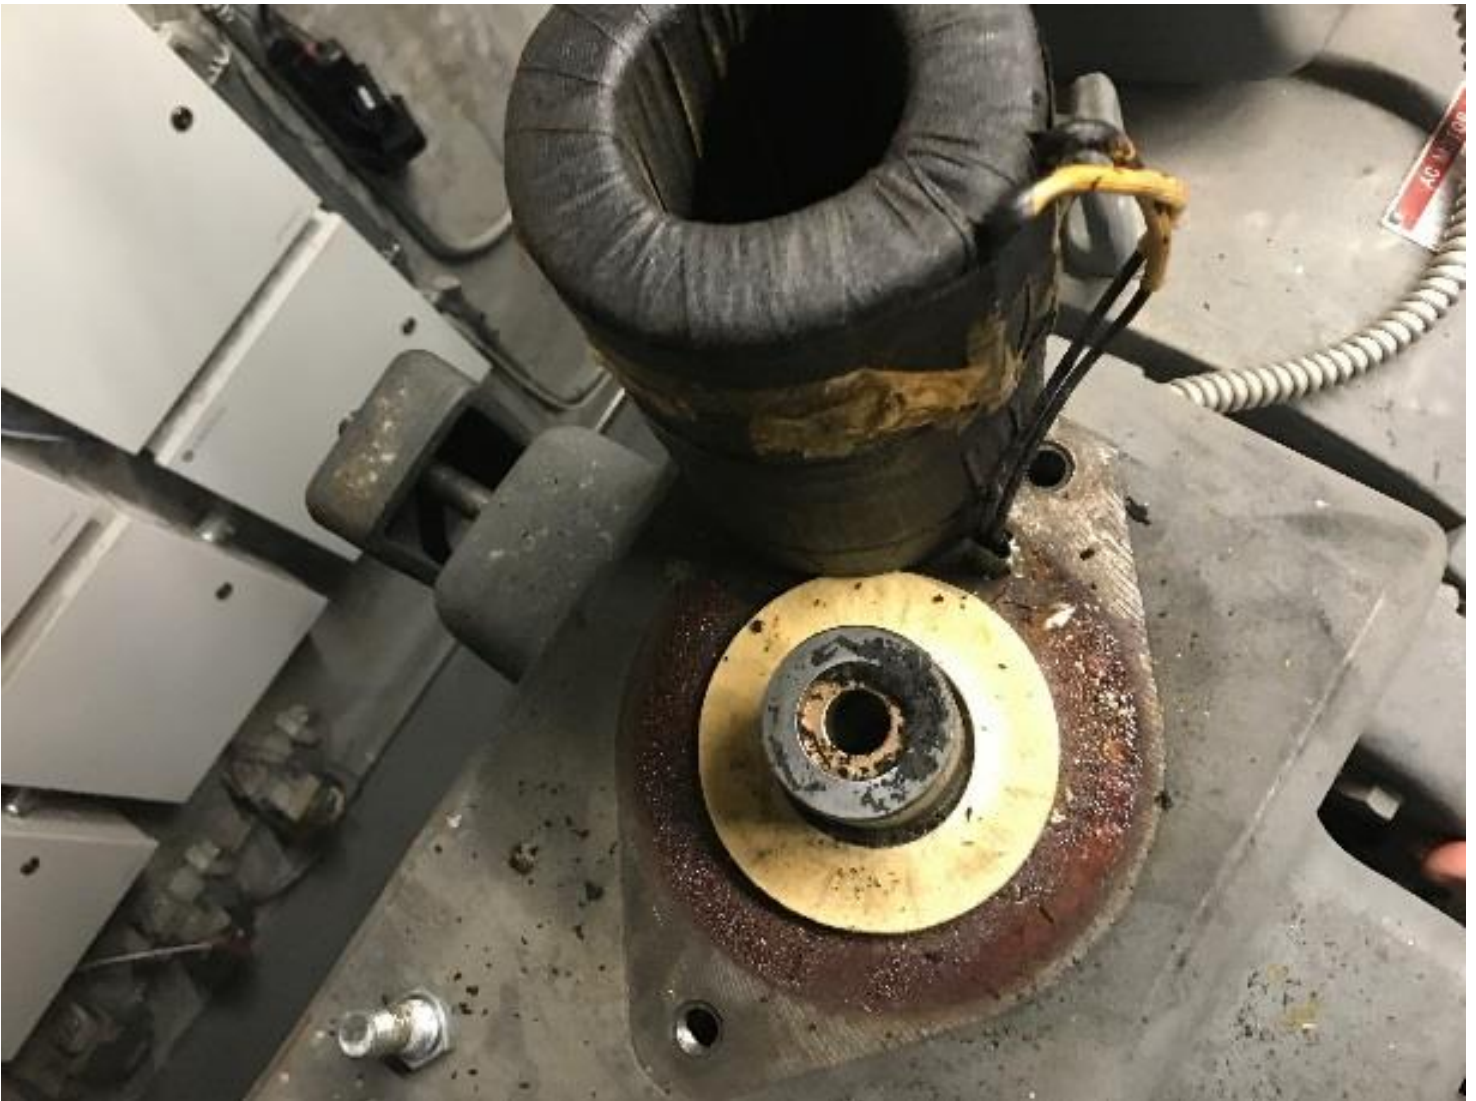
Failure scenario(s)	After the elevator doors opened, with the car and hall sill substantially flush, the brake plunger caused a delay in the brakes engagement. The elevator started to drift up approximately 4" before the brakes were fully engaged and the elevator stopped.
	Facts and evidence	<ul style="list-style-type: none"> • Video obtained from the building security camera captured the incident. • Safety Officer arrived on-site and mechanic had started repair job. Brake plunger assembly was already disassembled. • Mechanic stated they were not aware the repair was due to an incident so they did not wait for a Safety Officer prior to starting the repair job. • Mechanic stated the disintegrated rubber washer had been replaced during a brake upgrade that occurred in the last 12 months. • Brake upgrade was performed by mechanics with proper training (photo 1) • Disintegrated rubber washer left contaminants in the plunger housing (photo 3 and 4) • No clear evidence for what caused the rubber washer to disintegrate.

Photo 3 Machine brake assembly with rubber washer disintegrated to small pieces

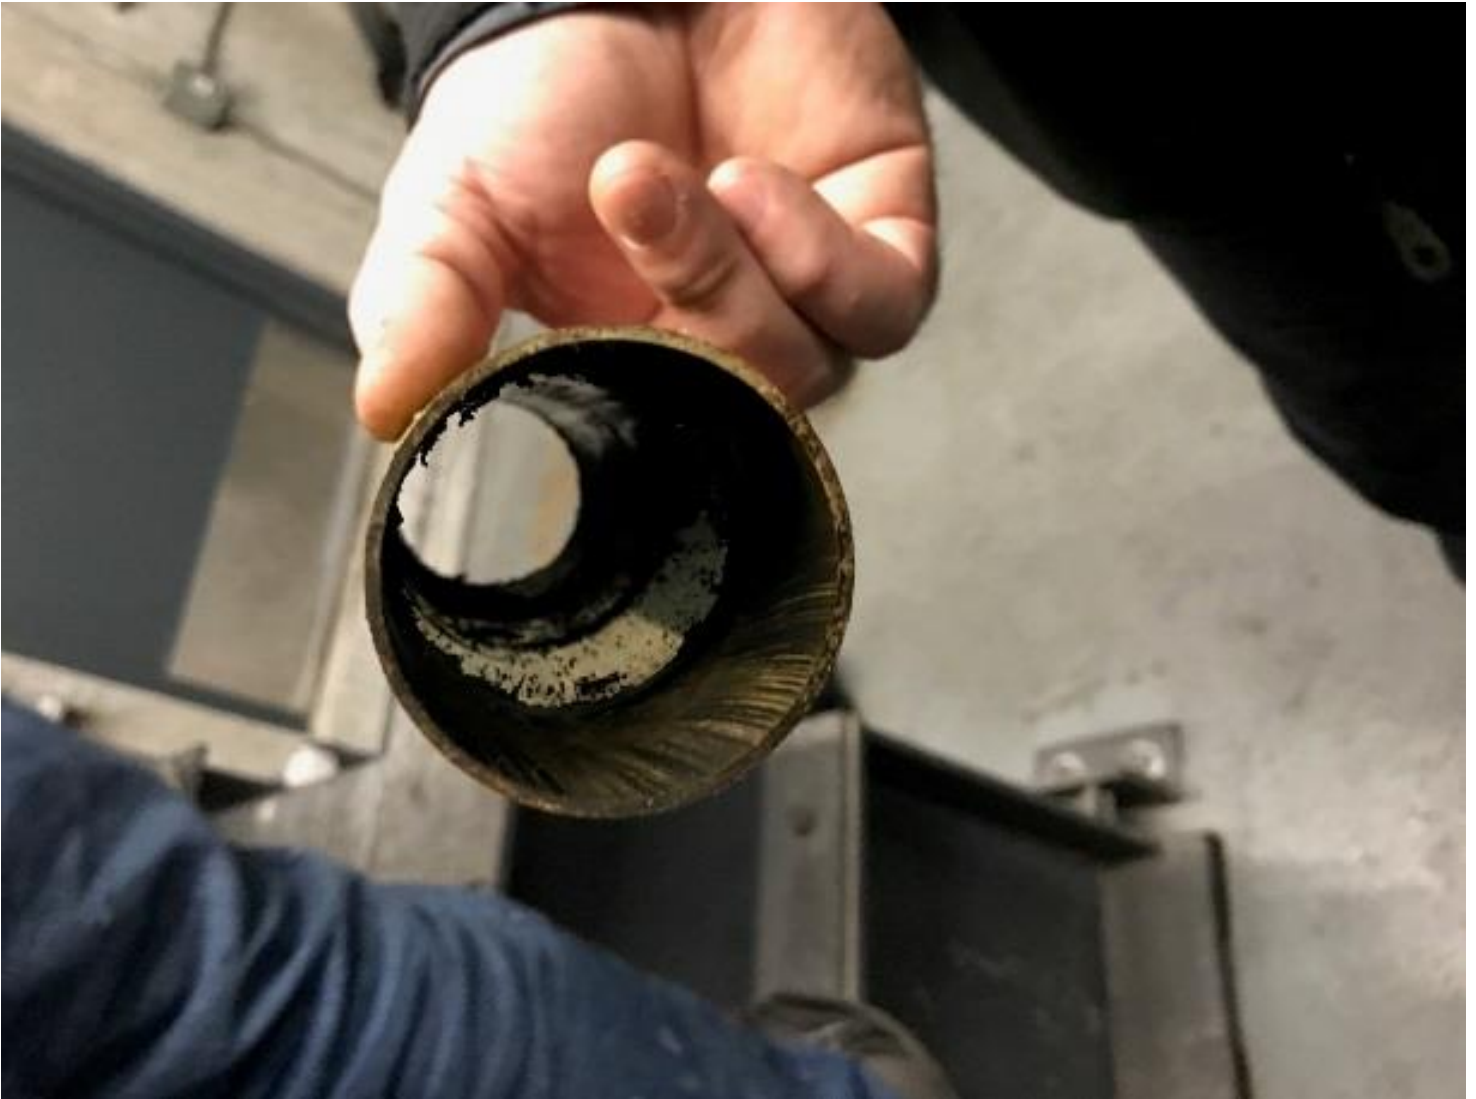
Photo 4 Brake brass sleeve with remnants of the rubber washer
