Incident Summary #II-1102219-2020 (#19872) (FINAL)

SUPPORTING INFORMATION	Incident Date		October 6, 2020
	Location		Quesnel, BC
	Regulated industry sector		Electrical - Low voltage electrical system (30V to 750V)
	Impact Injury	Qty injuries	1
		Injury description	An individual received an electrical shock from an improperly wired generator feeder.
		Injury rating	Insignificant
	Damage	Damage description	None
		Damage rating	None
	Incident rating		Insignificant
Incident overview		A three-phase generator feeder cable was wired improperly causing an individual to receive a shock when they contacted the metal connector.	
INVESTIGATION CONCLUSIONS	Site, system and components		<p>A generator was rented for an industrial site to power electrical equipment during a power outage. This generator has a cable with a connector on the end used to plug into various electrical equipment inside the facility.</p> <p>The cable was installed directly to the circuit breaker terminals of the 600Volt disconnect (at the generator. Images 2 and 3) with a female Arktite connector on the other end (Image 4). The specific connector for this voltage and current combination only allows it to be connected to sa

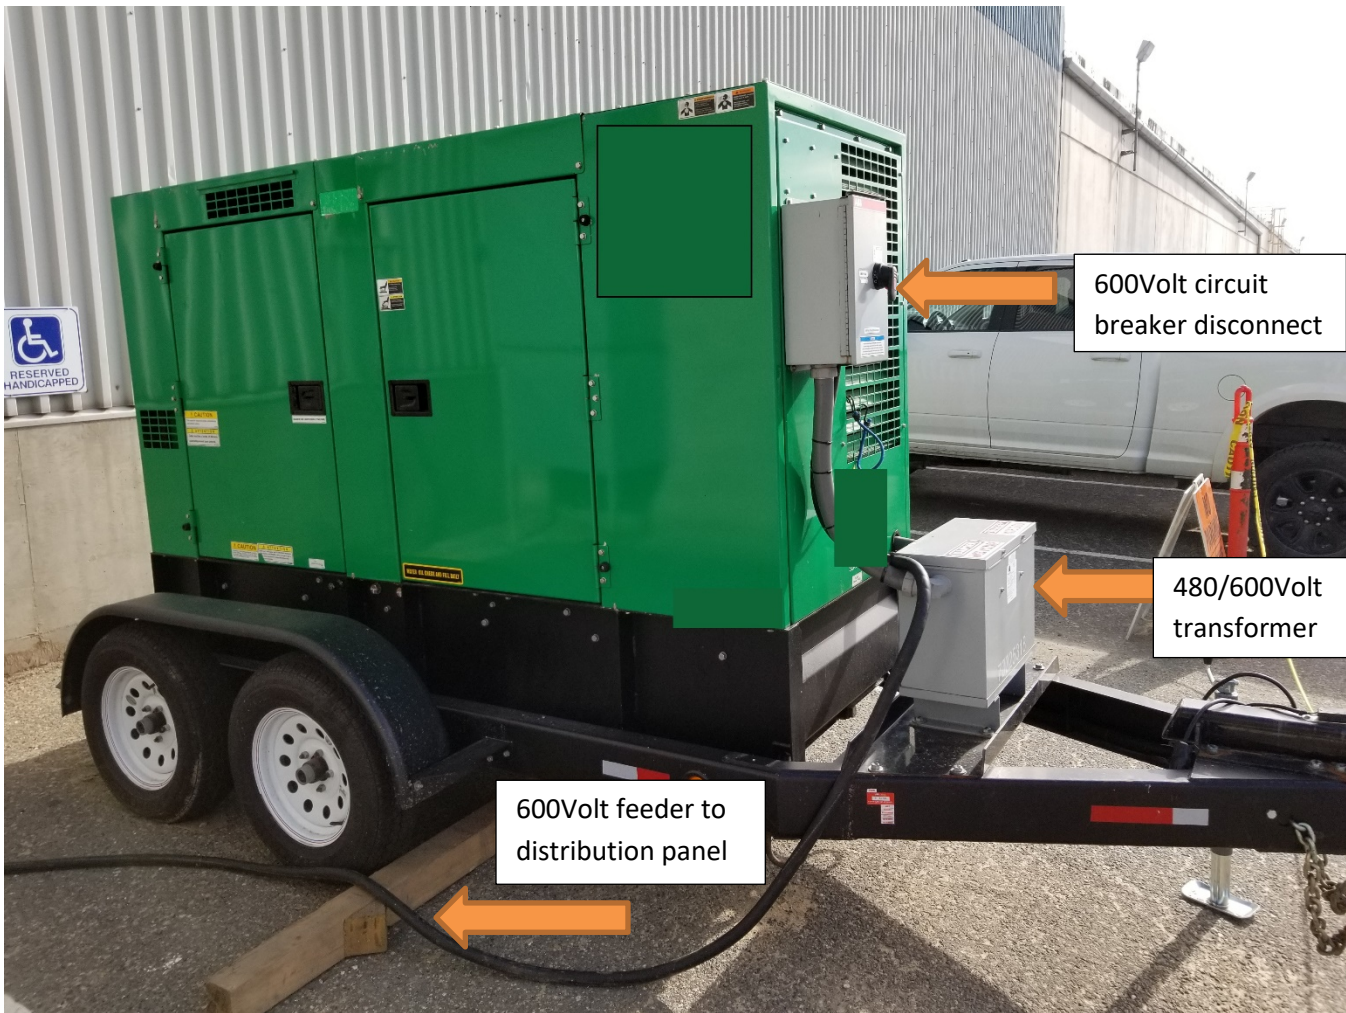
Image 1 - Generator set showing 480/600-Volt transformer and disconnect.

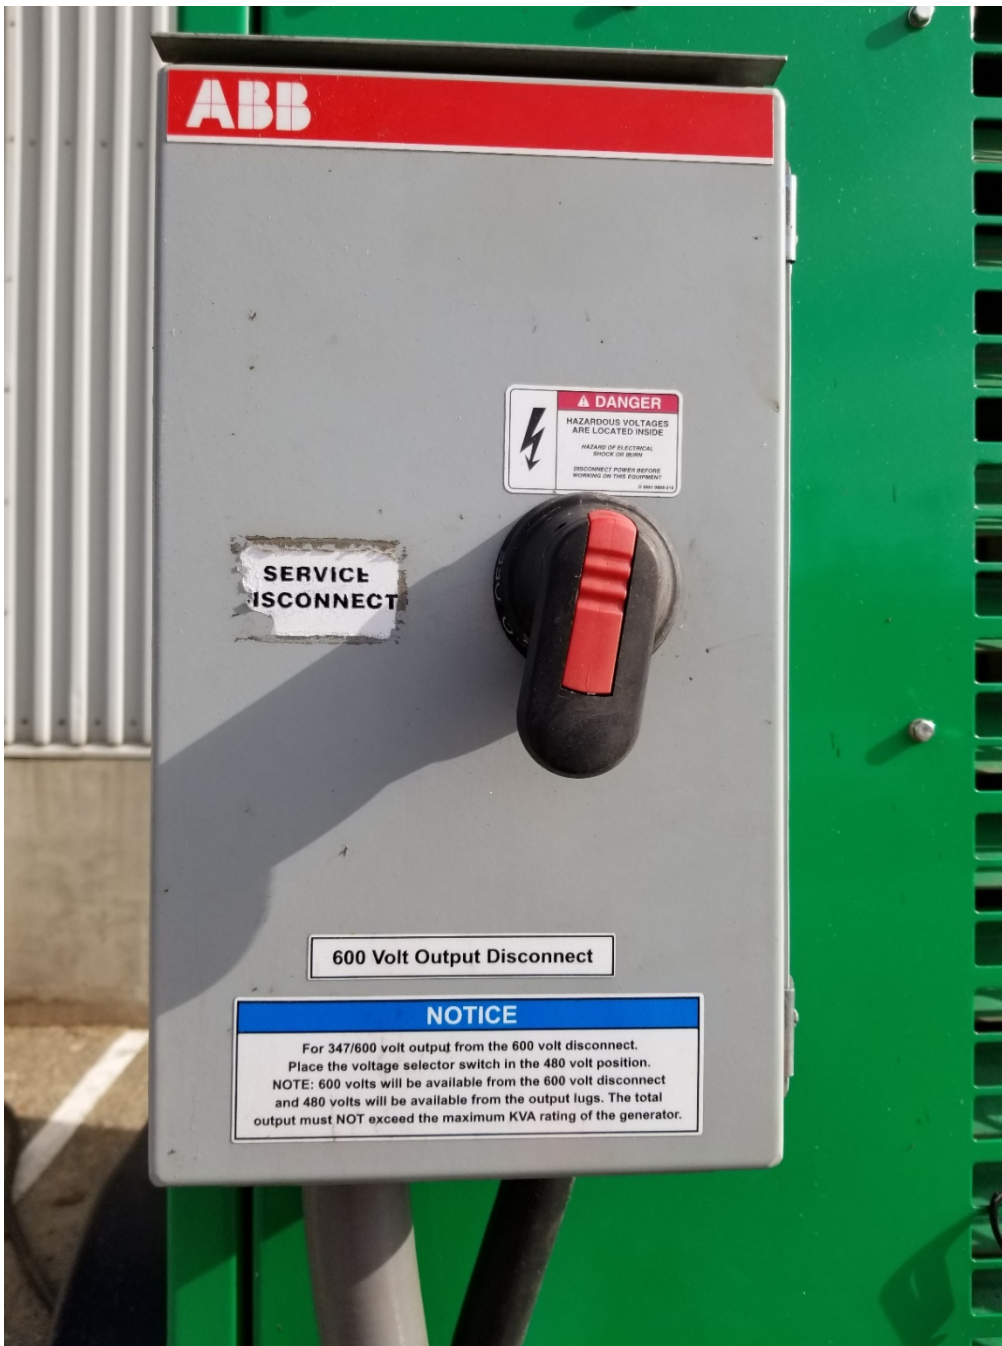
Image 2 - 600Volt circuit breaker disconnect.

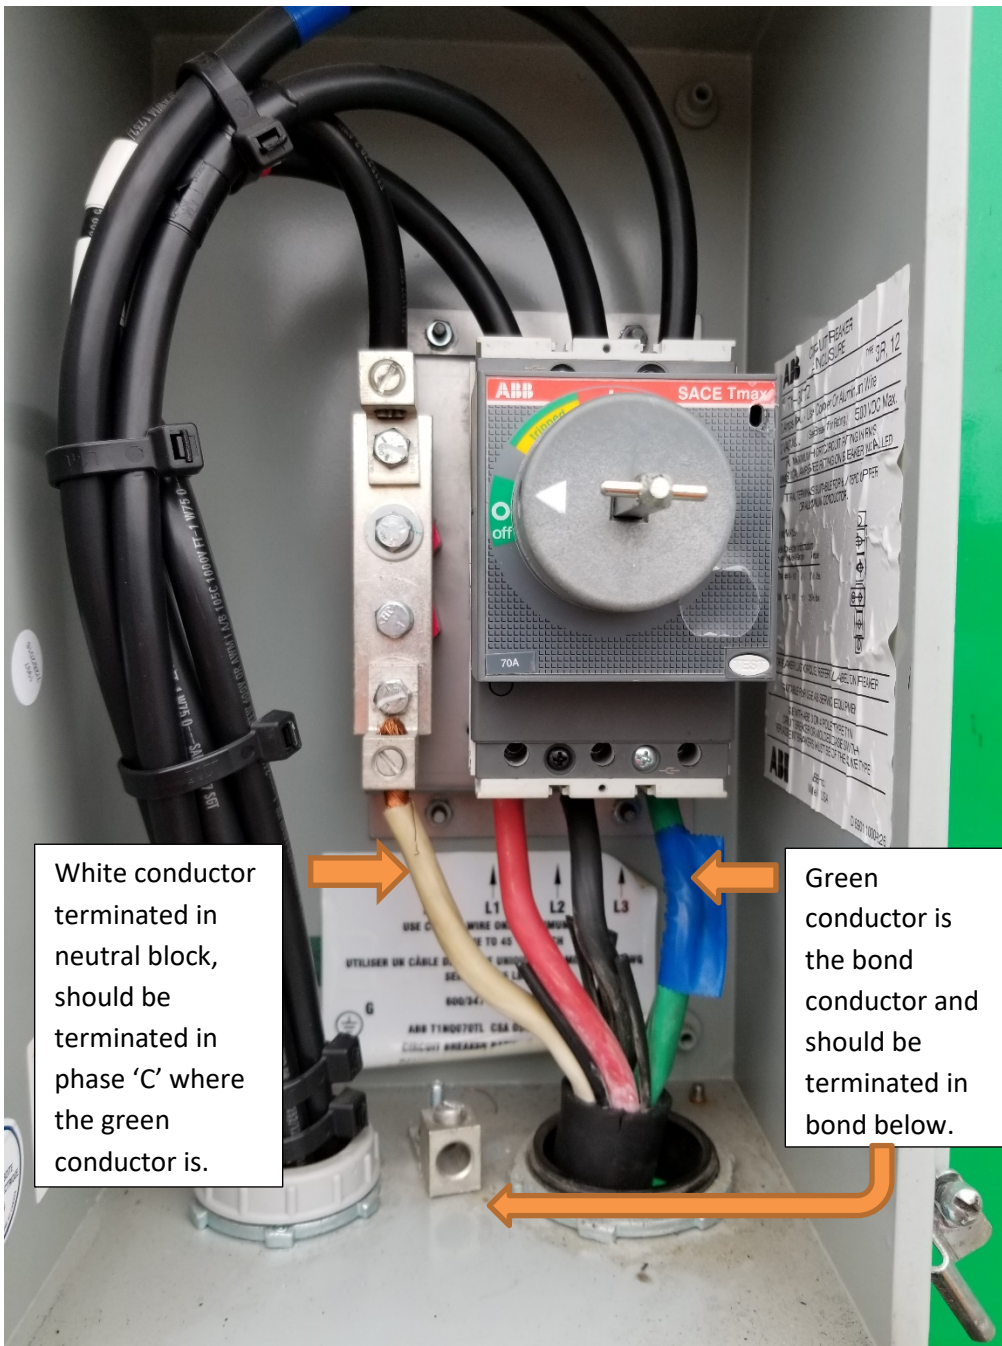
Failure scenario(s)		The cable fed from the generator was not wired correctly. With no connection to ground and all phases isolated from each other, the breaker did not trip, only the incorrect and exposed parts of the connector became energized. As voltage was applied to the green conductor through improper wiring of the cable, that energized the shell of the connector. When the individual handled the connector at the end of the cable, they became the path and received a shock as voltage went through them to the ground.
	Facts and evidence		A picture of the wiring of the breaker at the time of the incident, shows a green conductor (taped blue) connected to the 'C' phase. (Image 3) The proper installation of the green conductor should have been to the ground lug inside the 600Volt

<p>disconnect panel. The white conductor (normally used for phase 'C') was installed on the neutral terminal, however the 600Volt equipment did not require the neutral so this connection was incorrect. The proper installation of the white conductor should have been to the phase 'C' terminal (which should have been taped blue).</p> <p>The connector end of the cable (Image 4) remained unchanged and wired as per normal with the 3 phase conductors being red, black, white (identified blue) and the ground (green). With the green conductor bonded to the metal parts of the connector, and incorrectly installed in the phase C terminal, 600Volts would have been present on the metal parts of the connector leading to a shock when the ground path was completed (i.e., the individual handling the connector).</p> <p>Through interviews the following events and information was confirmed:</p> <ul style="list-style-type: none"> • The individual who wired the cable was not an electrician. • The welding machine at the site was reported as not working when plugged into the distribution panel, prompting an individual to unplug the welding machine. • The individual who unplugged the welding machine, unplugged the generator connector from the distribution panel and plugged the generator connector into the welding unit directly receiving a mild shock. • Following these events, a certified electrician was called to investigate.

Image 3 - Incorrect wiring of cable in 600-Volt circuit breaker disconnect.

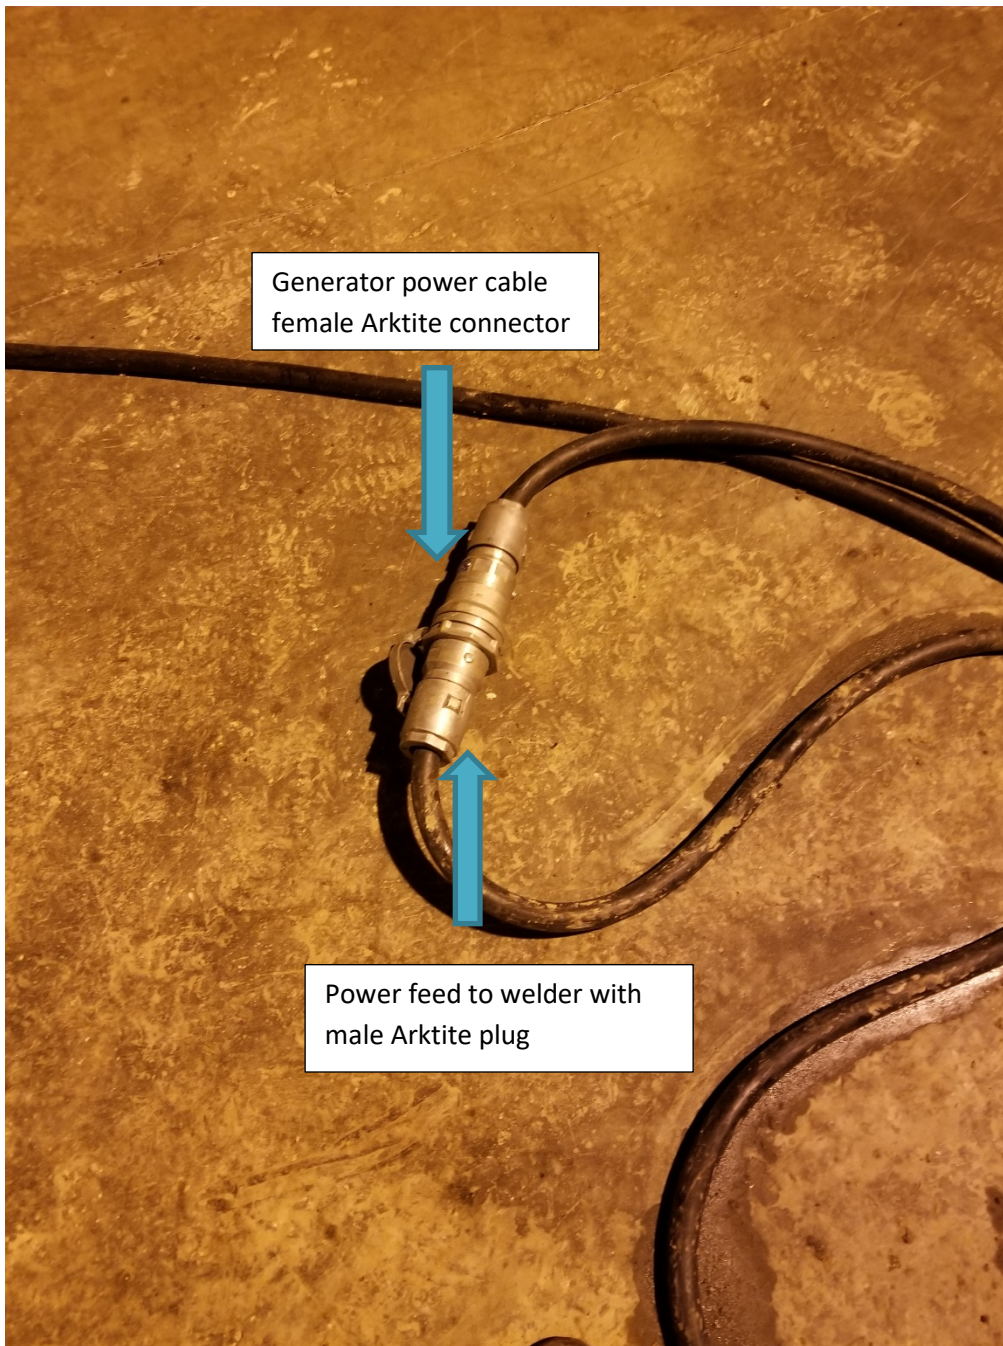
Image 4 - Cord end Arktite connector where individual received shock.
