Incident Summary #II-1263531-2021 (#24279) (FINAL)

Incident Date		October 2, 2021
SUPPORTING INFORMATION	Location		Abbotsford B.C
	Regulated industry sector		Gas - Natural gas system
	Impact Damage Injury	Qty injuries	0
		Injury description	N/A
		Injury rating	None
		Damage description	A Damaged, leaking copper gas line feeding a range
		Damage rating	Moderate
	Incident rating		Moderate
	Incident overview		A broken copper gas line behind a residential range, resulted in a kitchen fire.
INVESTIGATION CONCLUSIONS	Site, system and components		 ¹/₂" copper tubing was used to run gas from the basement furnace room to a gas range installed in a residential kitchen. Copper tubing is commonly used to run gas lines to appliances in residential homes. It is important that copper tubing is protected from mechanical impact, stress, punctures etc. It also needs to be clamped and supported so that the tubing cannot be subject to movement which can result in damage to the tubing. Moveable appliances such as gas ranges may be connected to the gas supply using a flexible gas connector. These gas connectors must only be connected to clamped and supported piping and tubing so that any movement is li

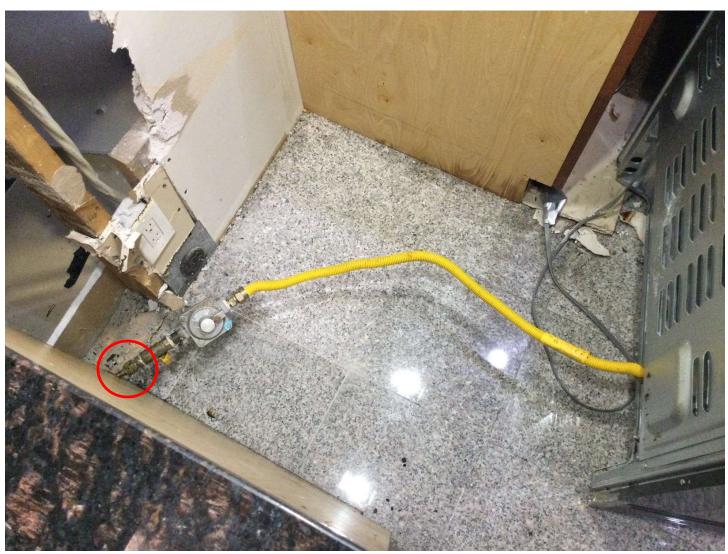
Picture 2- The flexible gas connector can be seen connected to the gas supply. The piping/ regulator was not clamped to the rear wall, this caused the assembly to pull forward straining the copper tubing against the edge of the cabinet. (copper tubing against cabinet circled in red)

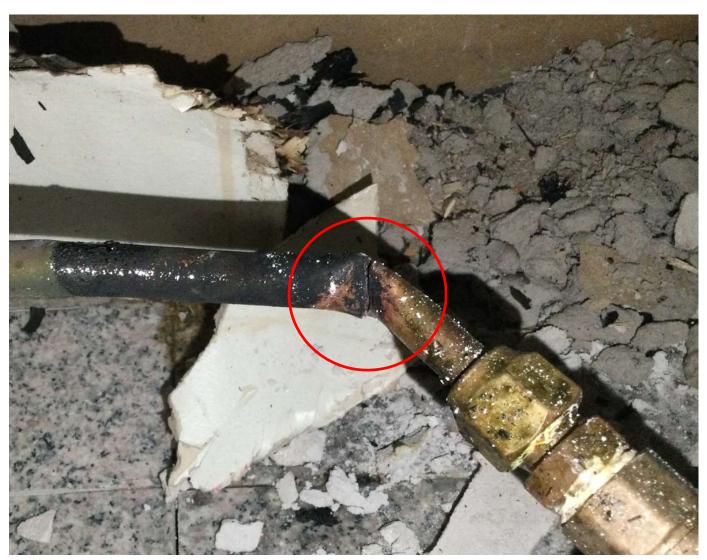
Picture 3- Close examination of the copper tubing shows a break where the tubing was kinked/creased.

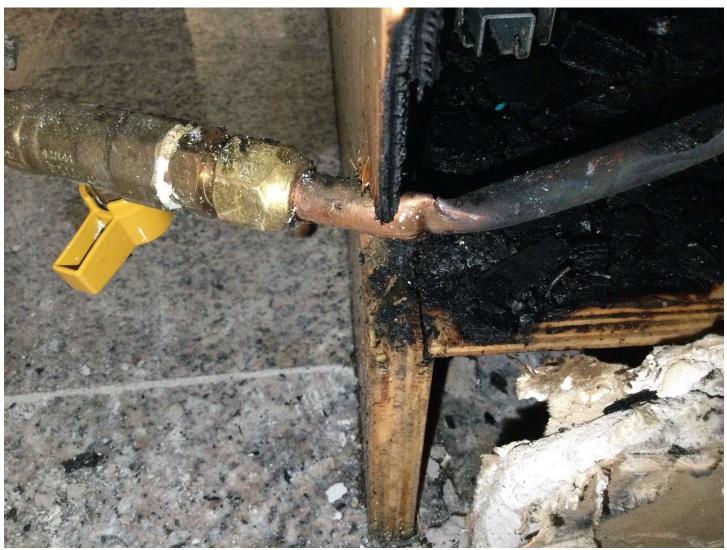
Picture 4- Picture above taken from behind cabinet where the tubing can be seen pushed up tight against the edge of the cabinet.
